Journal of Environmental Engineering

Volume 115 Number 3 June 1989

RADON REDUCTION IN CRAWL SPACE HOUSE

By Michael C. Osborne,¹ Associate Member, ASCE,
Dwight G. Moore, Jr.,² Robert E. Southerlan,³
Terry Brennan,⁴ and Bobby E. Pyle⁵

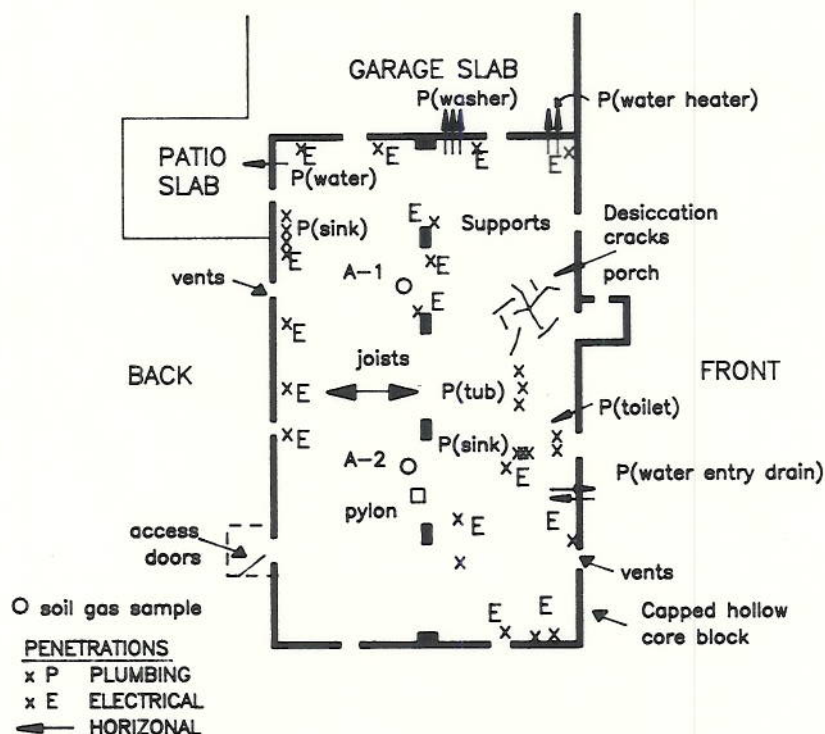
FIG. 1. Diagram of a Crawl Space

The residence which was selected for a detailed mitigation study was relatively free of complicating factors. The house is located in Hermitage, Tennessee, and is an 1,100-sq ft (102.2-m²) ranch style house built in 1962. It is a brick structure with a hollow core block foundation. The height of the foundation wall varies from 24 to 40 in. (0.61 to 1.02 m). The house is heated by a radiant heat system in the ceiling and cooled by a window air conditioner (no ductwork). Foundation vent cover plates and a tight-fitting access door allow good sealing of the crawl space area. Major radon entry points into the living area from the crawl space are limited to plumbing penetrations, including a 6 × 10-in. (15.2 × 25.4-cm) hole under the bathroom tub and electrical penetrations. A diagram of the crawl space is shown in Fig. 1.

Bare soil was exposed in the crawl space (no moisture barrier). It is A and B horizon Maury loam, a phosphatic, clayey-silty soil derived from the Middle Ordovician Bigby-Cannon formation. Desiccation cracks up to 1/4 in. (0.64 cm) wide are present in parts of the crawl space.

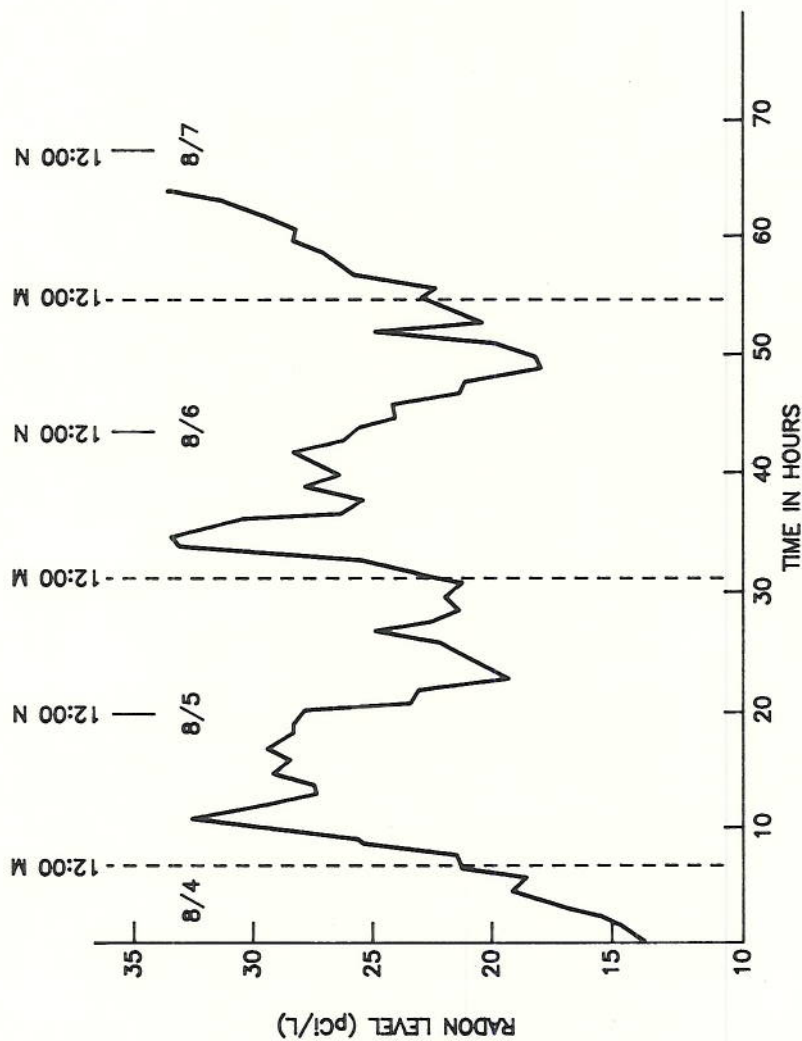
FIG. 2. Premitigation Radon Levels, Crawl Space

The CR test showed an average radon level of 25.3 pCi/L in the crawl space, with a low of 18.1 pCi/L and a high of 33.7 pCi/L (Fig. 2). The Pylon intake was 1 ft above the crawl space floor. The soil samples showed 130.5 and 143.2 pCi/L. The sample from the desiccation crack showed 42.2 pCi/L. Short count grab samples and activated carbon tests of the living area showed 3.0 pCi/L or less. A slightly higher value was found in the bathroom linen closet (3.3 pCi/L) and extracted from an electrical outlet in a closed-off bedroom (4.3 pCi/L).

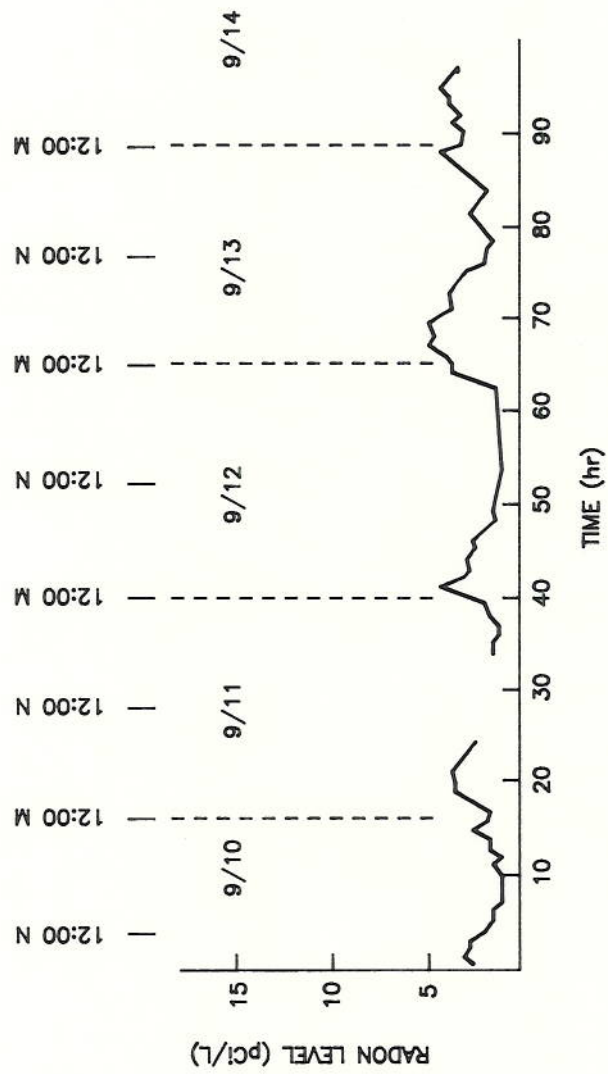
FIG. 3. Radon Levels, Crawl Space, Subplastic Suction, Foundation Vents Closed

the premitigation average of 25.3 pCi/L to an average of 2.2 pCi/L (Fig. 3). With the foundation vents open, the radon level was lowered further, averaging 1.5 pCi/L.

Next, the plastic film was sealed over the crawl space floor and the sub-plastic suction system installed. When suction was applied to the system, radon levels in the crawl space (foundation vents closed) were reduced from

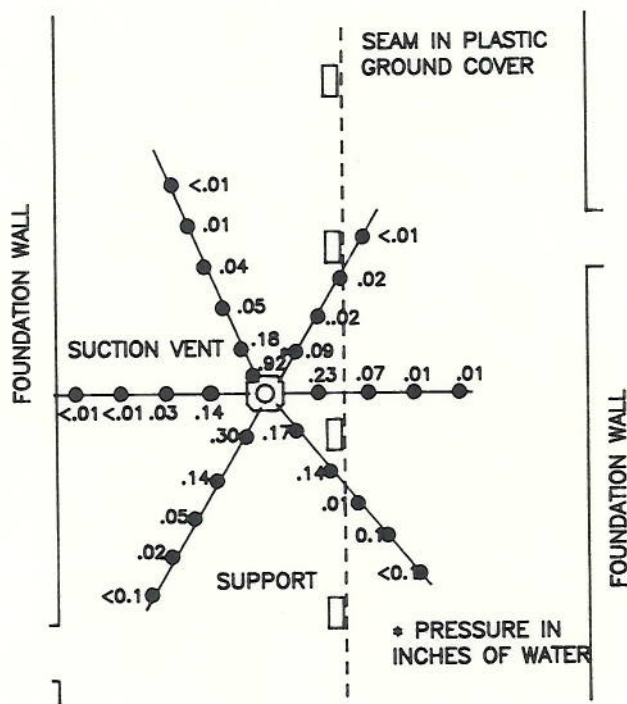
FIG. 4. Subplastic Depressurization, Crawl Space

The exhaust rate and static pressures in the vent system and below the plastic film were measured after 72 h of continuous fan operation. The exhaust rate, measured on the roof with an air bag, was 36.3 cfm (61.7 m³/hr), well below the maximum capacity of the fan. The static pressure in the exhaust vent, measured in the attic at the fan inlet, was 0.96 in. (2.34 cm) of water. Pressure in the vent 2 ft (0.61 m) above the crawl space floor had dropped to 0.92 in. (2.34 cm) of water and held at 0.92 in. (2.34 cm) of water in the gap just below the suction vent. Static pressures under the plastic film showed a sharp drop from the vent, declining to less than 0.01 in. (0.254 mm) of water at distances of 8–10 ft (2.44–3.05 m) from the vent. A subplastic pressure diagram is shown in Fig. 4.
