A SIMPLE APPROACH TO ASSESSING COPPER PITTING CORROSION TENDENCIES AND DEVELOPING CONTROL STRATEGIES

Daniel Williams, Darren A. Lytle, and Colin White

U.S. Environmental Protection Agency, ORD, NRMRL, WSWRD
26 W. Martin Luther King Dr.
Cincinnati, Ohio 45268

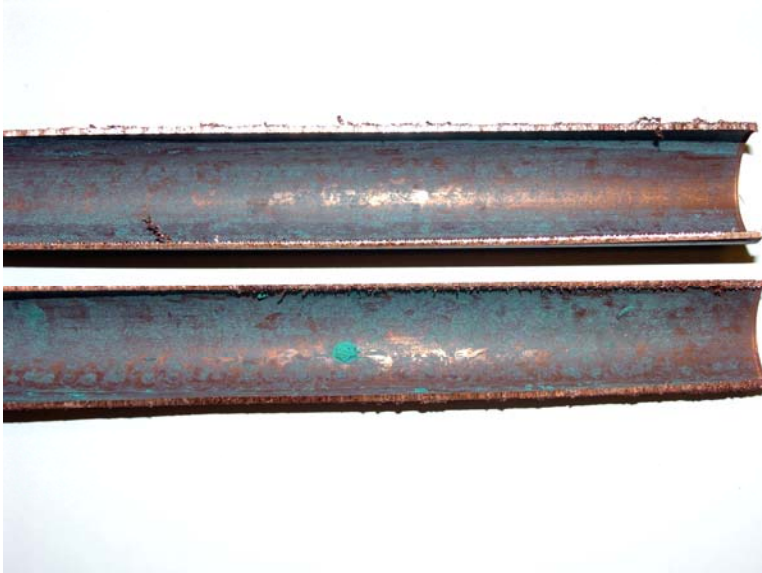
The first notable surface change was the formation of a blue-green colored corrosion deposit mound after only 72 days into the study. Corrosion deposit mounds are of particular interest and importance because they could represent a pit cap that covers an active site of localized corrosion attack. The pipe was not removed for advanced materials analysis at that time but, rather, it was left in place to permit further development.

Pipe sections were re-examined at 101 days. No distinct visual differences were noted between the internal pipe surface at 72 and 101 days. The corrosion by-product mound discovered at day 72 on the untreated pipe section was still present and did not appear to have changed in shape and size. The pipes were then removed for surface and solids analysis, and replaced with new sections.

FIGURE 3. Interior surface of copper pipes removed after 101 days:

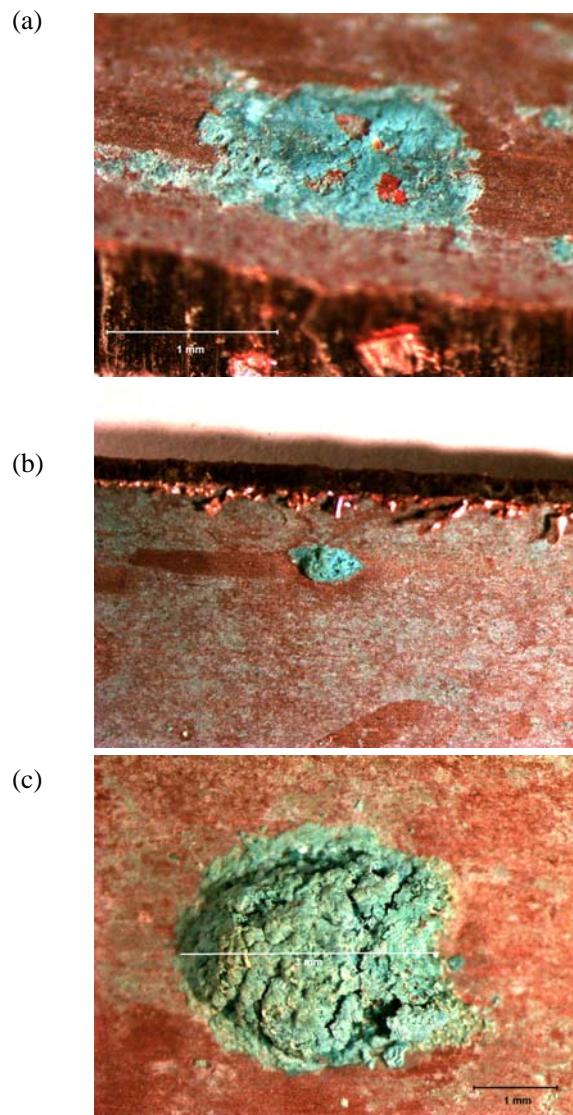
The removed pipe sections were photographed, and then longitudinally cut with a band saw while still wet. Experience has shown that if pipes are permitted to dry before cutting, vibrations associated with cutting can more easily dislodge corrosion by-products on the interior surface of pipes. A number of imperfections and other areas of interest on the pipe section surface were cross-sectioned for detailed analysis (Figure 3). Of particular interest was the large corrosion by-product mound previously noted (Figures 3 and 4c). The mound was approximately 3 mm in diameter, was blue to green in color, and appeared to be partially covered with a cream-colored solid. A cross sectional image through the mound clearly revealed the fact that localized corrosion was taking place below the mound (Figure 5a). The cross section image also showed all of the features of classic pitting corrosion attack: the pit cap, thin membrane, and the pit. The pit cap was as much as 0.75 mm thick, consisted of blue/green solids and had a hollow center core. A thin membrane of dark orange material (likely cuprite, Cu_2O) separated the cap from the pit. The membrane was approximately 0.2 mm deep, or 25% of the copper wall thickness at the cross section. The pit appeared to be full of more clearly defined crystals (appearing cubic in shape under high magnification viewing) that were dark orange in color (likely cuprite crystals). There were also a few areas within the pit that contained a white/green colored solid.

FIGURE 4. Stereomicrographs of areas on interior surface of the copper pipe that may indicate site of pitting corrosion (after approximately 101 days).

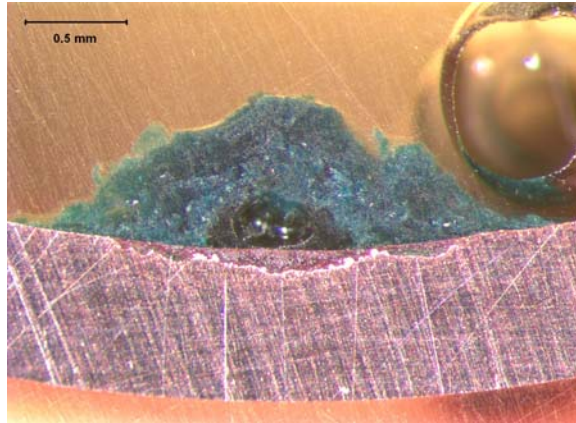
(a)

FIGURE 5. Large mound of corrosion deposits on surface of copper pipe. Cross section cut through the deposits clearly shows that localized corrosion is taking place beneath. Depth of attack at this particular cross section is nearly 20% of pipe wall thickness (after approximately 90 days).

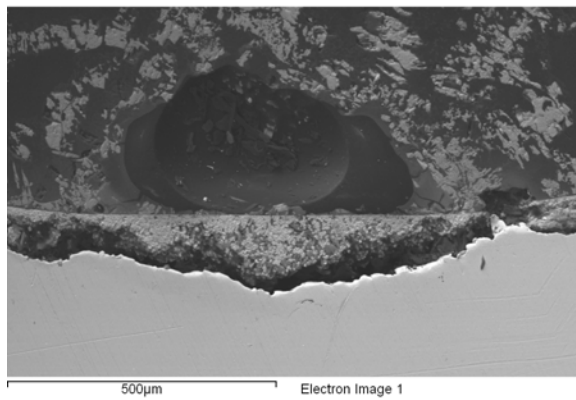
(b)

SEM imaging of the cross section of the large pit (Figure 5b) provided more detail regarding the structure and morphology of the area of localized attack. The pit located below the pit cap was approximately 0.15 mm (150 μm) deep. The thin membrane that separated the cap from the pit was copper rich. Where active, elemental chlorine (most likely a chloride compound) was found at the base of the pit, indicating that the pit must be a very important parameter with respect to pit propagation. Similar mapping analysis was also performed on a smaller pit. The pit cap was 0.32 mm thick, and the pit was 50 μm deep.
