# Progression of Clogging in a Permeable Pavement Parking Lot

*Thomas P. O'Connor, P.E., BCEE Environmental Engineer  
Stormwater Management Branch, Water Infrastructure Division*

# Edison Environmental Center Permeable Pavement Research and Demonstration Site

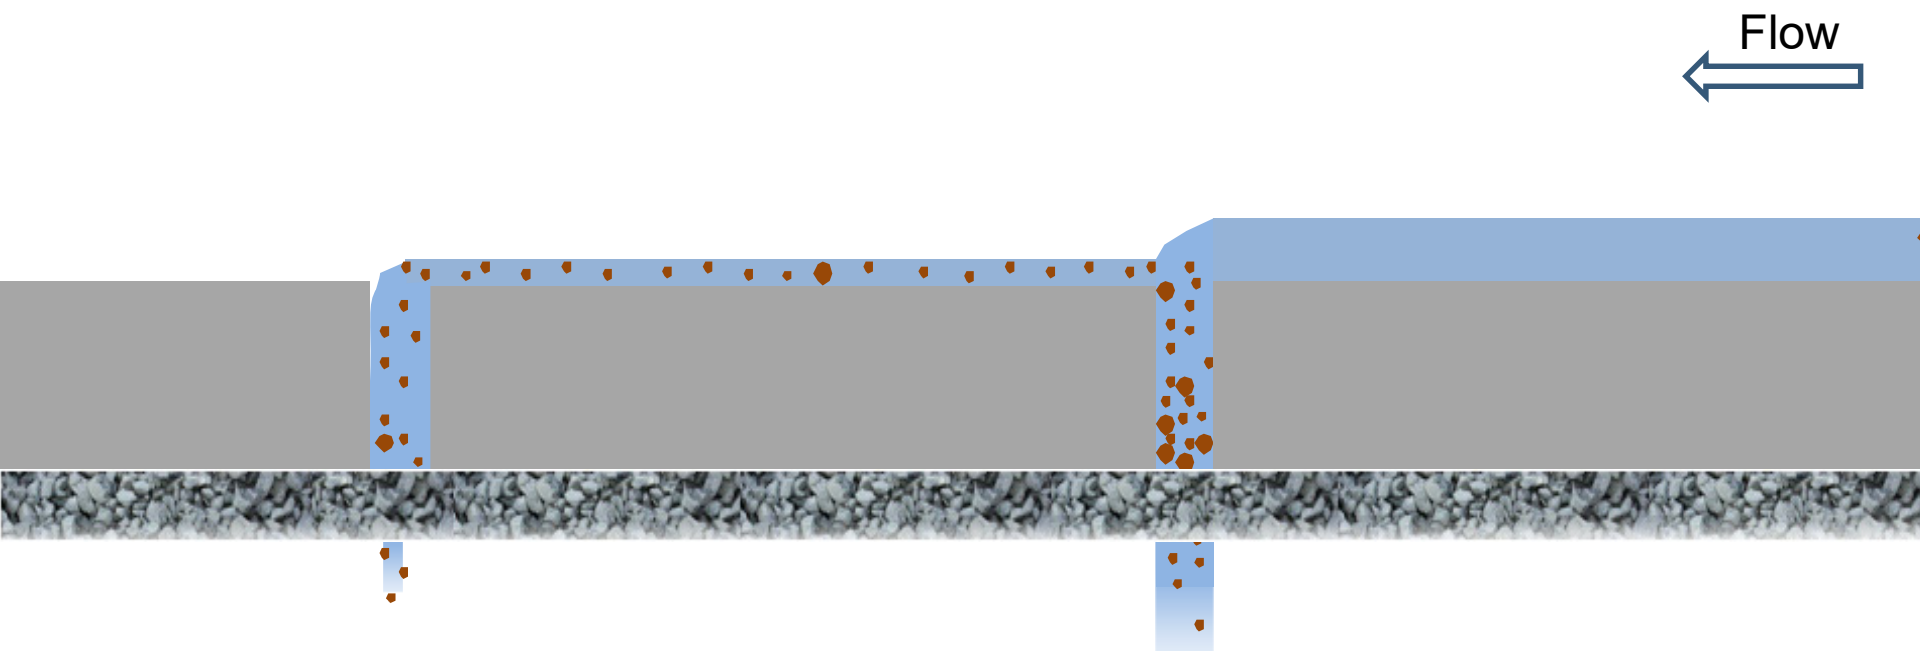
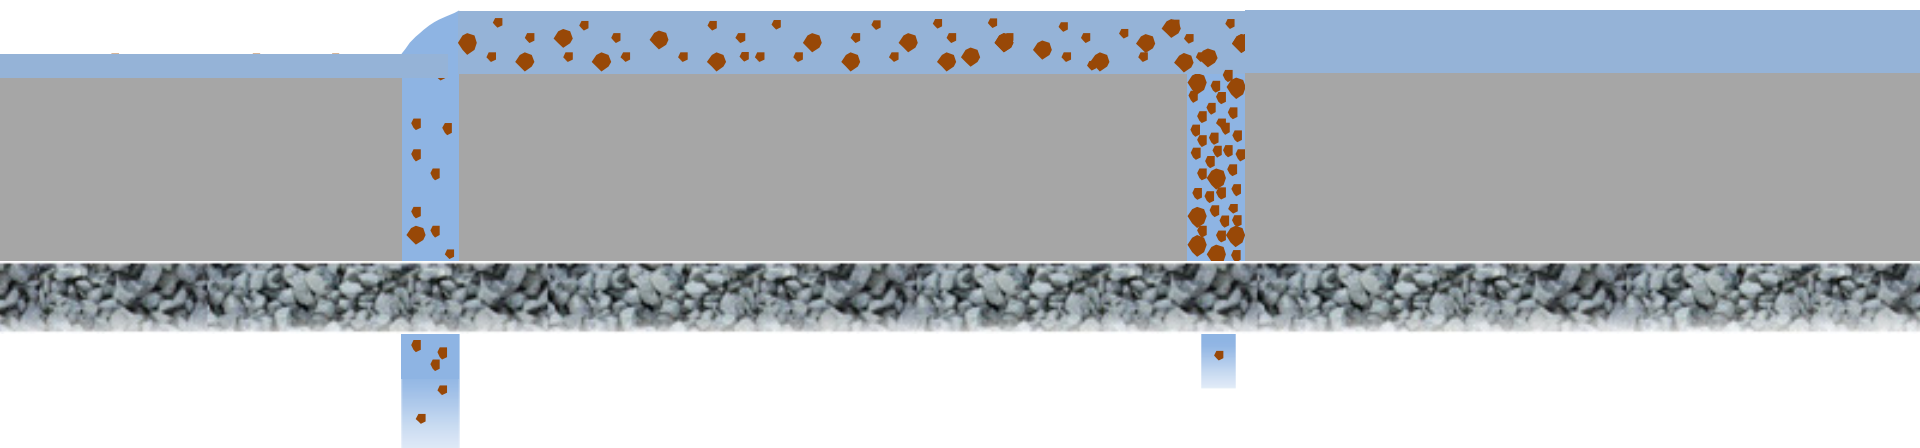
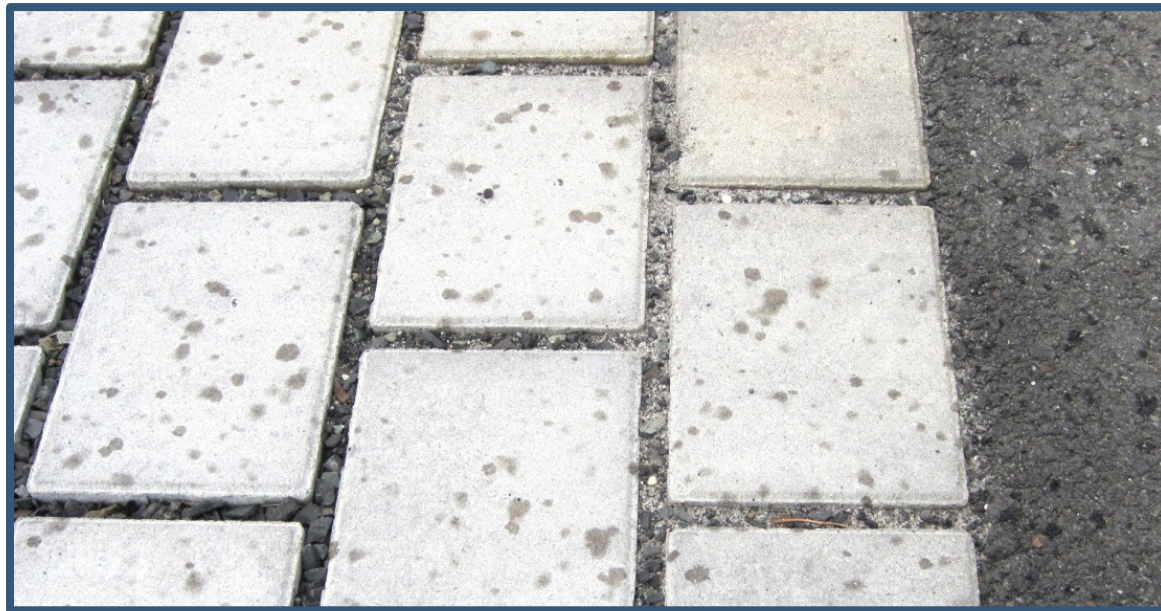
# Hypothesis of Clogging Process

**As gaps fill with sediment, up gradient locations clog and downgradient infiltration rates remain high.**

**Sediment accumulates (and clogging progresses) from the upgradient edge.**

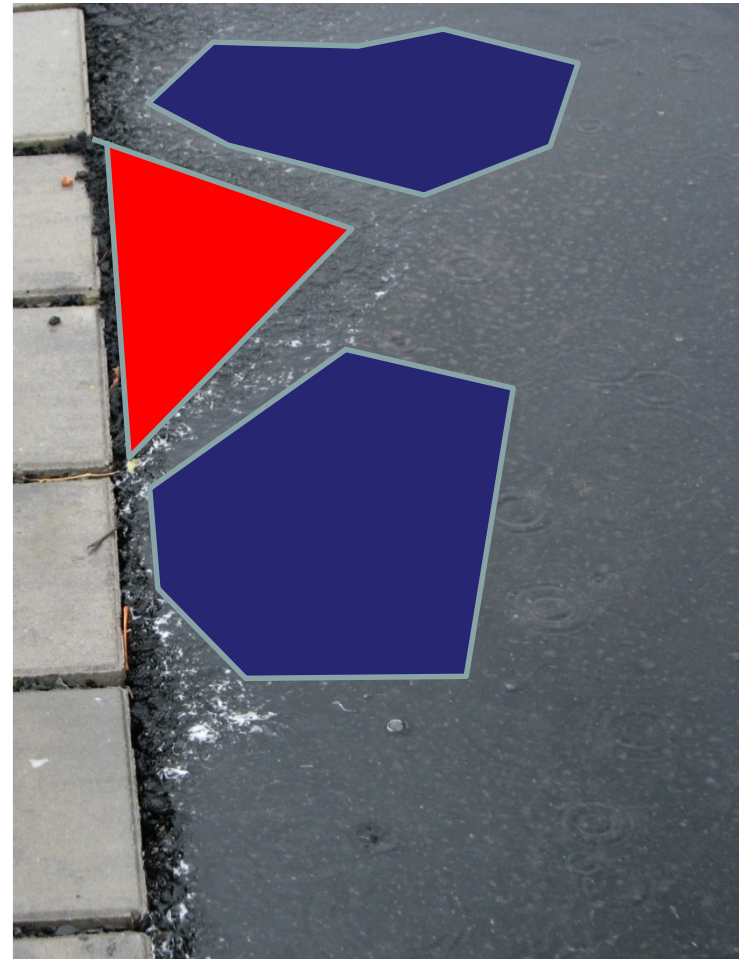
# Observation of Micro-topography and Concentrated Flow

**Red** – high spot prevents runoff from reaching permeable surfaces.

**Blue** – low spots concentrate flow.

The concentrated runoff is more likely to carry particles that clog permeable surfaces.

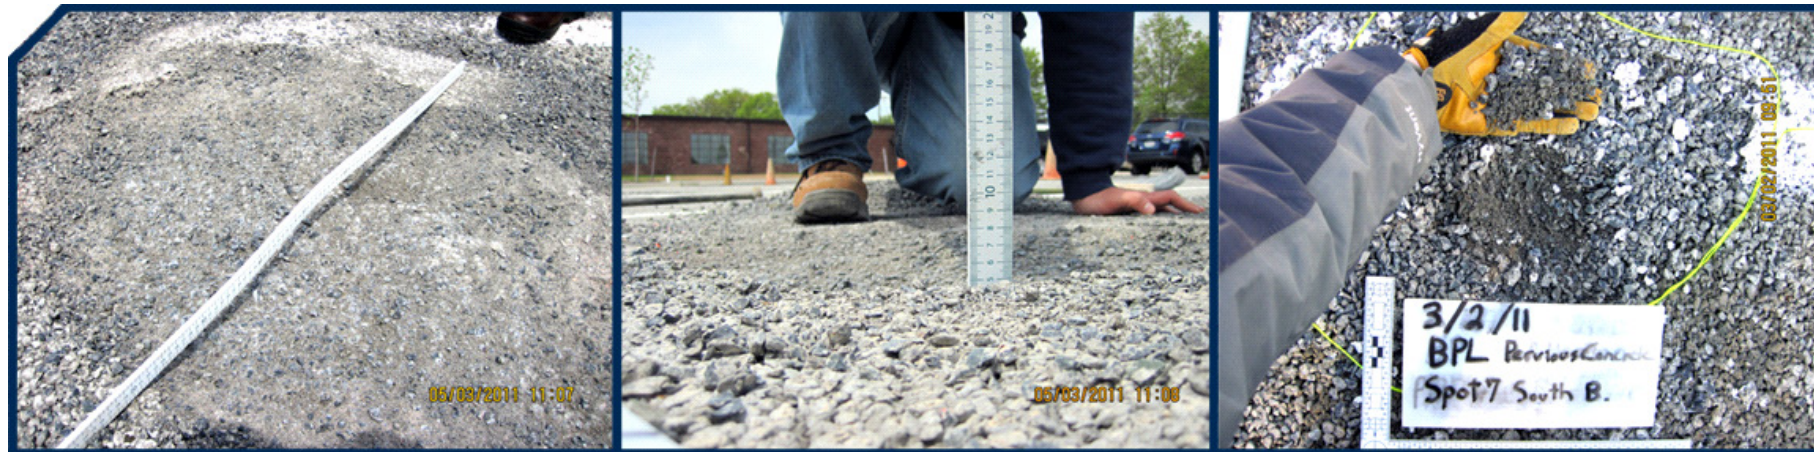
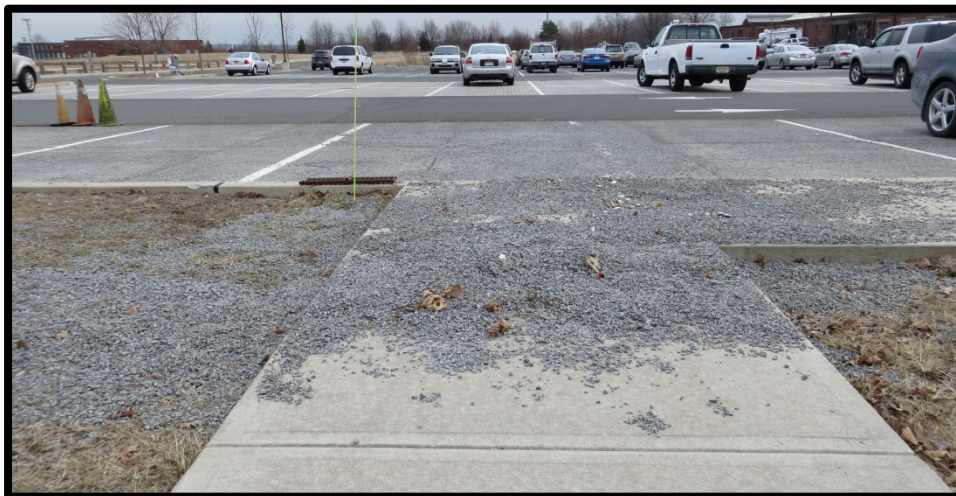
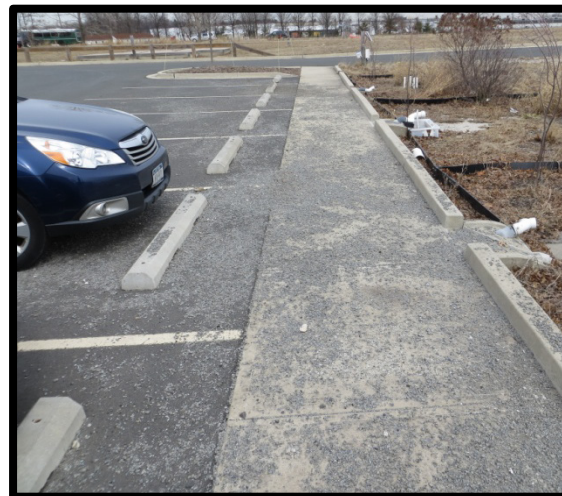
# Disaggregation of Pervious Concrete

Large portions of the pervious concrete disaggregated. The problem first became apparent about 18 months after pouring concrete. It was repaired by the contractor in May 2011, but recurred more extensively in 2014.

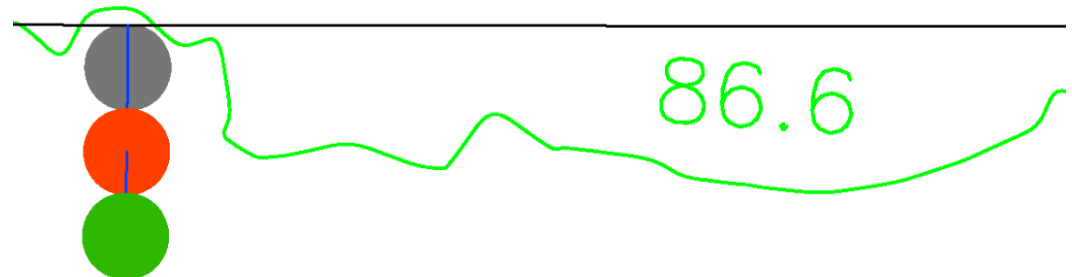
## Zoom of First Clogged Location

Clogged condition occurred  
577 days after installation.

The 86.6 ft contour line  
crosses into driving lane.

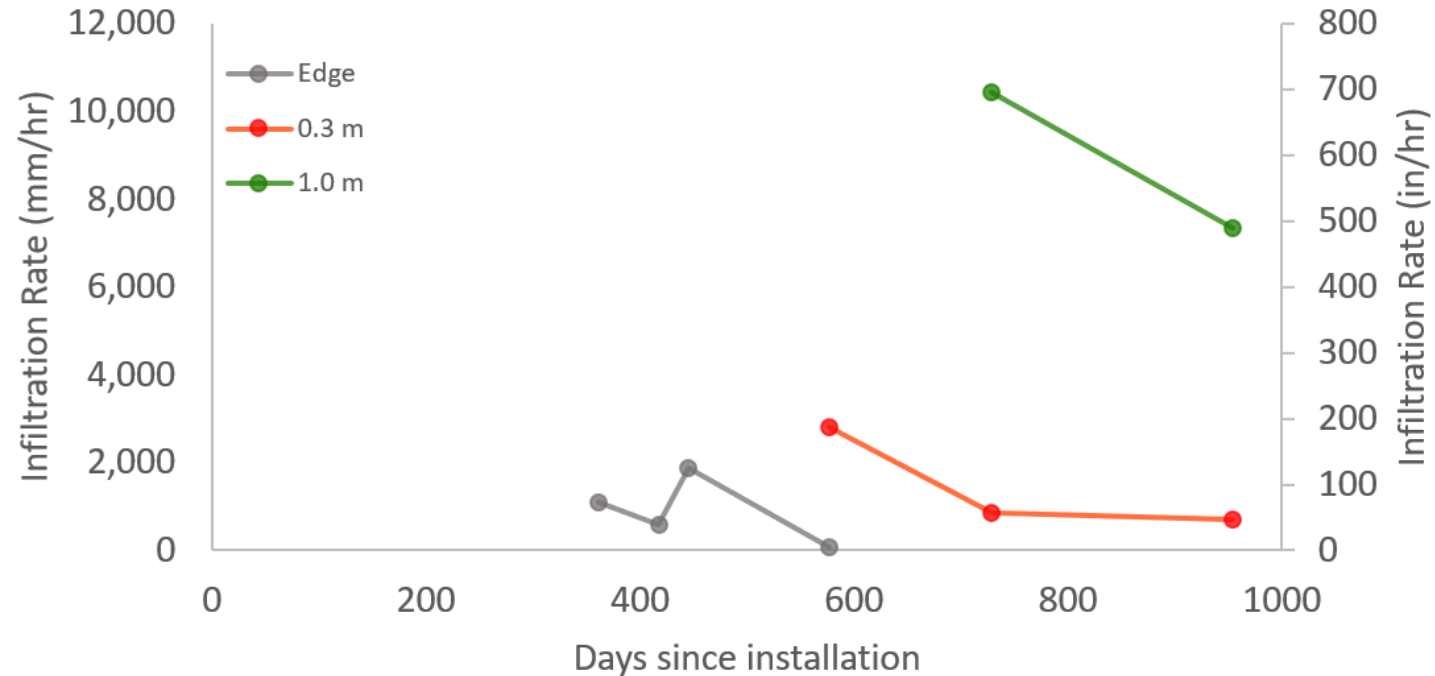
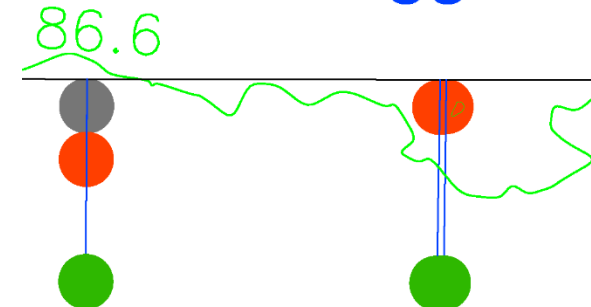
# Second Clogged Location

Clogged condition occurred 577 days after installation.

The 86.6 ft contour line crosses into driving lane.

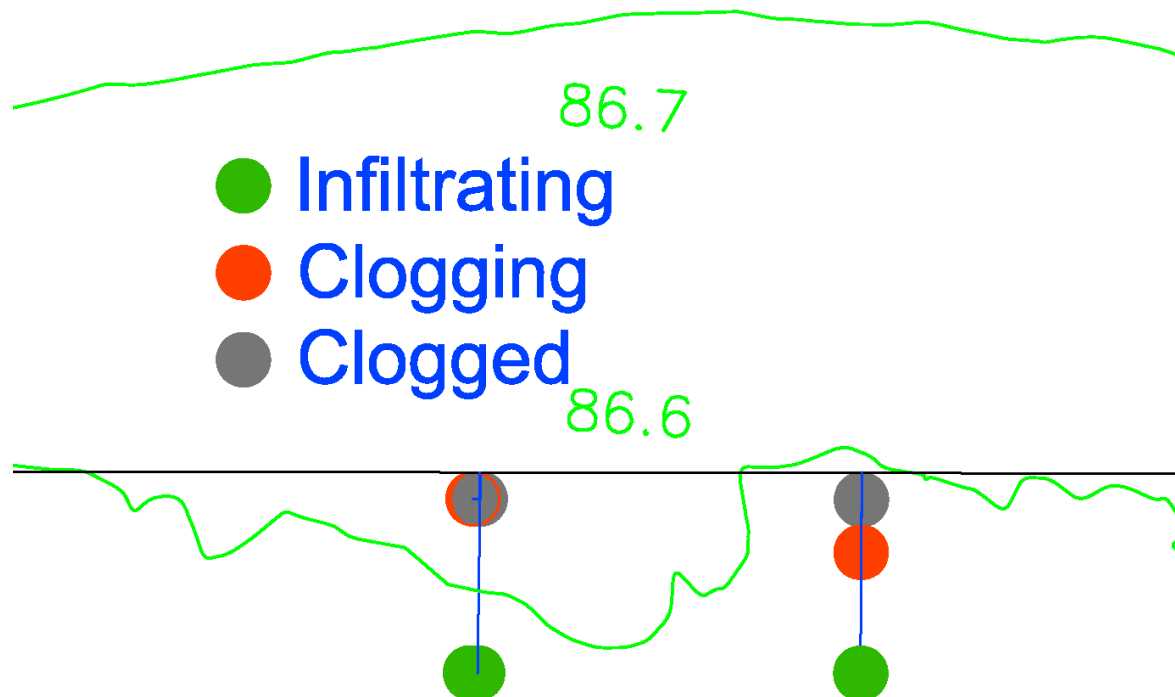
# Zoom for Third Clogged Location

Third location is **Clogged** 728 days after installation.

The 86.6 ft contour line not predictive while 86.7 ft contour line is.

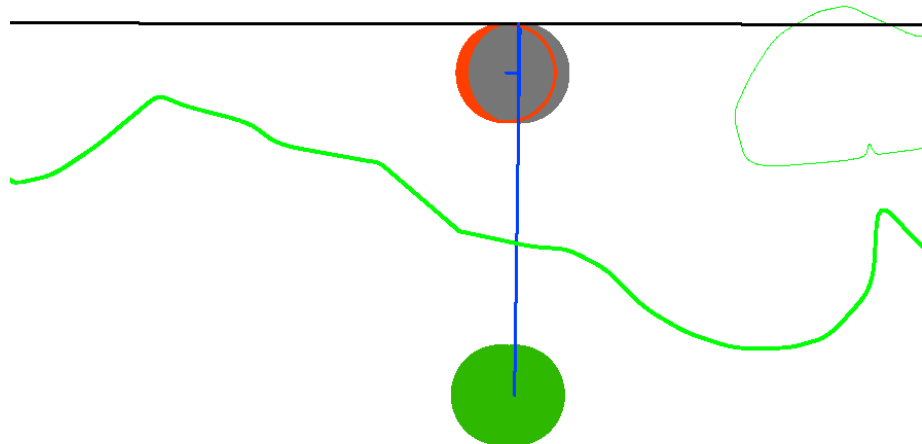
# Small Changes in Testing Location Affect Results

**Clogged** 728 days after  
installation; however,  
slightly west (0.13m) 954  
days after installation only  
**Clogging**.
