# Linking Changes in Management and Riparian Physical Functionality to Water Quality and Aquatic Habitat

Don Kozlowski<sup>1</sup>, Sherman Swanson<sup>1</sup>, Robert K. Hall<sup>2</sup>, and Daniel Heggem<sup>3</sup>

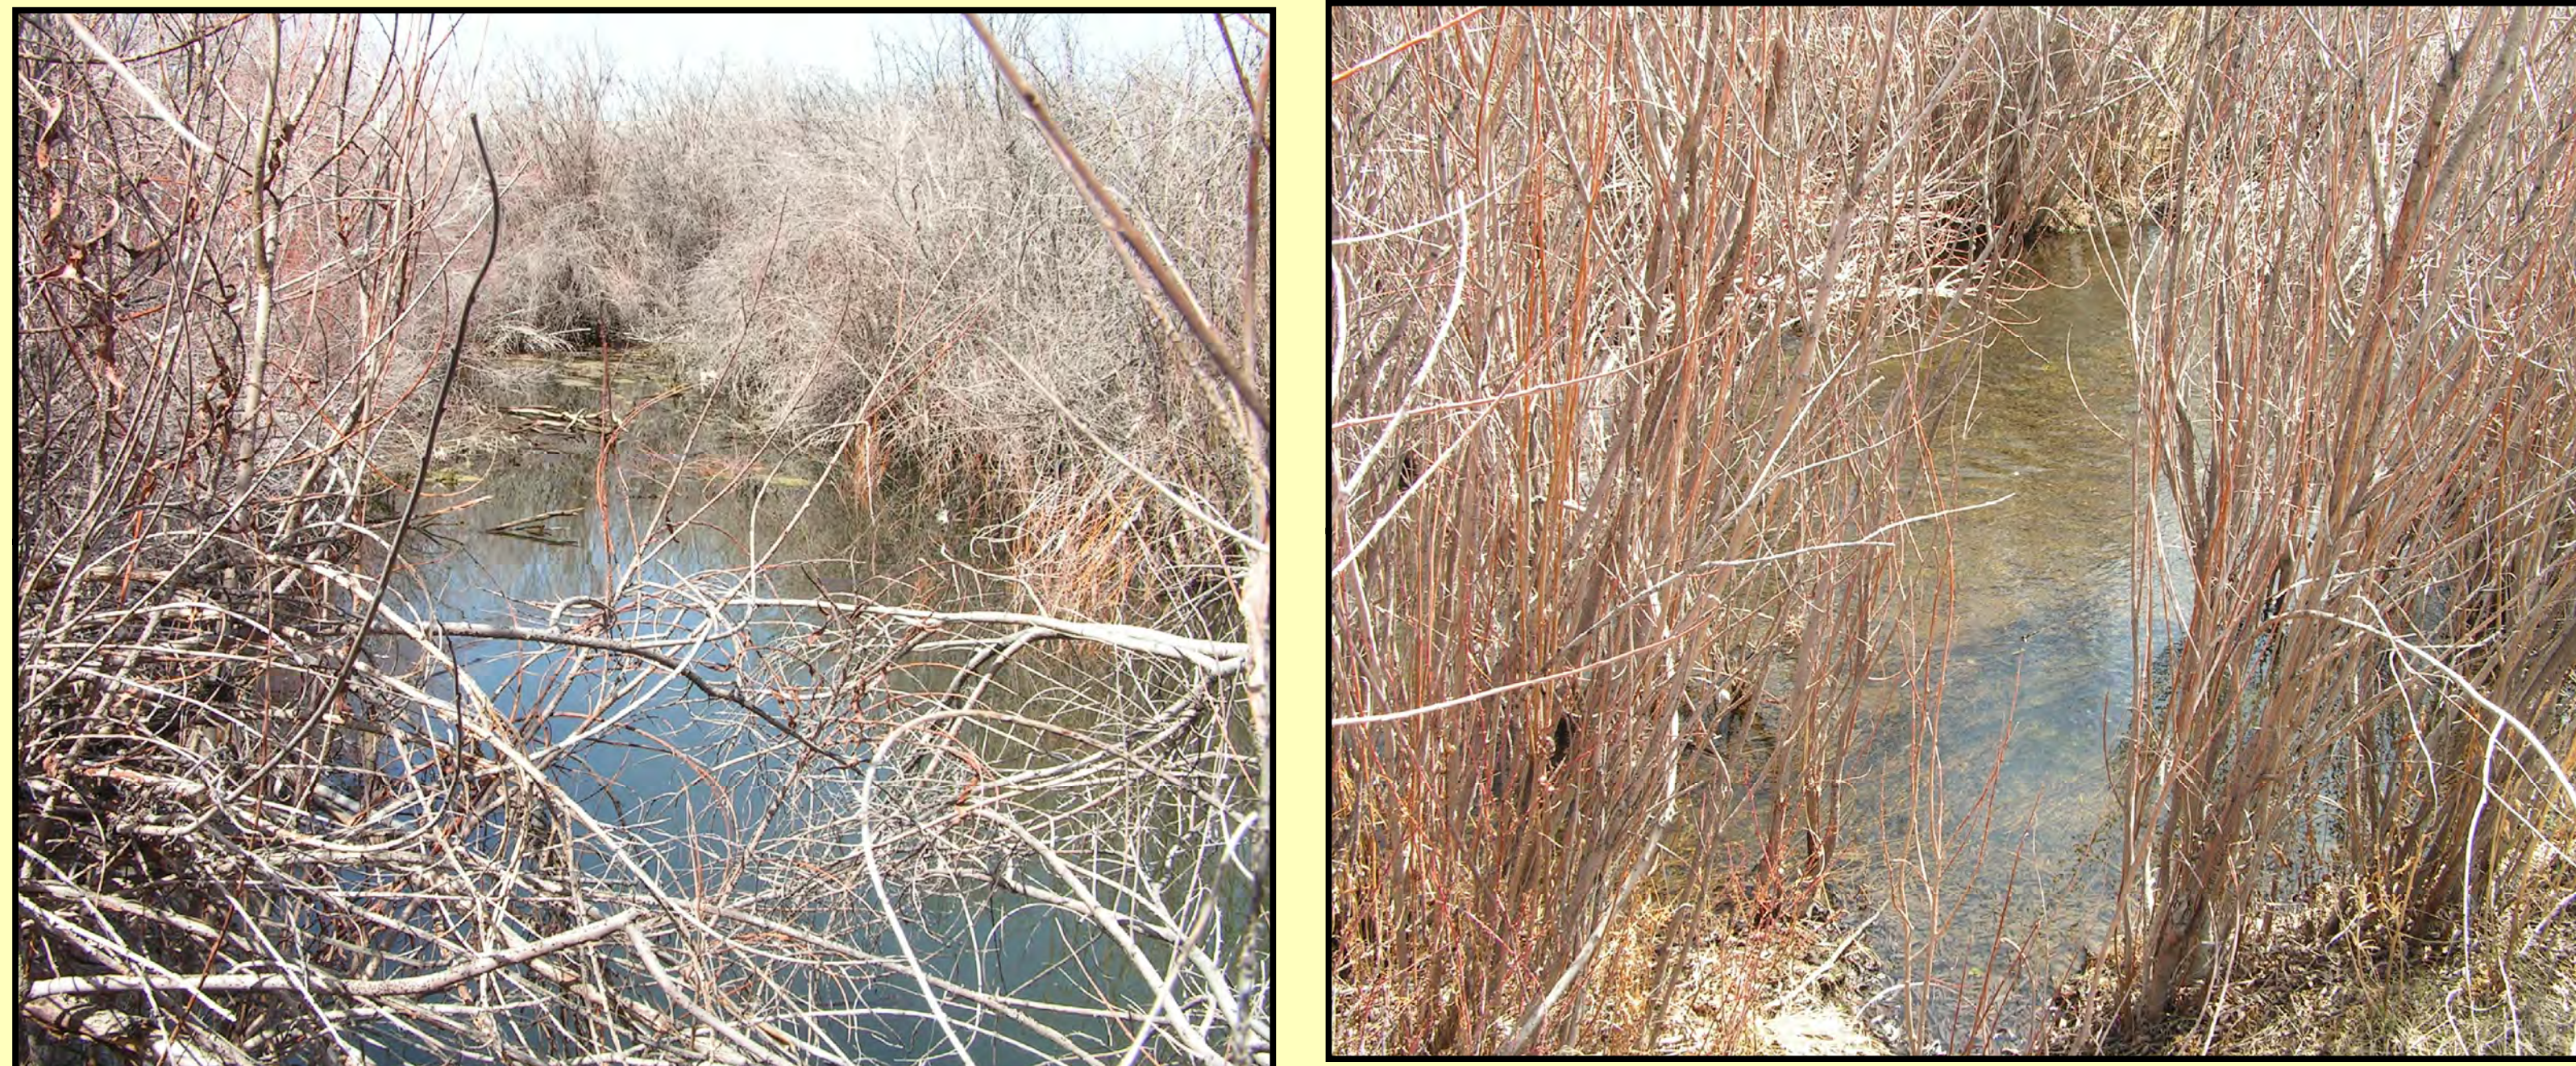
Figure 6. Increased riparian vegetation has created habitat for and enabled beaver to inhabit the riparian zone (left) helping to improve functionality and water quality within the system (right). Photos taken in 2010.

Changes in grazing management have led to increases in riparian vegetation, especially stabilizing wetland species (Figure 5), which improved the physical functionality of the riparian system. More beaver forage and dams accelerated the systems return to better functionality (Figure 6) via greater floodplain access and deposition.
