Compatibility of Material and Electronic Equipment with Methyl Bromide and Chlorine Dioxide Fumigation

Assessment and Evaluation Report

National Homeland Security Research Center
Office of Research and Development
U.S. Environmental Protection Agency
Research Triangle Park, NC 27711

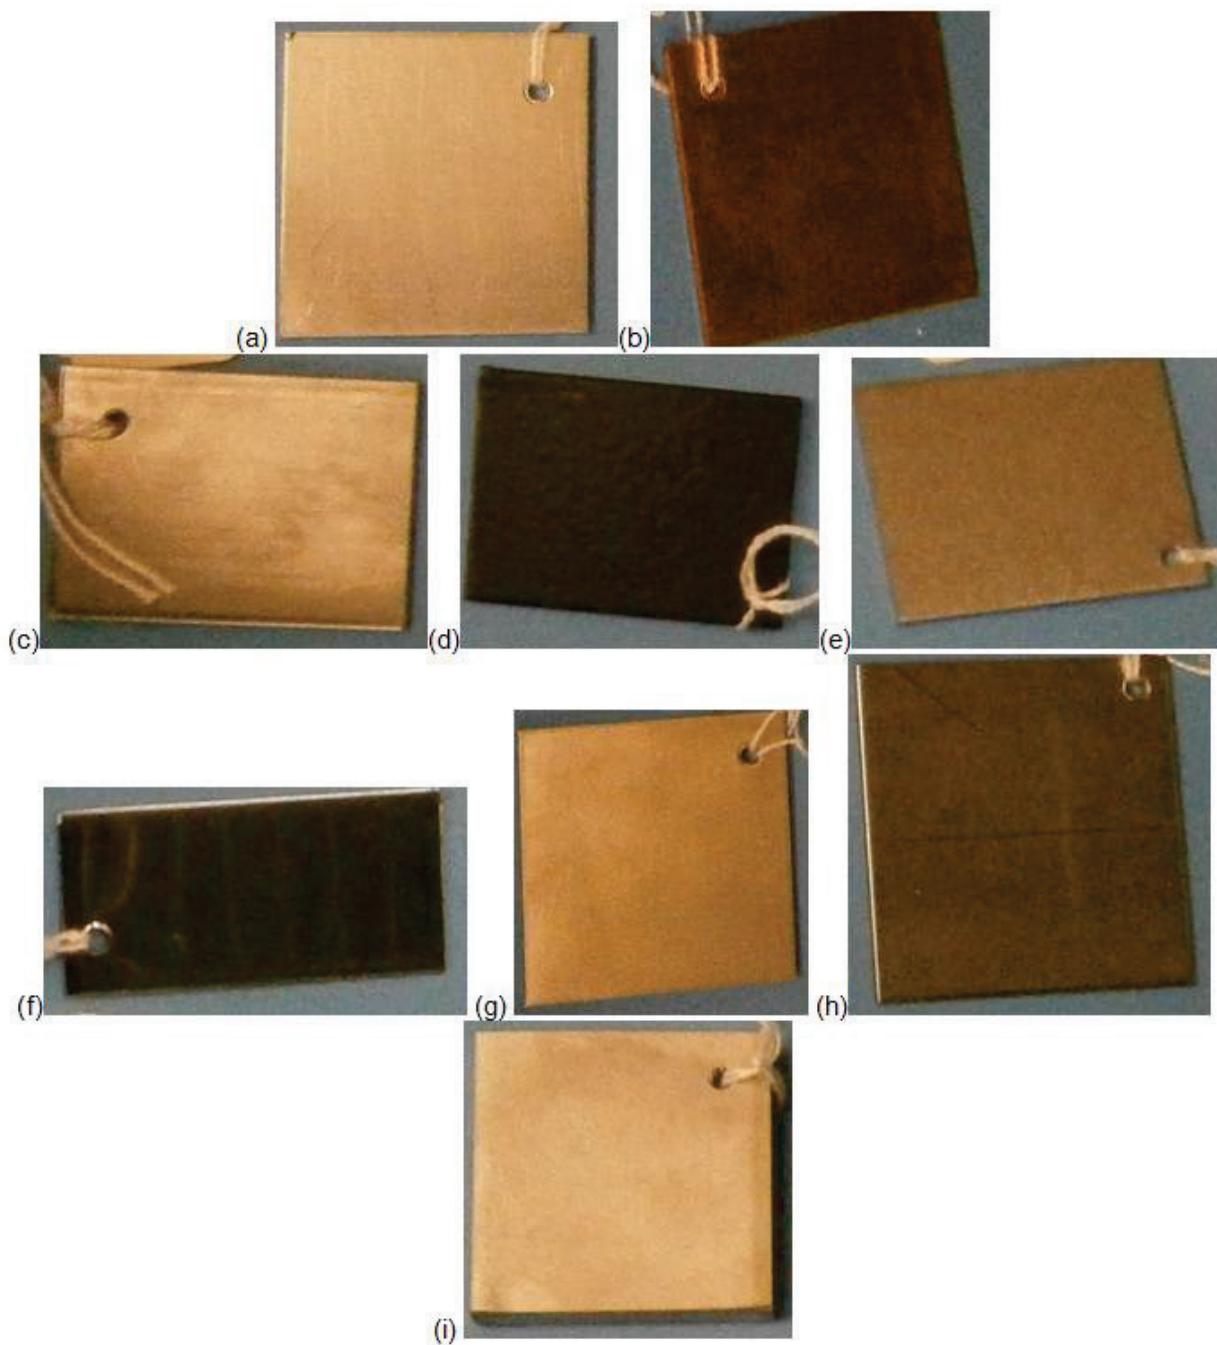
Figure 3-1. Metal Coupons Used in the Compatibility Testing (photos prior to fumigation): (a) 3003 Aluminum; (b) 101 Copper; (c) Low Carbon Steel; (d) Painted Low Carbon Steel; (e) 410 Stainless Steel; (f) 430 Stainless Steel; (g) 304 Stainless Steel; (h) 316 Stainless Steel; and (i) 309 Stainless Steel.

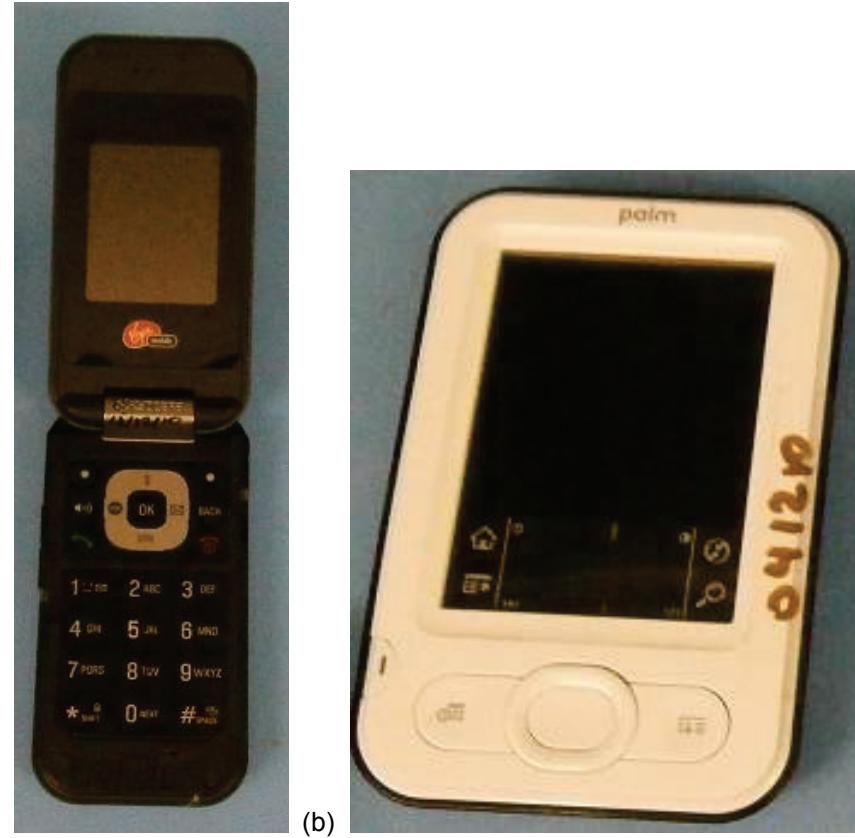
Figure 4-4(a) shows the cell phone one year following the 98-2 MeBr fumigation. During the 12-month observation period, no visual changes were noted. The cell phone screen indicated no signs of dimming of the back light or detectable color alterations. The cell phone ring and voice transmitting and receiving ability maintained their initial quality throughout the one-year observation period. Figure 4-4(b) shows the PDA one year following the 98-2 MeBr fumigation. The screen maintained its pre-exposure physical appearance and the outer casing appeared unchanged. An internal physical evaluation of the PDA was not possible without damaging the device.

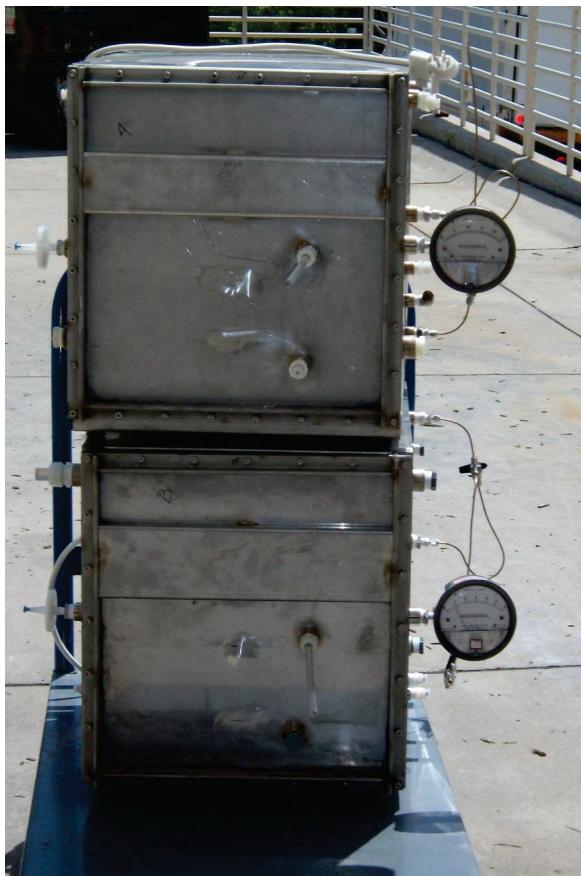
Figure 6-3. MeBr Outgassing Chambers

One-day after fumigation, the computers were placed inside chambers made from 304 stainless steel. This material was chosen because it is a special nonporous, silica-coated stainless steel that is inert to many reactive gases. Use of 304 stainless steel use eliminated any chamber adsorption artifacts. The chambers are shown in Figure 6-3. One chamber was dedicated to measuring MeBr outgassing from a test computer that was fumigated with 98-2 MeBr one day prior to the off-gassing measurements. The second chamber was used as a control for measuring the background outgassing from a control computer that had been subjected to the elevated temperature and humidity test condition 30 days prior to the off-gassing measurements.

The chambers were sealed with a Teflon gasket between the flanges of the front panel. Electrical power for the computers was supplied through a leak-tight bulkhead fitting. The computers could be turned on by inserting a piece of stainless steel rod through a bulkhead fitting and pressing the power button. The computer power state could be verified by peering through a $\frac{1}{2}$ " acrylic rod mounted through a different bulkhead facing the monitor. To sample the air inside the chambers, each chamber was equipped with a $\frac{1}{4}$ " OD stainless steel tube that was connected into the inlet of the mass spectrometer. The mass spectrometer had an atmospheric pressure ionization source with a triple quadrupole mass spectrometer for mass selection. The mass spectrometer was calibrated for MeBr with standard methods. The MeBr calibration was linear to 2 ppmv and was anticipated to be linear to 20 ppmv. Values over that limit were outside the calibrated range and subject to significant error and instrumental non-linearity. This calibration range is important to note because, in this outgassing study, MeBr concentrations up to 650 ppmv were measured. Further research should be done to characterize the actual MeBr concentration from desorption.
