# Decontamination of Drinking Water Distribution System Infrastructure after Contamination with Untreated Source Water

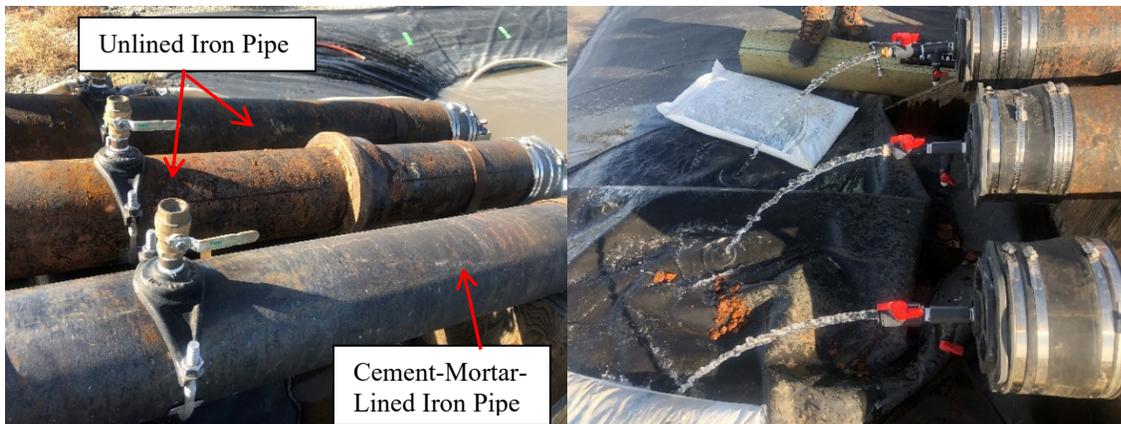
**Figure 4: Individual pipe sections next to the Water Security Test Bed lagoon (left) and the**

same pipe sections with the open drainage valves shown (right).

Three individual short sections of pipe were set up next to the lagoon. The individual pipe setup is shown in Figure 4. One pipe section was the same cement-mortar-lined iron pipe used in the 450-ft WSTB pipe. The other two sections were unlined cast iron pipe sections with heavy corrosion (tuberculation) on the interior. Each pipe was approximately 10 ft long. The unlined iron pipes were obtained from the District of Columbia Water and Sewer Authority (DC Water). All pipe surface samples taken from the individual pipes were direct scrapings of the inner surface. Further details on the contamination, flushing, chlorination, and sampling processes are described in Section 2.

To compare data on decontamination of heavily tuberculated (corroded) unlined pipe to the much smoother cement-lined pipe from INL, individual sections of pipe were set up next to the lagoon. The setup is shown in Figure 4. In this setup, two pipe sections obtained from DC Water were made of unlined iron with heavy corrosion, and one section was a piece of cement-mortar-lined iron INL pipe. The goal of this experiment was to have decontamination data on both types of pipe contaminated with lagoon water and both pipe types contaminated with Potomac River water. Potomac River water was added to a short (10 ft) section of corroded iron and a separate short section of cement-mortar-lined INL pipe. Lagoon water was used to contaminate the other corroded section (the middle pipe section in Figure 4) of DC Water pipe. A cement lined pipe section from INL was not contaminated with the lagoon water, since data was already available for the prior experiment with the 450 ft of INL pipe.

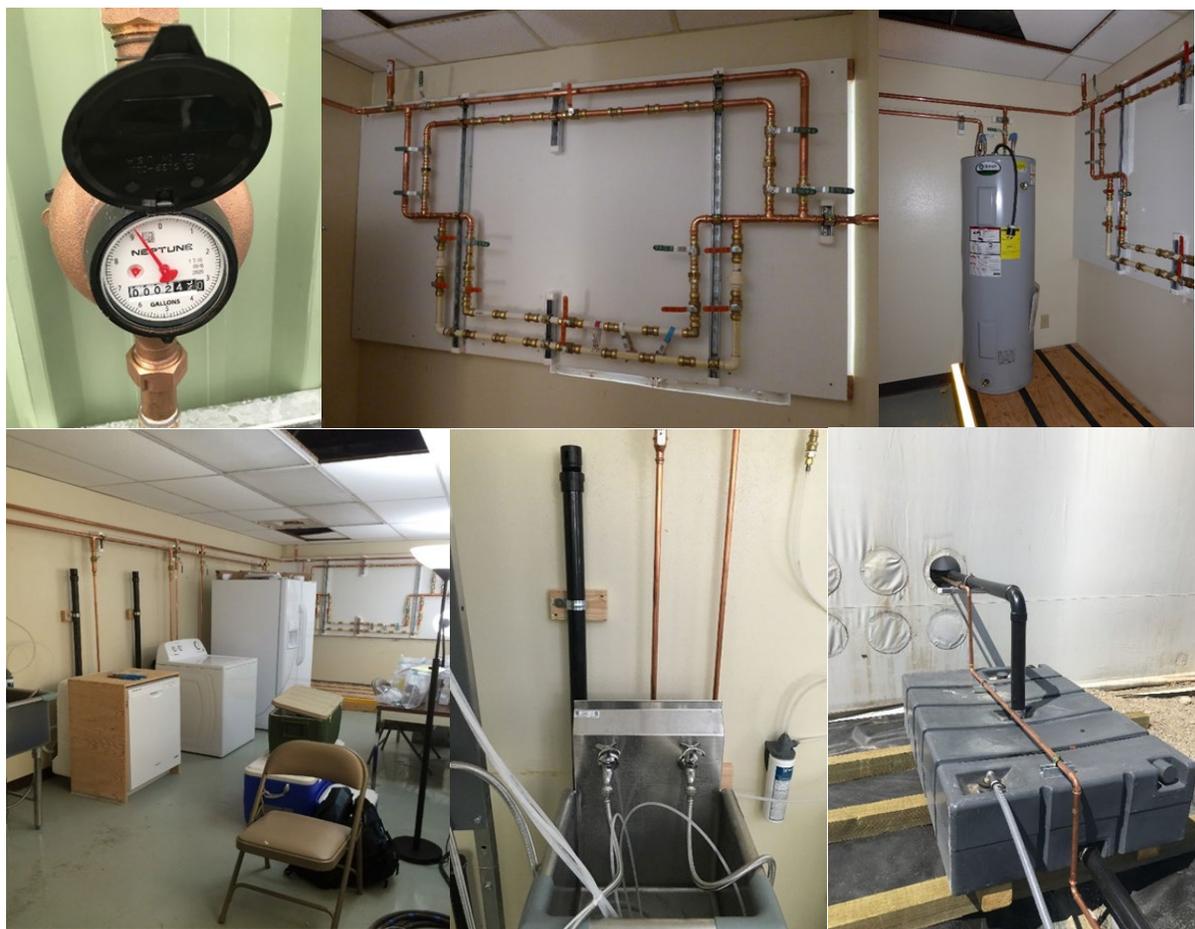
**Figure 5: Premise plumbing setup at the WSTB: the water meter outside the building (top left), premise plumbing pipes (top middle), water heater (top right), dishwasher, washing machine and refrigerator (bottom left), utility sink (bottom middle) and exterior tank (bottom right).**

The WSTB also includes a premise plumbing system that is connected to the 8-in diameter distribution main via a 1-in copper service connection (Figure 2). Water flows through the service connection into a water meter, copper plumbing pipes, a removable pipe coupon section with copper, polyvinyl chloride (PVC) and cross-linked polyethylene (PEX) pipes, and appliances including a water heater, dishwasher, washing machine and refrigerator with water dispenser. Water empties into a utility sink with hot- and cold-water taps and then drains to an exterior tank. All water from the tank eventually flows to the lagoon. These components are shown in Figure 5.

Pipe in the premise plumbing system is mostly 1-in diameter copper, with coupon sections made of copper, PVC and PEX (Figure 5, top middle). The other piping used in this experiment was heavily corroded and tuberculated 8-in diameter unlined iron pipe sections obtained from DC Water. Individual sections of pipe (approximately 10 ft long) were set up next to the lagoon. The individual pipe setup is shown in Figure 4, and internal and external pictures of the pipe are shown in Figure 7. In Figure 4, two of the pipe sections are unlined iron, and one section is cement-mortar-lined iron pipe.

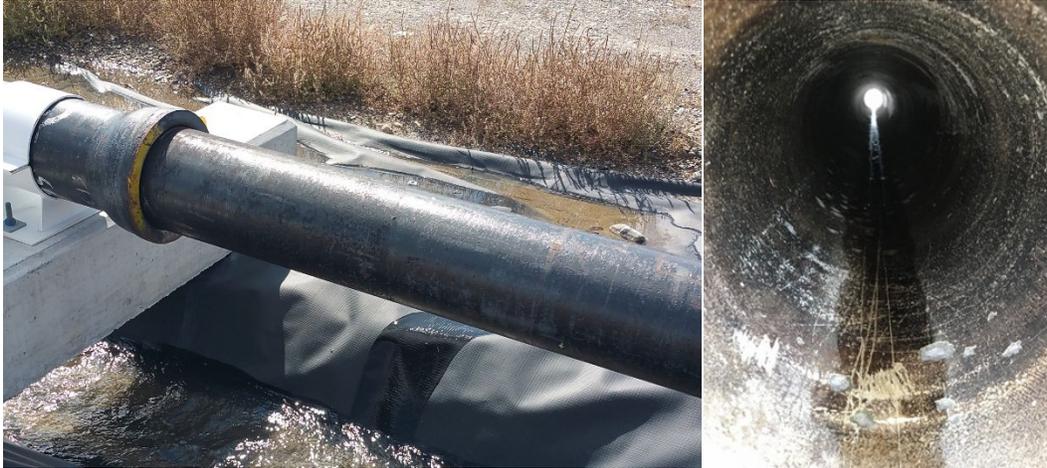
**Figure 6: External and internal view of the cement-mortar lined pipe.**

Most of the distribution system-sized pipe used at the WSTB for decontamination experiments is constructed of 8-in diameter cement-mortar-lined ductile iron, which was previously excavated from the INL property. This piping had been used as water distribution piping for over 30 years prior to excavation and reuse on this project. Visual inspection of the cement-mortar lining indicated that the lining was in good condition. The interior and exterior view of this pipe is shown in Figure 6.

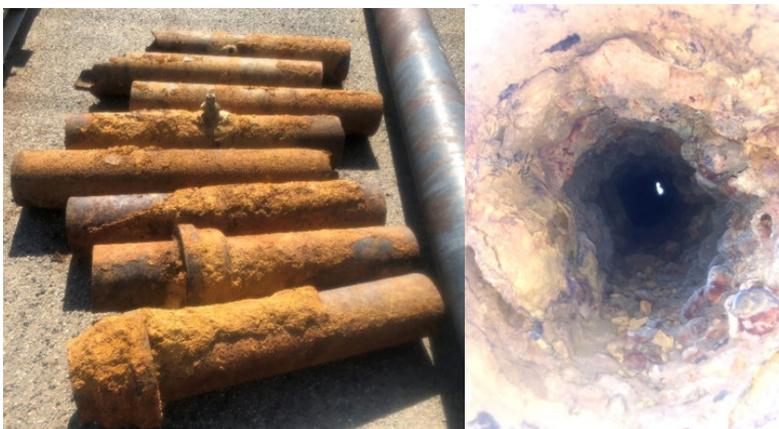
**Figure 7: External (left) and internal (right) view of the cast iron pipe with heavy corrosion (tuberculation) on the interior.**

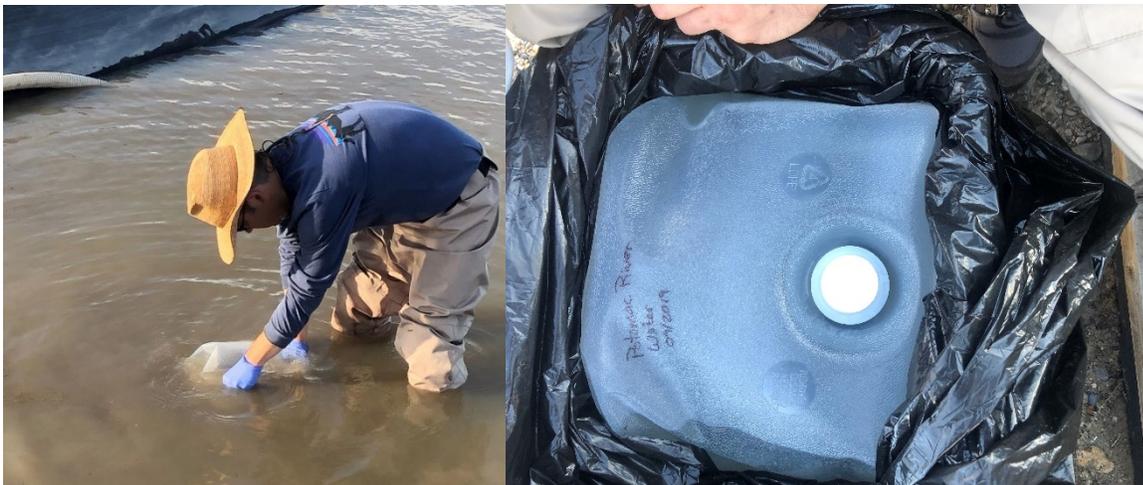
**Figure 8: Mixing *E. coli* into lagoon water (left) and a carboy of Potomac River water (right).**

The other water used in the short sections of pipe was collected from the Potomac River downstream from the intake to the DC Water Dalecarlia treatment plant, and shipped by DC Water to the INL WSTB site in a carboy (Figure 8). This source water was not spiked with *E. coli*. This water was used to contaminate two of the individual pipe sections set up next to the lagoon (one corroded iron and one cement-mortar-lined iron). The contamination procedure is further described in Section 2.3.3.

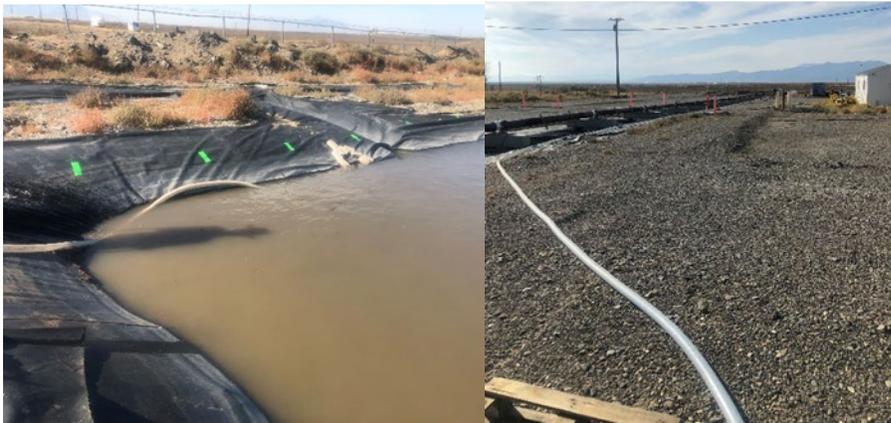
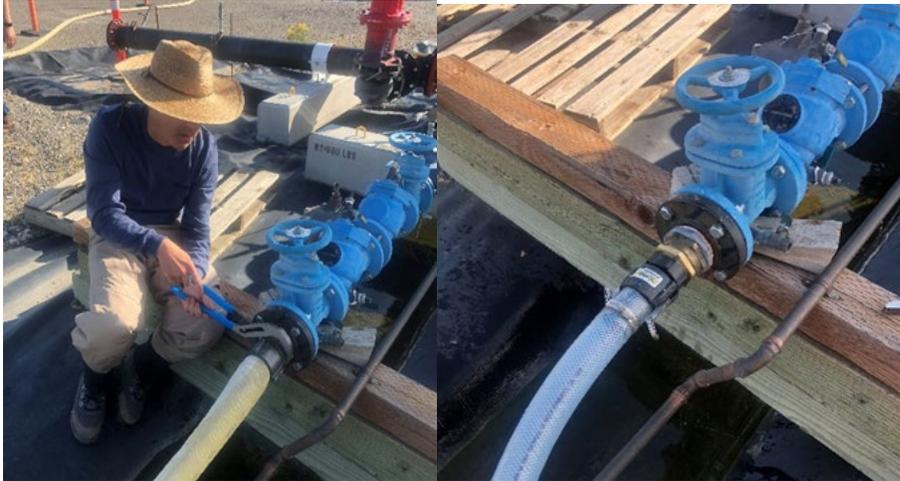
**Figure 9: The setup used to contaminate the WSTB pipe with lagoon water: hose connected to pump in lagoon (top left), hose from lagoon across WSTB site (top right), disconnection of fire hose (bottom left), and connection of lagoon hose (bottom left).**

Contamination of the pipe occurred by pumping the lagoon water (described in Section 2.2) from the lagoon into the upstream end of the pipe, letting it flow through the 450 ft of pipe and emptying back into the lagoon. Pumping lagoon water in a loop kept the pipe full of contaminated water and kept the sediment and *E. coli* in the lagoon well mixed. Water was recirculated in this manner for 18 h (hours). Figure 9 shows the setup used to contaminate the pipe. A hose connected to a swimming pool pump was put into the lagoon (top left) and run the length of the WSTB pipe (top right). On the upstream end, the fire hose that fed tap water to the pipe was disconnected (bottom left), and the line that supplied the lagoon water was attached (bottom right). The pipe was then filled with lagoon water and flow commenced. The pump supplied approximately 10 pounds per square inch (psi) of pressure in the pipe.

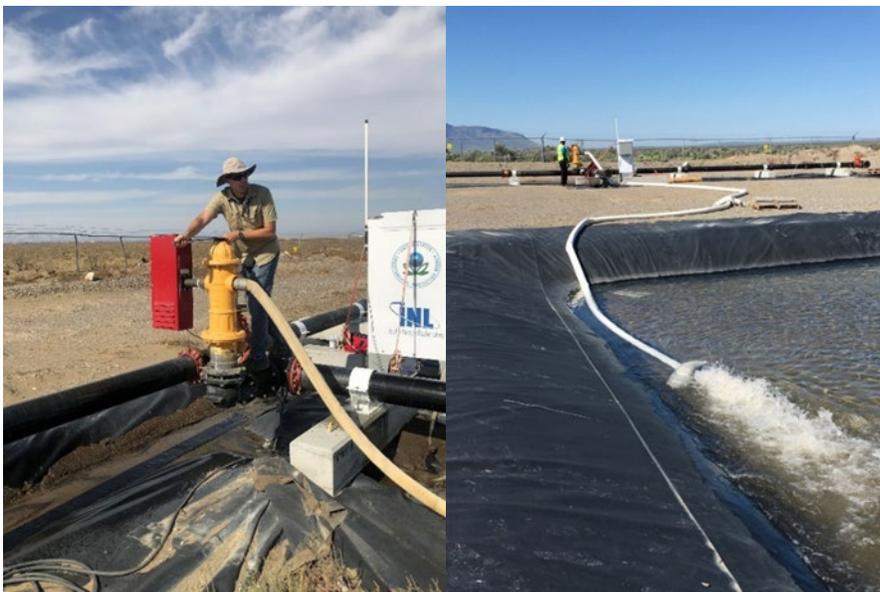
**Figure 10: Flushing contaminated water from the WSTB distribution pipe via the**

**downstream fire hydrant. The left image is the fire hydrant with the hose connected, and the is the hose in the lagoon with sandbags is on the right.**

Flushing is shown in Figure 10. A fire hose was attached to the downstream fire hydrant (Figure 10, left) with the outlet placed in the lagoon and braced with sandbags and cement blocks (Figure 10, right). The hydrant was opened as much as possible while keeping the fire hose stable and against the ground. Flow through the hose was estimated to be approximately 150 gpm (0.96 ft/sec). Flushing in this manner took place for 20 min.

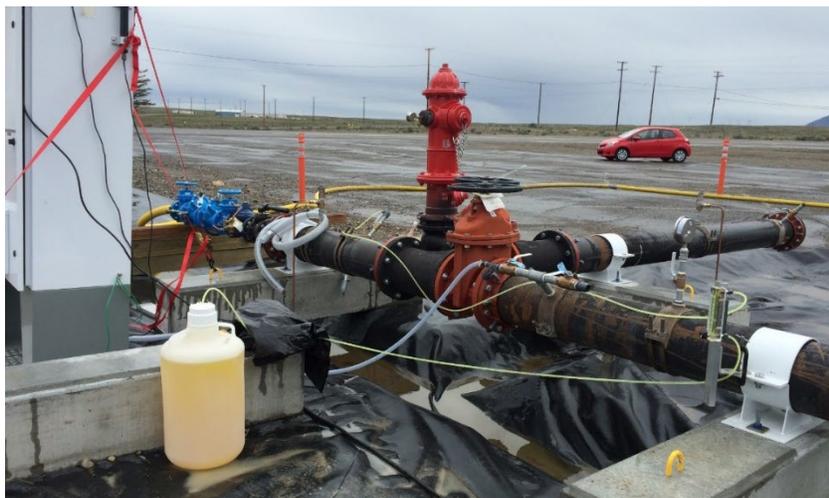
**Figure 11: Example of how chlorine was introduced to WSTB distribution pipe.**

After hydrant flushing was complete, the pipe was chlorinated. Chlorination took place by pumping store-bought concentrated bleach (8.25% hypochlorous acid [HOCl]) into the WSTB pipe. One gallon of bleach was diluted into five gallons of tap water in a carboy and then pumped into the WSTB pipe over a period of one hour with flow through the pipe at 15 gpm. This procedure effectively filled the pipe with chlorinated water. Figure 11 shows a past example of how the disinfectant was added to the pipe.

Once chlorine was detected at the downstream fire hydrant, the flow through the pipe was shut off, resulting in a chlorine concentration of 55 milligrams (mg)/L in the pipe. The water then sat stagnant overnight for approximately 20 h. After the 20-h contact period, the fire hydrant was opened again and flushed for 20 min at a rate of 150 gpm. After flushing, flow through the pipe with tap water (i.e., return to service) was re-established at 2.5 gpm for the duration of the experiment.

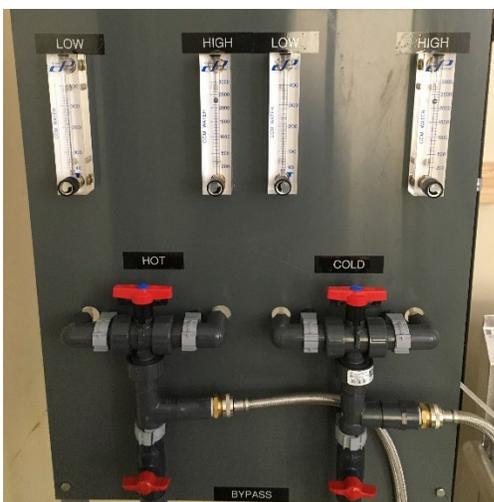
**Figure 12: Flow meters downstream from the utility sink used to control flow through the premise plumbing system.**

Before contamination, tap water continuously flowed through the premise plumbing system for four weeks to allow biofilm and deposits to form on the inner surfaces of the pipes and appliances. During this pre-contamination phase, total flow through the plumbing system was set to 138 gallons per day (0.096 gpm or 363 mL/min), which is the typical usage in many households (DeOreo et al., 2016). Water flowed through the utility sink taps, with equal flows through the hot and cold water taps. Flow was regulated by a set of flowmeters downstream from the utility sink (Figure 12). The dishwasher and washing machine were operated for one cycle once per week, and the refrigerator water dispenser was opened for 10 minutes once per week.
