## EPA Fire Hydrant Flushing and Chlorination Experiments at Idaho National Laboratory

### Introduction

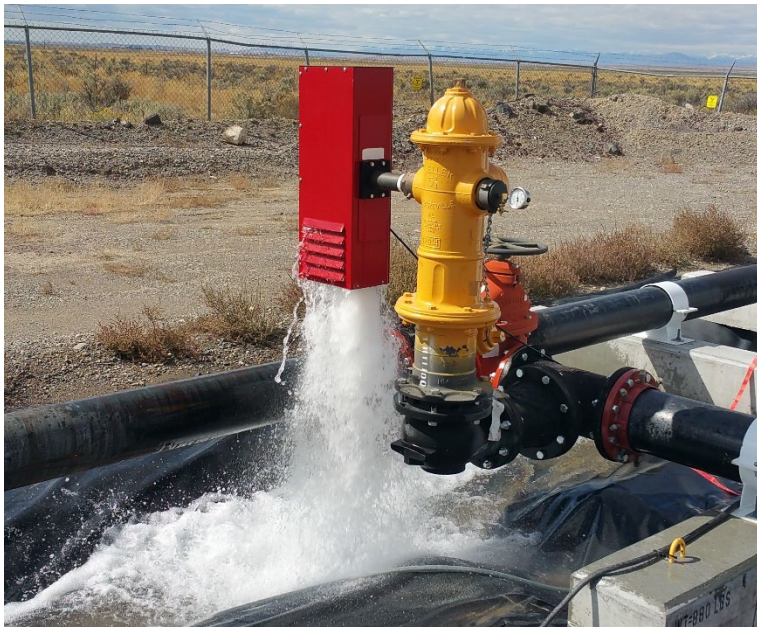
**Figure 2: Fire hydrant with automatic flusher flushing water.**

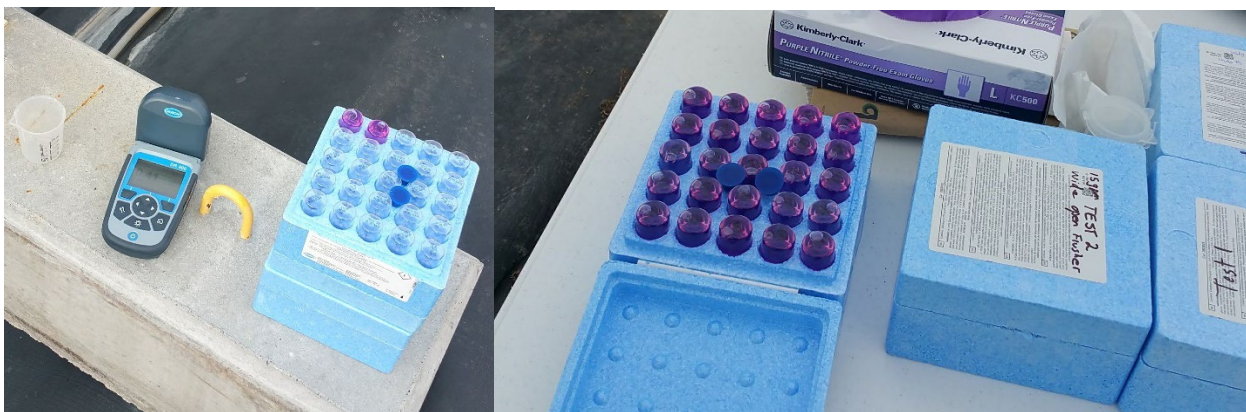
**Figure 3: Free chlorine samples upstream showing that sodium thiosulfate had removed the chlorine (left) and downstream showing that there was still a chlorine residual (right) downstream from the flushing hydrant. These ampules are from the experiment that shut off the downstream flow before the thiosulfate arrived at the flushing hydrant.**

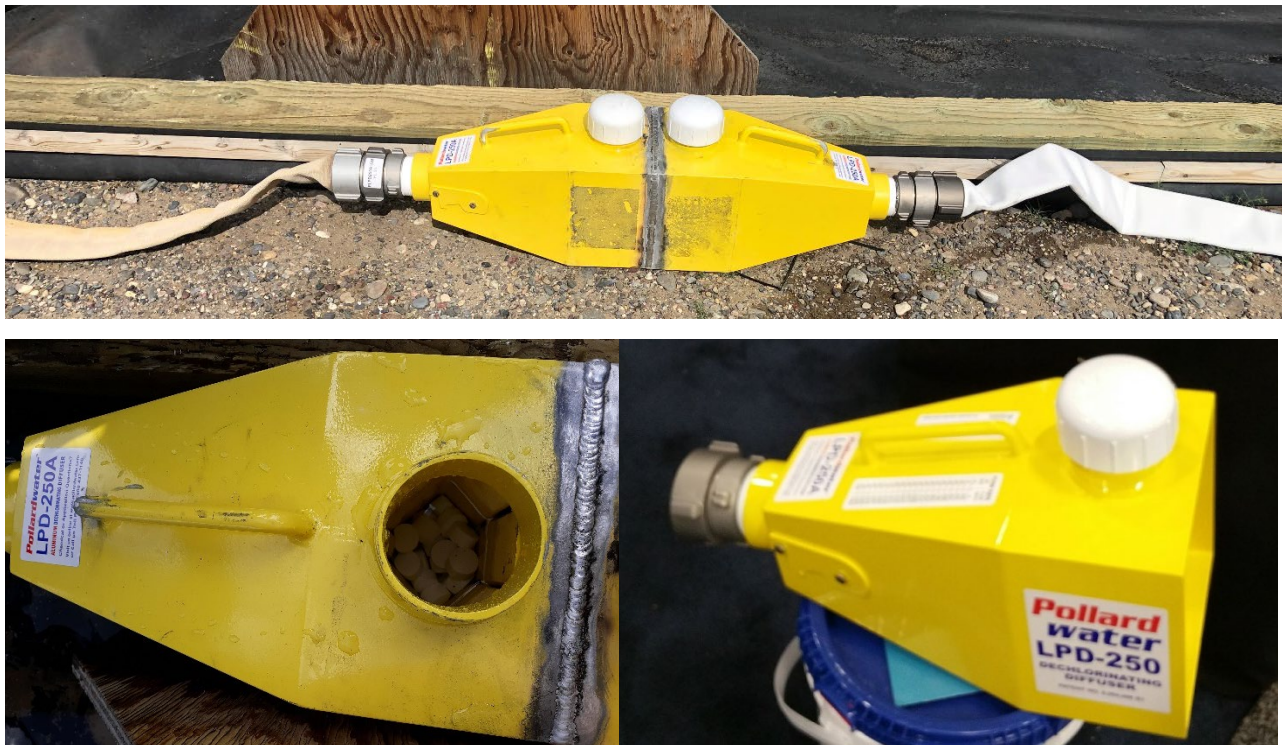
**Figure 6: The prototype hydrant diffuser with hoses attached (top), Twenty one-inch diameter chlorine tablets in the diffuser (bottom, left), and a regular hydrant flow diffuser before modification (bottom, right).**

Hydrant diffusers are made with optional metal sleeves to hold dechlorinating tablets so that the water being discharged from the hydrant can be dechlorinated as it exits the diffuser. This prevents chlorinated water from harming aquatic or plant life near the point of discharge. However, in response to a biological water contamination incident, it is likely that additional chlorine would need to be added to the water prior to discharge to prevent the spread of biological contamination to the environment or downstream treatment works. Therefore for this experiment, two Pollard 250 hydrant aluminum diffusers (LPD-Chlor™ FNST 2-1/2 in. aluminum dechlorinator, Pollardwater, New Hyde Park, NY) were welded together to make a custom chlorination diffuser (Figure 6). One diffuser connected directly to the fire hydrant and the other diffuser redirected the flow into a fire hose. This setup also allowed the two metal sleeves to be used for the addition of the Clorox® Pool and Spa™ chlorine tablets for small pools (Clorox Company, Oakland CA). Using the hose allowed the flow to be more directly discharged into a manhole or storm sewer while creating less airborne splash. Additional chlorine contact time prior to discharge could be added by lengthening the hose. The chlorine levels in the WSTB were maintained around 0.2 mg/l for the chlorination experiment. The flush rate was established at approximately 100 gpm. Twenty one-inch diameter chlorine tablets (99% trichloro-s-triazinetriene and 1% other) were added to one of the sleeves. The hydrant was discharged through the Pollard assembly for 45 minutes and the chlorine levels were measured at 5-minute intervals from the discharge hose. Figure 7 shows the location of the diffuser in connection to the WSTB pipe and lagoon, and Figure 8 shows the diffuser hose discharge entering the lagoon.

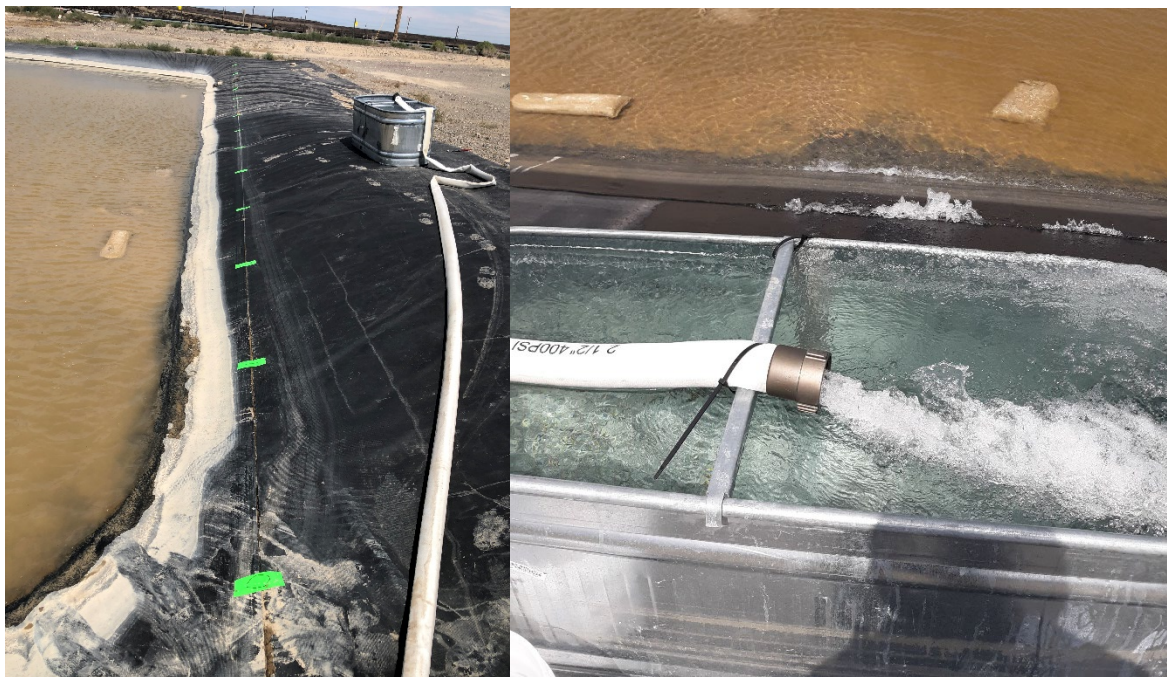
**Figure 8: Diffuser discharge into the WSTB lagoon.**
