# Decontamination of Malathion from Drinking Water Distribution System and Premise Plumbing Infrastructure

Jeffrey Szabo, John Hall, and James Goodrich  
Center for Environmental Solutions and Emergency Response  
Cincinnati, OH 45268

EPA 600/X-23/330 | May 2023 |

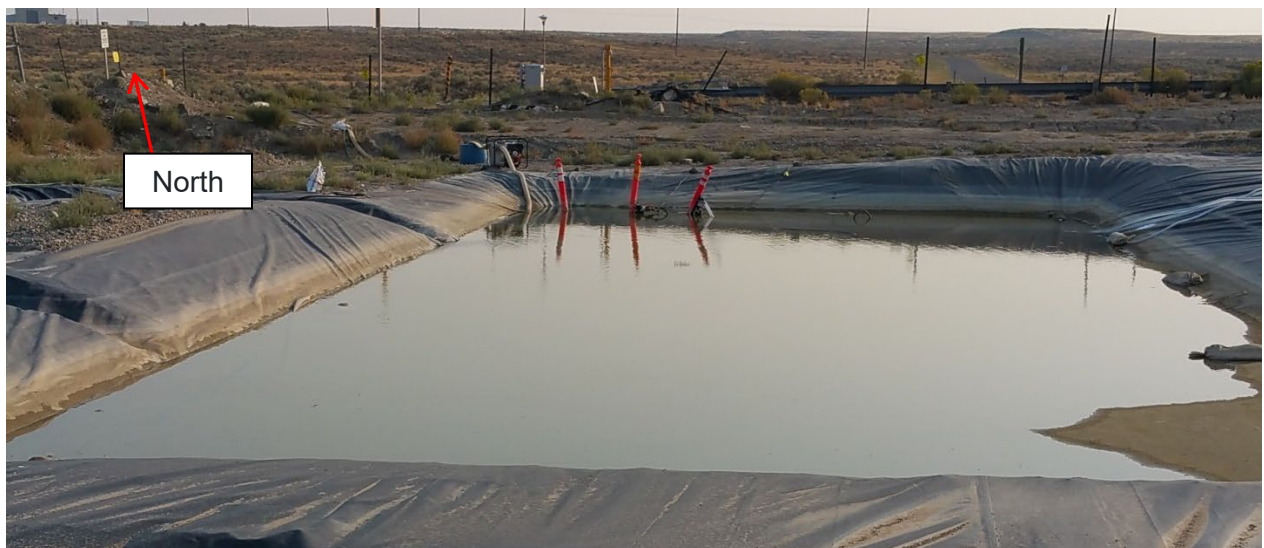
**Figure 3: Water Security Test Bed discharge lagoon.**

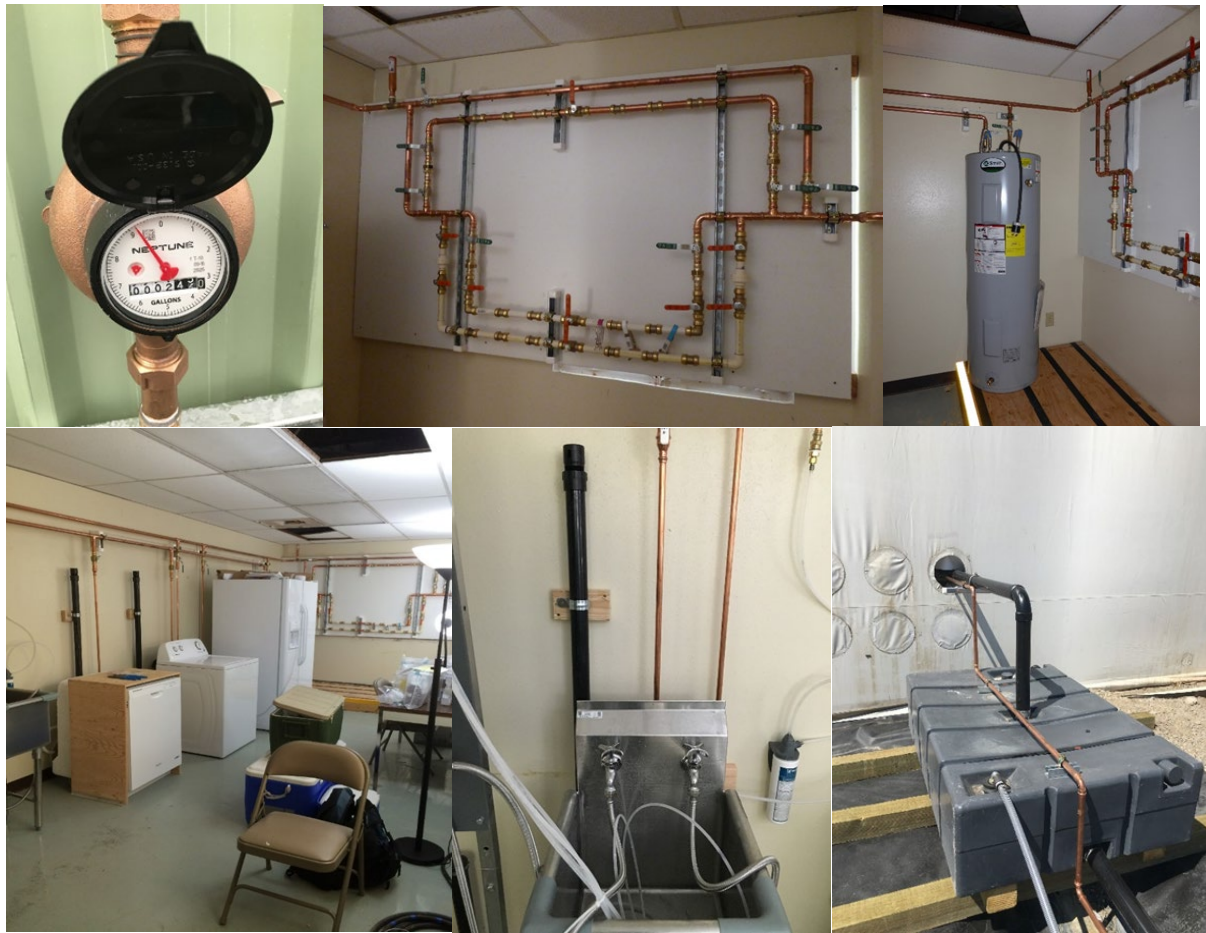
**Figure 4: Premise plumbing setup at the WSTB: the water meter outside the building (top left), premise plumbing pipes (top middle), water heater (top right), dishwasher, washing machine and refrigerator (bottom left), utility sink (bottom middle) and exterior tank (bottom right).**

The WSTB also includes a premise plumbing system that is connected to the 8-in (20 cm) diameter distribution main via a 1-in (2.5 cm) copper service connection (seen in Figure 2). Water flows through the service connection into a water meter, copper plumbing pipes, a removable pipe coupon section with copper, polyvinyl chloride (PVC), and cross-linked polyethylene (PEX) pipes, and appliances including a water heater, dishwasher, washing machine, and refrigerator with water dispenser. Water empties into a utility sink with hot- and cold-water taps and then drains to an exterior tank. All water from the tank eventually flows to the lagoon. These components are shown in Figure 4.

Pipe in the premise plumbing system is mostly 1-in (2.5 cm) diameter copper, with coupon sections made of copper, PVC and PEX (Figure 4, top middle).

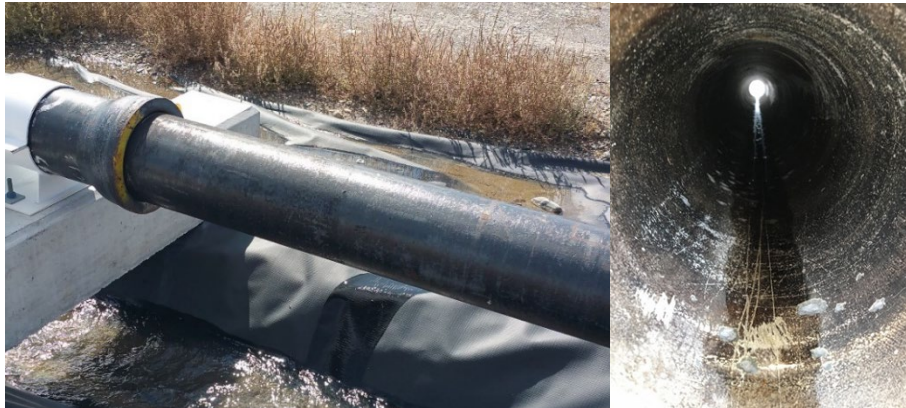
Figure 5: External and internal view of the cement-mortar lined pipe.

The distribution system-sized pipe used at the WSTB for decontamination experiments is constructed of 8-in (20 cm) diameter cement-mortar-lined ductile iron and was previously excavated from the INL property. This piping had been used for water distribution for over 30 years prior to excavation and installation at the WSTB. Visual inspection of the cement-mortar lining indicated that the lining was in good condition. The interior and exterior view of this pipe is shown in Figure 5. Removable coupons of the cement mortar lined pipe are shown in Figure 6, as is the section of pipe where they are located.

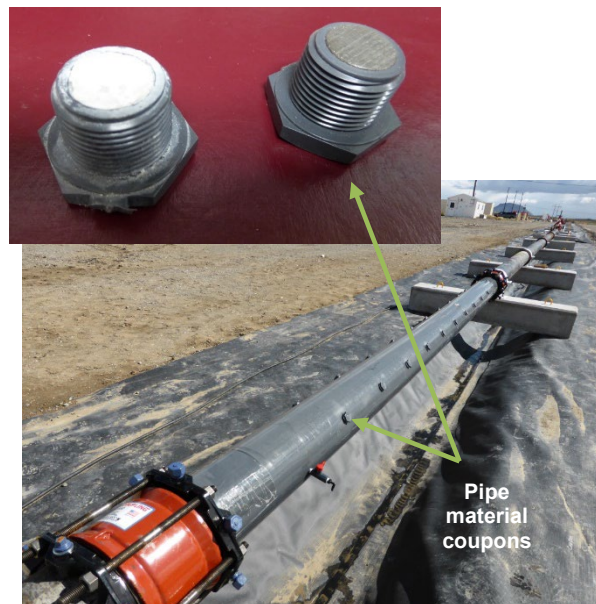
Figure 6: Removable pipe coupon section and images of the coupons.

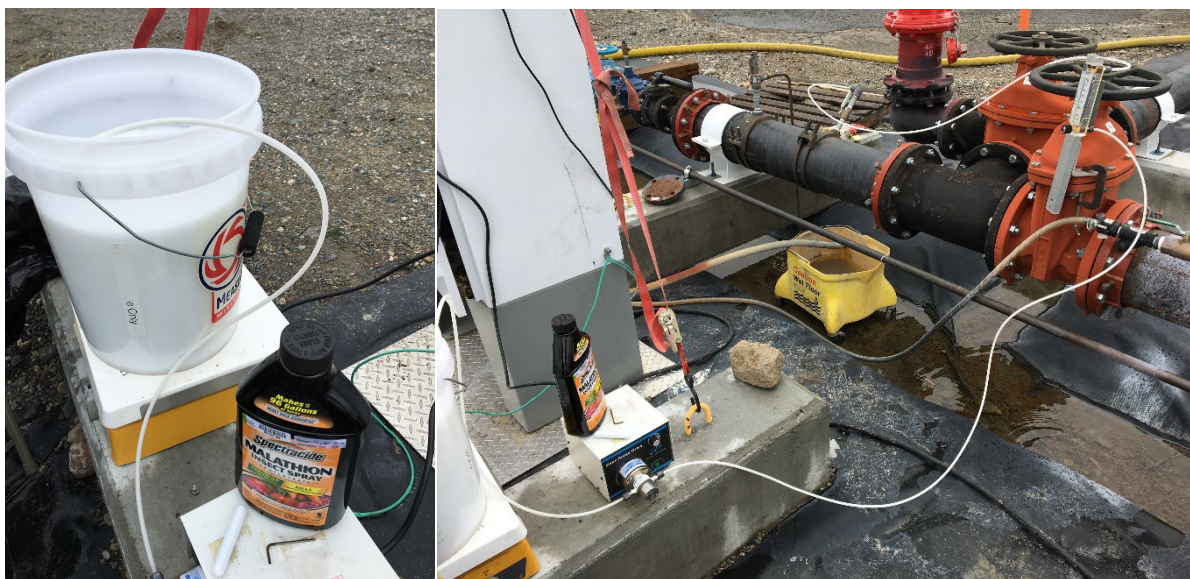
**Figure 7: Malathion contaminant injection setup in the 450 ft pipe.**

Contamination of the pipe occurred by first diluting a commercially available malathion formulation in multiple 6.5 gallon (24.6 L) buckets. The pesticide formulation was 50% malathion (by weight) in a 1-quart bottle, which contains 1.07 lb (485.78 g, or 485,780 mg) malathion. The contents of the 1-quart bottle were diluted to 40 L using local tap water from the INL site. This solution was pumped using a gear pump into the INL pipe at 0.667 L/min, which resulted in the 40 L being pumped in 1 hour. Flow in the pipe was 15 gpm (56.8 L/min), which theoretically resulted in 142 mg/L malathion in the contaminant slug. This setup is depicted in Figure 7.

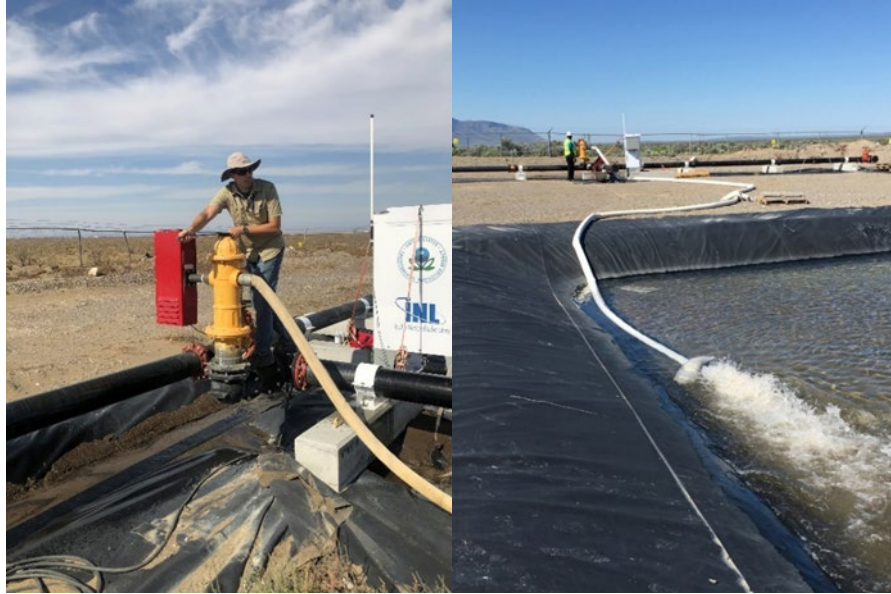
**Figure 8: Flushing contaminated water from the WSTB distribution pipe via the downstream fire hydrant. The left image is the fire hydrant with the hose connected, and the hose in the lagoon with sandbags is on the right.**

After the 1-hour contaminant injection, the first decontamination step was to flush the system through the downstream fire hydrant. Flushing is shown in Figure 8. A fire hose was attached to the downstream fire hydrant (Figure 8, left) with the outlet placed in the lagoon and braced with sandbags and cement blocks (Figure 8, right). The hydrant was opened so that flow through the hose was estimated to be 50 gpm (189 L/min). Flushing in this manner took place for 20 min. After 20 minutes, the hydrant was closed, and flow was set to 15 gpm (57 L/min) using the flowmeter at the end of the pipe for the next four hours. After the four-hour period, flow through the flowmeter was set to 2.5 gpm (9.5 L/min), where it remained for the rest of the experiment.

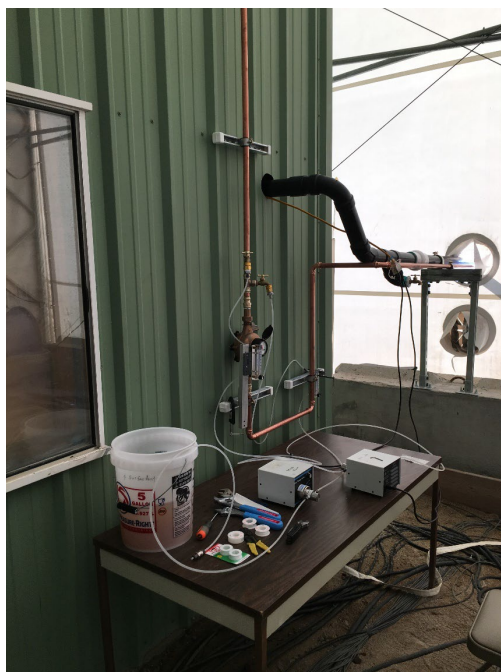
**Figure 10: Malathion contamination of the premise plumbing system. Diluted malathion is pumped from a bucket into a flow meter, where it flows into the copper pipe.**

Contamination of the premise plumbing system was accomplished by pumping diluted malathion from a bucket into the flow meter (Figure 10). A 10 L solution of 3,976 mg/L malathion was made by diluting 39.76 g (0.088 lbs, or 77 ml of the 50% malathion solution) up to 10 L in a bucket. The 10 L solution was injected into the premise plumbing system at 0.167 L/min for 1 hour, with the premise plumbing system flow set to 1.6 gpm (6.06 L/min), split equally between cold and hot water. The resulting concentration of malathion was theoretically 110 mg/L. The refrigerator flow, dishwasher and washing machine were started 20 min after the injection started.

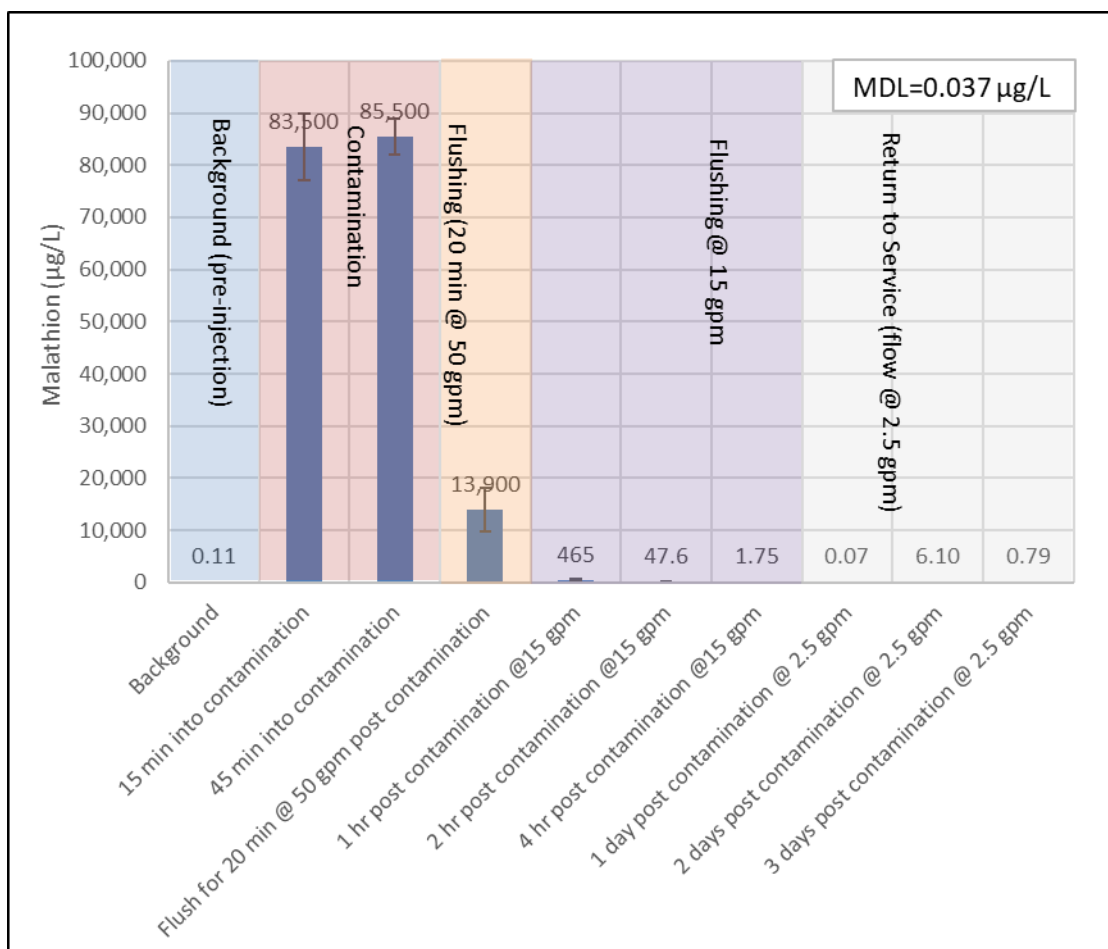
MDL=method detection limit; error bars represent the range between duplicate samples

**Figure 11: Contamination and decontamination of malathion from the bulk water phase using flushing in the 450 ft WSTB pipe.**

Figure 11 and Figure 12 show the phases of the decontamination experiment in the 450 ft (137 m) WSTB pipe. Background is the baseline malathion concentration in the water or on the pipe surface before contamination. The contamination phase is when the insecticide containing malathion was injected into the pipe. The flushing phase (20 min @ 50 gpm or 189 L/min) is when the downstream fire hydrant was opened for 20 min at a flowrate of approximately 50 gpm (189 L/min). Flushing at 15 gpm (57 L/min) took place immediately after the 50-gpm (189 L/min) flush and lasted for 4 hours. Return to service occurred after the flushing phases. The flow was lowered to 2.5 gpm (9.5 L/min) for the next three days, which represented a baseline level of flow, or return to normal service.

Figure 11 shows that a small amount of malathion (0.11  $\mu\text{g}/\text{L}$ ) was detected in the water before contamination. It's possible that low levels of malathion could be present due to local insecticide use, but there could also be interference from constituents in the local tap water or external contamination. During contamination, malathion increased to 83,500 to 85,500  $\mu\text{g}/\text{L}$  in the contaminant injection pulse. Flushing at 50 gpm (189 L/min) for 20 min reduced the malathion concentration by 84% to 13,900  $\mu\text{g}/\text{L}$ . The flushing period was designed to remove one pipe volume, which is approximately 1,000 gallons (3,785 L). Residual malathion in the pipe after the 20 min flush can be attributed to malathion persistence in dead leg portions of piping (i.e., pipe sections that are isolated from the normal flow of water). These sections are difficult to flush and could be a source of the residual malathion detected in this study post-flushing. Additionally, the slug dosing of the contaminant could have resulted in an elongated longitudinal dispersion of the malathion (e.g., a U-shaped pattern of dispersion) (Yang et al., 2008), where the tail ends of the dispersed contaminant were still in the pipe at the end of the 20 min flush period.

Malathion concentration continued to decrease at the one-, two-, and four-hour time points post-contamination during flushing at a flow rate of 15 gpm (57 L/min). At the four-hour time point, malathion concentration was reduced by over 99.99%. Malathion samples taken 1, 2, and 3 days after contamination with flow at 2.5 gpm (9.5 L/min) showed that malathion concentration was close to background levels (Figure 11). The one exception was day two post-contamination, when concentration spiked to 6.1  $\mu\text{g}/\text{L}$ . While external contamination of the sample can't be ruled out, this spike might have come from malathion hung up in a dead end or fixture in the pipe. If flushing is used in practice to mitigate a malathion contamination incident, contamination trapped in dead ends should be considered when designing a flushing strategy.

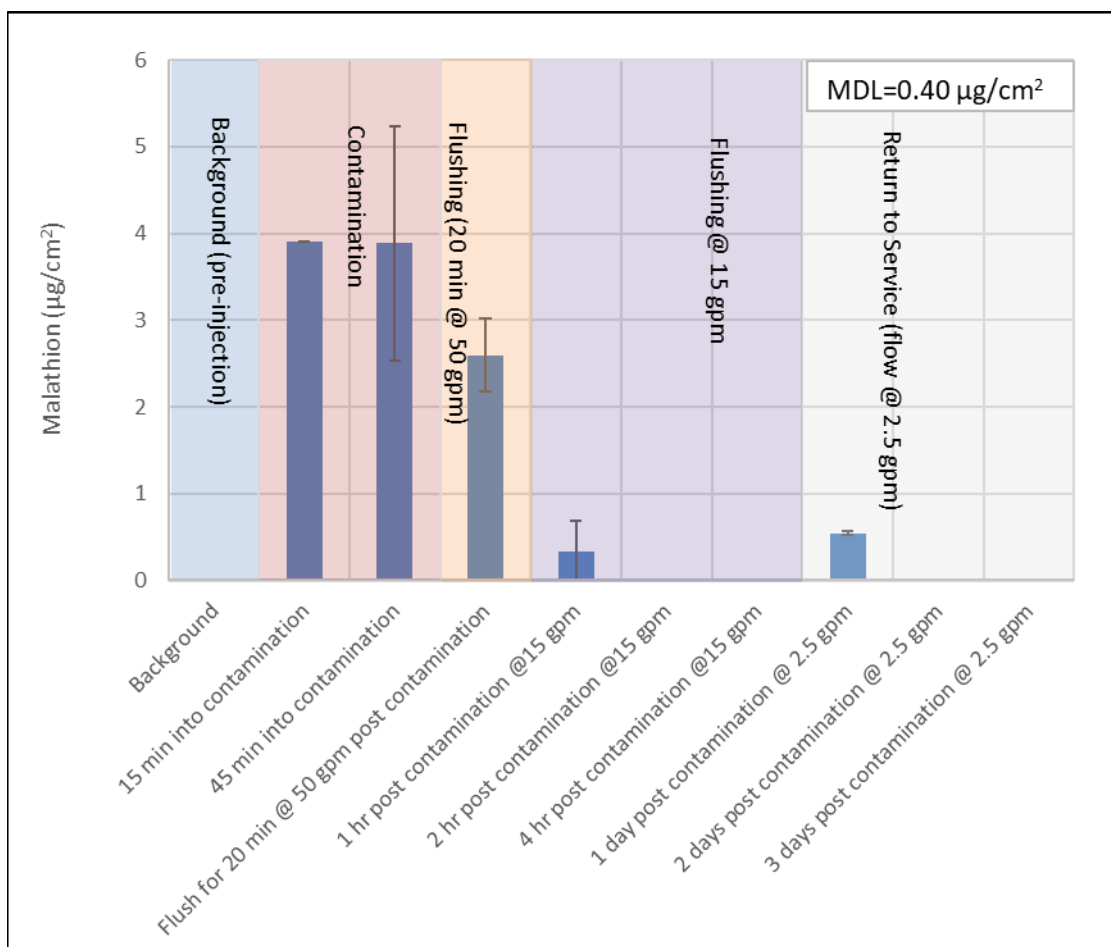
MDL=method detection limit; error bars represent the range between duplicate samples

**Figure 12: Contamination and decontamination of malathion from the pipe coupons using flushing in the 450 ft WSTB pipe.**

Coupons containing the pipe interior material of construction (cement-mortar) were also sampled for any adsorbed malathion. Results are shown in Figure 12. No malathion was detected on the coupons before contamination. During contamination, adsorbed malathion increased to nearly 4 µg/cm<sup>2</sup>. After flushing for 20 min at 50 gpm, adsorbed malathion levels dropped to 2.6 µg/cm<sup>2</sup>, or a decrease of 33%. As noted earlier, malathion was still present in the water during this sample point, and this likely contributed to the presence of malathion on the interior pipe surface. Malathion levels on the pipe material further decreased to 0.34 µg/cm<sup>2</sup> (91% reduction) one hour after contamination when the flow was at 15 gpm (57 L/min). This value is below the MDL. At two and four hours after contamination (flow at 15 gpm/57 L/min), no malathion was detected on the pipe coupons. In the days after contamination when flow was at 2.5 gpm (9.5 L/min), malathion was detected on the 1-day sample, but not at days 2 and 3. Little malathion was in the water at the 1-day sample point, so the presence of malathion on this sample was likely due to variation in adsorption between coupons. Still, the amount of adsorbed malathion on the 1-day coupon sample was 86% less than during contamination.

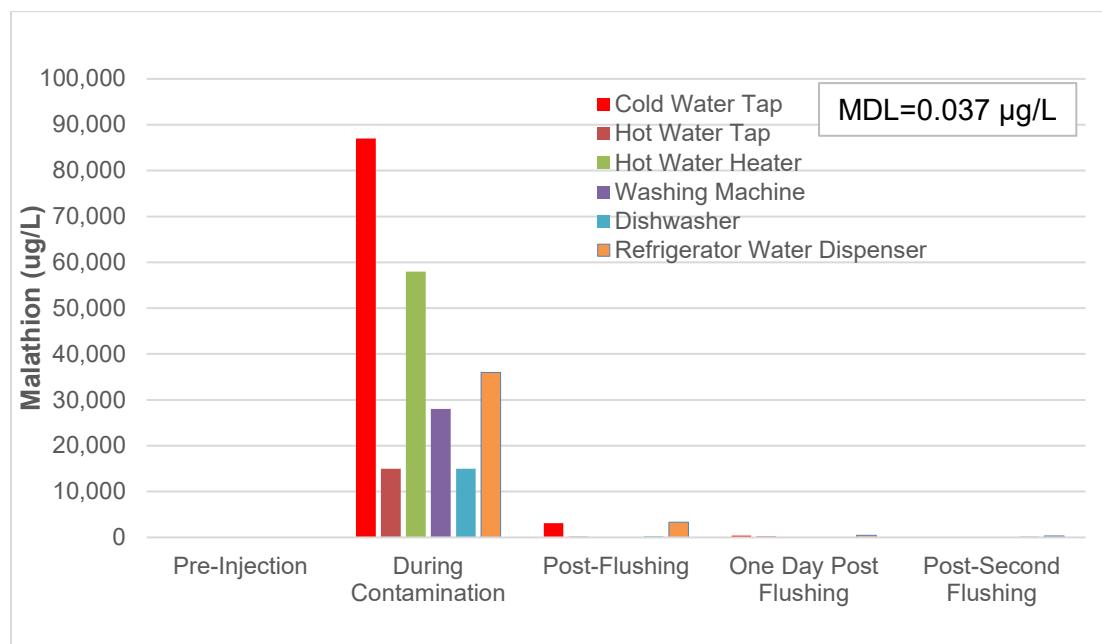
MDL=method detection limit

**Figure 13: Contamination and decontamination of malathion from the bulk water phase using flushing in the premise plumbing system.**

Figure 13 shows the results from the background, contamination, and decontamination sampling phases in the home plumbing system. Background is baseline level of malathion coming out of the water taps or water in the appliances before contamination. The contamination phase is when malathion contaminated water was introduced into the pipes and appliances. The flushing phase is when the taps were flushed, the water heater drained and refilled, and the appliances run for one cycle with water. The system of pipes and appliances was sampled the next day after the previous day's flush with flow overnight. The system was flushed again and sampled. The full flushing procedure is described detail in section 4.2.2. Note that since lower concentration samples are difficult to see in Figure 13, the data and percent removal of malathion compared to the contamination concentration are summarized in Table 2.

Figure 13 shows that malathion levels spiked during contamination, with 87,000 µg/L in the cold tap, and lesser amounts in the hot water, water heater and appliances. Contaminated water was diluted in the hot-water tank, which reduced the malathion concentration in the downstream
