Industrial Contractors Supplies, Inc. Surface Dust Guard with Diamond Wheel for Radiological Decontamination

TECHNOLOGY EVALUATION REPORT

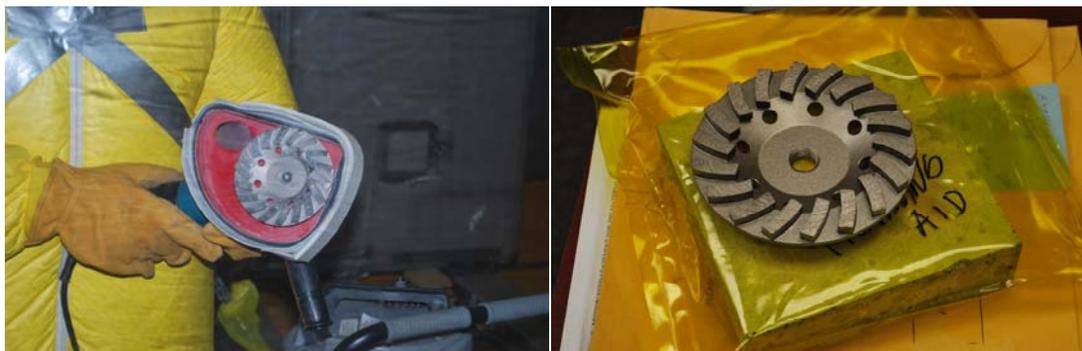
The Industrial Contractors Supplies, Inc. SDG is a vacuum shroud that can be attached to almost any commercially available handheld grinder or polisher with a 5 inch wheel (e.g. Bosch, DeWalt, and Hitachi, etc). During this evaluation the SDG was used with a Makita 9564CV angle grinder equipped with a DMD (CGD30P45H, Industrial Contractors Supplies, Inc.). (Hence, the SDG-DMD.)The DMD was 10 cm in diameter and had 18 segments of 40/60 medium grit diamond crystal segments. This technology decontaminates bound Cs-137 from surfaces by removing the surface layer and collecting the resulting secondary waste using a high efficiency particulate air (HEPA) vacuum connected to the SDG. The vacuum was powered by 110 volt (V) electricity generating a flow of 136 cubic feet per minute (cfm). The angle grinder component was also powered by 110V electricity; according to vendor specifications, it operates at speeds up to 10,500 revolutions per minute. Figure 2-1 shows the components of the SDG-DMD.

Figure 2-1. Angle grinder equipped with SDG and DMD (left). DMD (right).

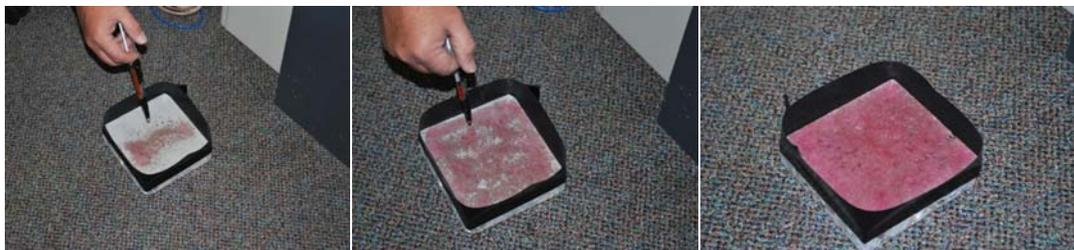
The aerosol delivery device was constructed of two syringes. The plunger and needle were removed from the first syringe and discarded. Then, a compressed air line was attached to the rear of the syringe. The second syringe contained the contaminant solution and was equipped with a 27 gauge needle, which penetrated through the plastic housing near the tip of the first syringe. Compressed air flowing at a rate of approximately 1 - 2 L per minute created a turbulent flow through the first syringe. When the contaminant solution in the second syringe was introduced, the solution became nebulized by the turbulent air flow. A fine aerosol was ejected from the tip of the first syringe creating a controlled and uniform spray of fine liquid droplets onto the coupon surface. The contaminant spray was applied all the way to the edges of the coupon which were taped (after having previously been sealed with polyester resin) to ensure that the contaminant was applied only to the surfaces of the coupons. The photographs in Figure 3-1 show this procedure being performed using a nonradioactive, nonhazardous aqueous dye to demonstrate that the 2.5 mL of contaminant solution is effectively distributed across the surface of the coupon.

Figure 3-1. Demonstration of contaminant application technique.

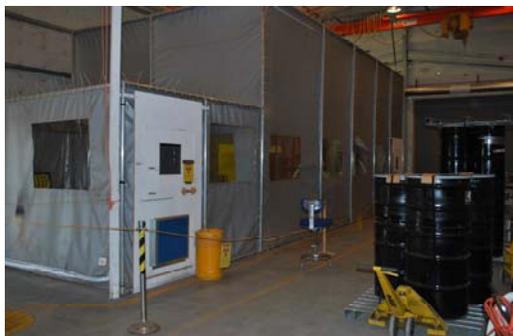
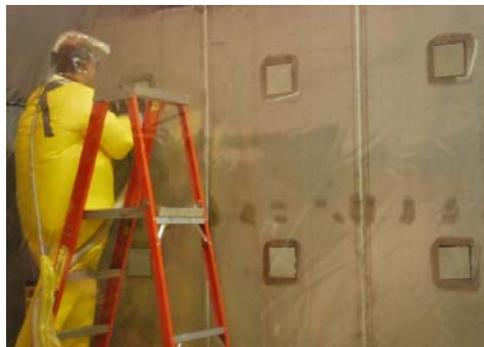
To evaluate the decontamination technologies on vertical surfaces (simulating walls), a stainless steel test stand was fabricated that held three rows of three concrete coupons. The test stand, approximately 9 feet (ft) × 9 ft, was erected within a containment tent. The concrete coupons were placed into holders so their surfaces extended just beyond the surface of the stainless steel face of the test stand. Eight of the nine coupons placed in the test stand were contaminated with Cs-137, which has a half-life of 30 years. One uncontaminated coupon was placed in the bottom row of the test stand and decontaminated using the SDG-DMD in the same way as the other coupons. This coupon was placed there to observe possible secondary contamination caused by the decontamination higher on the wall. Figure 3-2 shows the containment tent and the test stand loaded with concrete coupons.

Figure 3-2. Containment tent: outer (left) and inner view with test stand containing contaminated coupons (right).

The containment tent consisted of two rooms. One room contained the test stand to hold the contaminated coupons; the other room (the shorter part of the tent as shown in Figure 3-2) held the vacuum. An opening in the tent wall between the two rooms was just large enough to allow the vacuum hose connected to the SDG-DMD to pass through. The tent

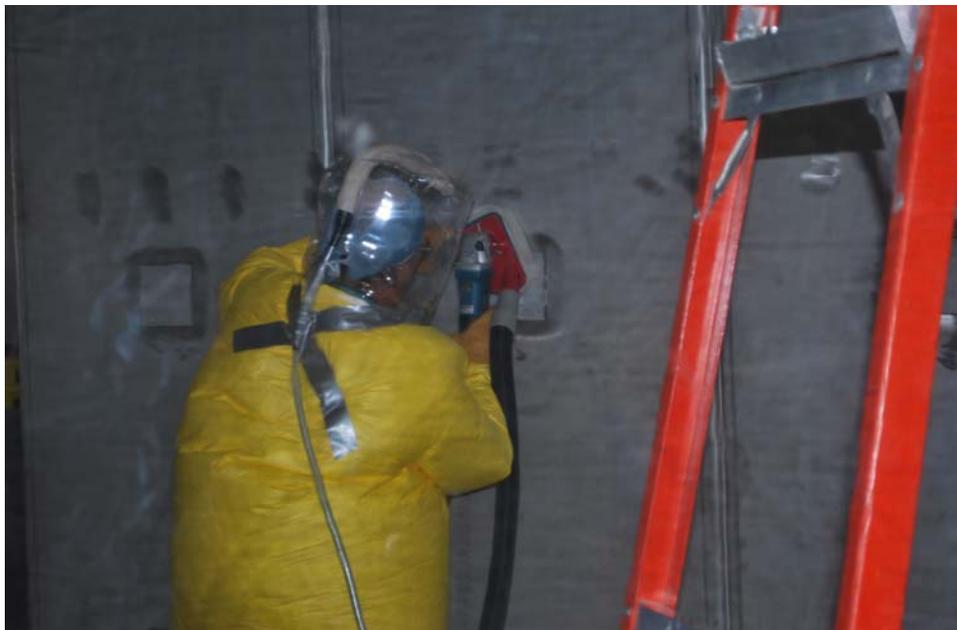
opening was taped closed around the hose prior to the start of the evaluation. Figure 3-3 shows the vacuum hose connecting to the SDG as the operator applies the SDG-DMD to a concrete coupon.

Figure 3-3. SDG-DMD being applied to concrete coupon.

The nine concrete coupons in the test stand were sanded using the SDG-DMD starting with the top row and working from left to right, then proceeding to the middle and bottom rows. The coupons were sanded in this manner to simulate an approach that would likely be taken in an actual decontamination event, where higher wall surfaces would be decontaminated first because of the possibility of secondary contamination lower on the wall. The SDG-DMD was connected to the vacuum and operated at full power for 20-30 seconds on each coupon, enough time to ensure that the entire surface of each had been covered. This procedure would correspond to a rate of coverage ranging from 0.2 m² to 0.3 m² per minute. The temperature and relative humidity were recorded before and after the approximately one hour test. These conditions did not vary significantly in the room where the evaluation was performed. Over the duration of testing, the temperature was 17.7 °C and the relative humidity was 26%.

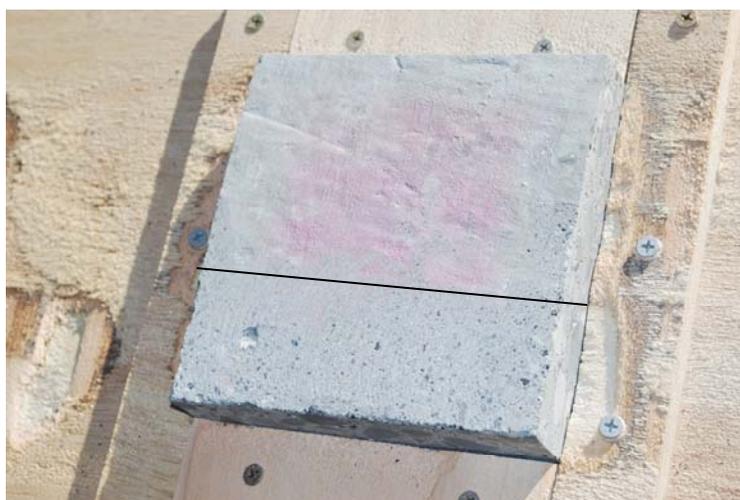
A number of operational factors were documented by the SDG-DMD operator. One of the factors was damage to the surface of the concrete coupons. Figure 5-1 shows a non-contaminated coupon that has had the bottom third sanded with the SDG-DMD and the top two-thirds left unsanded. The slight pink color is due to a dye that was applied to the surface of this noncontaminated coupon for illustrative purposes. The bottom of the coupon has had the surface characteristics (pink color, smooth concrete finish, etc.) stripped away. One large piece of aggregate on the left side of the coupon fell out during sanding; several dark colored pieces of aggregate are visible in the bottom third but not in the top two-thirds of the coupon. The SDG-DMD can damage any concrete surface on which it is used.

Figure 5-1. Concrete coupon demonstrating surface damage.
