Permeable Pavement Research Highlights

Performance and effectiveness of permeable pavement systems

Edison Environmental Center
Edison, New Jersey

In-Street Application
Louisville, Kentucky

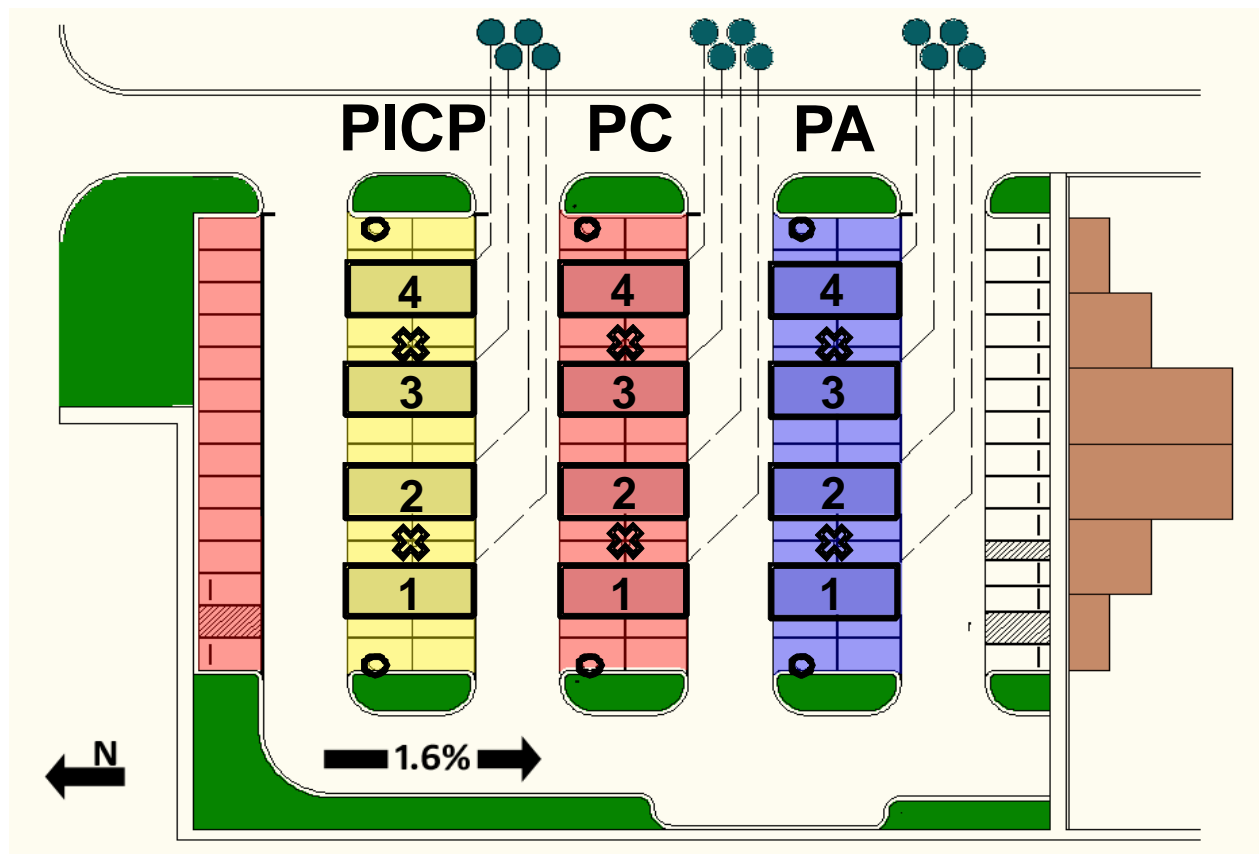
The design at the EEC incorporated water quality monitoring capabilities.

The permeable pavement parking lot at the Edison Environmental Center allows evaluation of water quality effects.

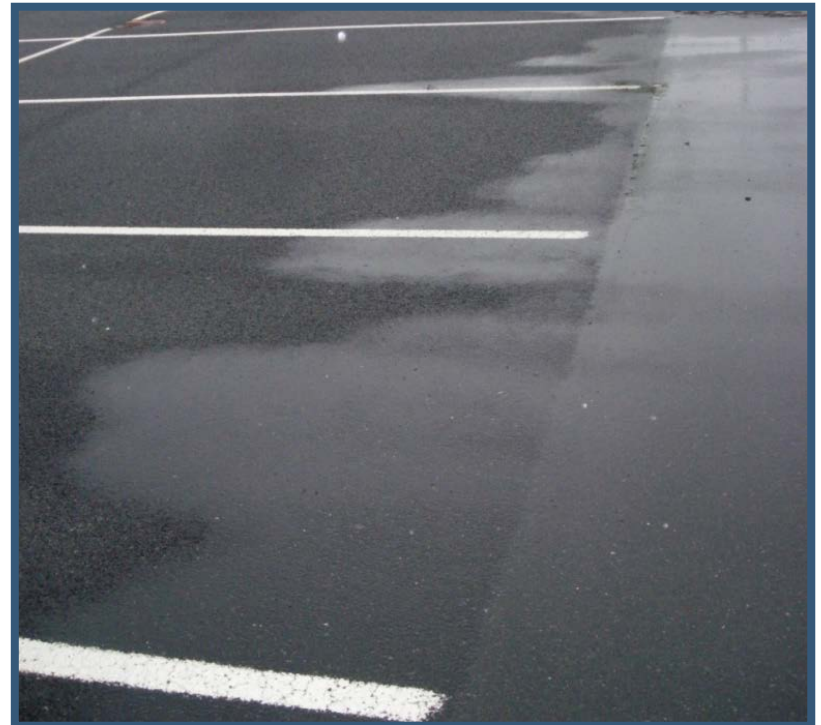
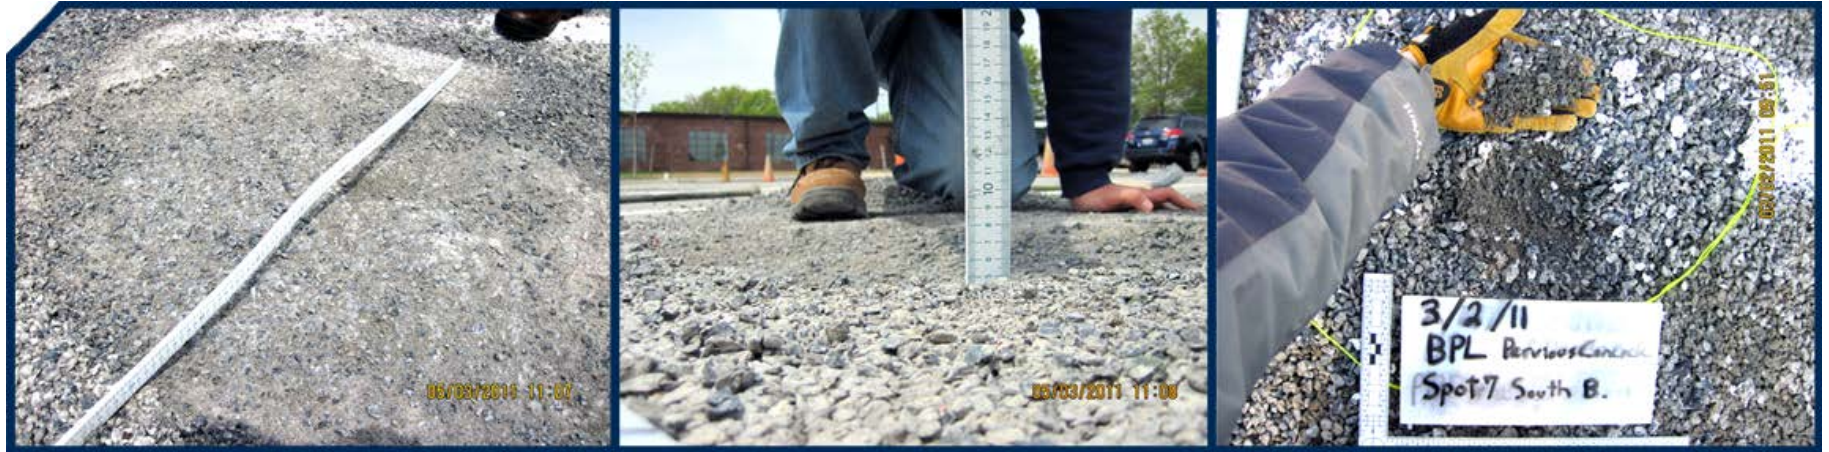
Large portions of the pervious concrete disaggregated.

The problem first became apparent about 18 months after pouring concrete. It was repaired by the contractor in May 2011, but has recurred.

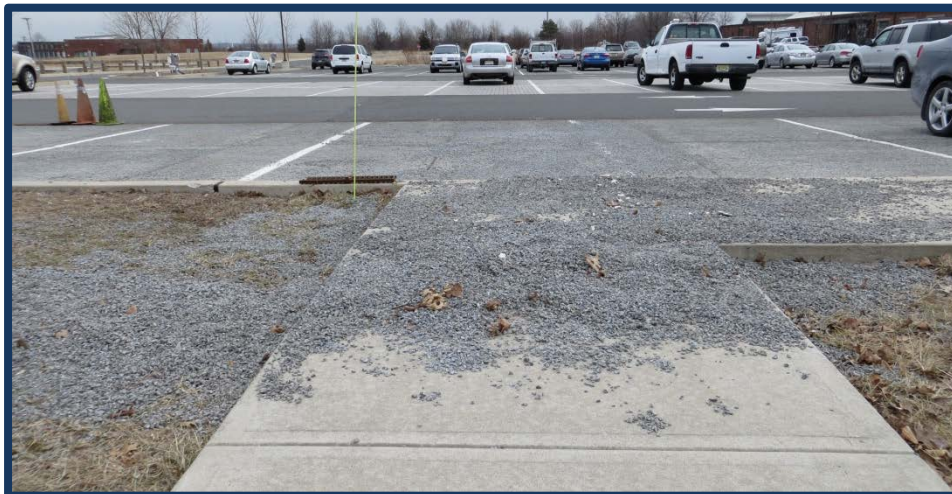
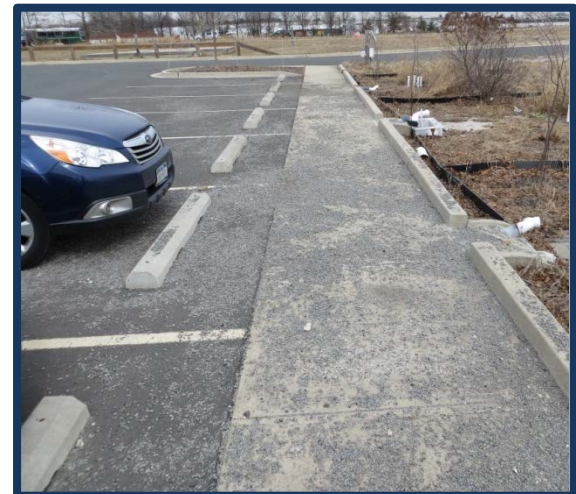
Is structural failure coupled with chloride?

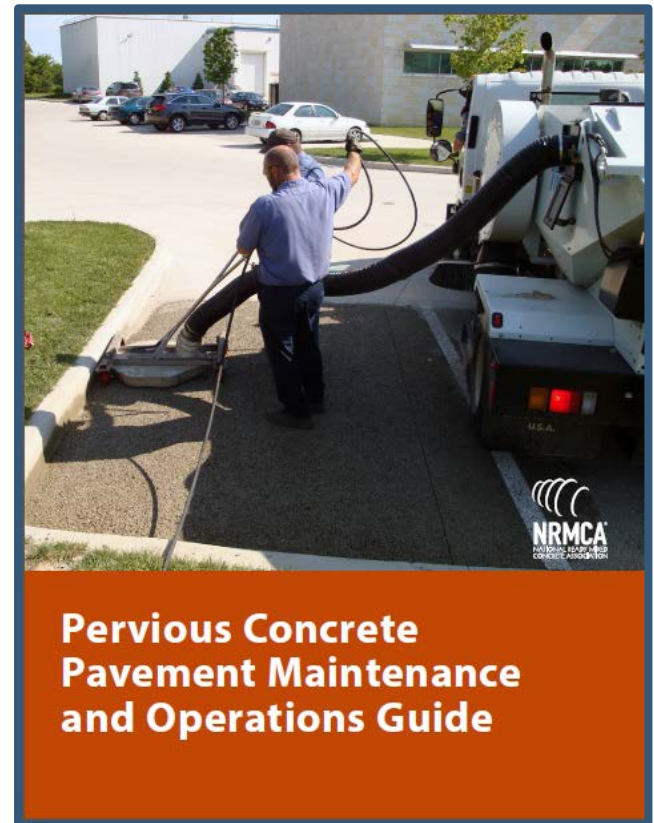
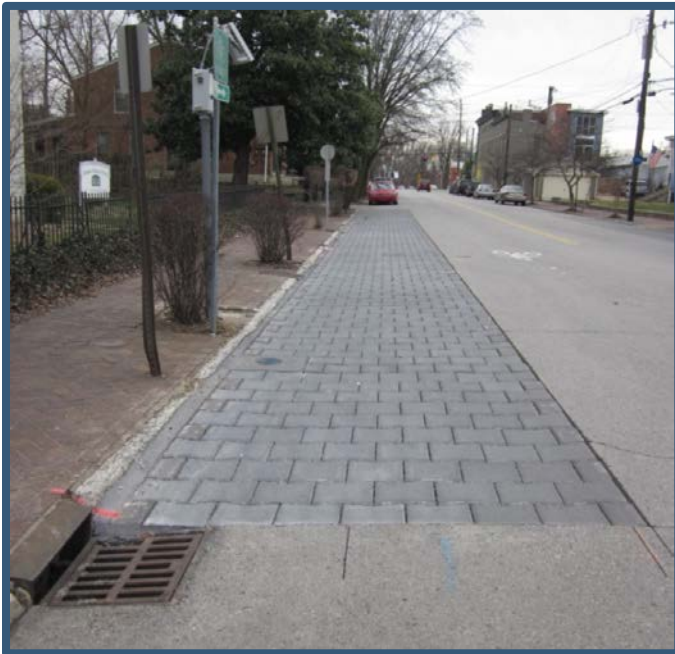
In 2011, Louisville MSD installed permeable pavement strips in parking lanes near the catch basins in the Butchertown section of Louisville.

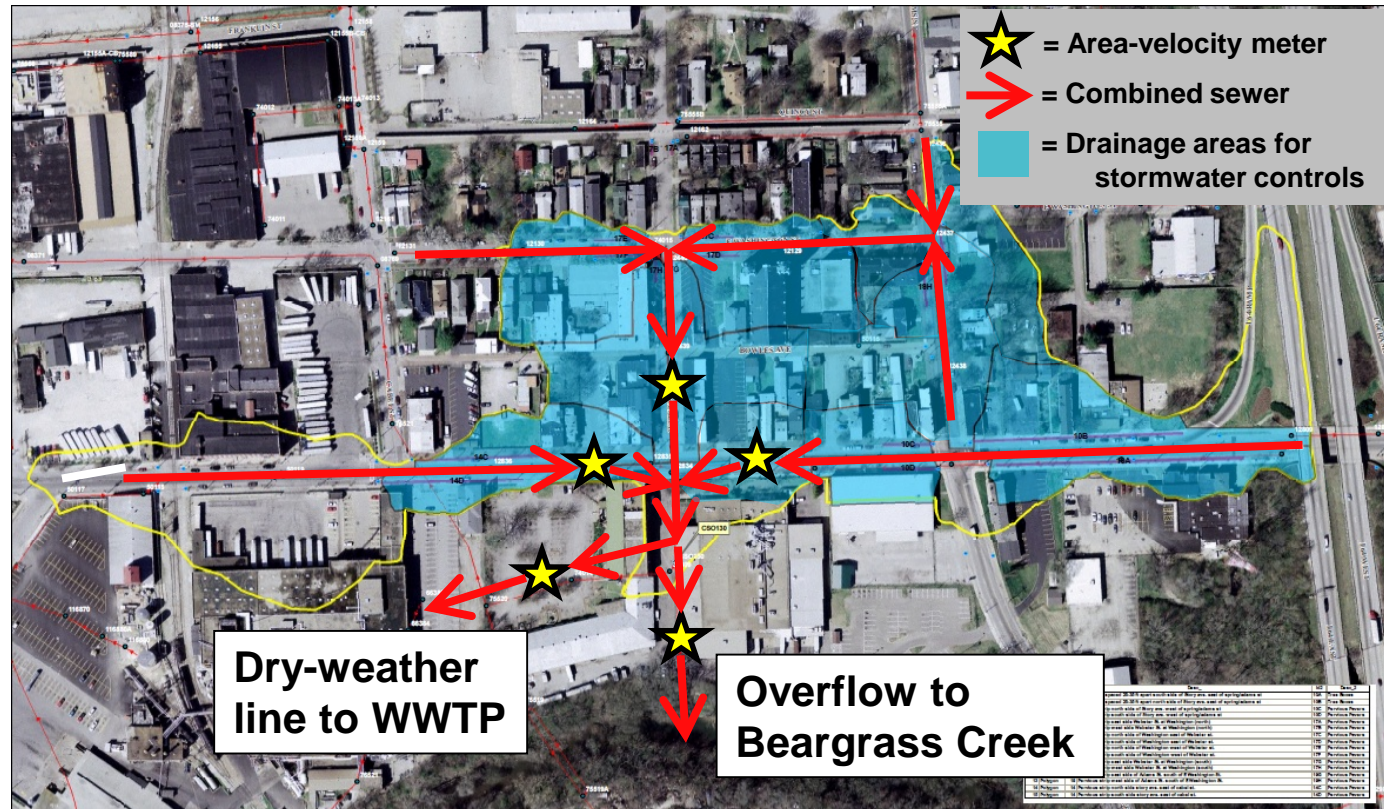
In-sewer flows were measured at 5 locations for at least 1 year before construction to develop the preconstruction condition model using InfoWorks (Innovyze).

Sigma 920 area-velocity flow meters (later FloWav) were installed and managed by LJCMSD.

The flow meters separated the basin into 4 catchments, and catch basins were used to define 29 subcatchments.

Drainage areas were defined using 6-inch LIDAR data and refined with on-site observations.

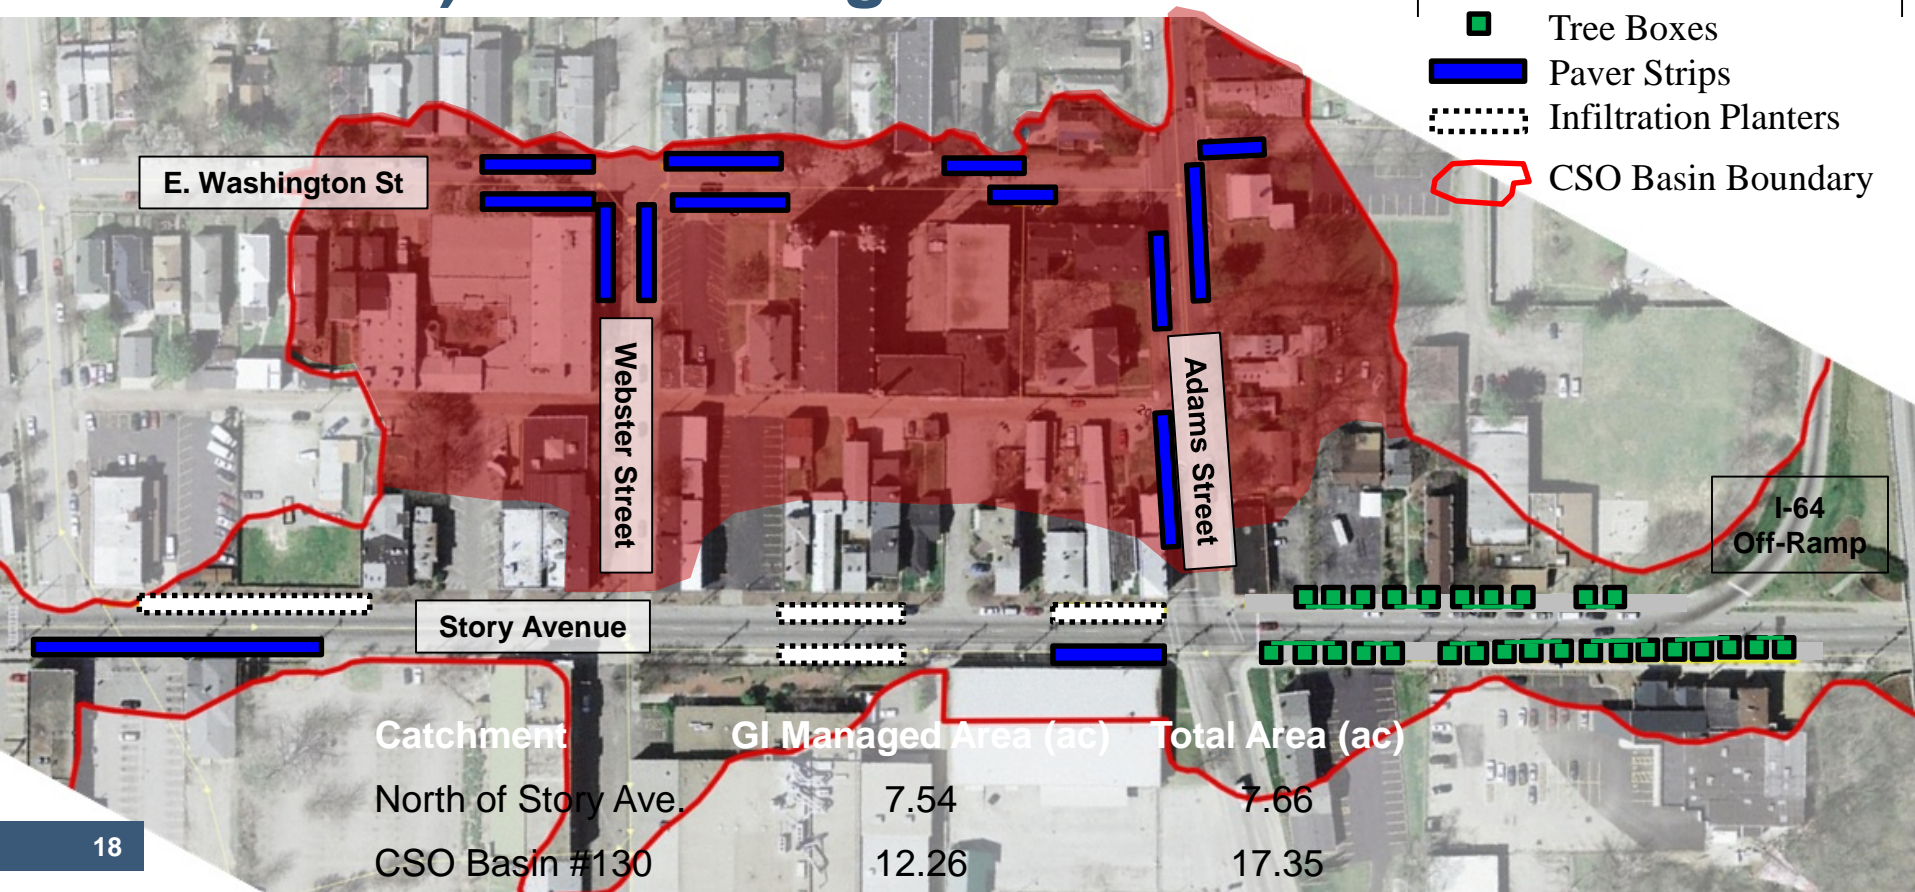
We selected the largest subsewershed area to evaluate the effectiveness (north of Story Avenue) as a surrogate.

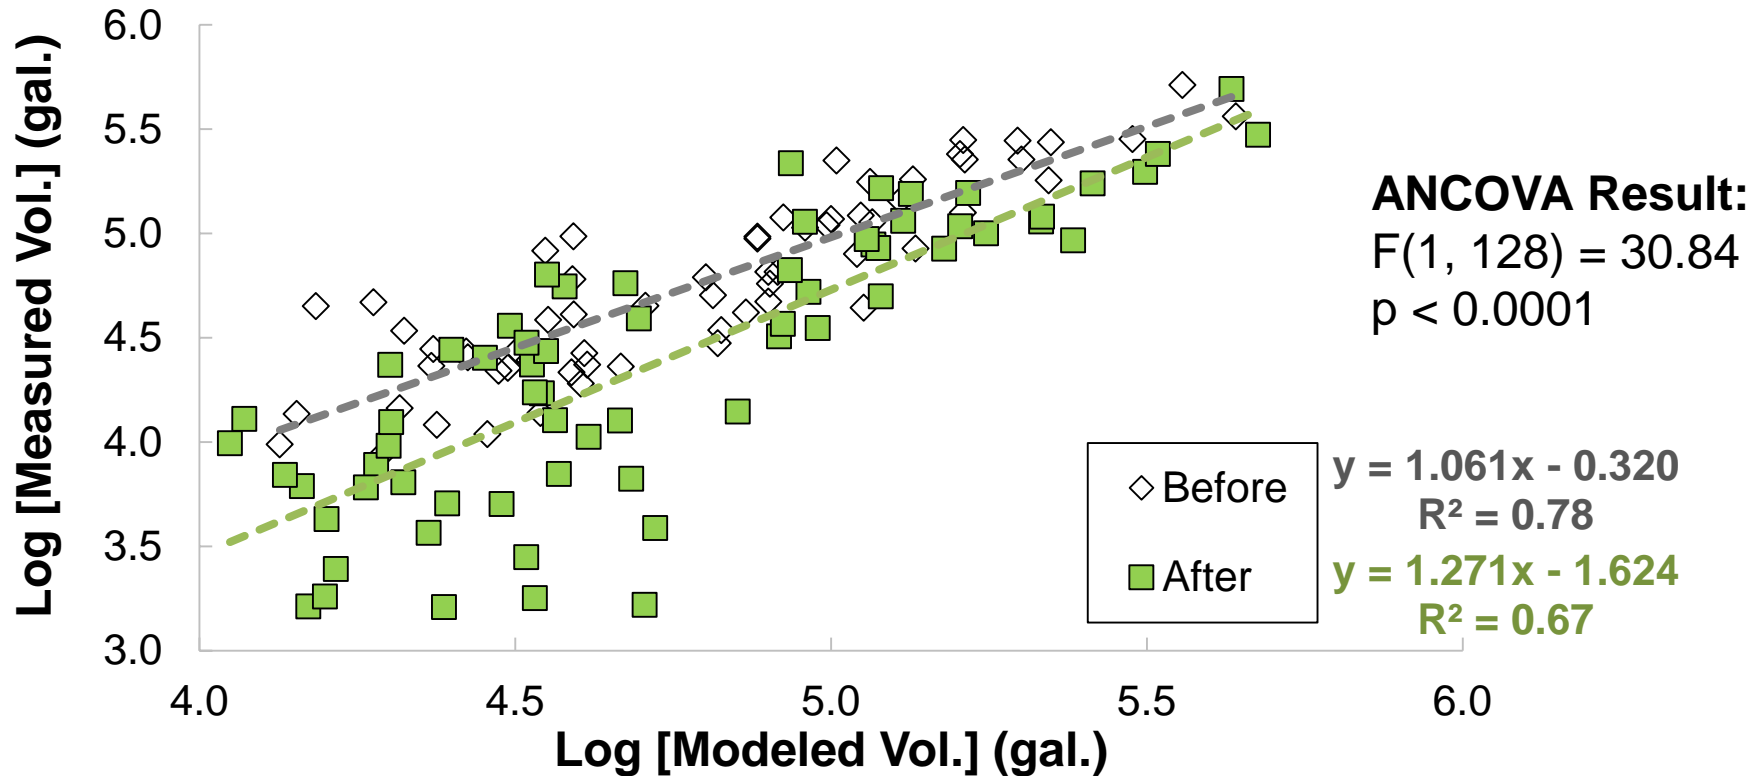
Using the BACI approach, GI significantly reduced in-sewer flow volume per event.

Period	Control Mean (gal)	Impact [GI] Mean (gal)	Predicted [GI] (gal)	% Change
Before	63,509	59,319		
After	54,108	24,623	50,053	– 51%

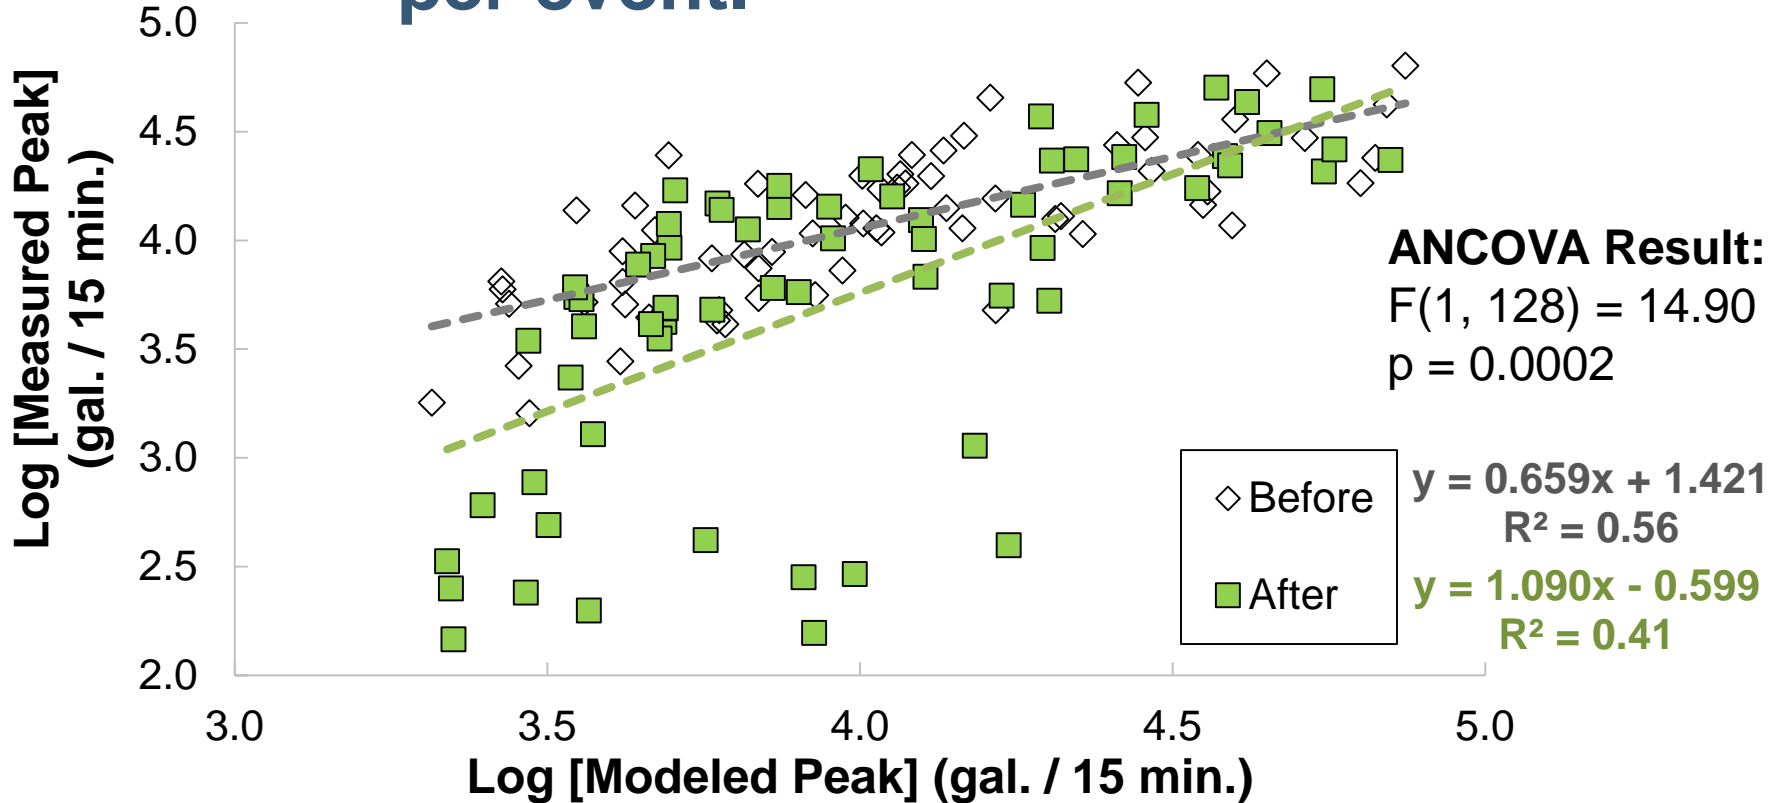
Using the BACI approach, GI also significantly reduced peak flow rates per event.

Period	Control (gal. / 15 min.)	Impact [GI] (gal. / 15 min.)	Predicted [GI] (gal. / 15 min.)	% Change
Before	11,051	12,122		
After	9,308	5,313	10,826	- 51%

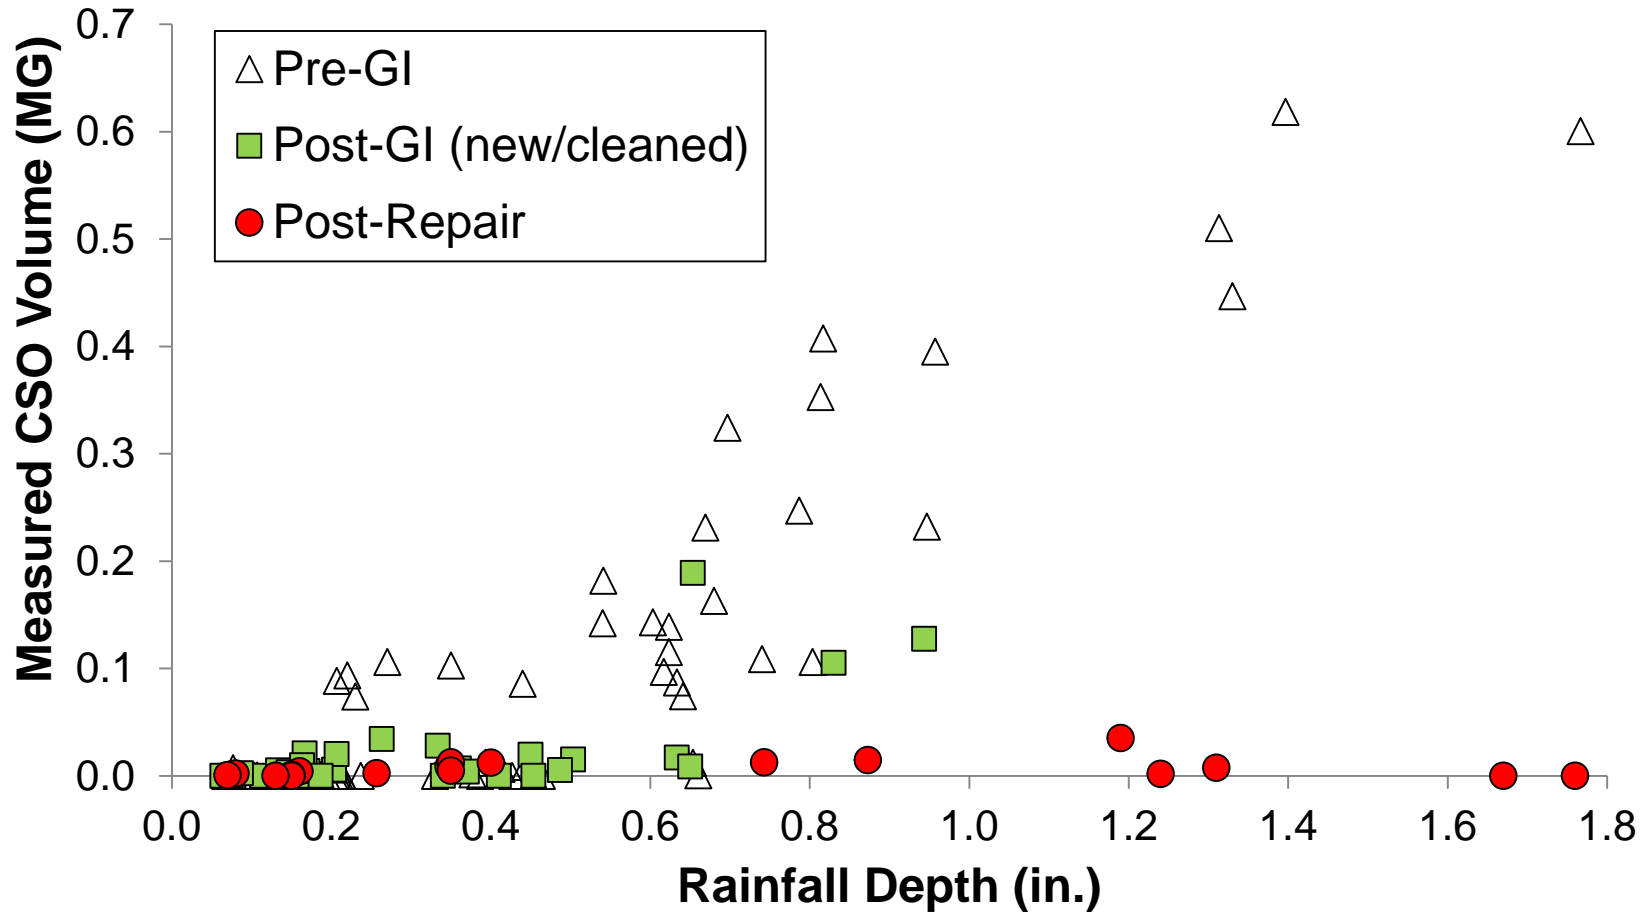
Results after replacing the dry-weather line are promising for meeting basin AAOV targets.
