Permeable Pavement Research Highlights

Performance and effectiveness of permeable pavement systems

Edison Environmental Center
Edison, New Jersey

In-Street Application
Louisville, Kentucky

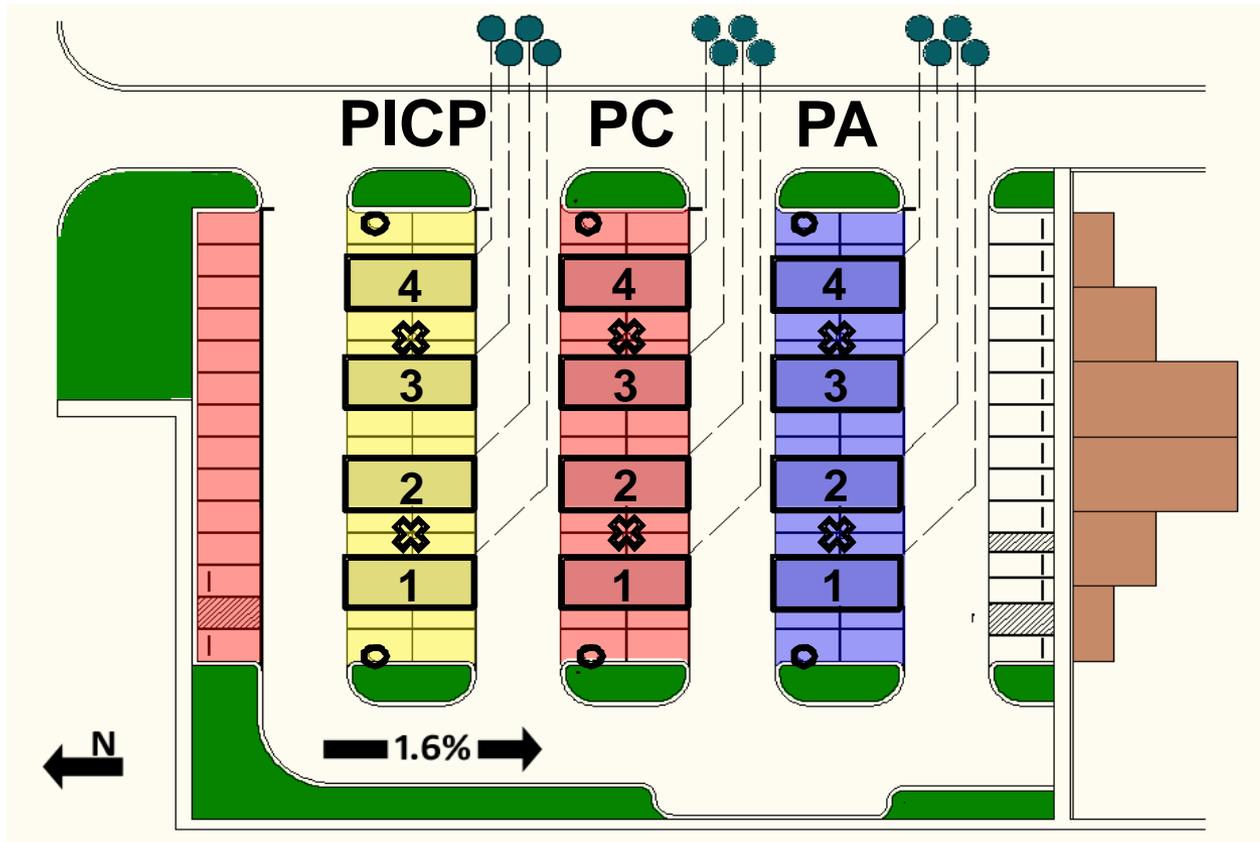
The design at the EEC incorporated water quality monitoring capabilities.

- Interlocking concrete pavers
- Pervious concrete
- Porous asphalt
- Rain gardens
- Buried distribution pipes
- Tree islands
- Hot mix asphalt
- Buried well/piezometers
- Collection tanks
- Buried WCRs

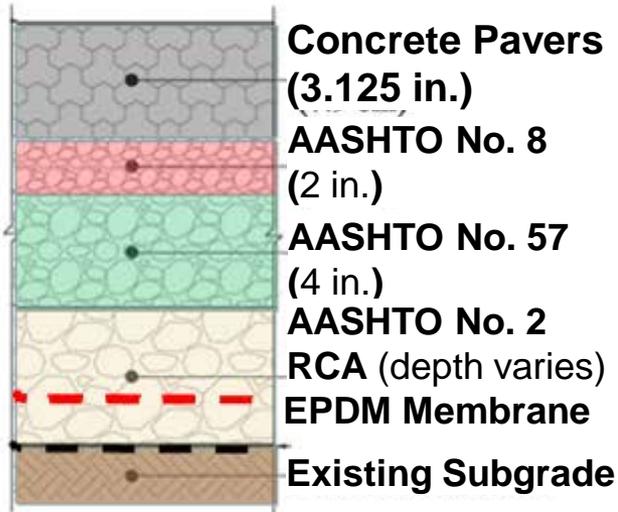
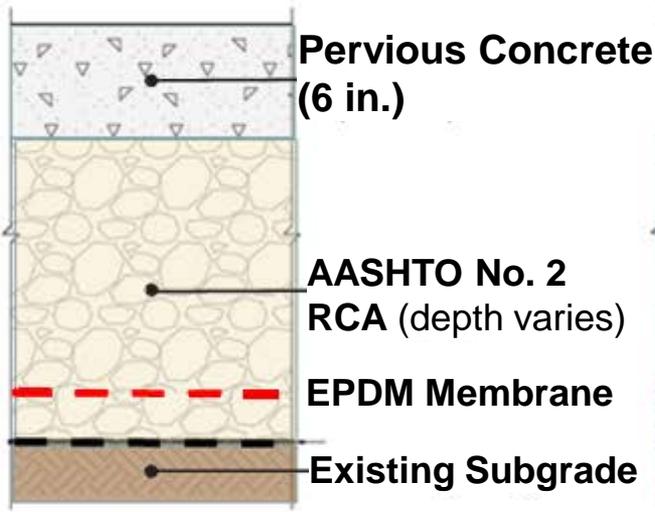
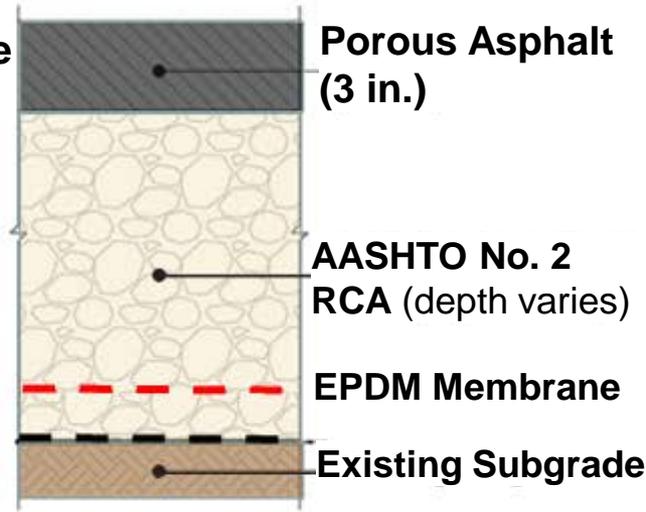
Vertical cross sections of permeable sections varied slightly from material to material.

Not to scale

Based on engineering drawings from Morris & Ritchie Associates, Inc. 2009

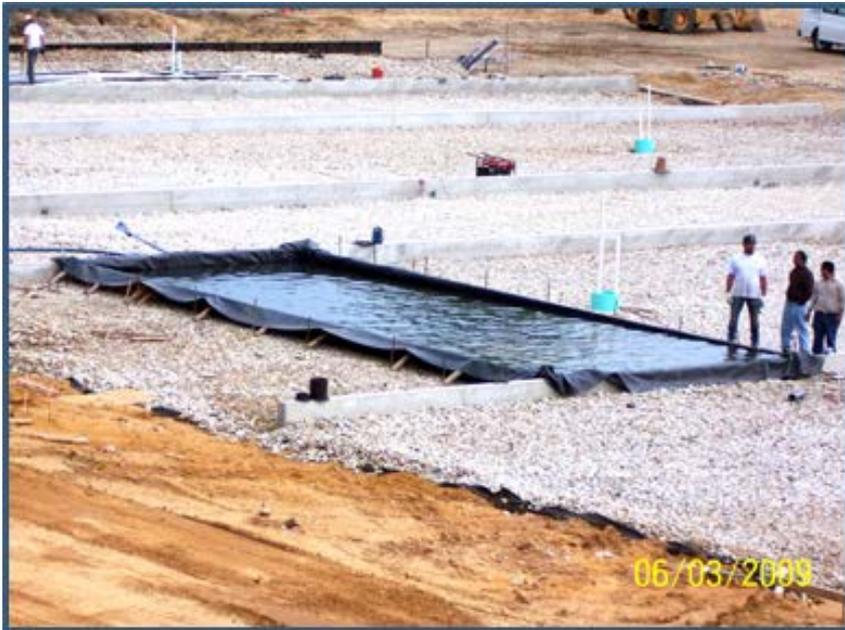
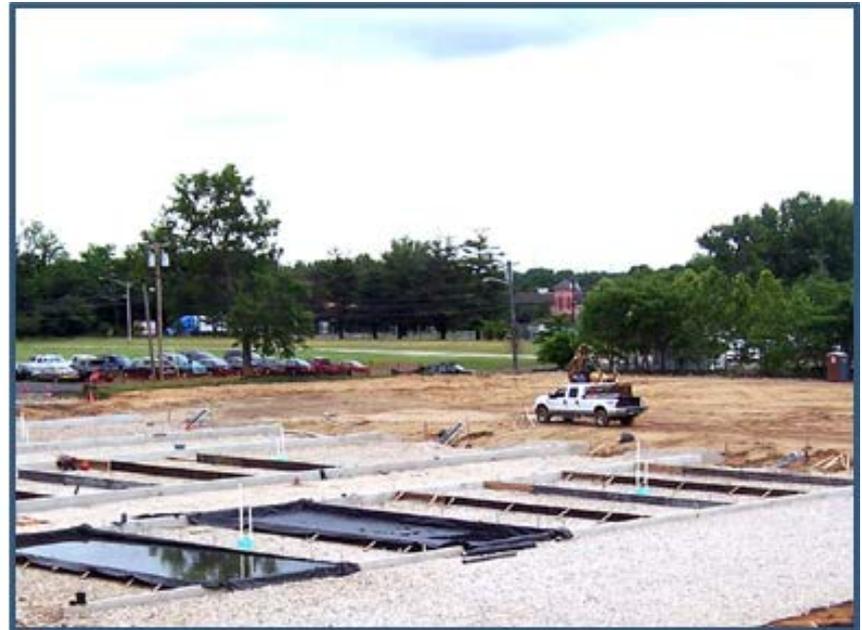
Four equally-sized and spaced lined sections collect infiltrating water from each monitored permeable surface with the balance infiltrating to the underlying soil.

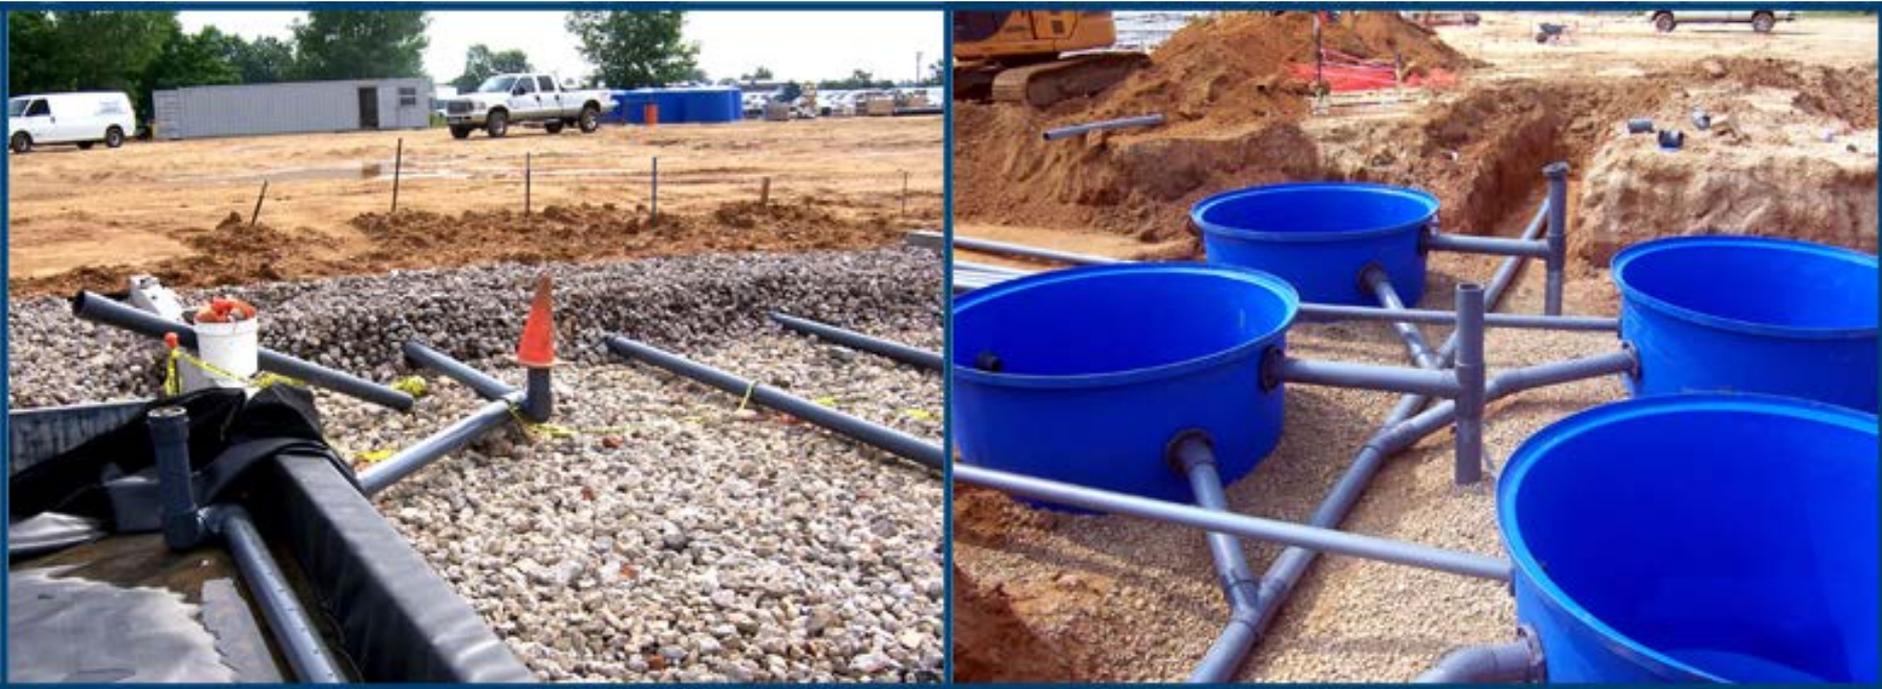
Infiltrate drains from the lined sections to 1,500-gallon tanks on the east side of the parking lot where it can be sampled.

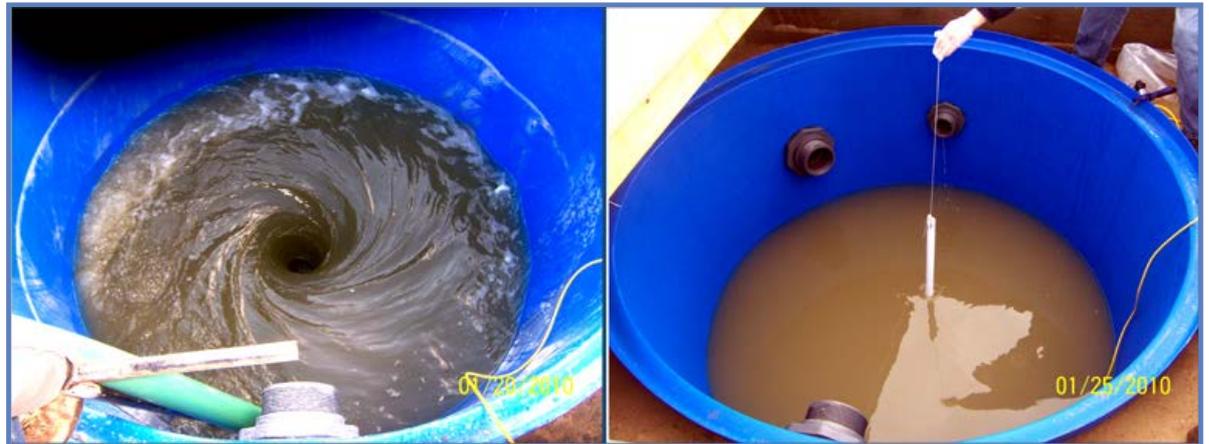
- Published or in review
 - Chloride
 - Speciated nitrogen
 - Organic carbon
 - Phosphate
 - pH
 - Eh
- Just starting
 - Microbial indicators
- In production
 - SVOCs
 - Metals

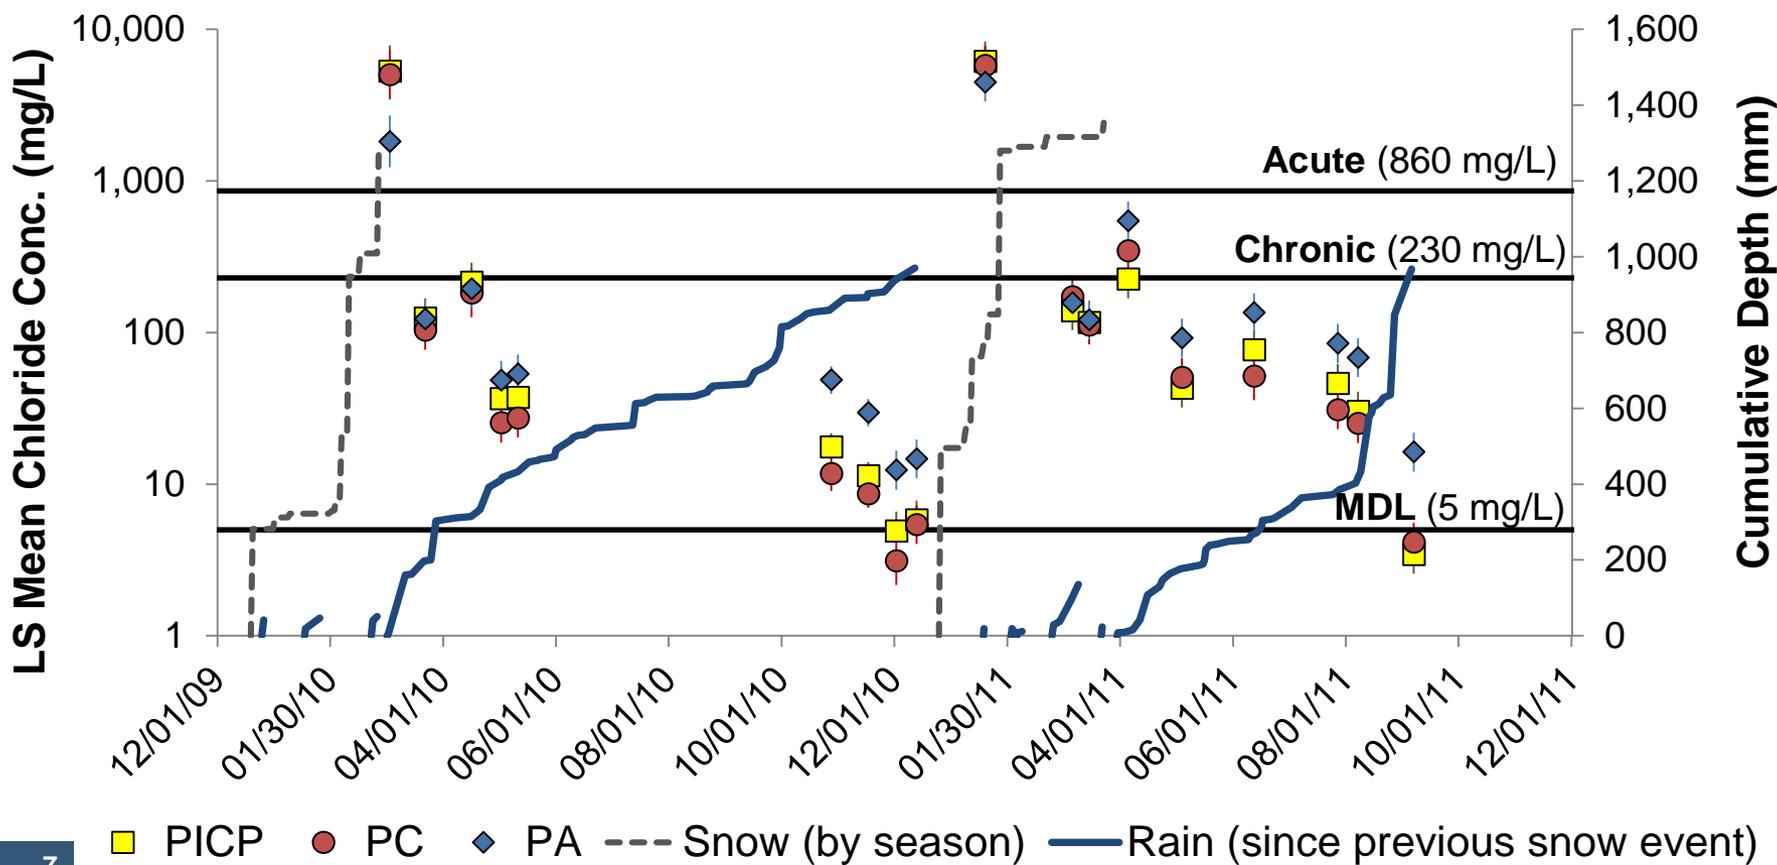
After winter salt application, chloride concentration decreases throughout the remainder of the year.

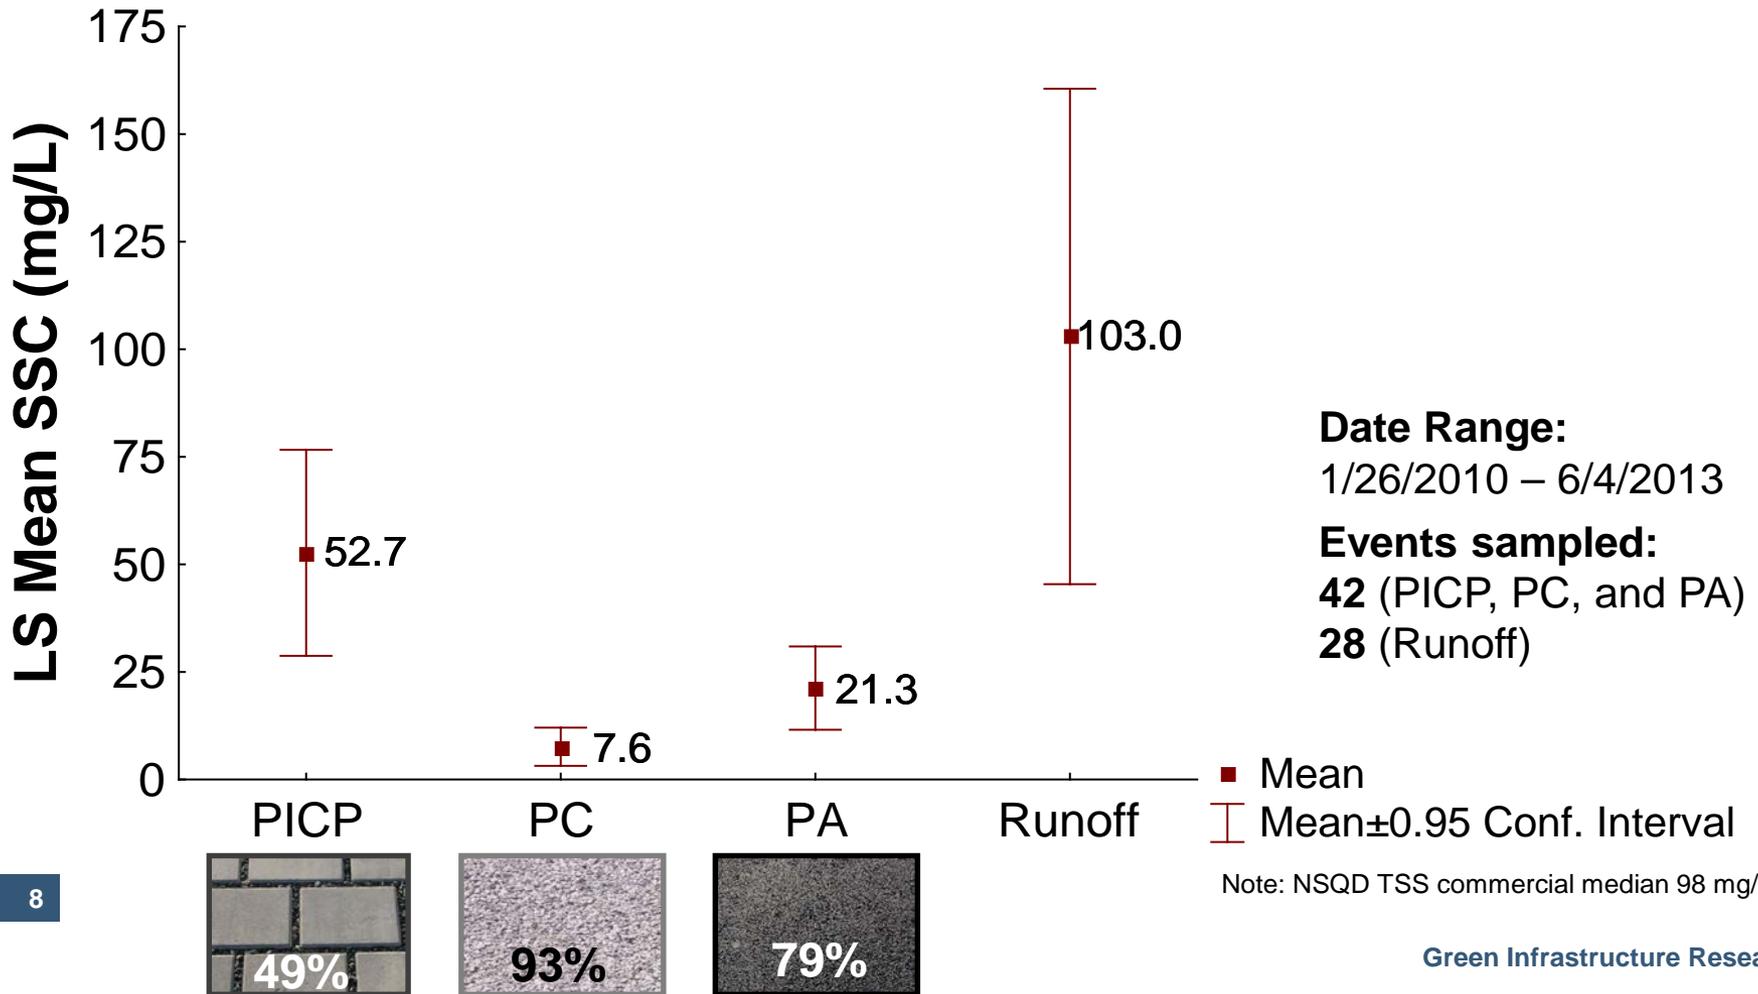
All permeable surfaces reduced Suspended Solids Concentration (SSC) to different degrees.

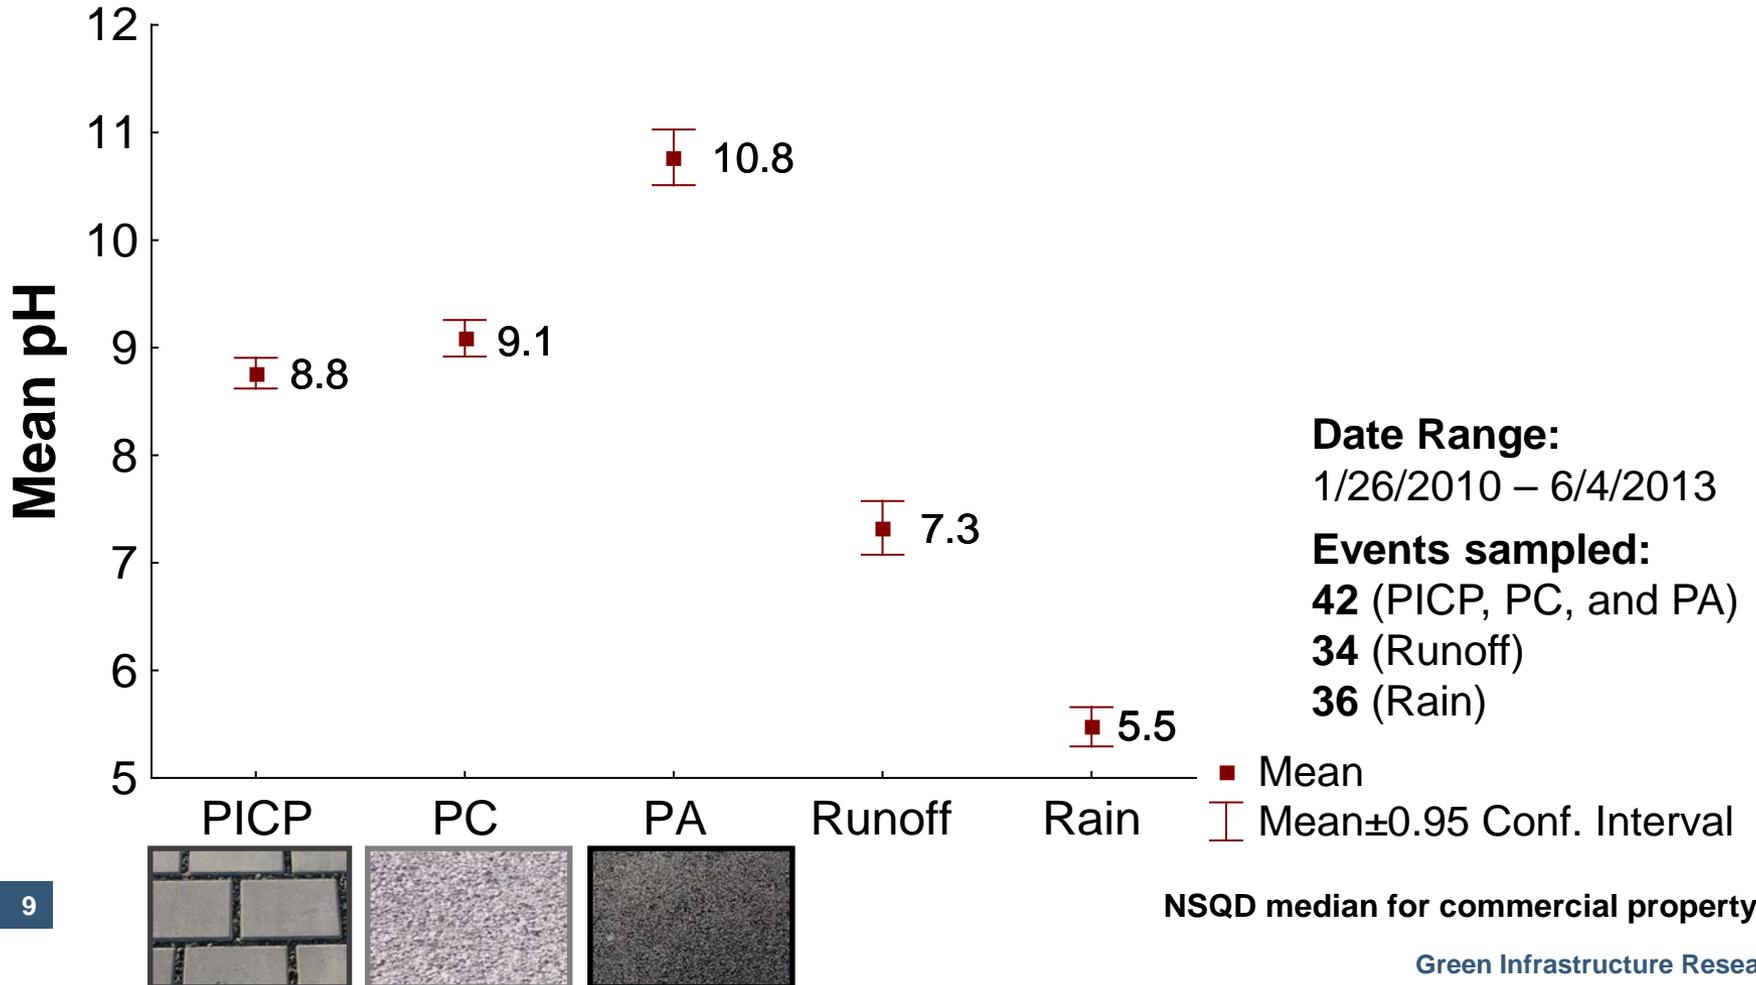
Acidic rainfall is buffered by all pavement surfaces, and PA exfiltrate is surprisingly basic.

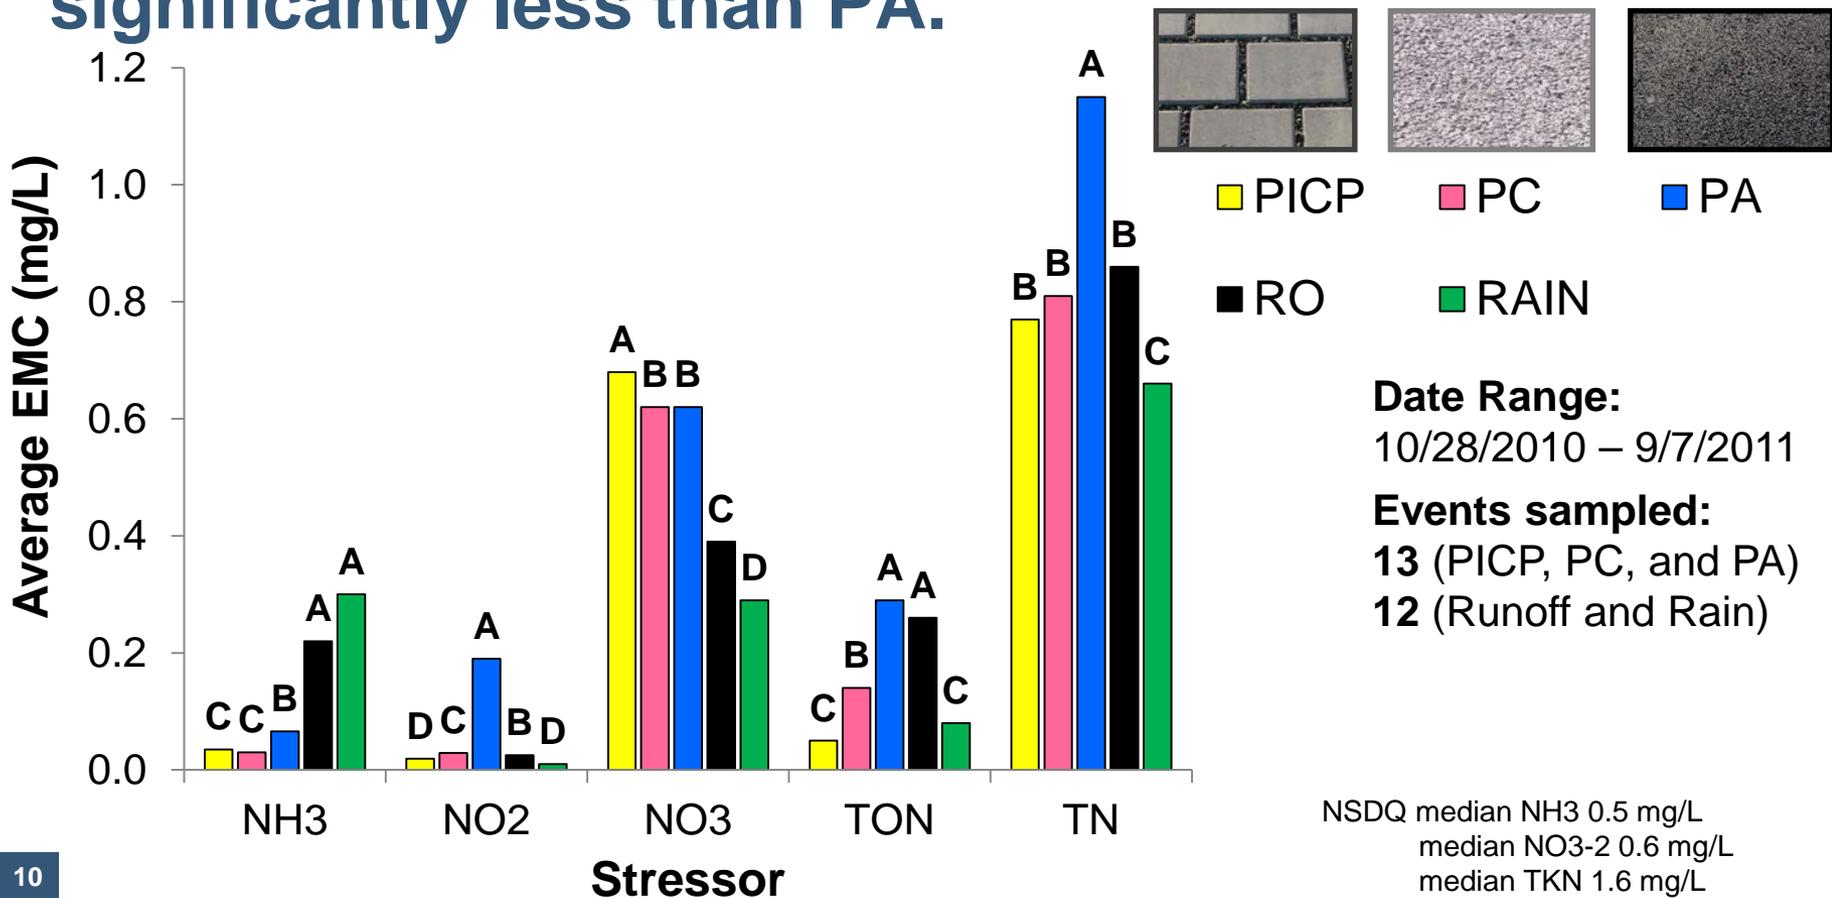
TN concentrations in PICP, PC, and runoff were not significantly different, but all three were significantly less than PA.

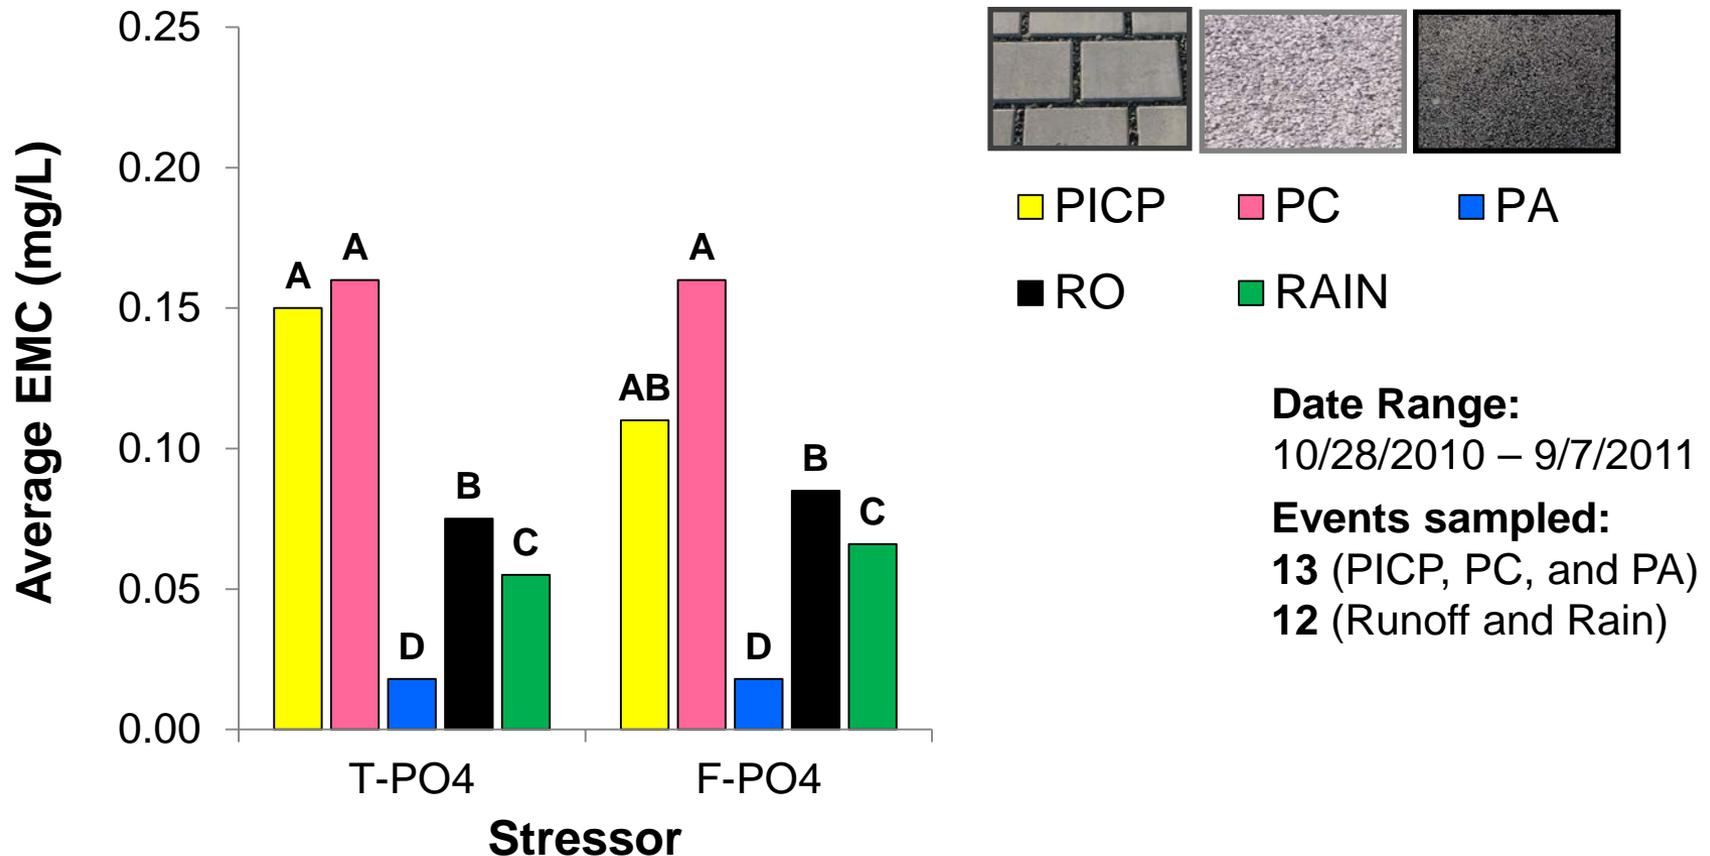
Total phosphate concentrations in PICP and PC were significantly larger than in the runoff, and all were significantly larger than PA.

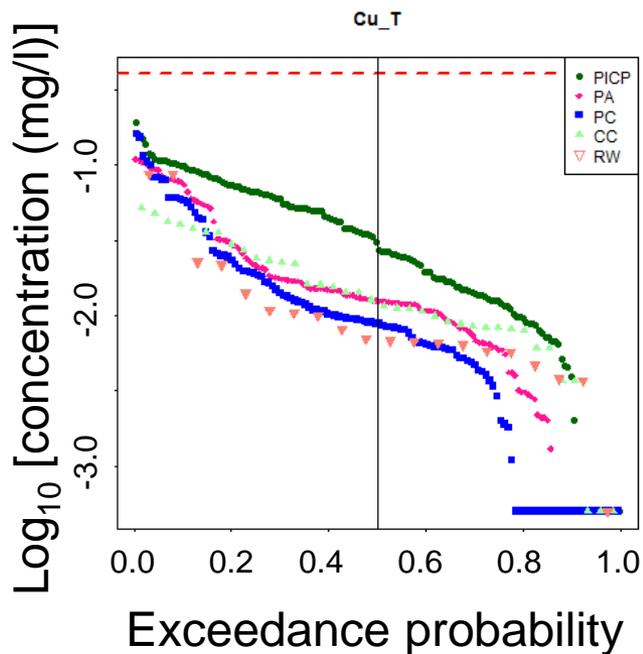
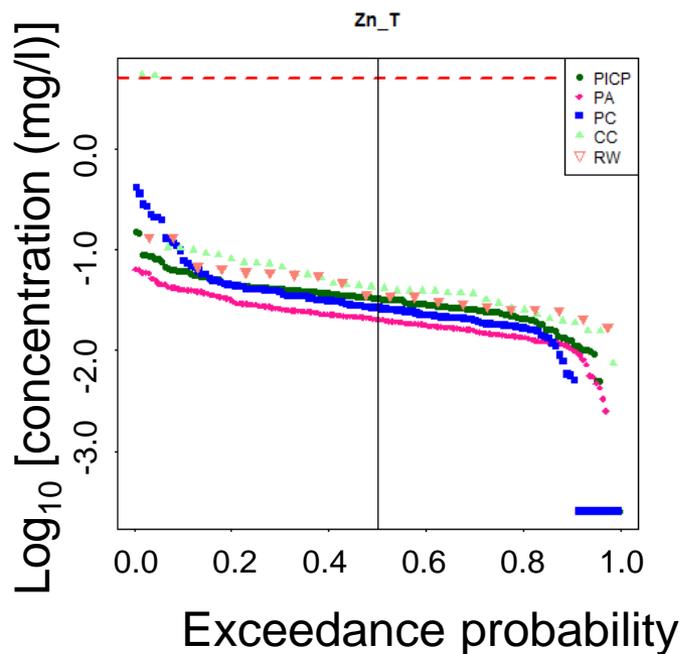
The concentration of priority-pollutant metals were generally less than the groundwater discharge limit.

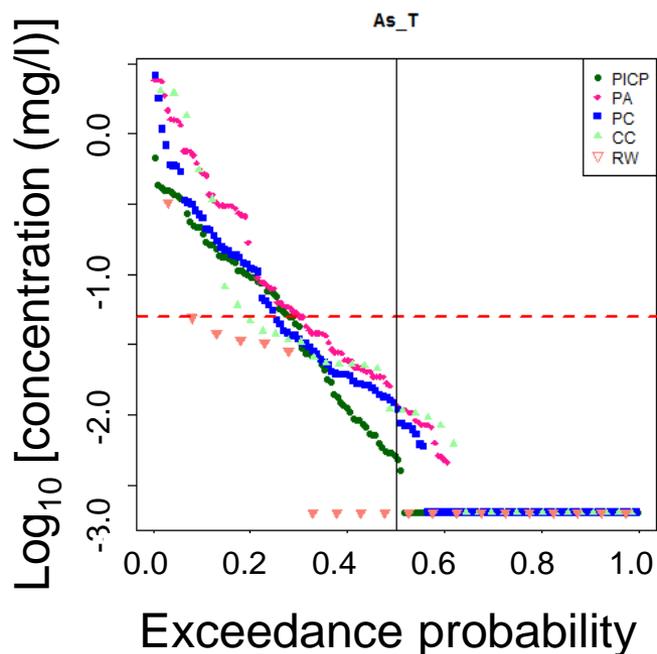
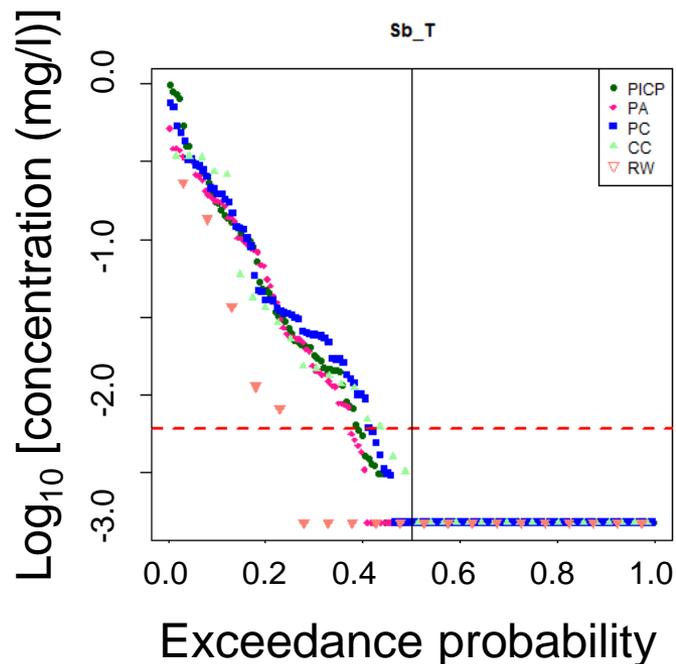
Arsenic and antimony sometimes exceeded the groundwater limits

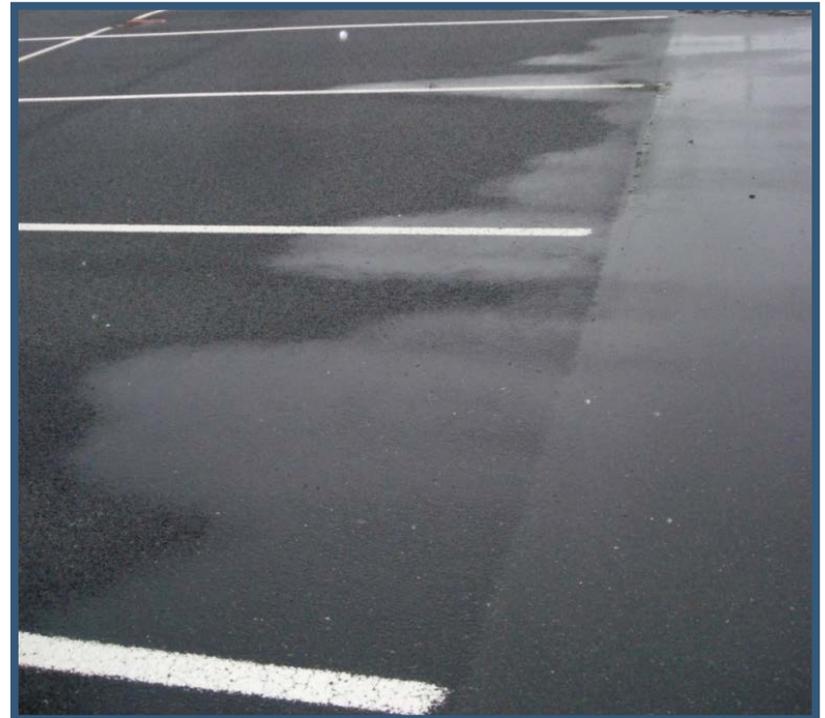
Surface results:

- The three surfaces have very large infiltration rates.
- Clogging progresses from upgradient to downgradient.
- Microtopography partly determines clogging pathway.
- 5 to 7% of the captured water evaporates through the surfaces.

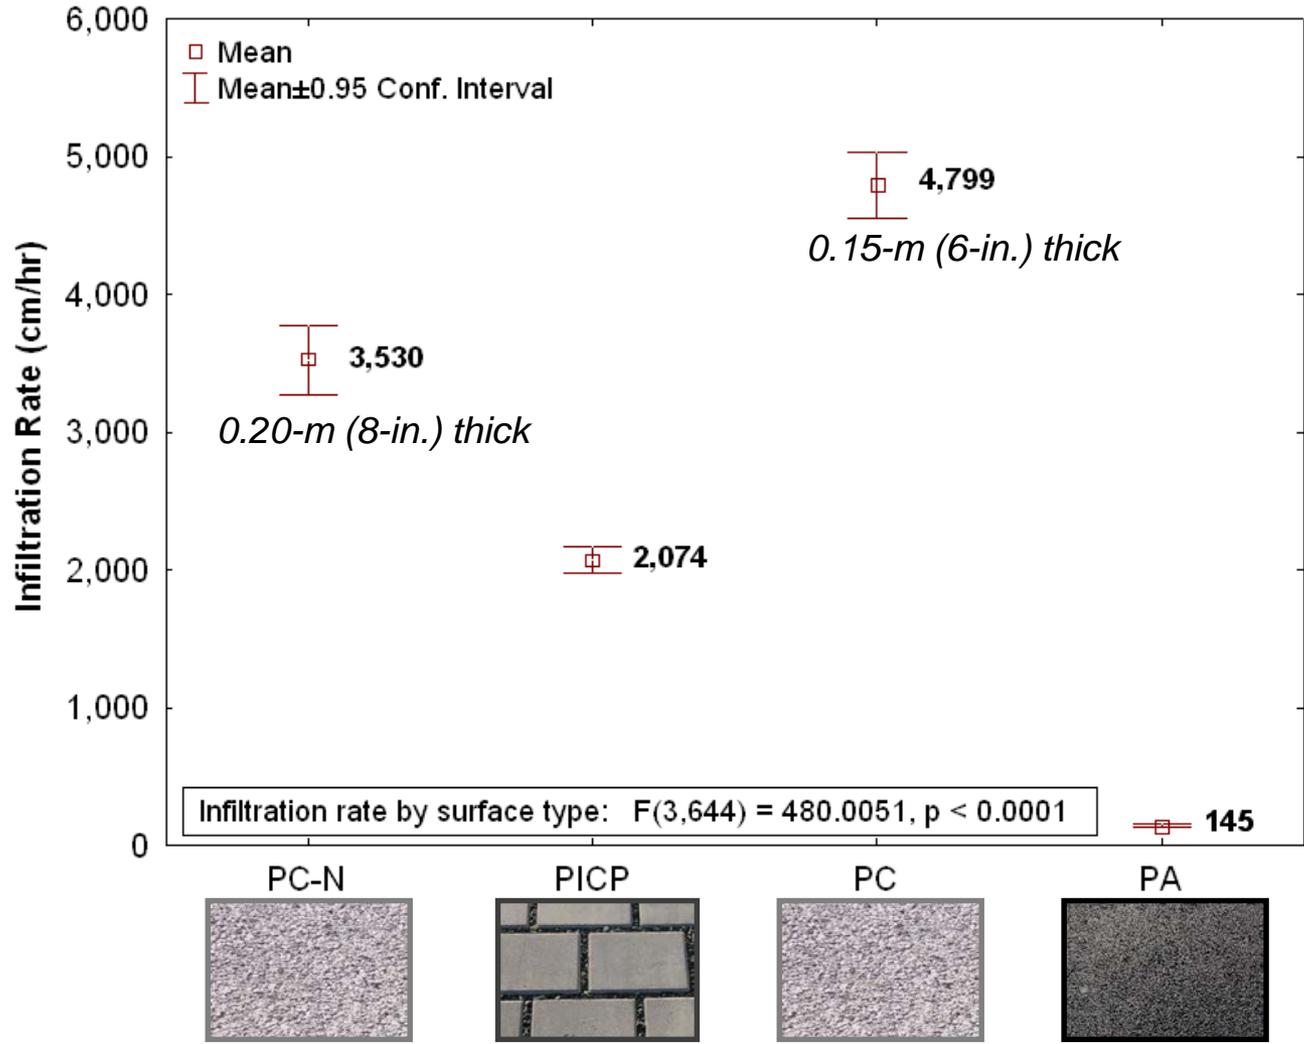
The infiltration rate varies among the four tested surfaces, but all surfaces are sufficient to handle maximum expected direct rainfall rates.

100-year, 5-minute rainfall intensity

- Edison, NJ
20.8 cm/hr (8.2 in/hr)

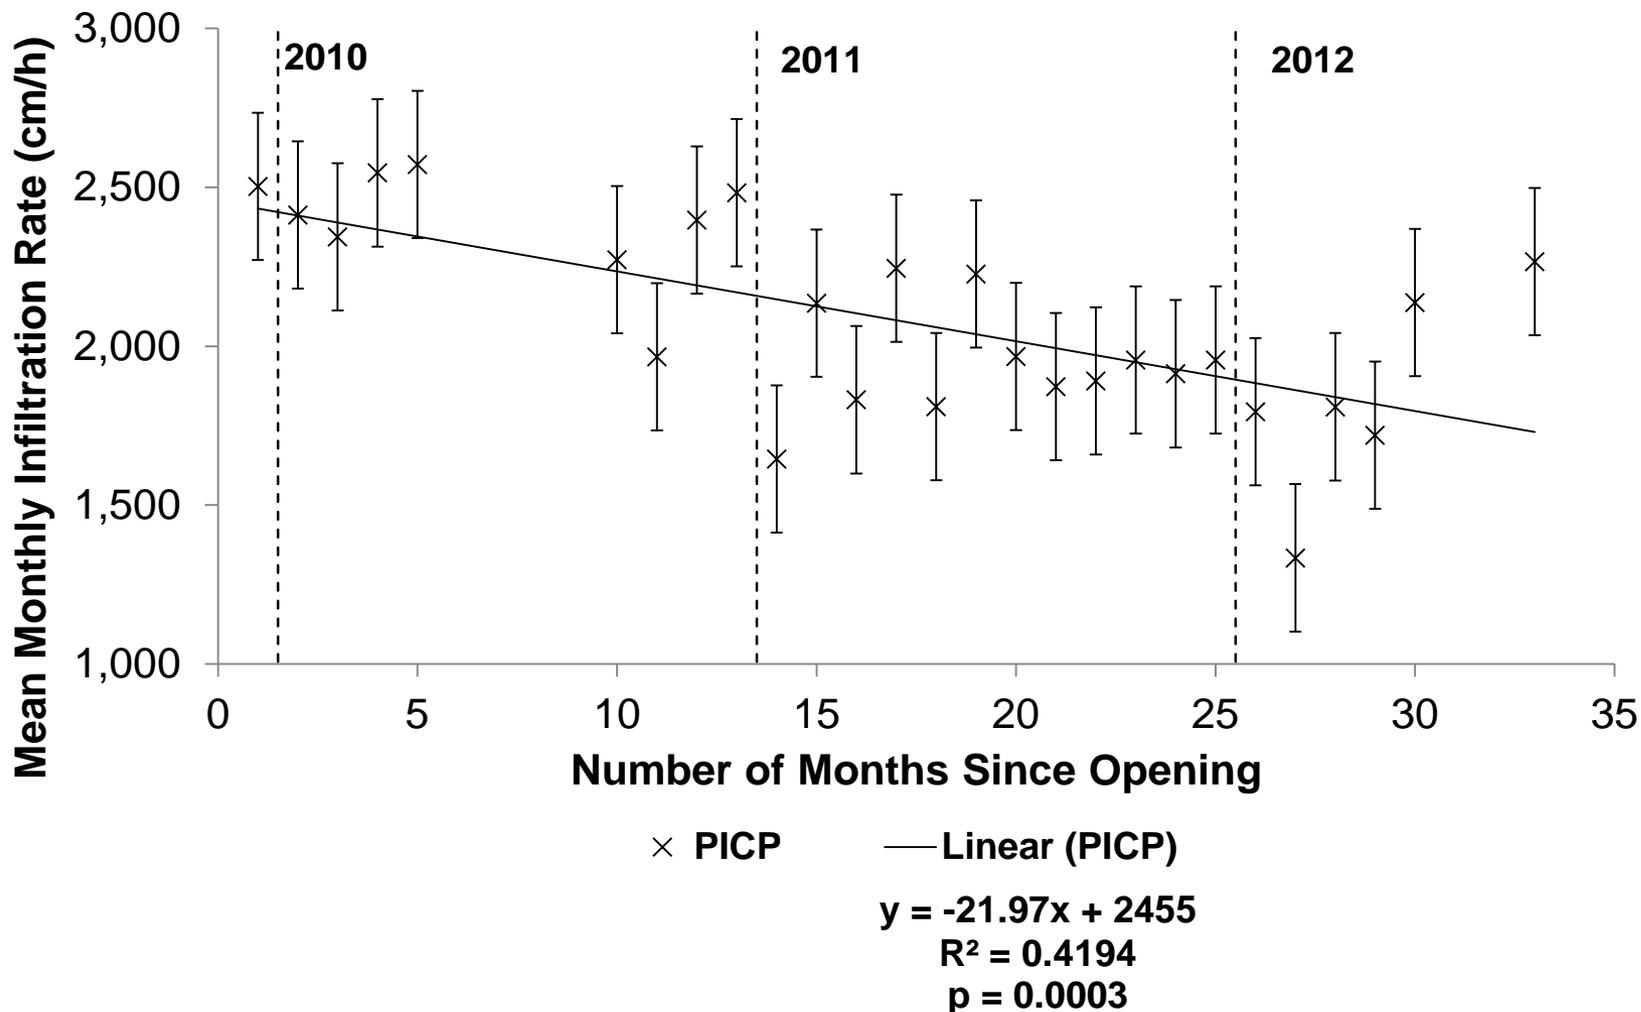
Infiltration decreased with age for the three surfaces that received run-on from driving lane.

Bars represent standard error.

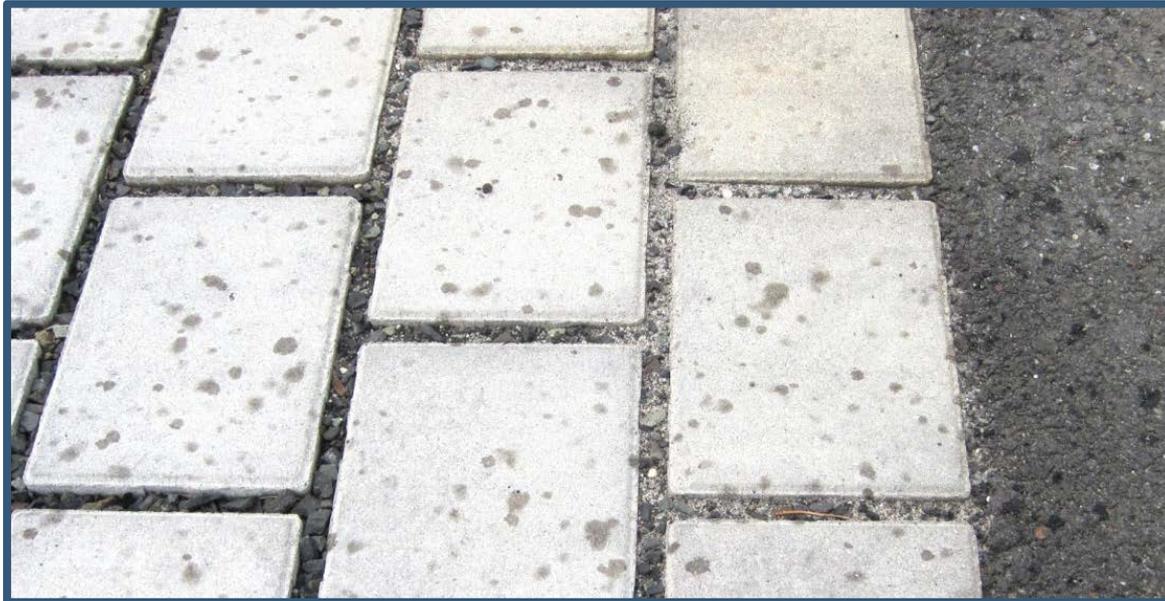
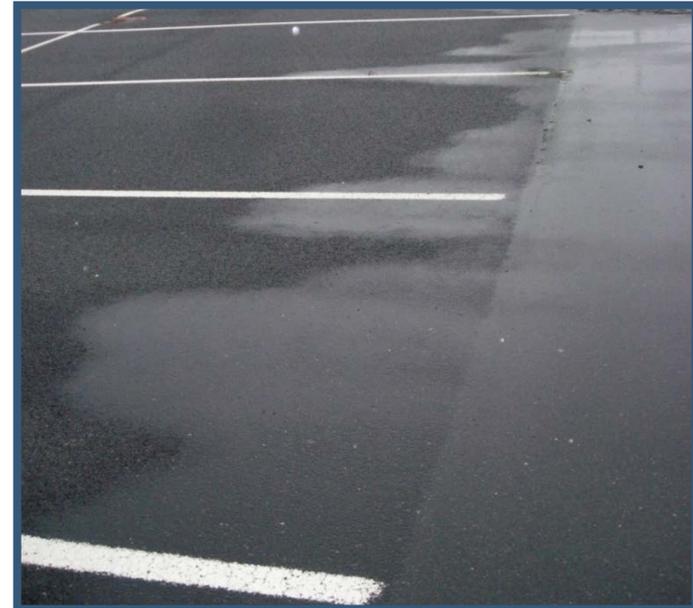
Sediment accumulates (and clogging progresses) from the upgradient edge.

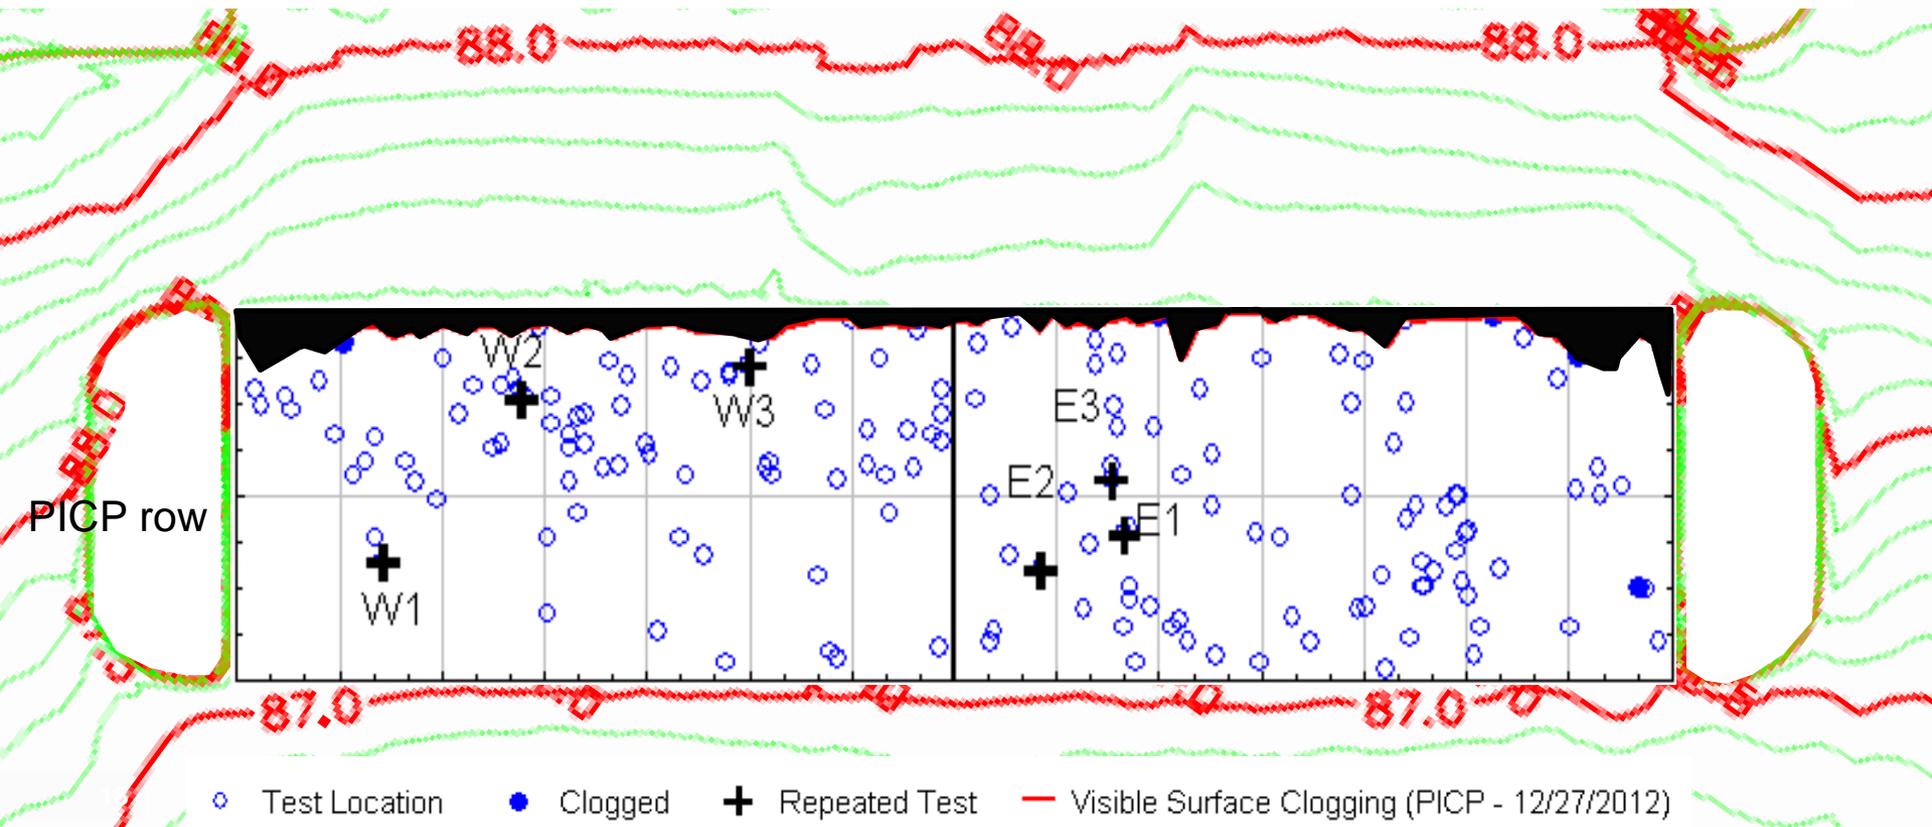
The surface clogging progression varied because of microtopography.

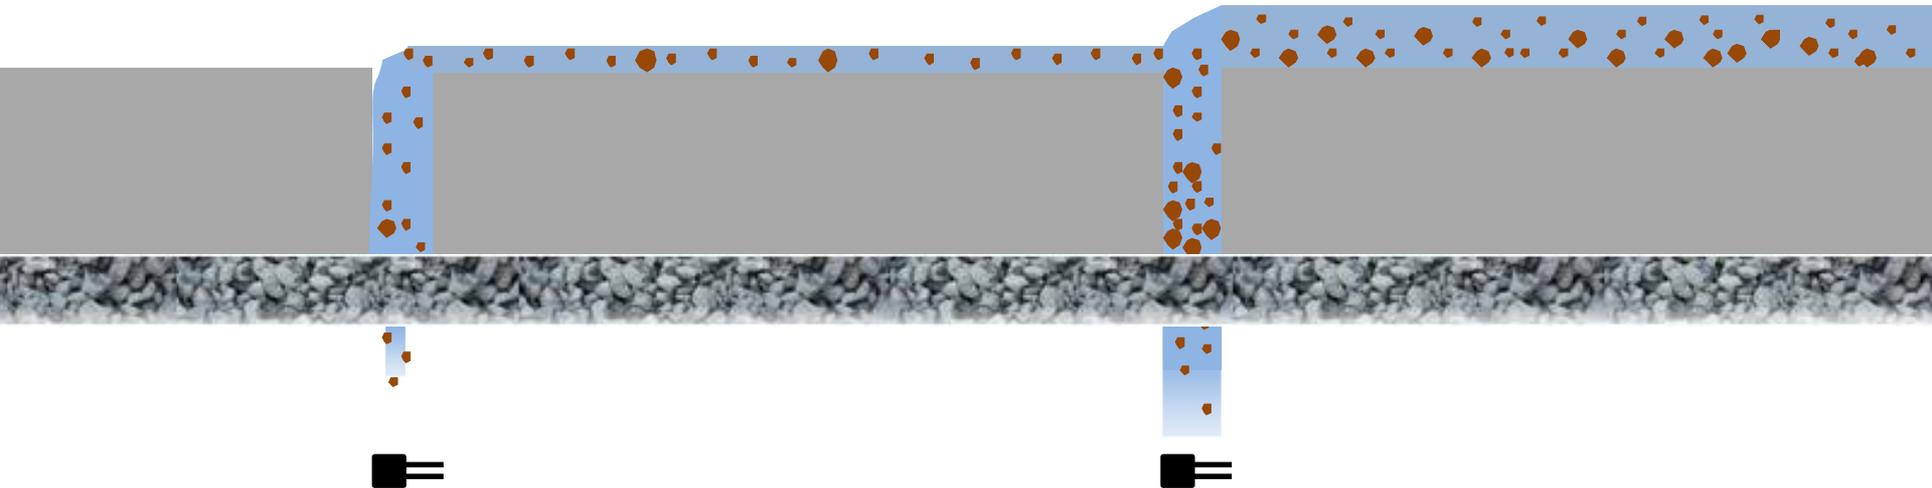
We developed a working hypothesis of the mechanics of the clogging processes.

Small response

Large response
