Permeable Pavement Research Highlights

Performance and effectiveness of permeable pavement systems

Edison Environmental Center
Edison, New Jersey

In-Street Application
Louisville, Kentucky

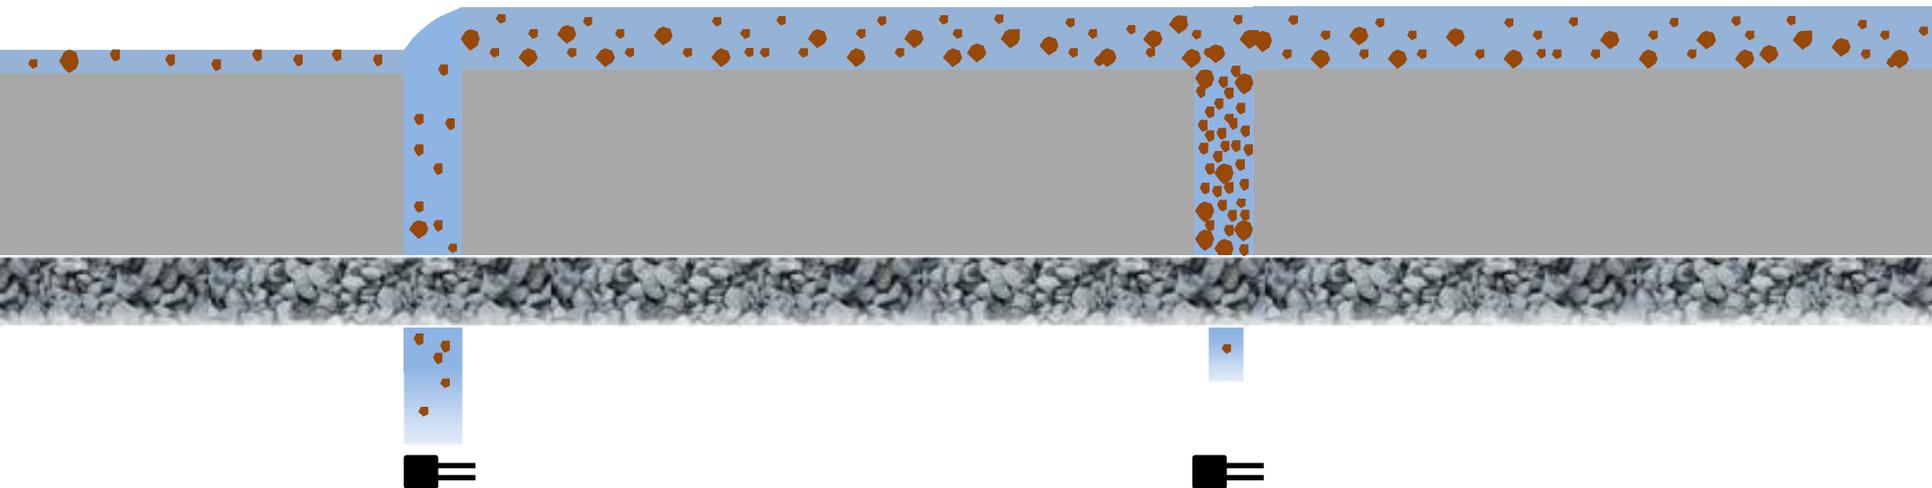
As gaps fill with sediment, the location of the primary infiltration moves downgradient.

Large response

Medium response

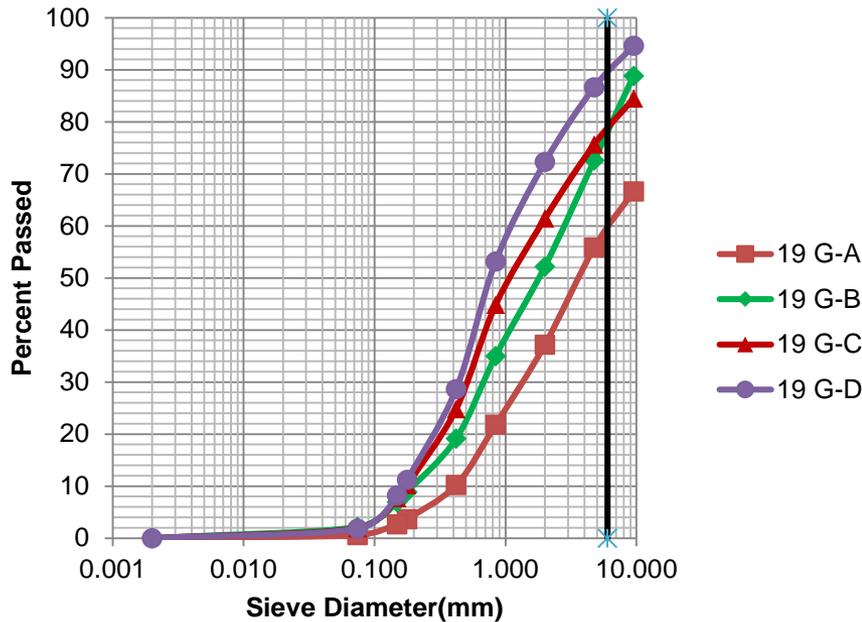
Mar. – May 2012
(9 in. rainfall)

Recovered sediment particle size analysis shows initial accumulation of fines in the upgradient sections.

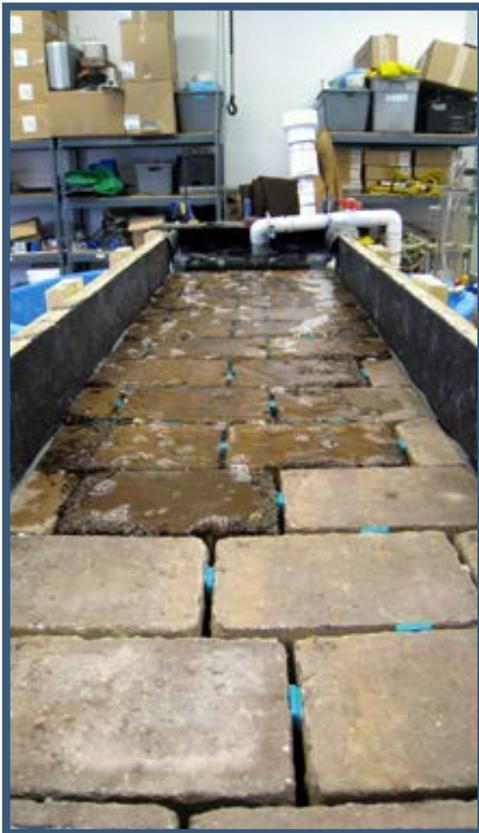
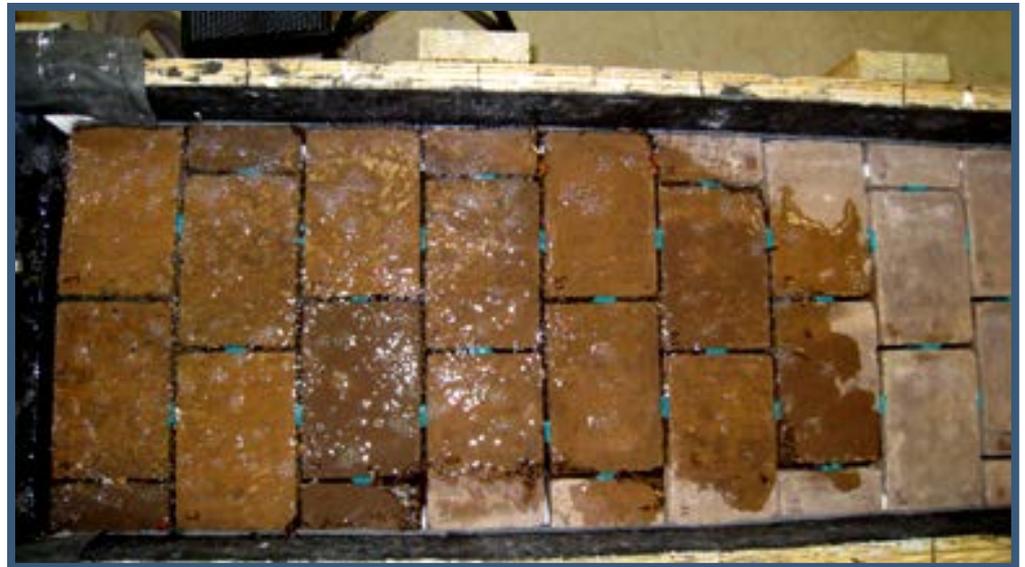
Flume tests show the progressive infiltration of the runoff that leads to the clogging.

The flume tests are showing the same general pattern of accumulated sediment as observed in the field.

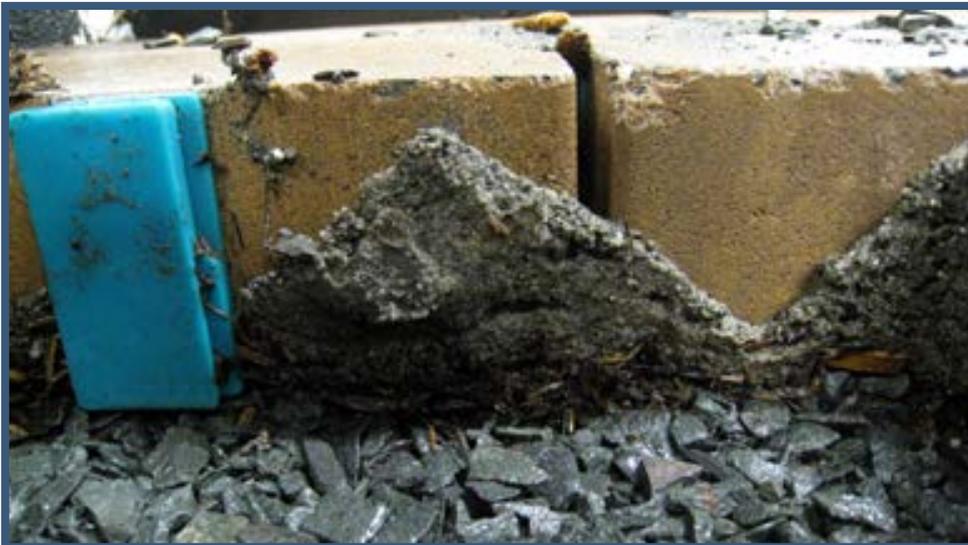
Inorganic material near up gradient edge

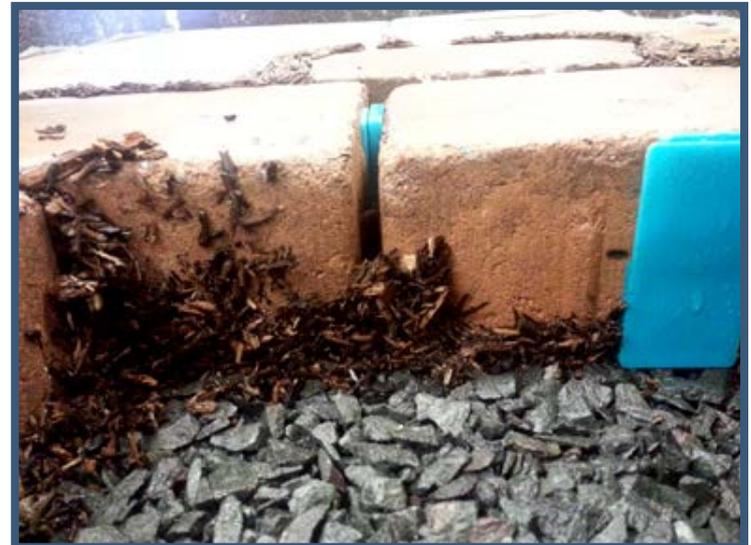
Organic material near down gradient edge

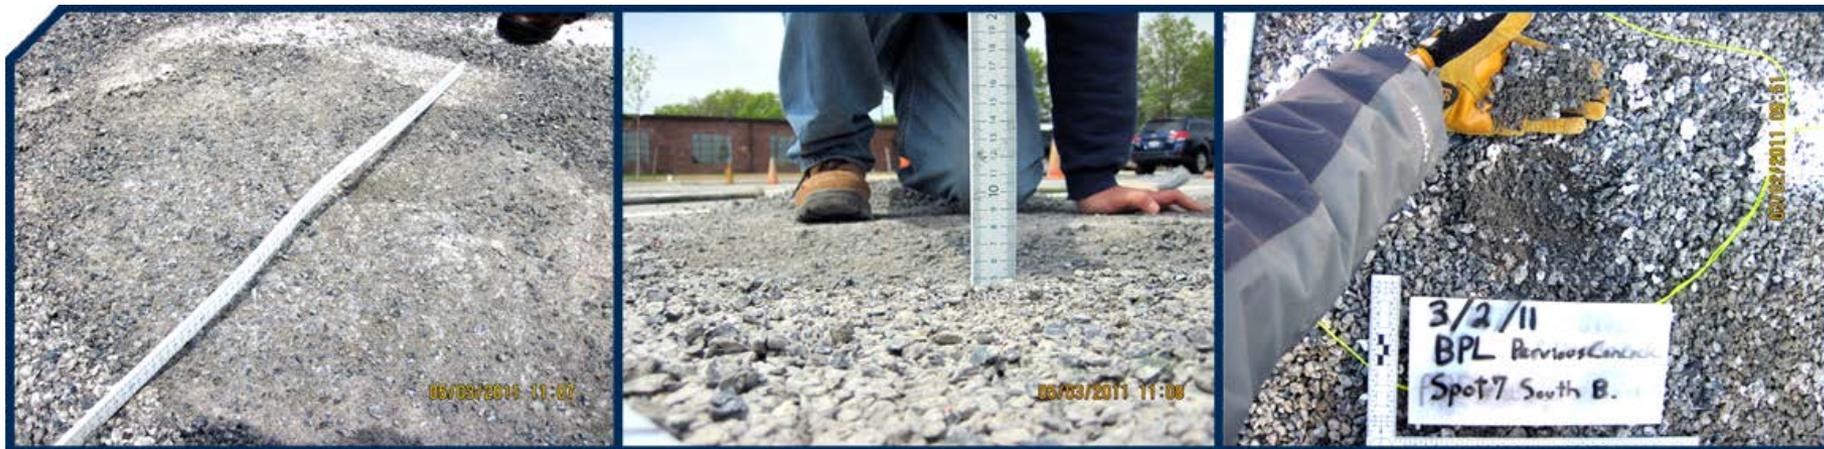
Large portions of the pervious concrete disaggregated.

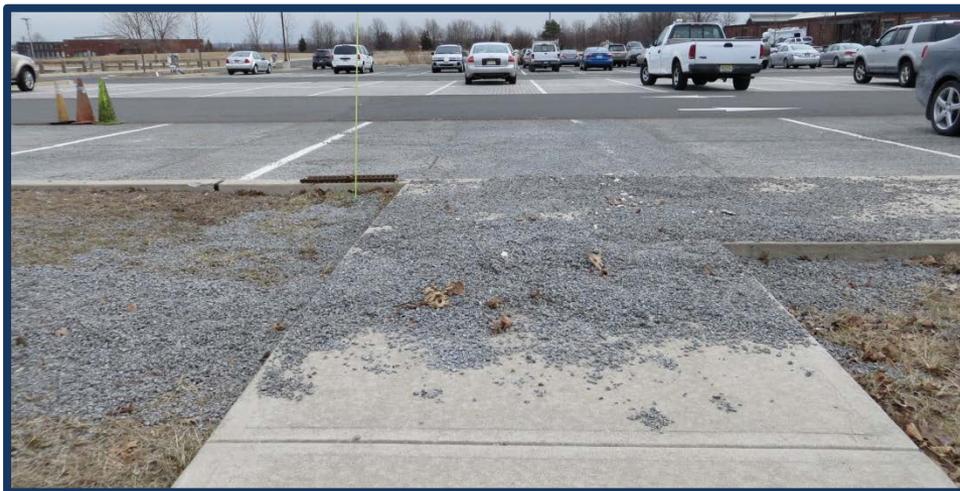
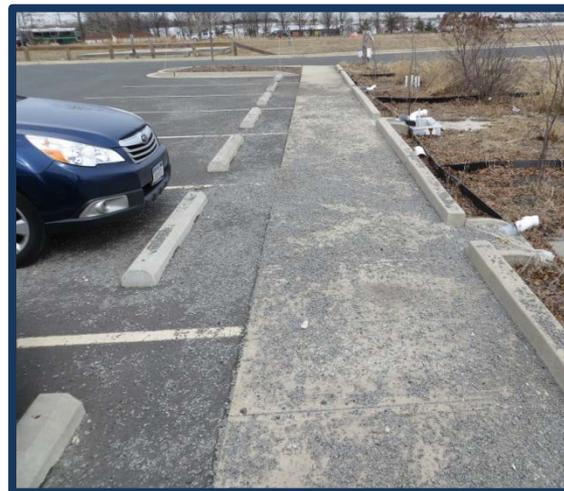
The problem first became apparent about 18 months after pouring concrete. It was repaired by the contractor in May 2011, but has recurred.

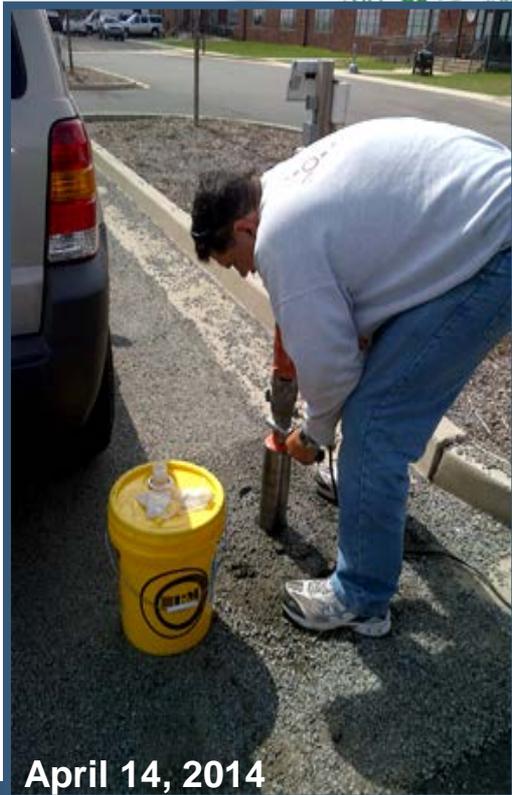
April 14, 2014

Is structural failure coupled with chloride?

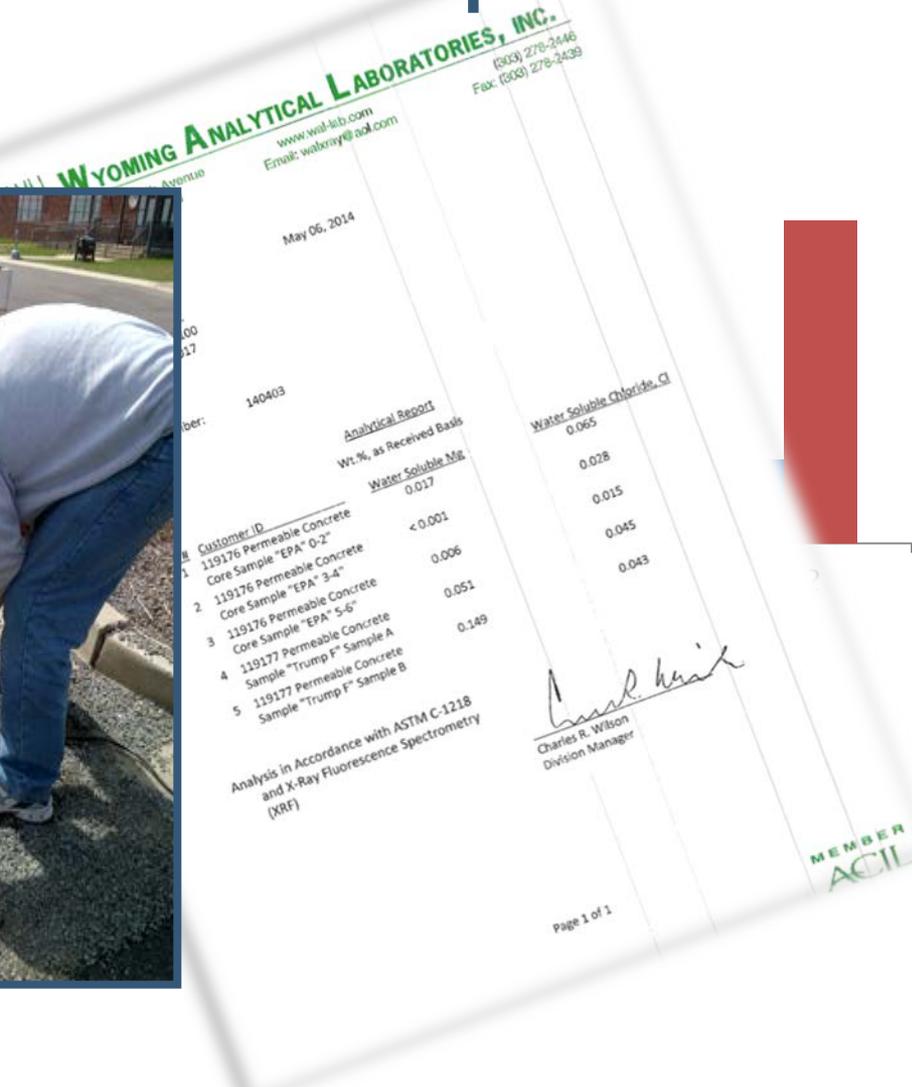
■ Mg ■ Cl

“Deicing chemicals should not be used on any type of concrete in the first year.”

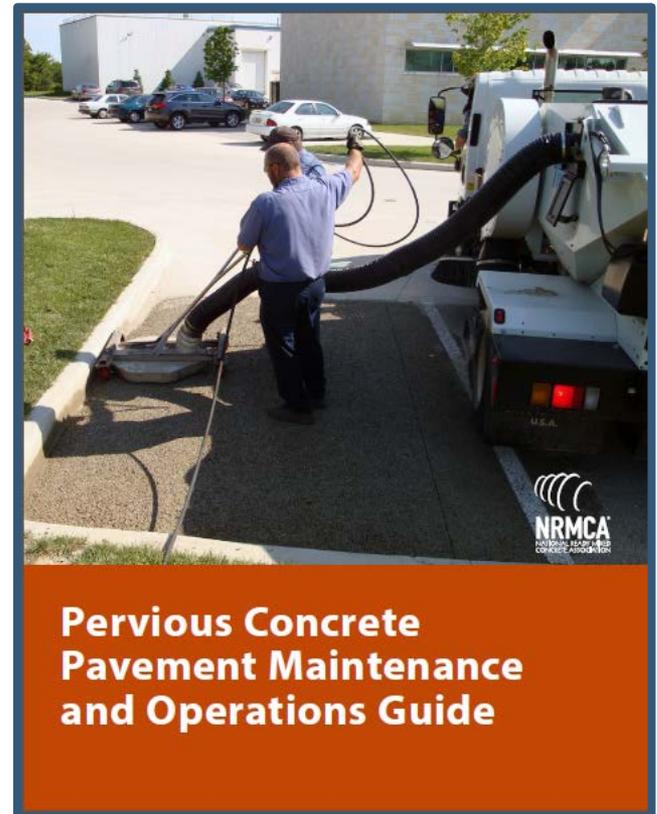
In 2011, Louisville MSD installed permeable pavement strips in parking lanes near the catch basins in the Butchertown section of Louisville.

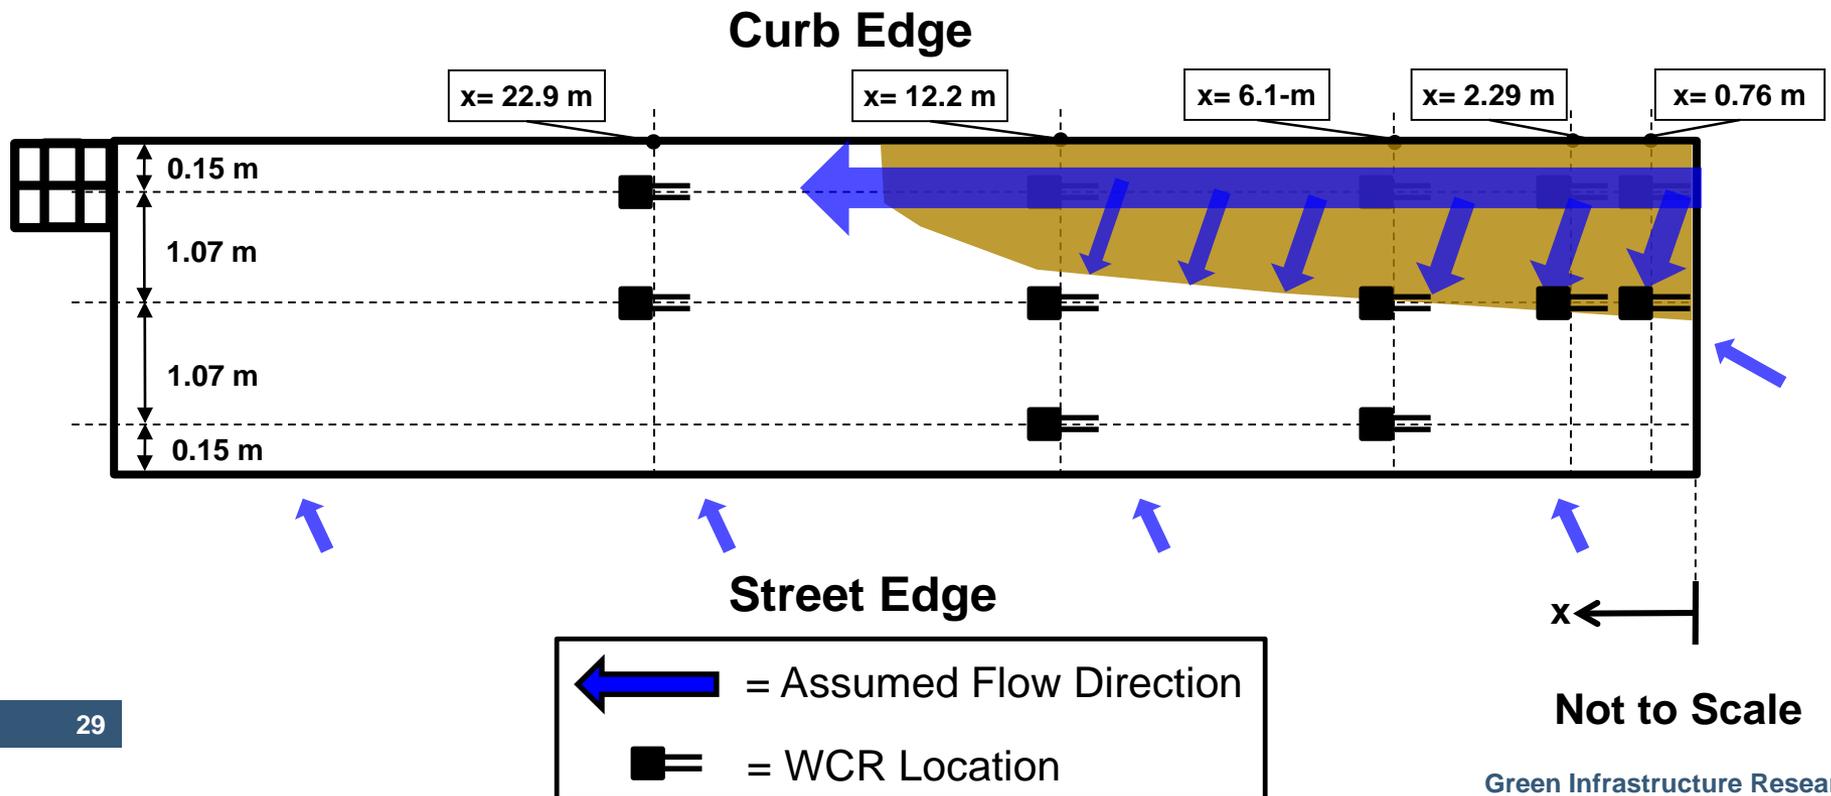
In this curb and gutter system, we expected concentrated flow along the curb to transport and deposit sediment from the drainage area.

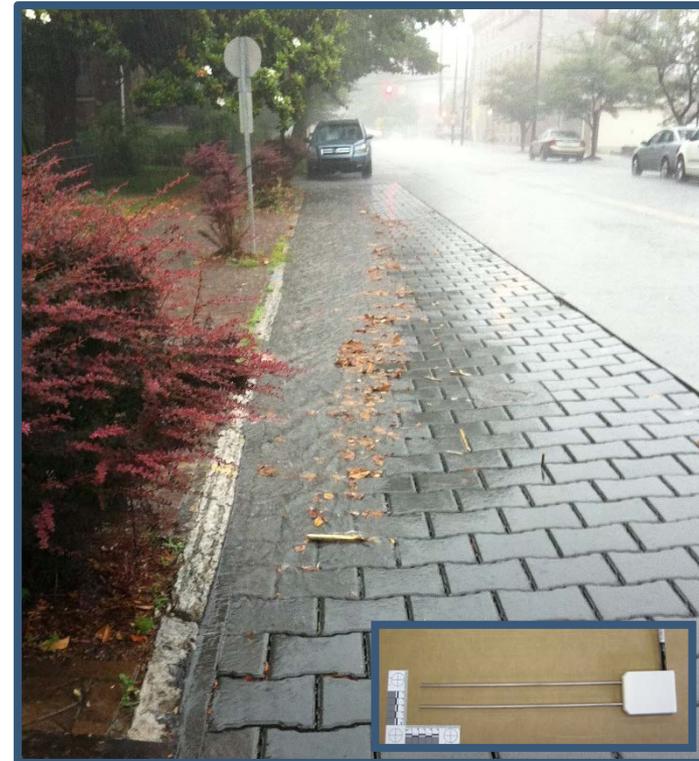
Findings:

- Exfiltration rates vary with age.
- Exfiltration rates vary with water depth and constant hydraulic flux is not representative of exfiltration processes.
- Much of the exfiltration occurs through the sides.
- SCM geometry is important.

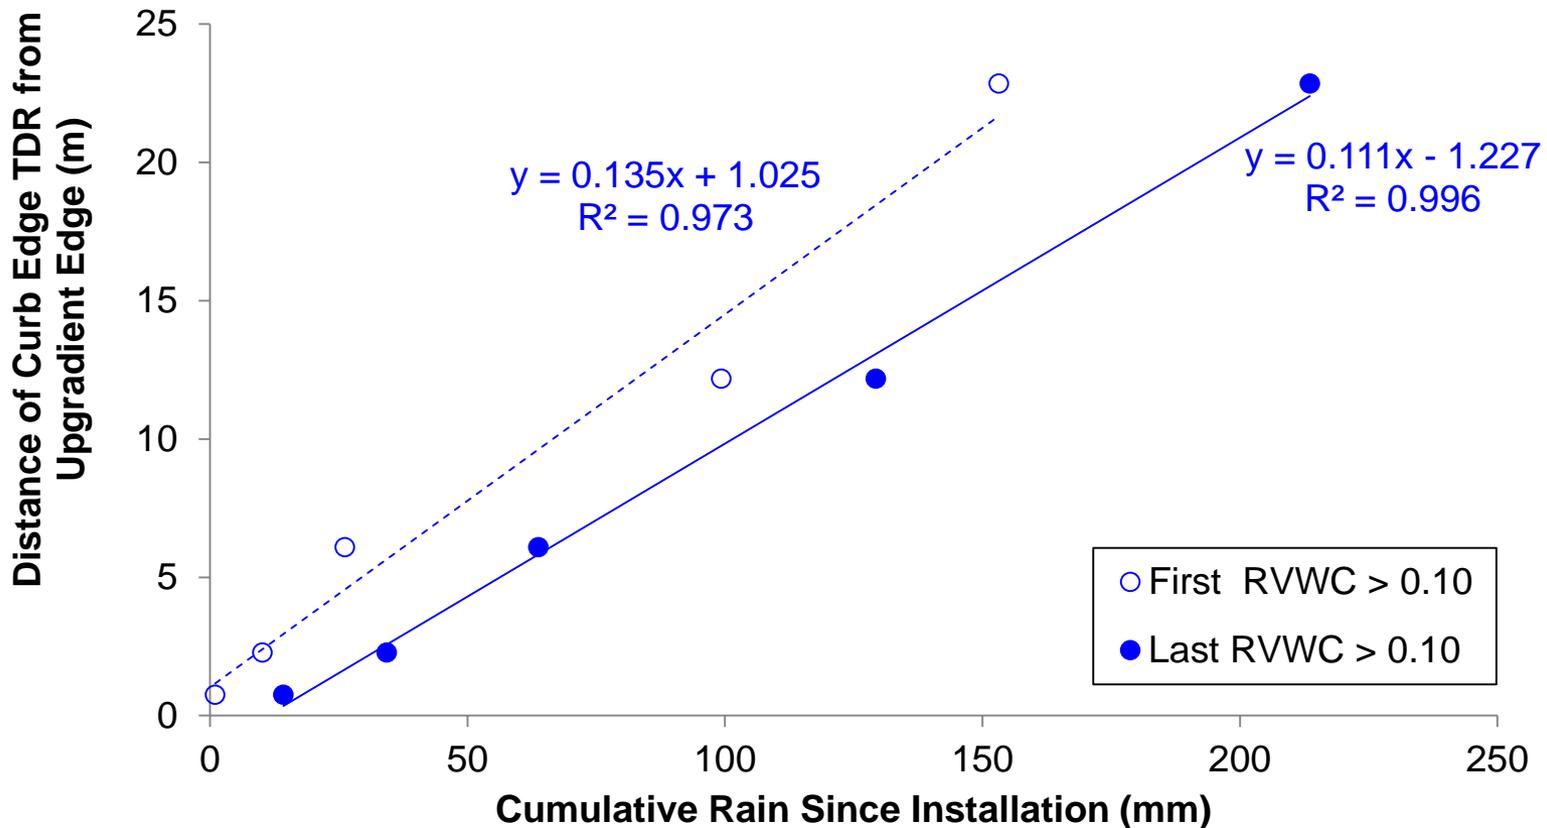
Control Louisville 19G

Installed instruments can be used to determine the control's longitudinal clogging rate.

Response threshold 0.10 RVWC

The initial clogging rate was about 0.123 m per mm (10 ft per inch) of rain.

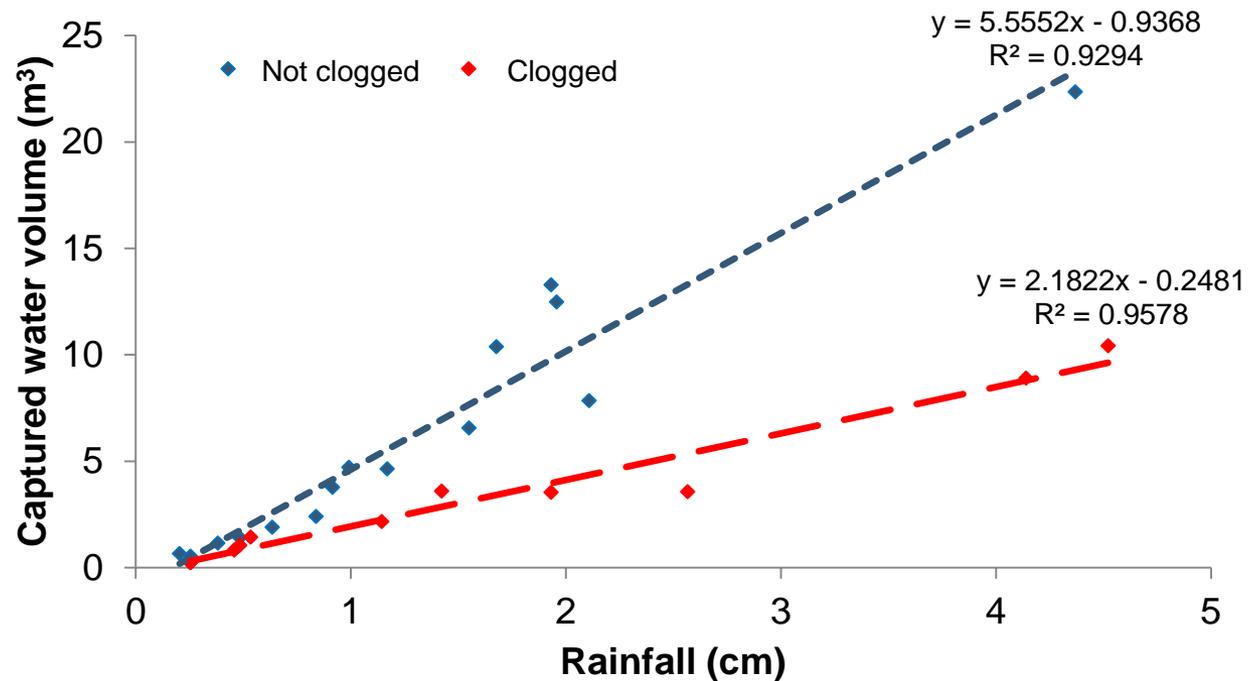
Louisville control 19H
Level data at 1-minute intervals
Rainfall data at 5-minute intervals MSD gauge TR05

Even when clogged, the surface is not sealed.

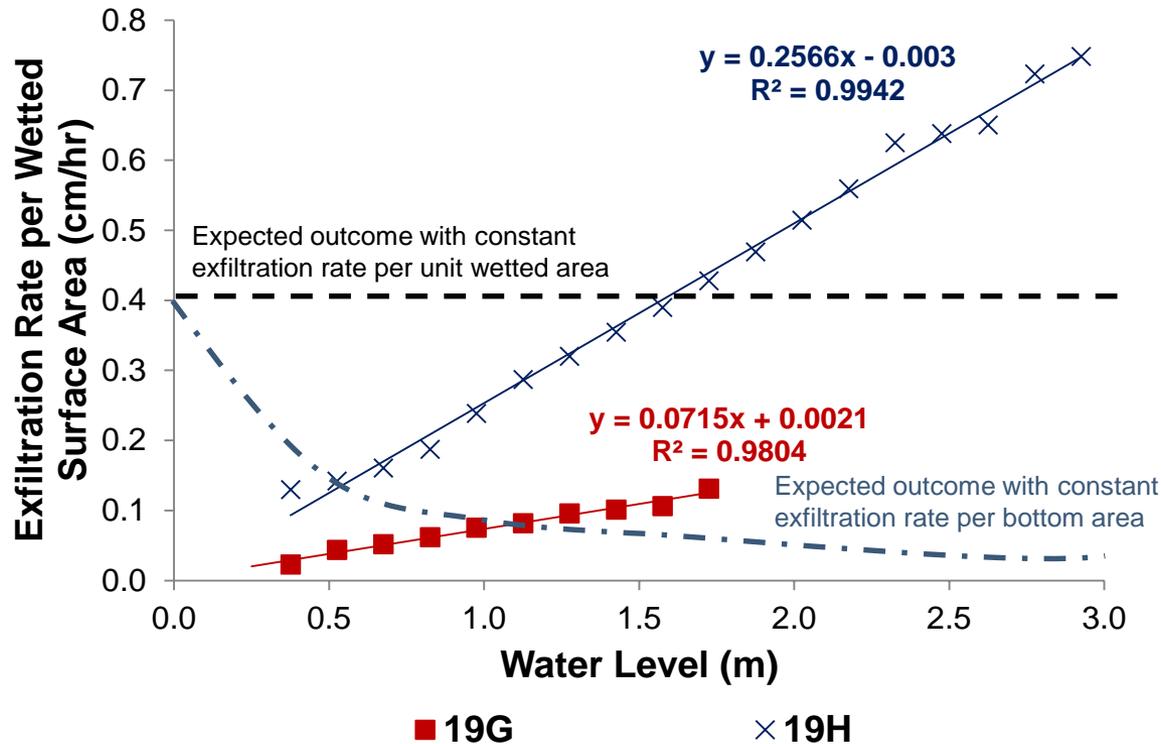
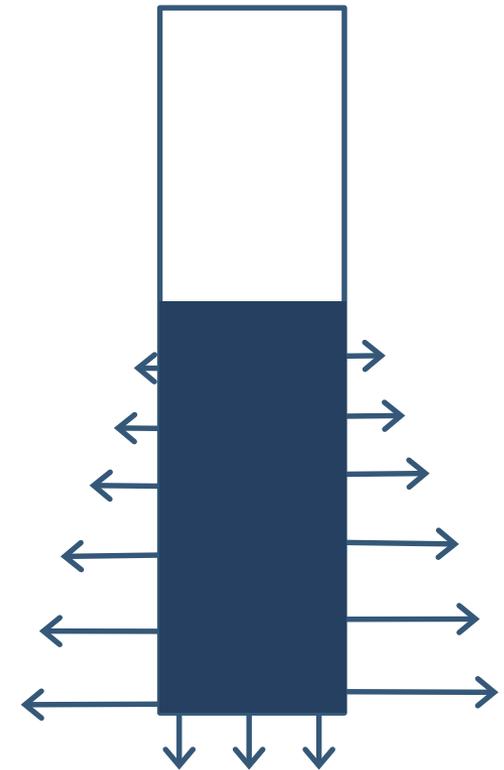
Constant exfiltration across wetted perimeter or base is not supported by the measurements.

Modeling the fate of runoff showed that most of the captured water exfiltrated laterally through the side walls.

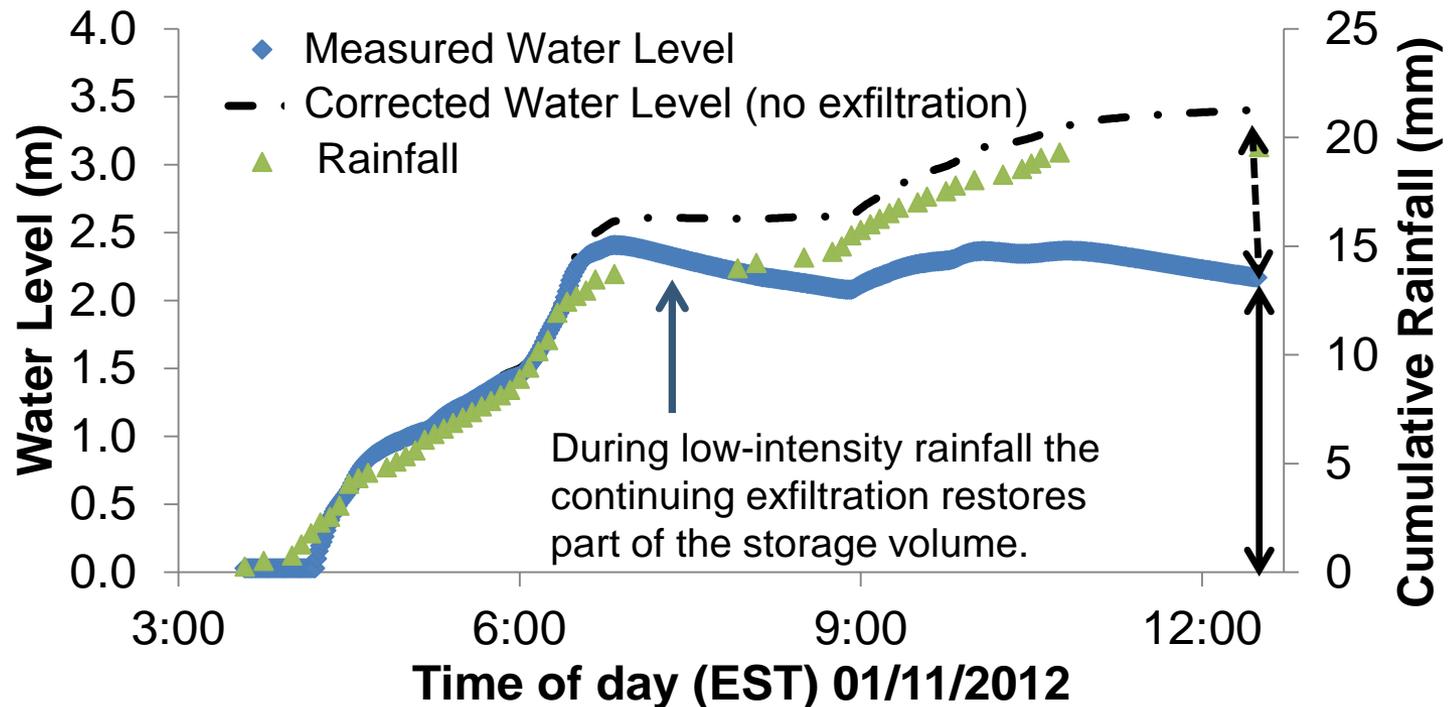
Intra-event exfiltration can be significant

Static sizing criterion may significantly oversize the SCM.

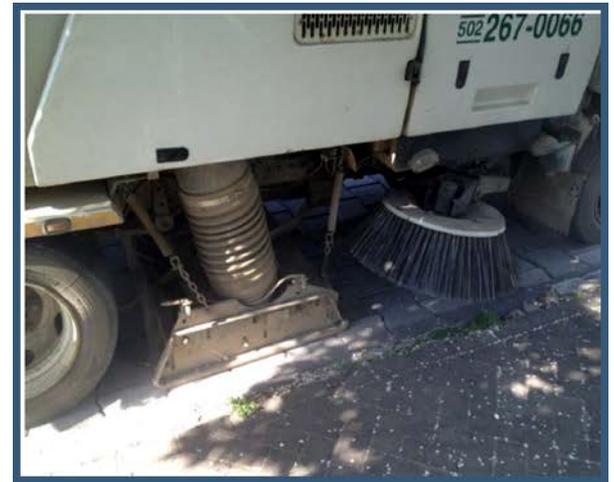
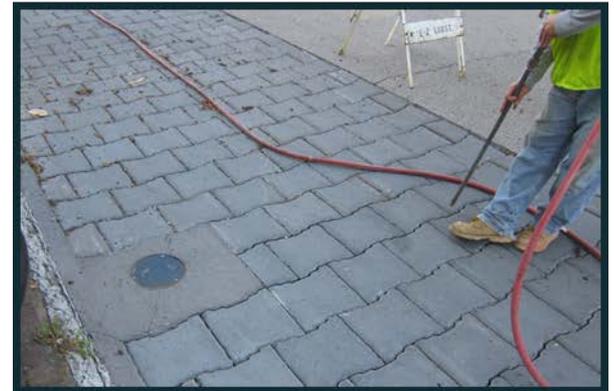
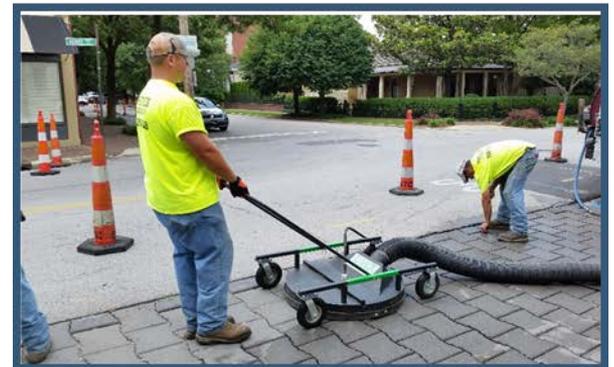
- Multiple techniques were implemented.
- Each technique increased surface infiltration capacity, but did not always restore baseline conditions.
- Longevity of the restored infiltration capacity varied.
- Results are probably product specific.

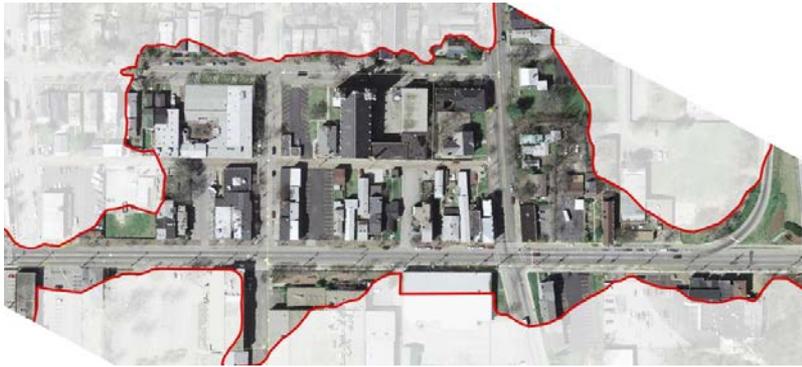
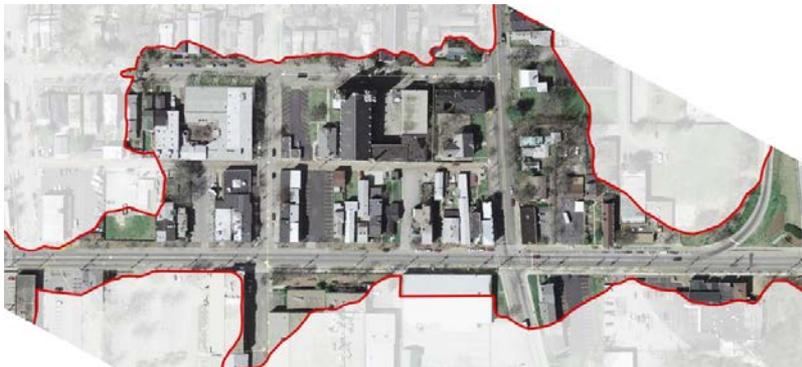
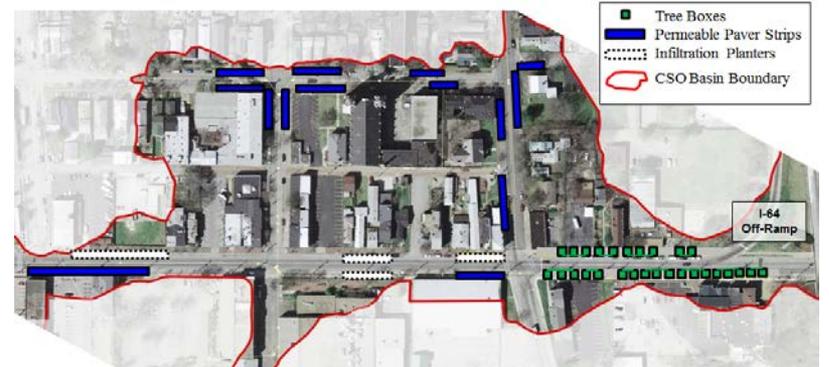
Impact

Before

After

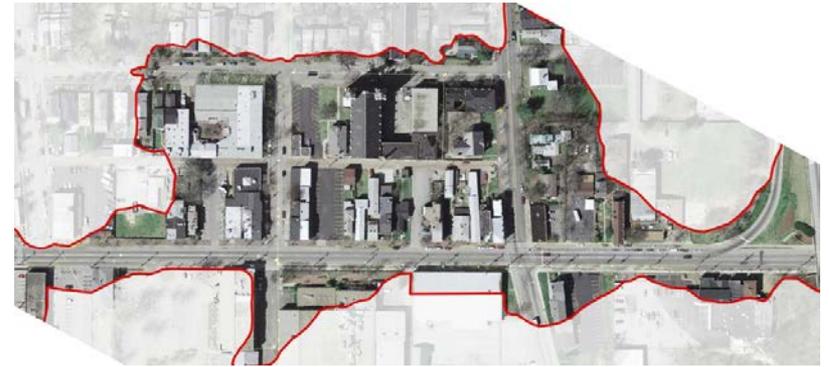
Ideally, we wanted a Before-After Control-Impact (BACI) Study.

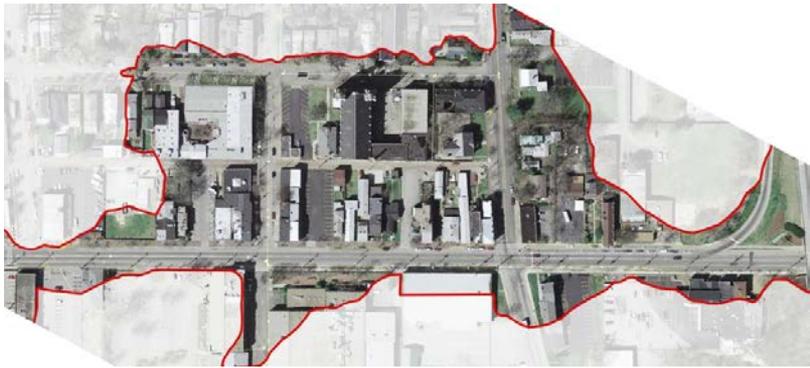
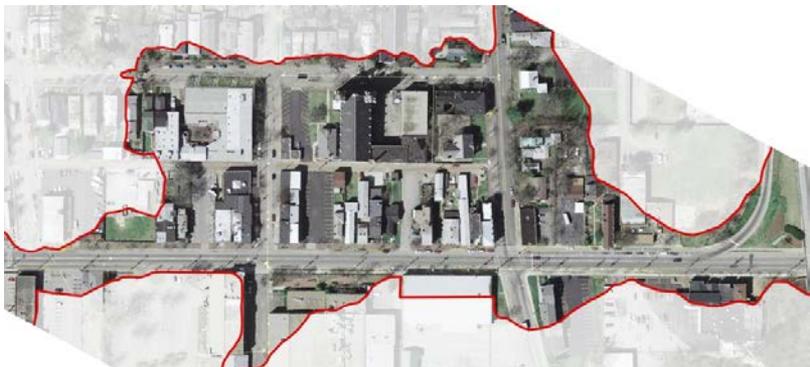
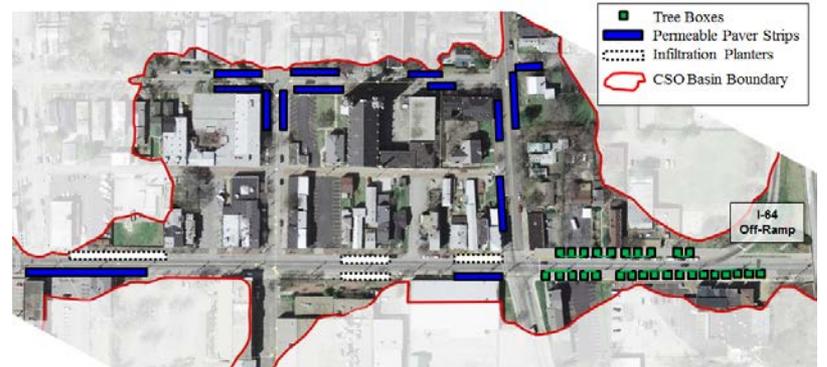
Plan “B” created a virtual sewershed for comparison.

Modeled (InfoWorks)

Measured

Before

After

The statistics allow determination of whether the “impact” had a measurable effect after adjusting for all other factors.

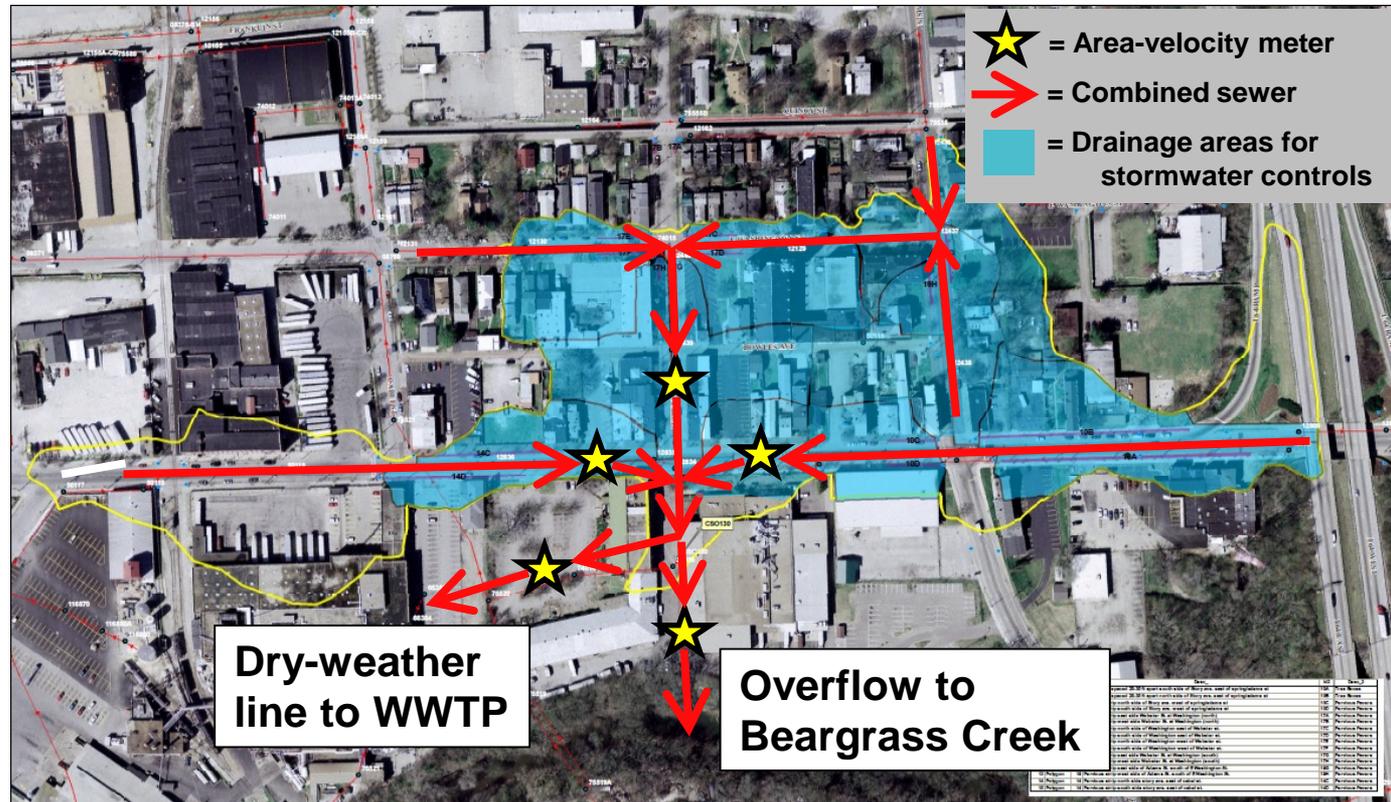
In-sewer flows were measured at 5 locations for at least 1 year before construction to develop the preconstruction condition model using InfoWorks (Innovyze).

Sigma 920 area-velocity flow meters (later FloWav) were installed and managed by LJCMSD.

The flow meters separated the basin into 4 catchments, and catch basins were used to define 29 subcatchments.

Drainage areas were defined using 6-inch LIDAR data and refined with on-site observations.

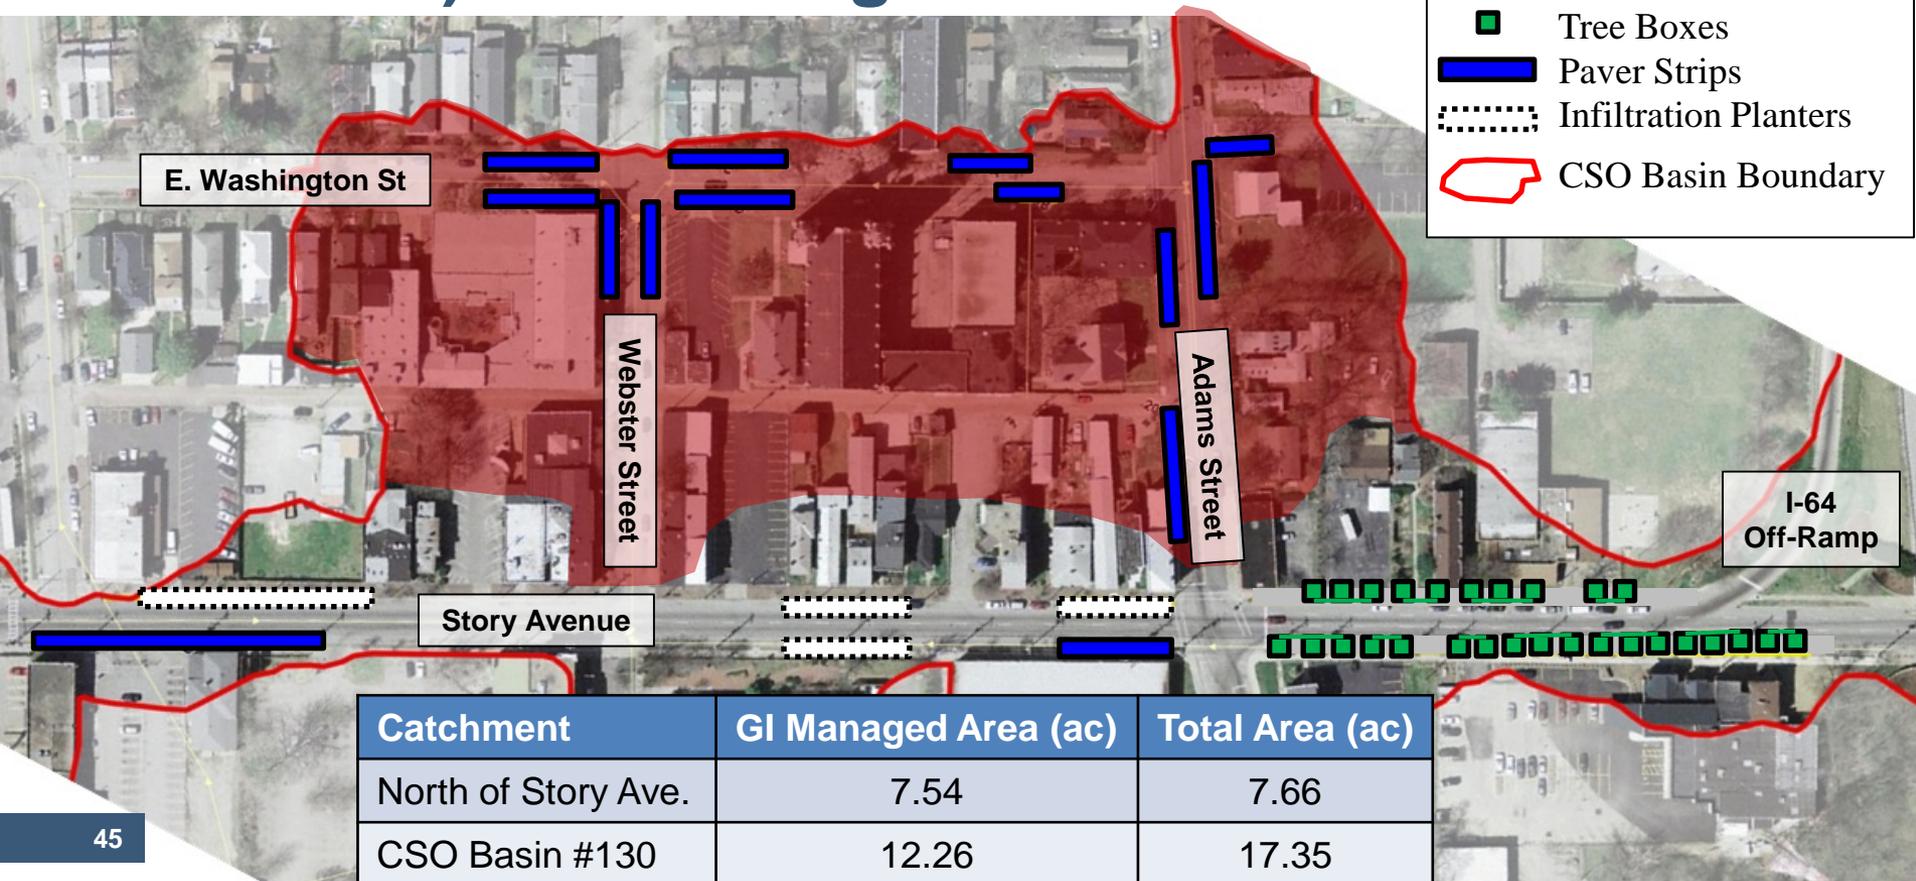
We selected the largest subsewershed area to evaluate the effectiveness (north of Story Avenue) as a surrogate.

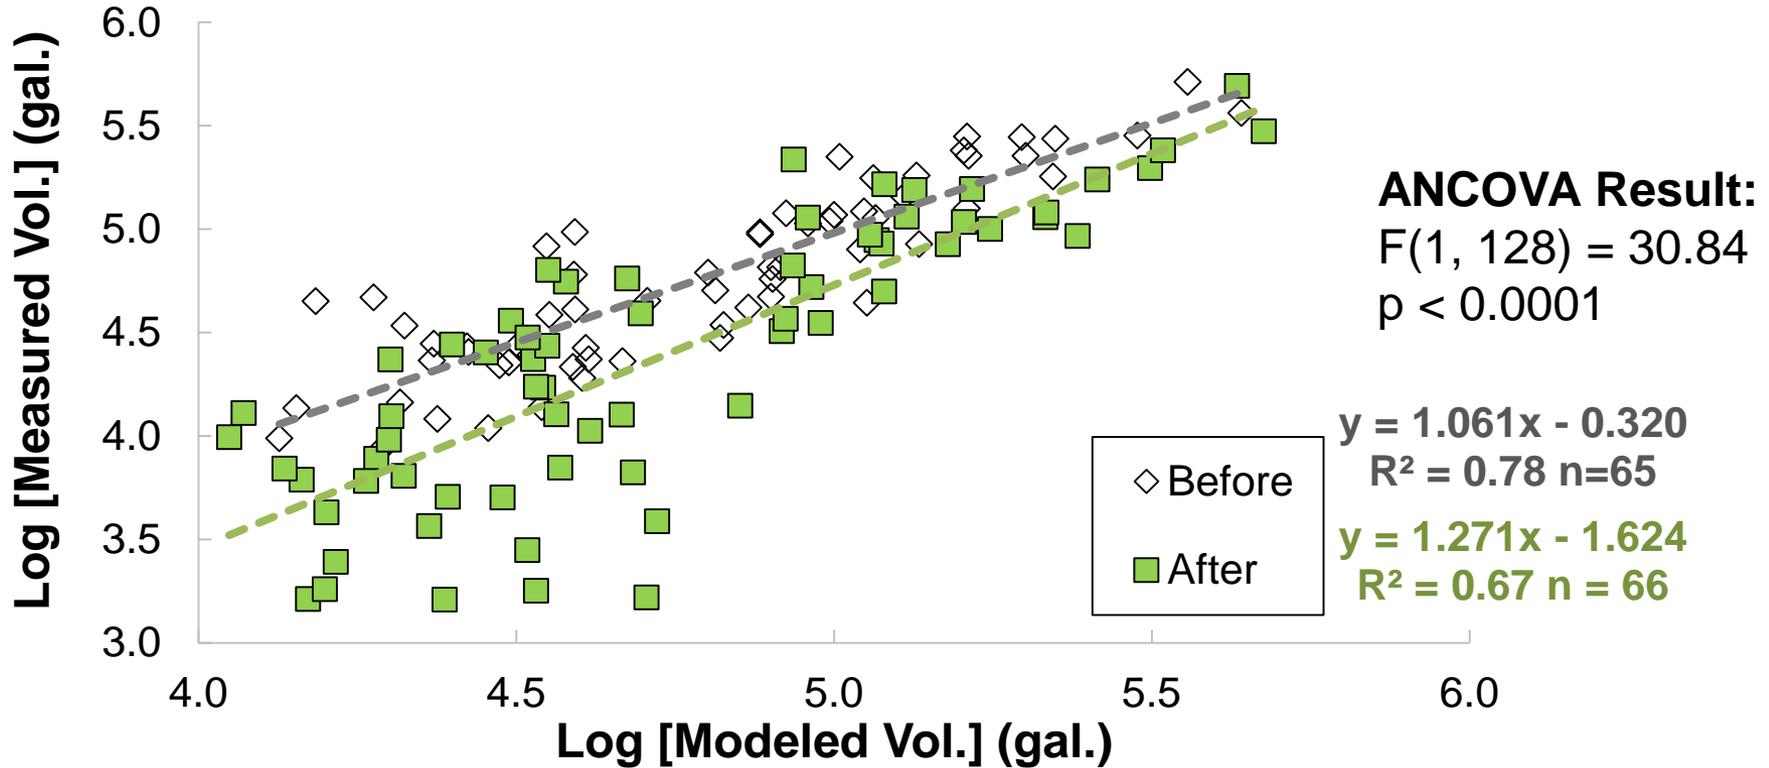
Using the BACI approach, GI significantly reduced in-sewer flow volume per event.

Period	Control Mean (gal)	Impact [GI] Mean (gal)	Predicted [GI] (gal)	% Change
Before	63,509	59,319		
After	54,108	24,623	50,053	- 51%

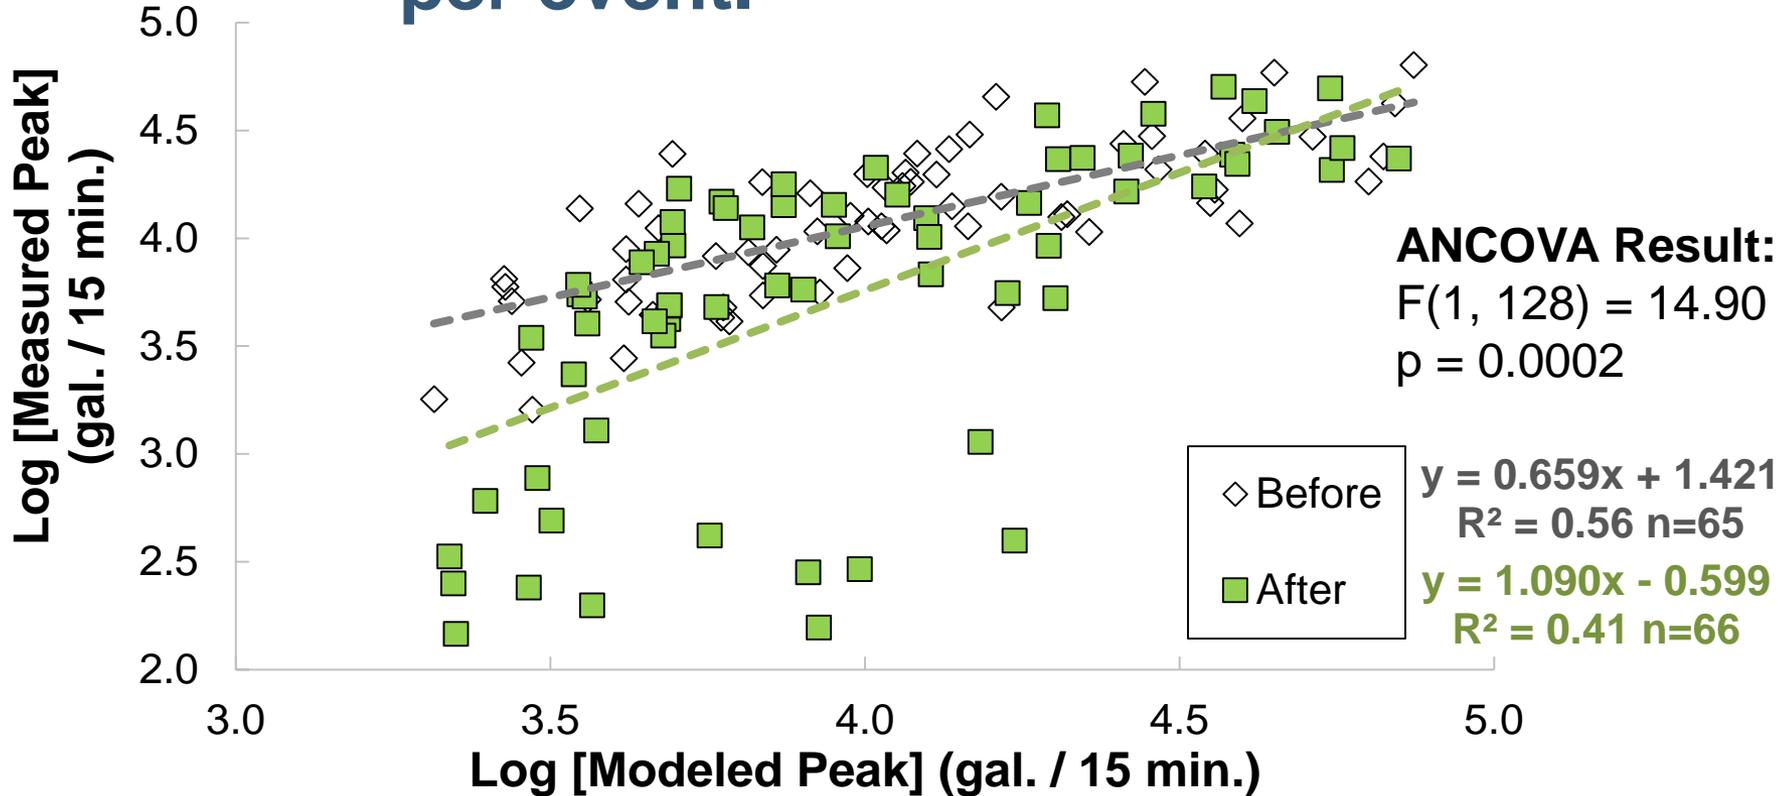
Using the BACI approach, GI also significantly reduced peak flow rates per event.

Period	Control (gal. / 15 min.)	Impact [GI] (gal. / 15 min.)	Predicted [GI] (gal. / 15 min.)	% Change
Before	11,051	12,122		
After	9,308	5,313	10,826	- 51%
