Permeable Pavement Research Highlights

Performance and effectiveness of permeable pavement systems

Edison Environmental Center
Edison, New Jersey

In-Street Application
Louisville, Kentucky

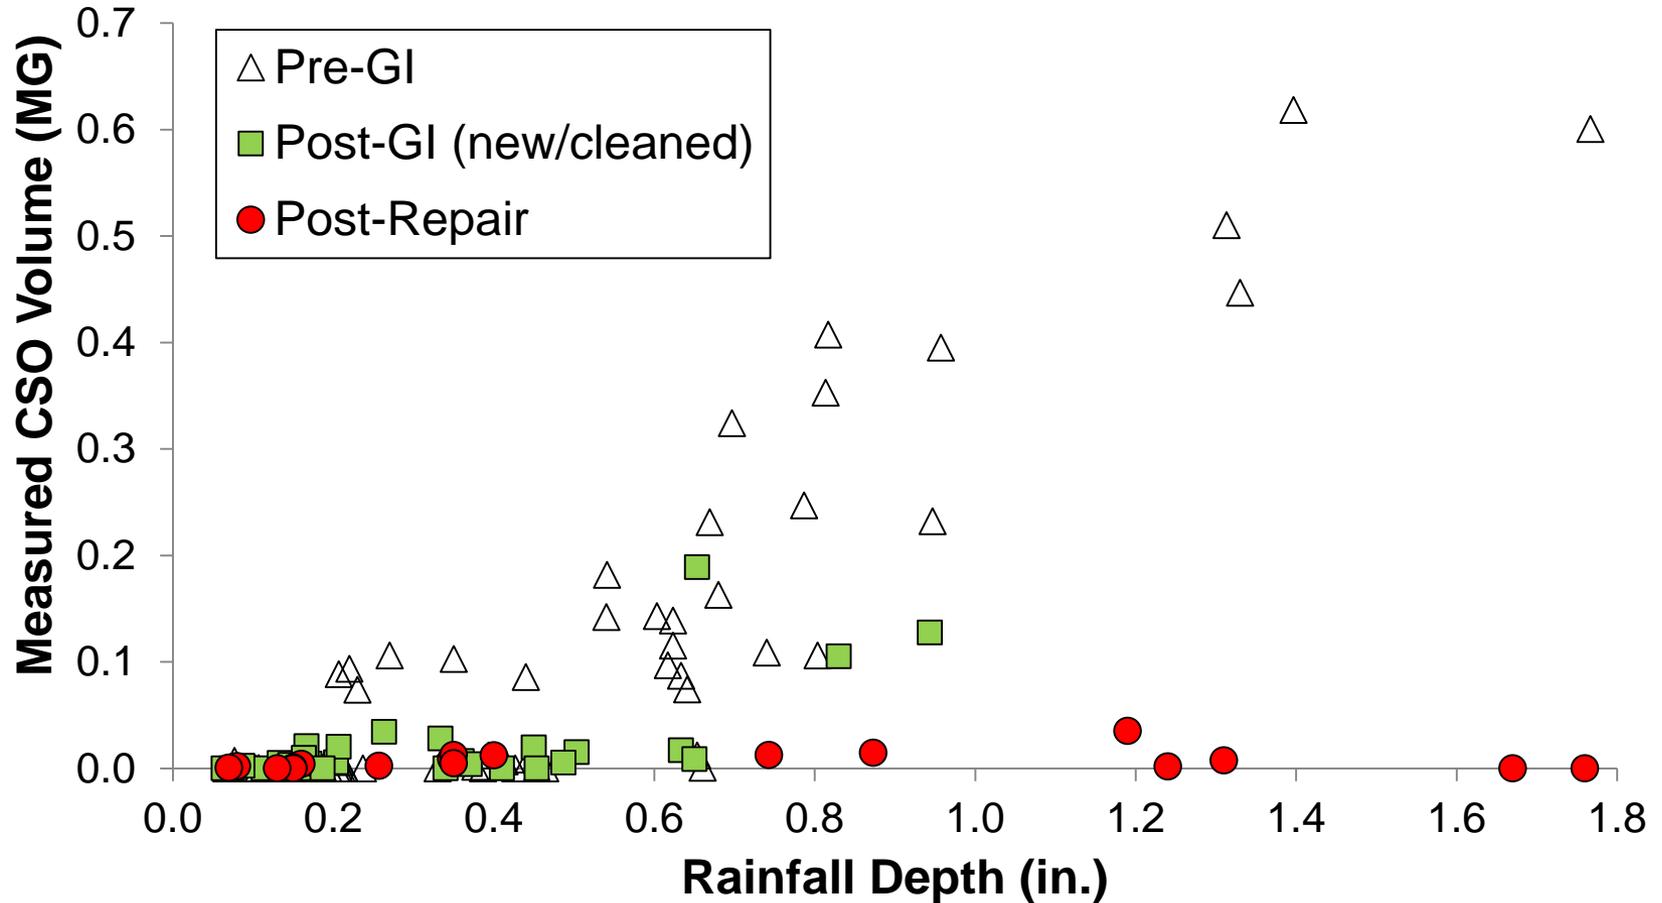
Results after replacing the dry-weather line are promising for meeting basin AAOV targets.

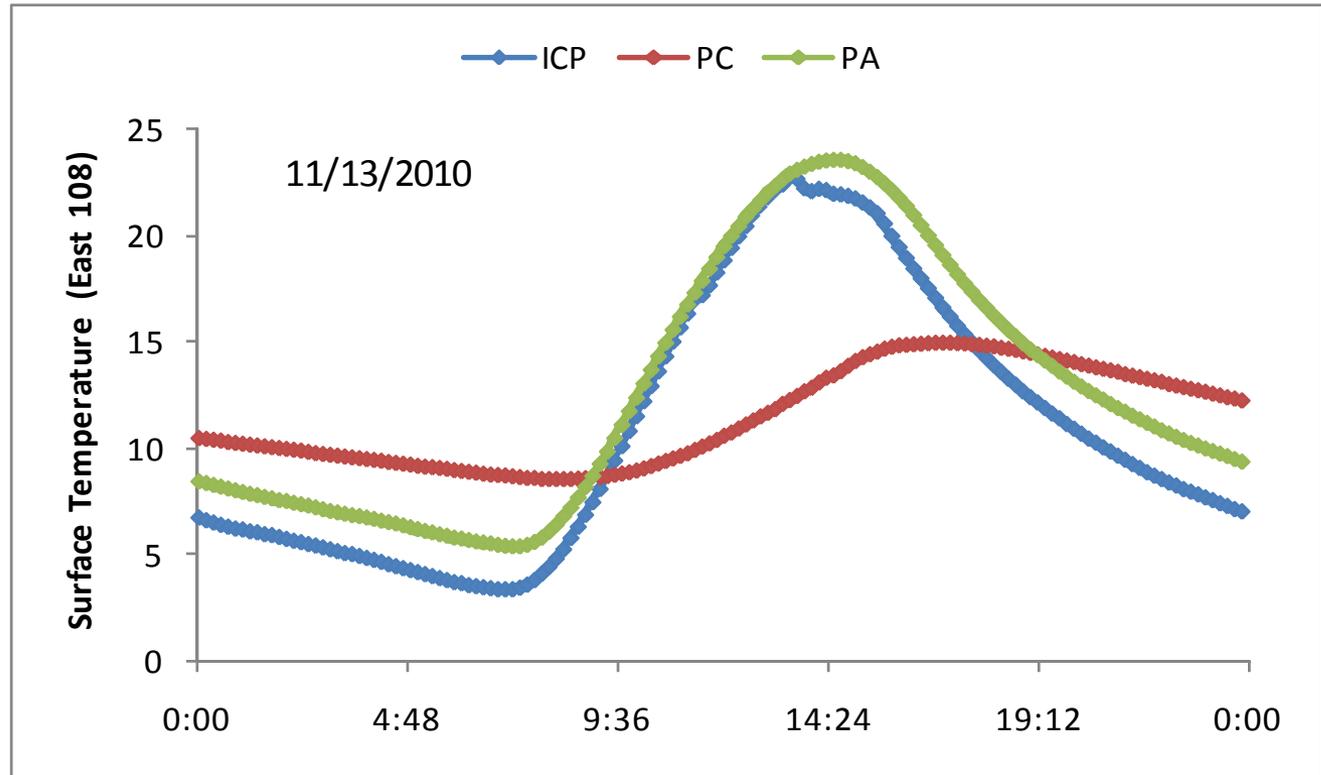
The typical diurnal surface temperature pattern shows

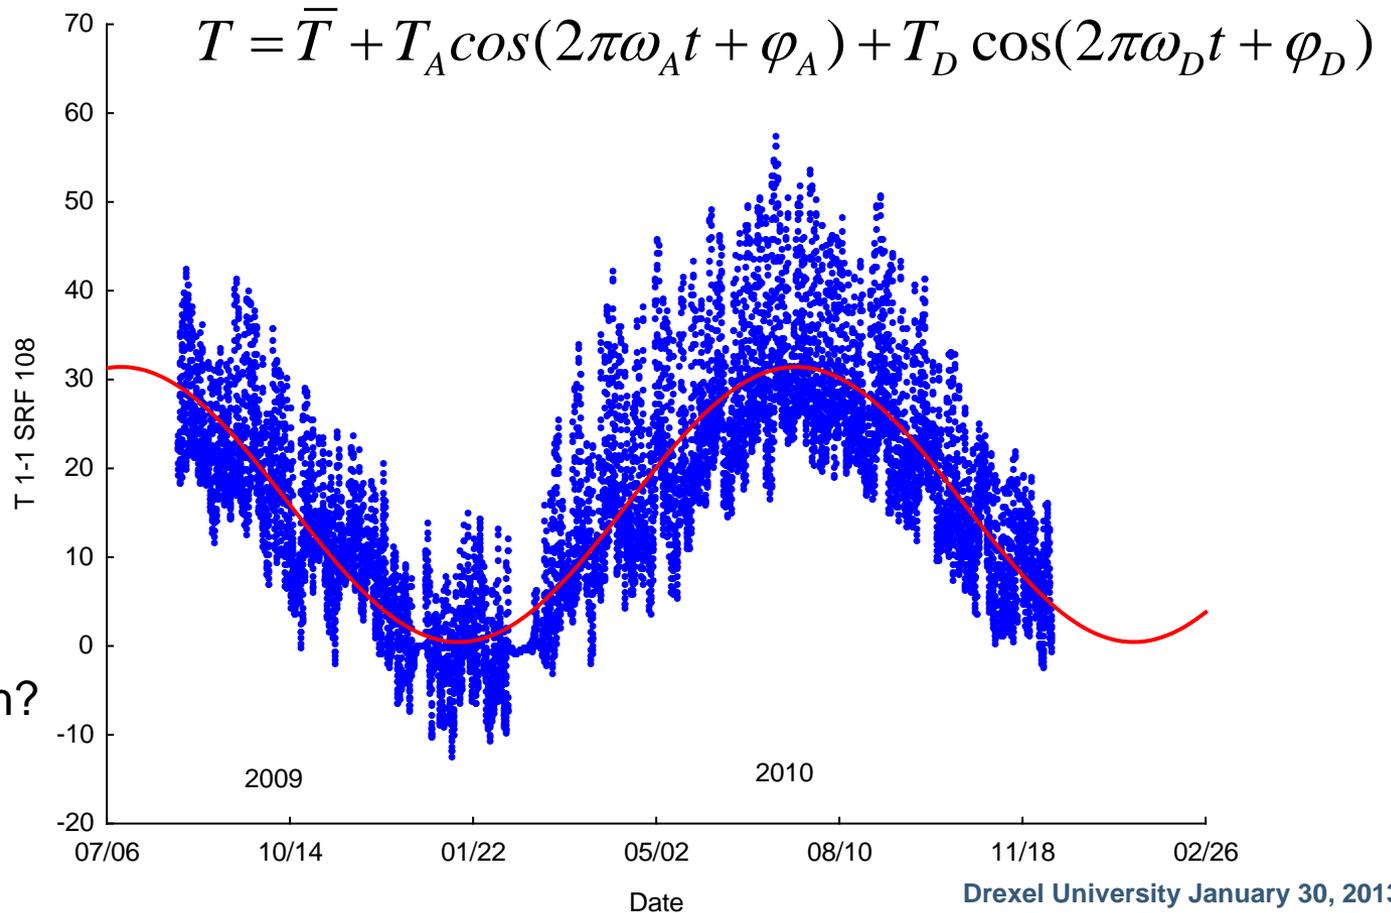
Average and annual amplitude look reasonable. Daily varies during Year (monthly?).

Annual and daily phase shift?

Variation with depth?

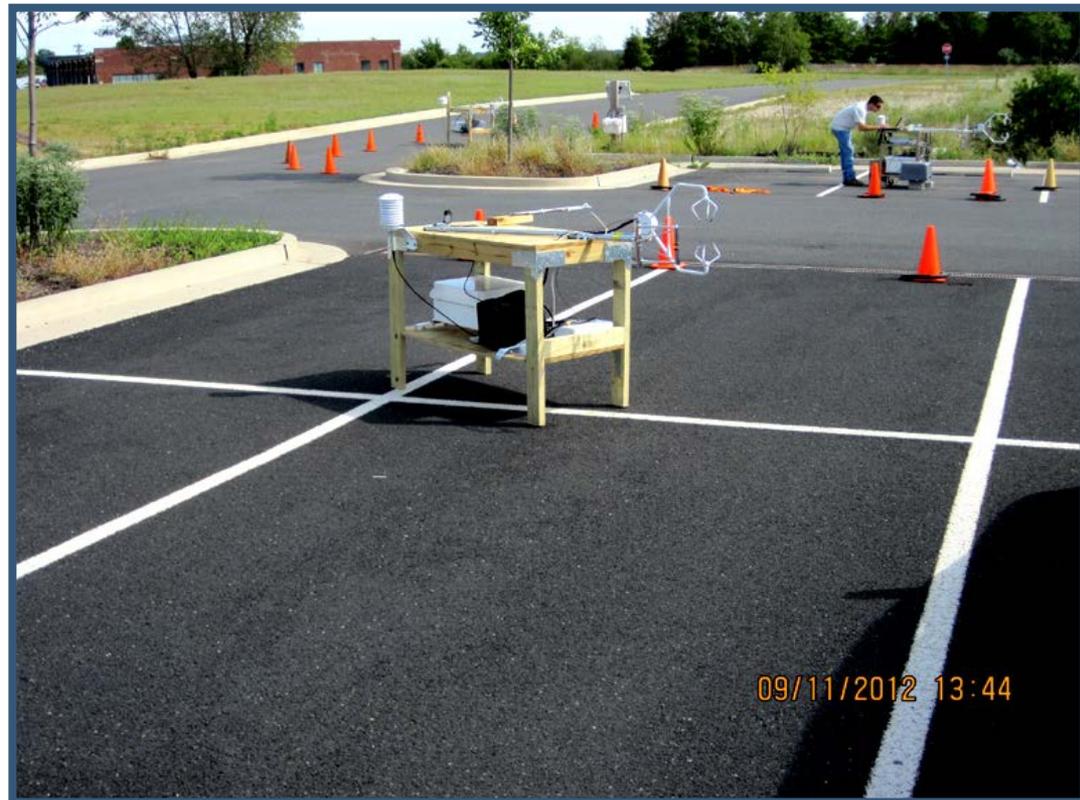
How do these surfaces affect the urban heat island?

How do short and long wave radiation patterns differ among the surfaces?

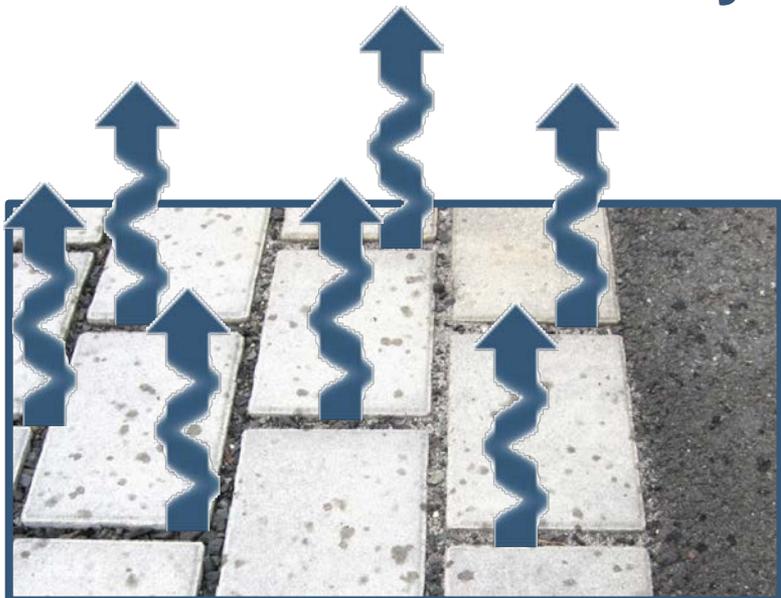
Annually, evaporation from the storage gallery accounted for a measureable part of the rainfall volume for this system.

Percentage of rainfall volume on design drainage area that evaporated		
Surface	PICP	PC	PA
Section 1	5.8%	N/A (leaked)	3.9%
Section 2	4.4%	7.0%	5.6%
Section 3	3.9%	7.6%	2.4%
Section 4	5.8%	6.5%	4.2%
Average	5.0%	7.0%	4.0%

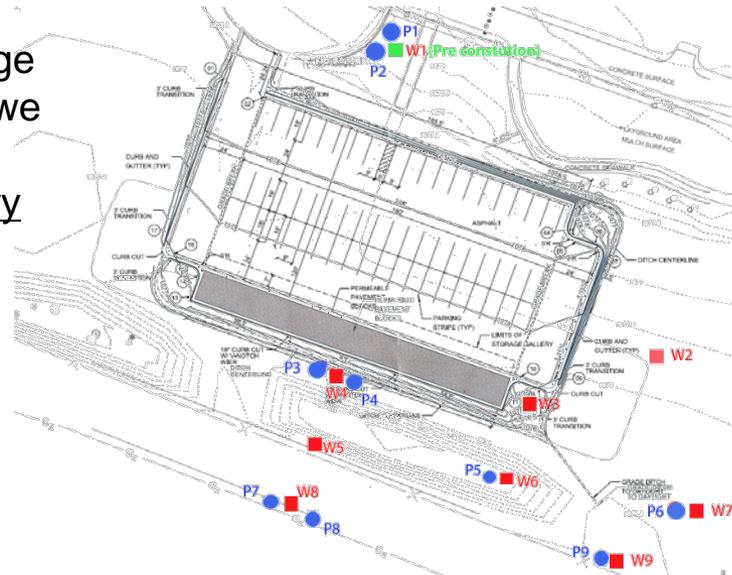
Near-field monitoring of groundwater using wells and piezometers

In addition to monitoring the storage gallery infiltration and exfiltration, we are installing a collection of wells, piezometers, and tensiometers to try to monitor the subsurface processes.
