# Green Infrastructure Performance and Effectiveness in CSO Basin #130 (Louisville)

**Five Cities Plus Conference**

# The test basin is the 17 acre drainage basin CSO130 in the Butchertown section of Louisville.

## **Within CSO 130, MSD decided that the preferred stormwater control is permeable paver strips installed as parking lanes near the catch basins.**

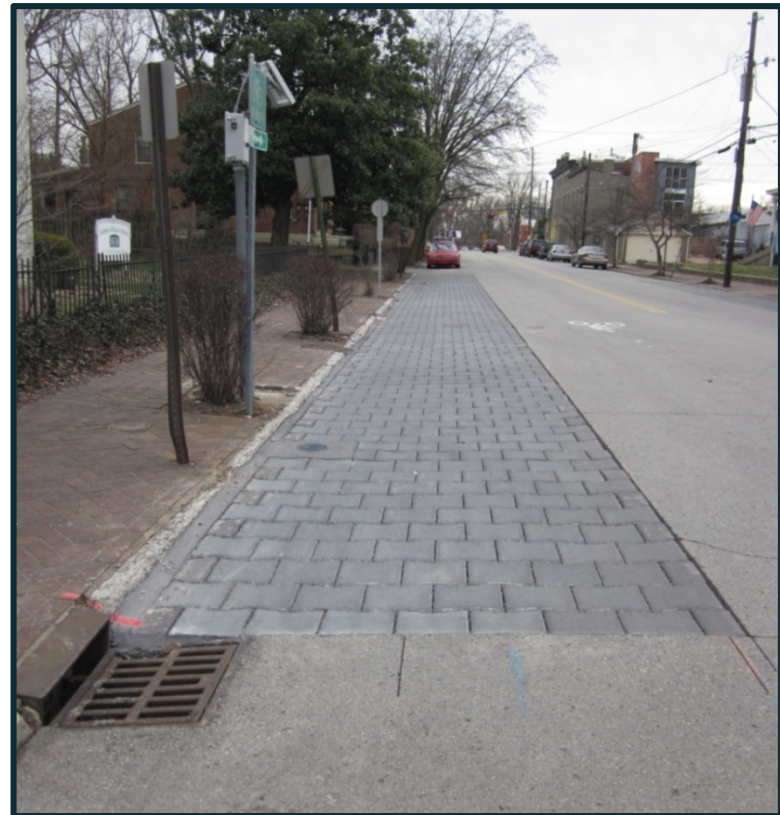
MSD made a policy decision to assume responsibility for the ongoing maintenance.

This led them to place the controls on publically-owned property.

The limited publically-owned property and generally narrow sidewalks forces the controls into the streets.

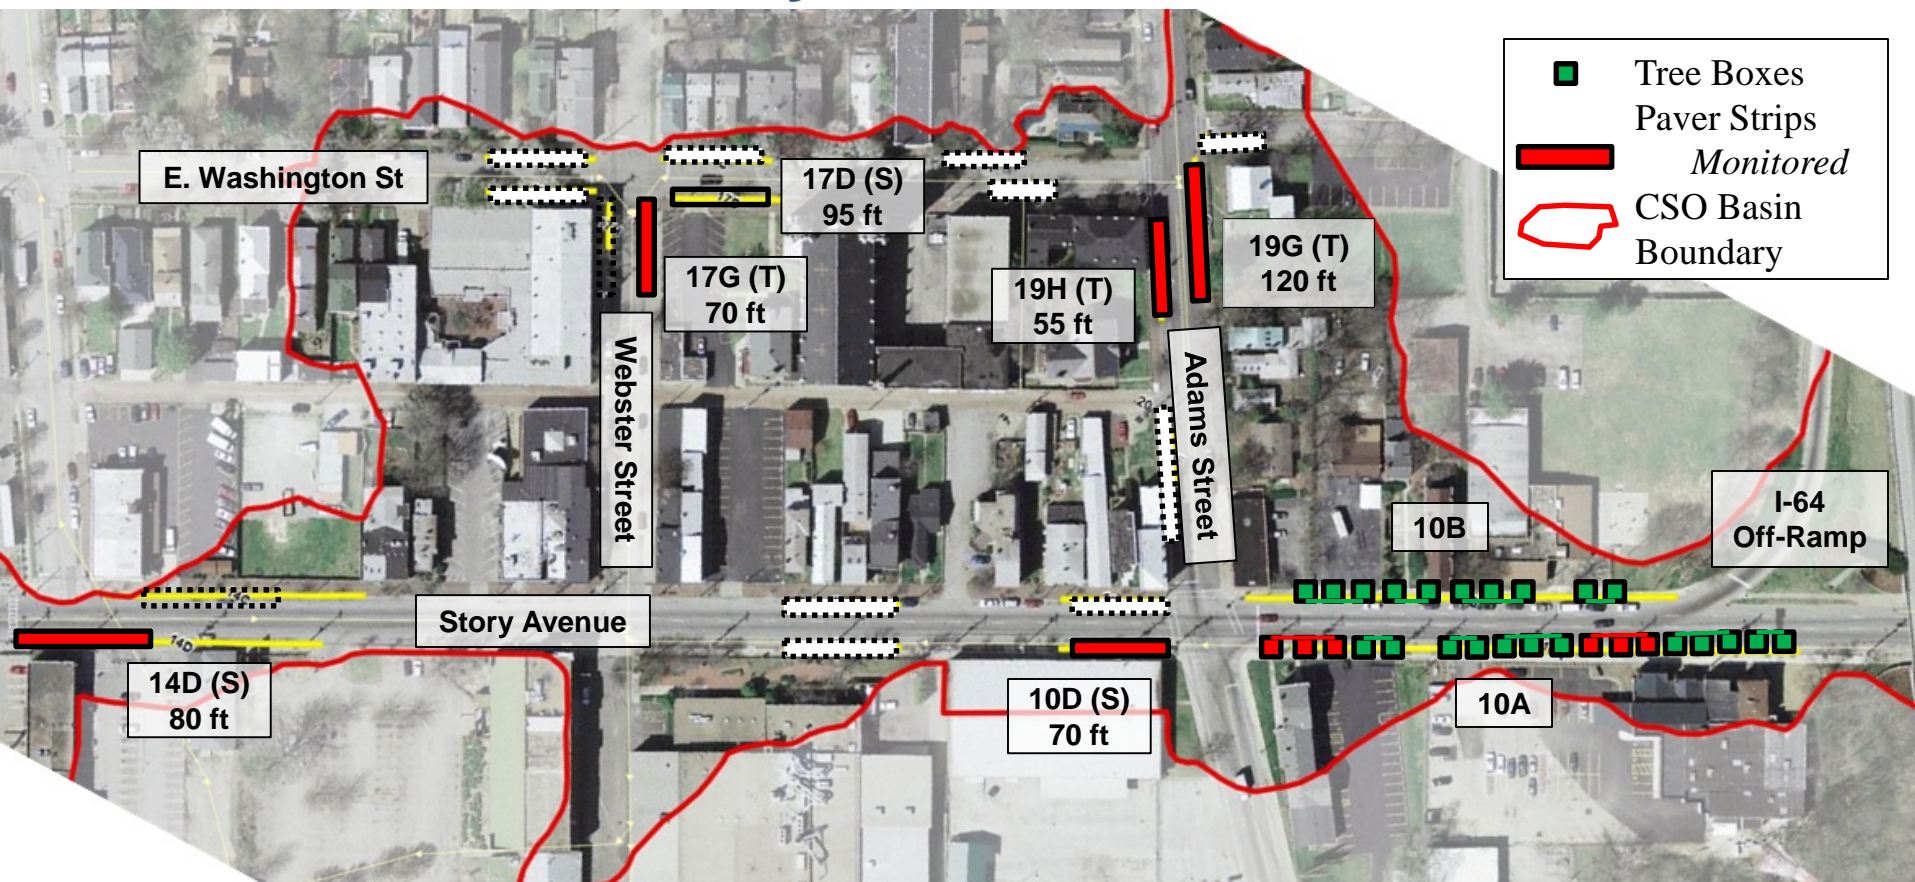
## 6 of 18 articulated paver strips and 6 of 28 tree boxes were heavily instrumented.

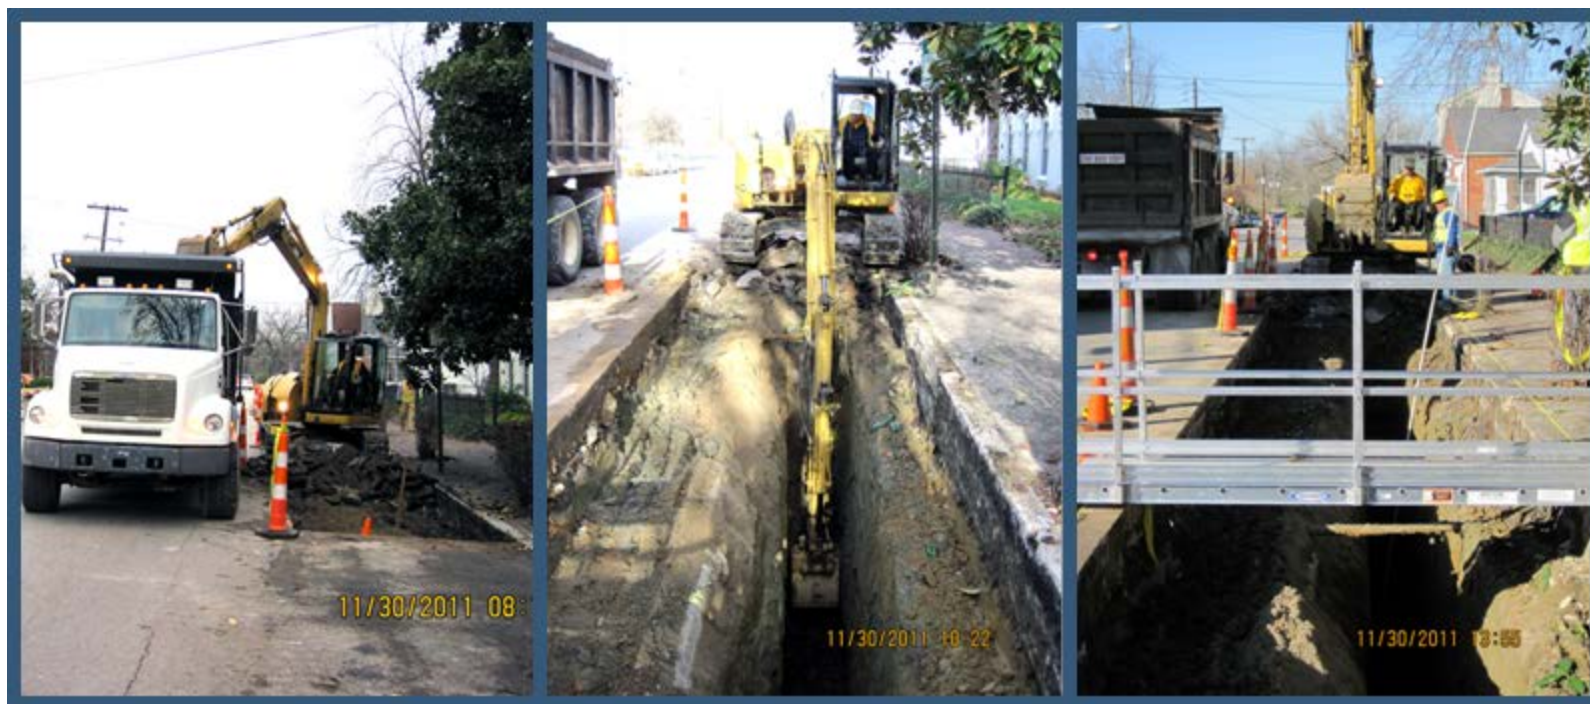
**The MSD contractor removed existing pavement, excavated the trench and storage gallery before we installed the selected monitoring equipment.**

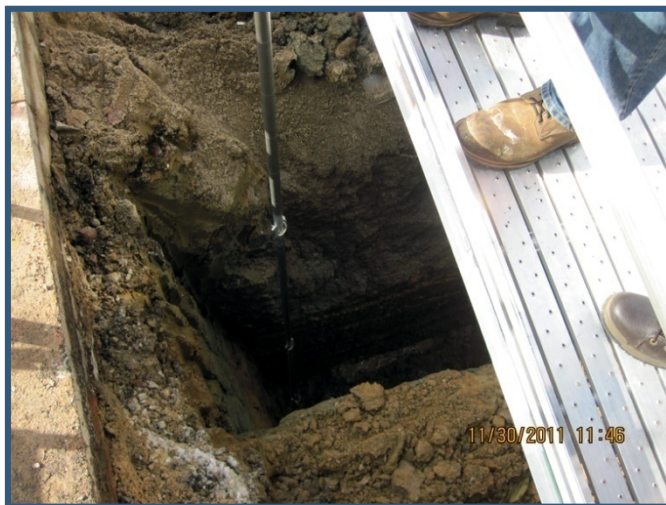
Sample collection with extended hand auger

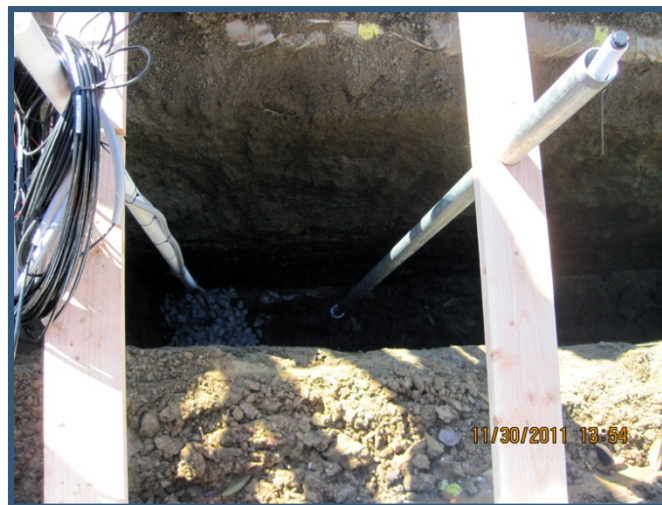
“Long pipe” Infiltration testing

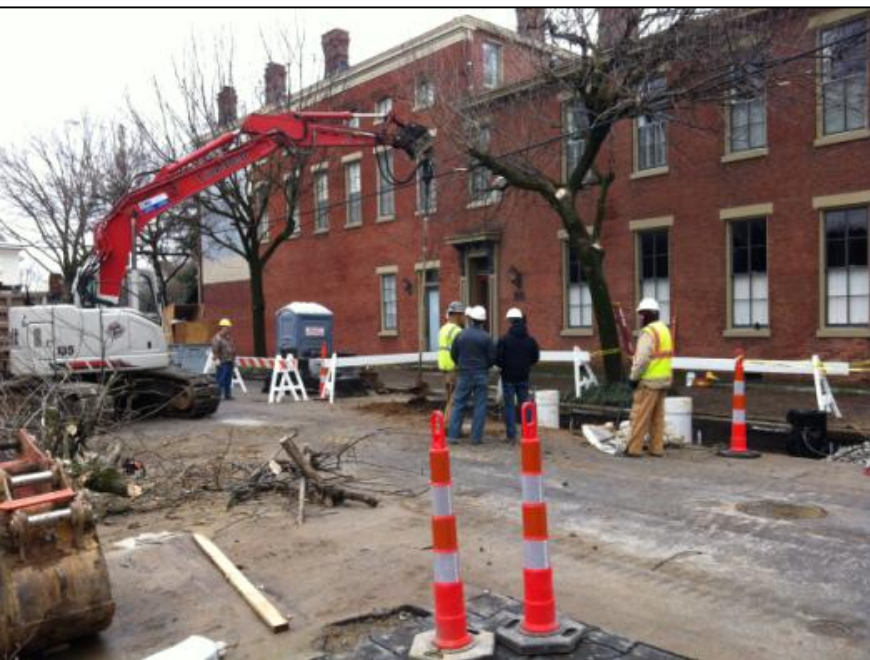
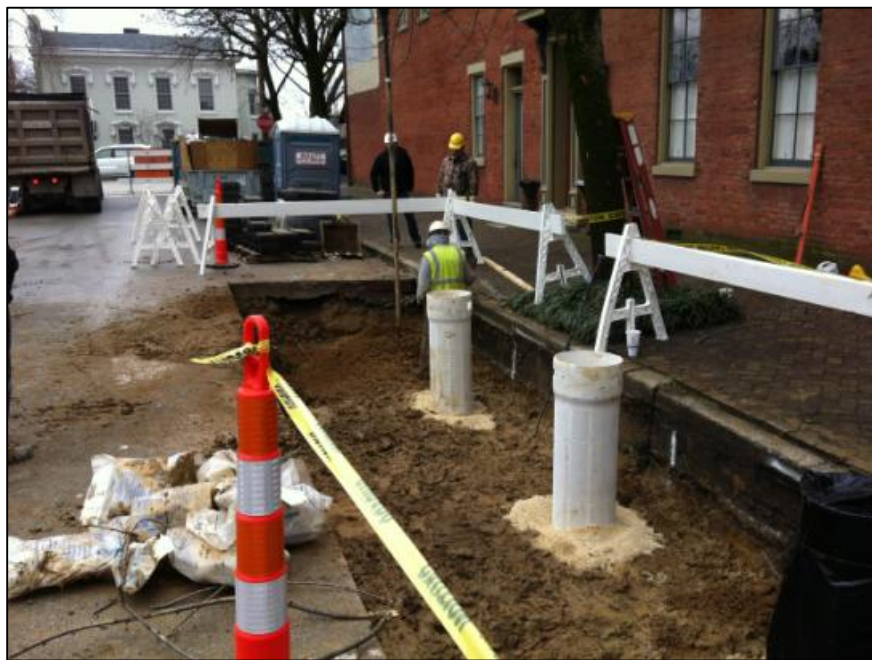
**Most of the articulated paver strips installed in the next phase used shafts instead of trenches.**

Photos: Josh Rivard, University of Louisville  
Louisville Control 19B  
02 22 2013

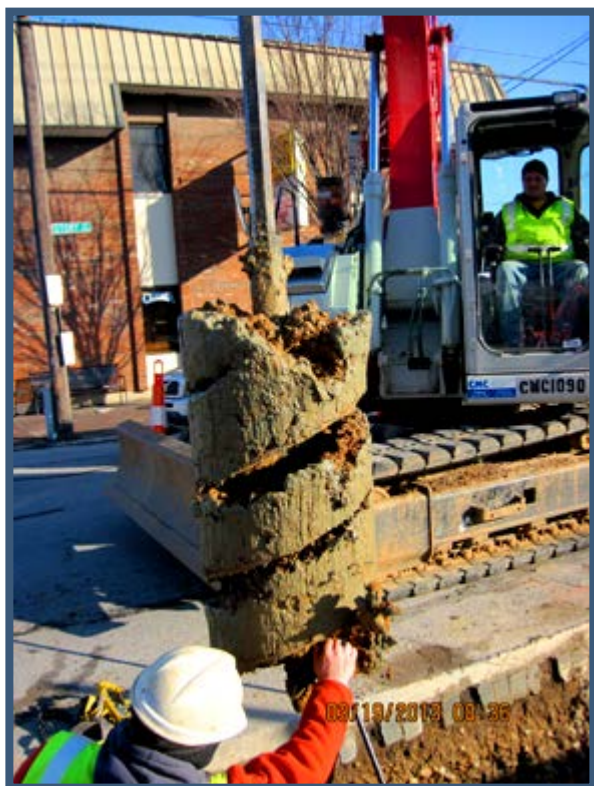
**ARTICULATING CONCRETE BLOCK SHAFT STRIP**  
NOT TO SCALE

**The design change introduced augured shafts to hydraulically connect to soil with large infiltration capacity.**

The number and depth of shafts varies across the controls.

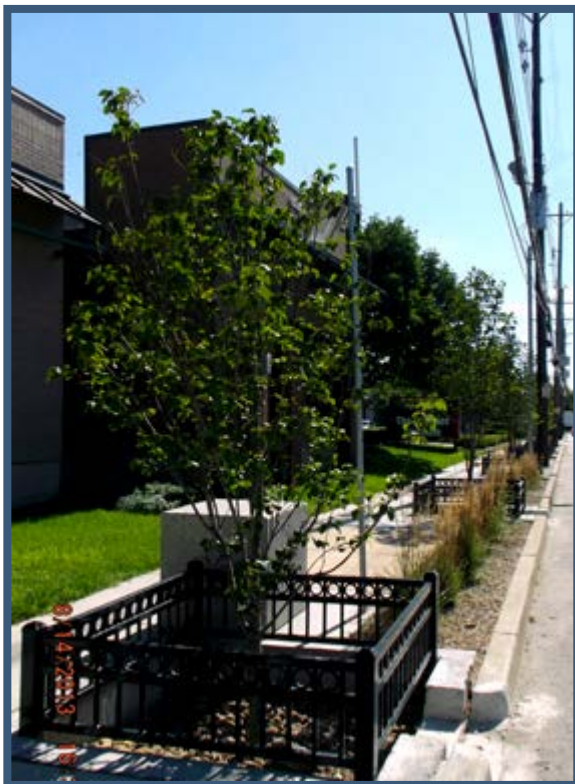
**Tree boxes were installed in groups of two or three with a connecting infiltration trench and at locations where no parking lanes were present.**

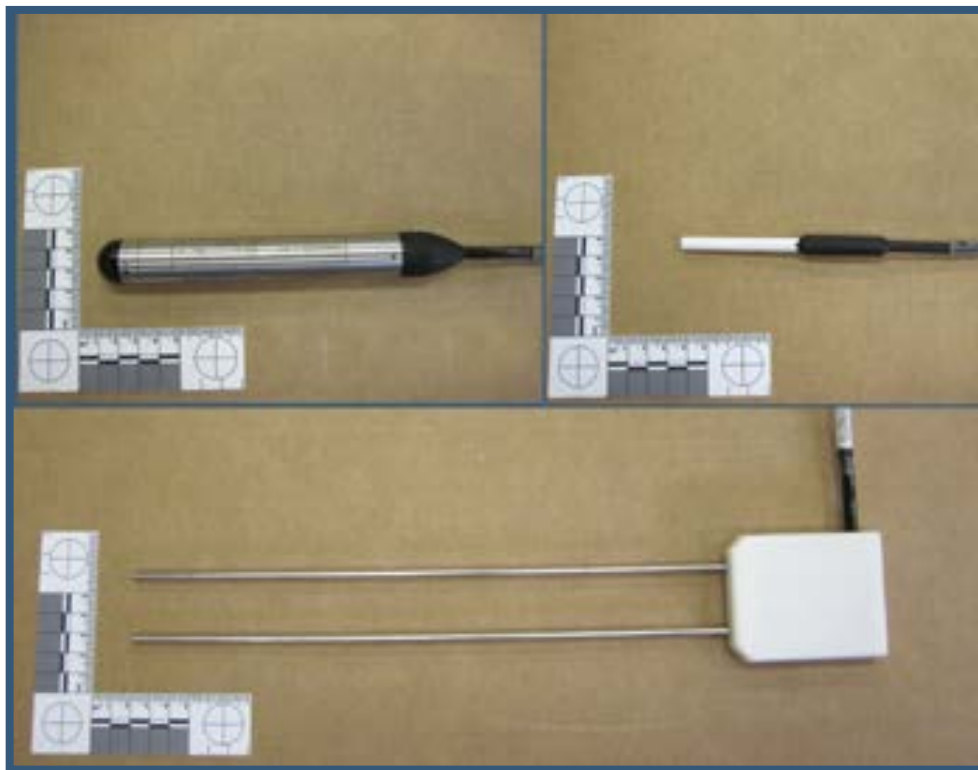
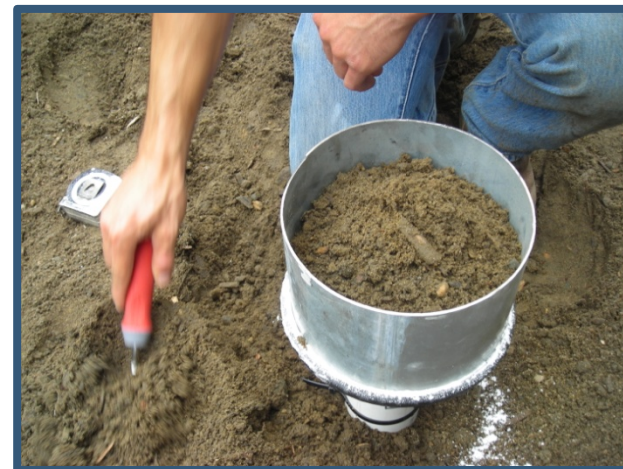
**The permanently installed sensors are pressure transducers, time domain reflectometers (TDRs), thermistors, and passive capillary lysimeters.**

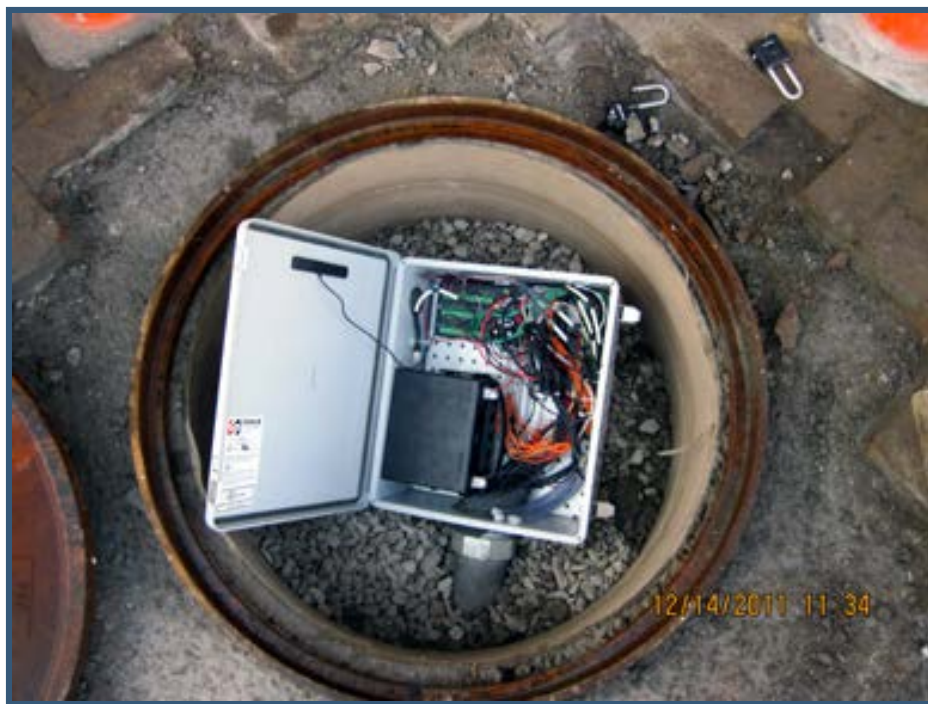
19G

**The instruments in each control are hard wired to the datalogger.**

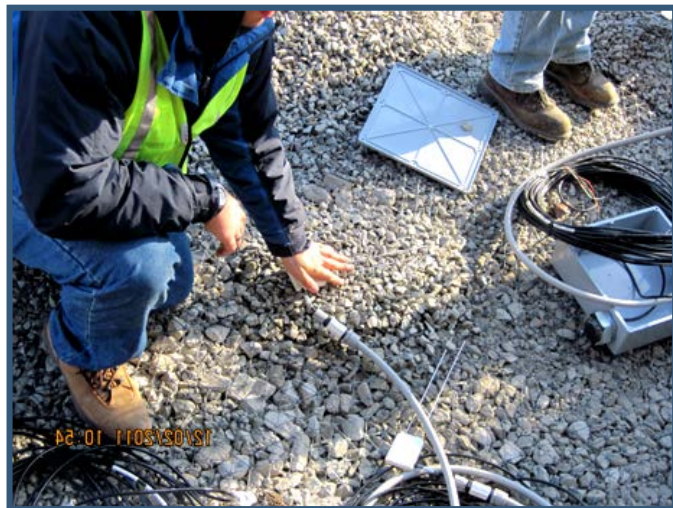
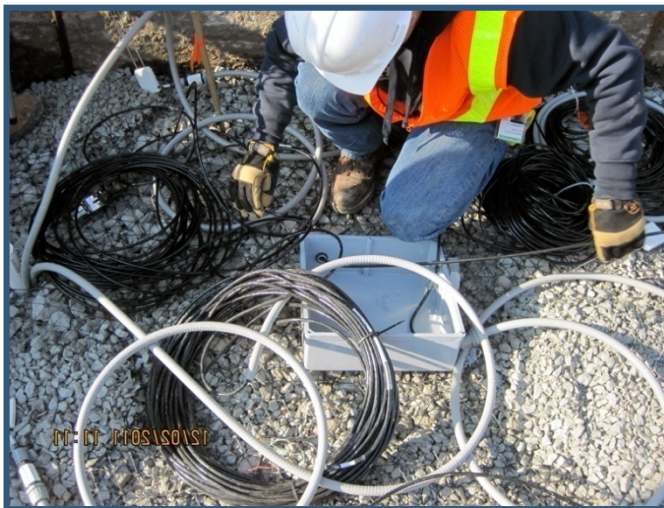
**Time Domain Reflectometers (TDRs) were installed 40 cm below the paver surface in the aggregate to measure surface clogging progression.**

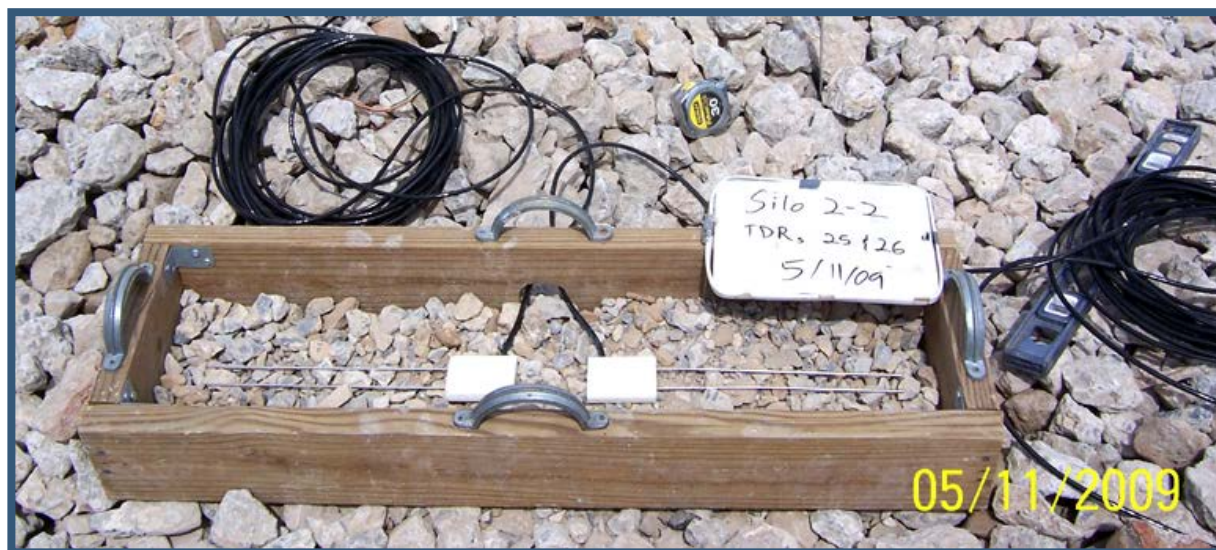
**The foundational research<sup>1</sup> linking the TDR response to moisture content was done in mineral soils, not gravel so the output value is the “Relative Volumetric Water Content” (RVWC).**

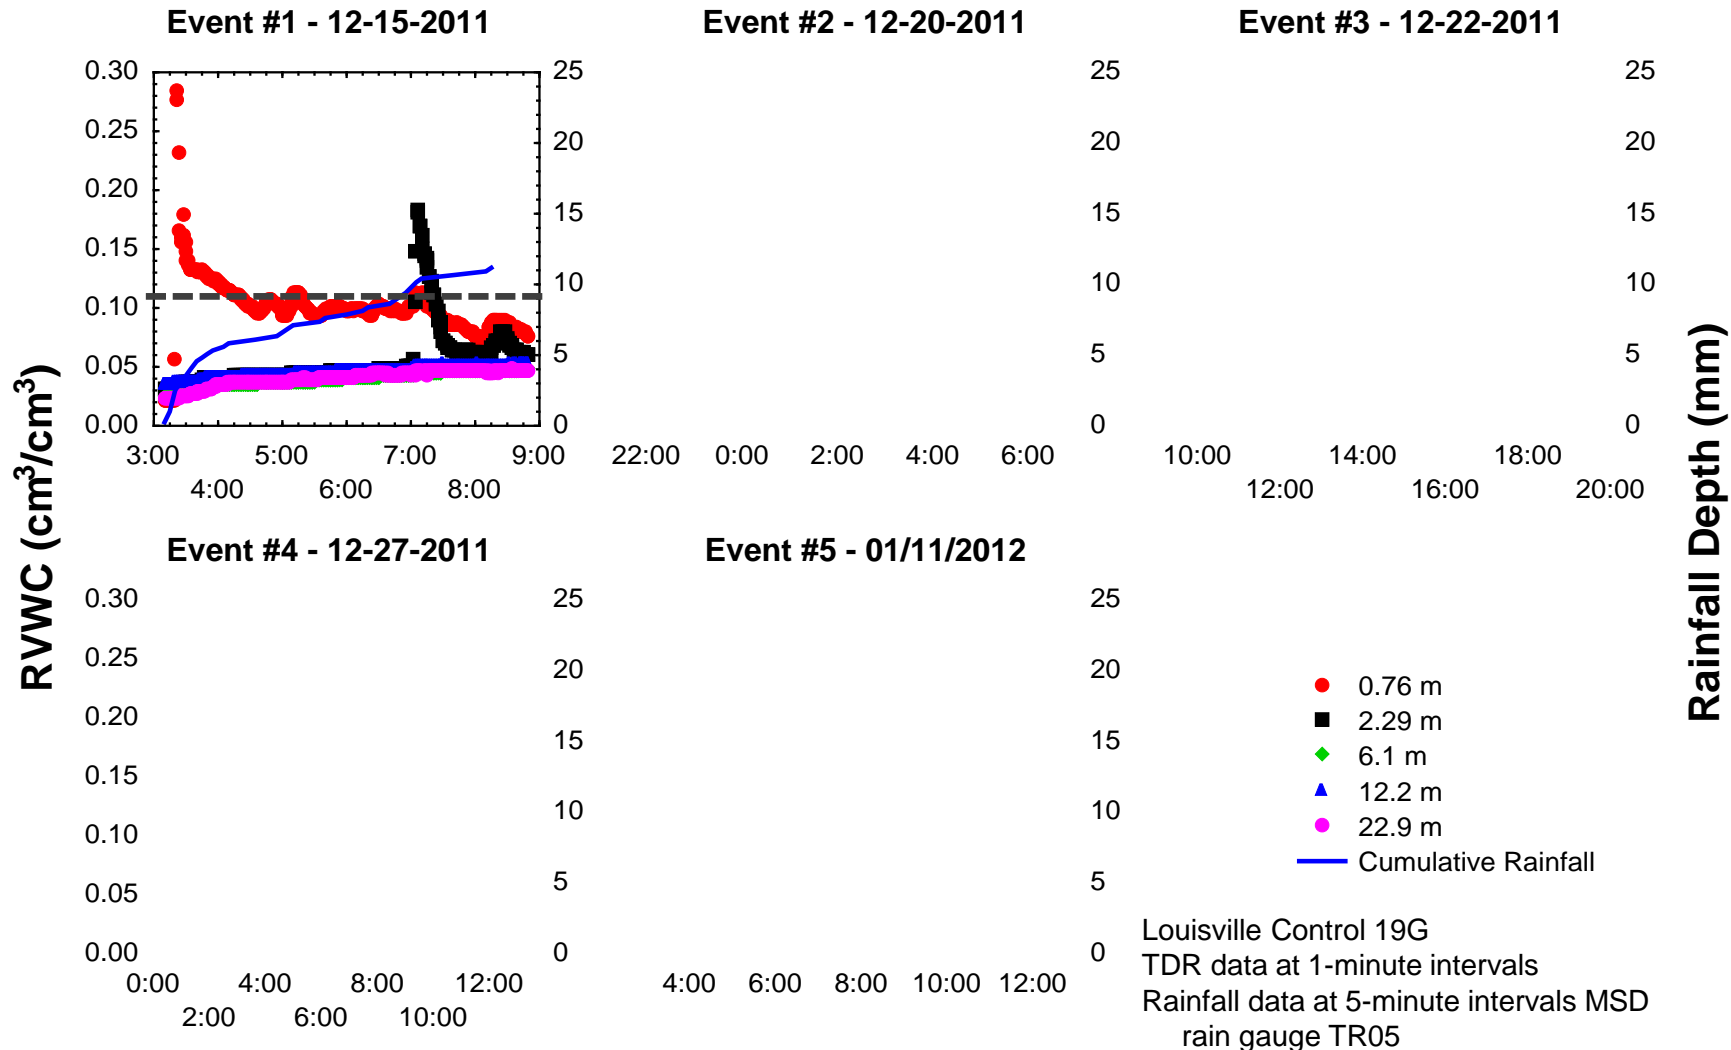
# Using the TDRs nearest the curb edge, we can monitor the progression of surface clogging.

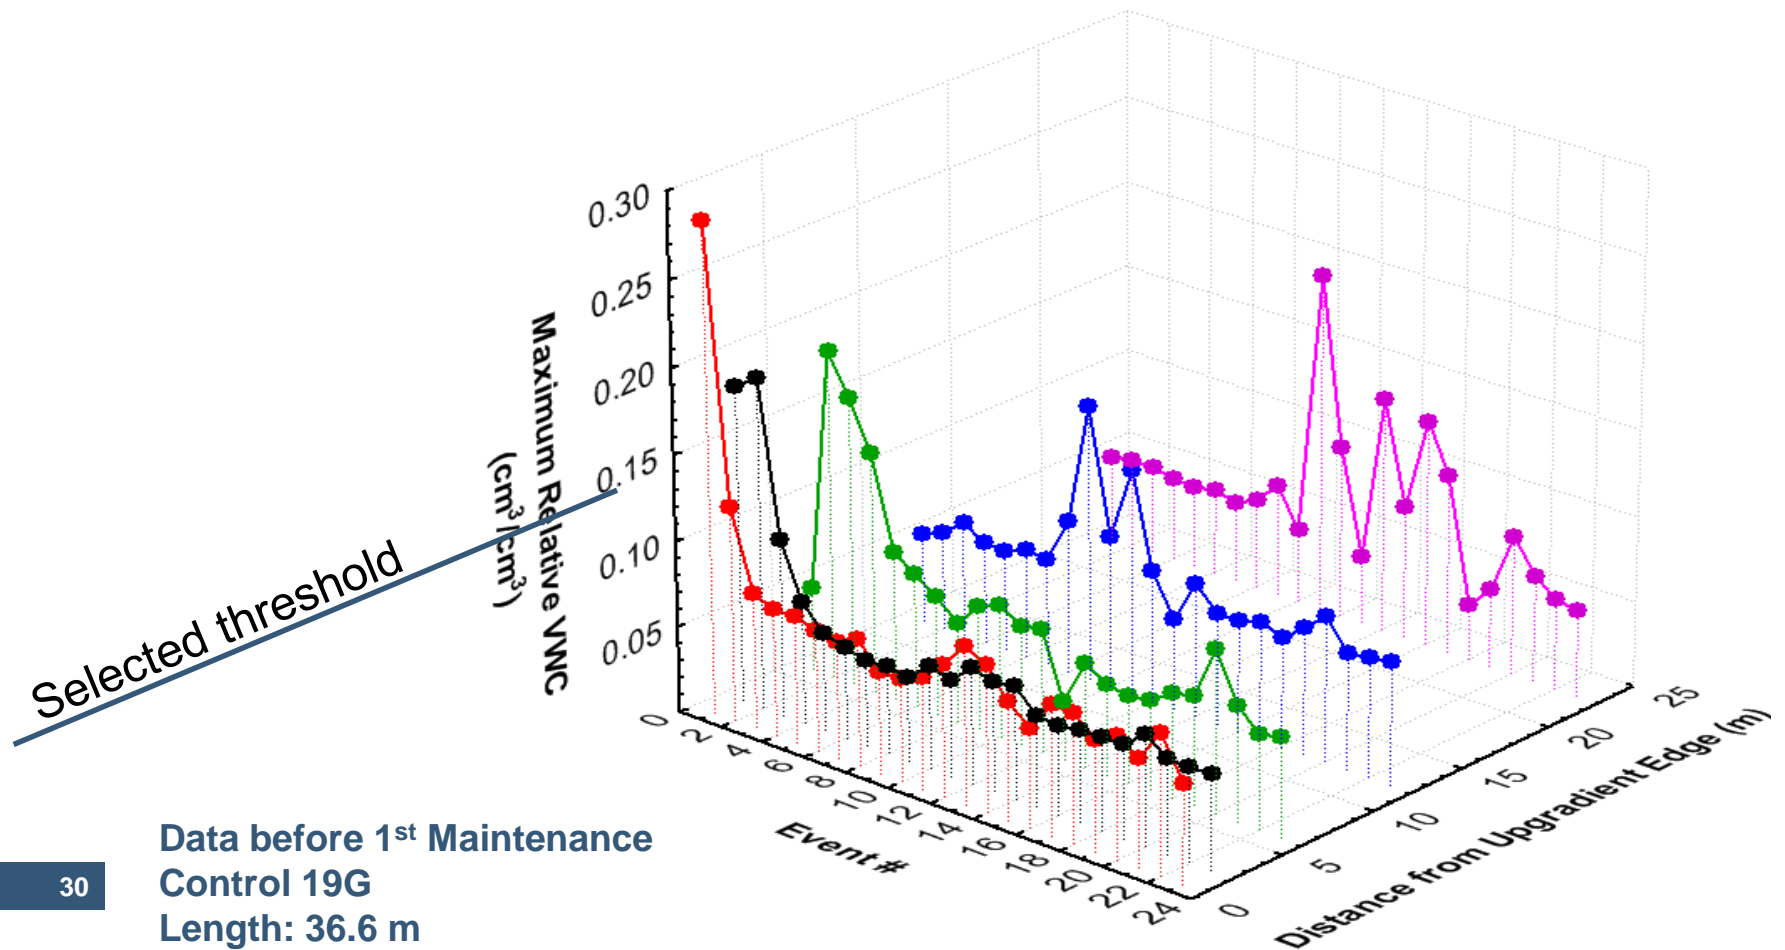
## The curb edge TDR responses support the predicted clogging progression.

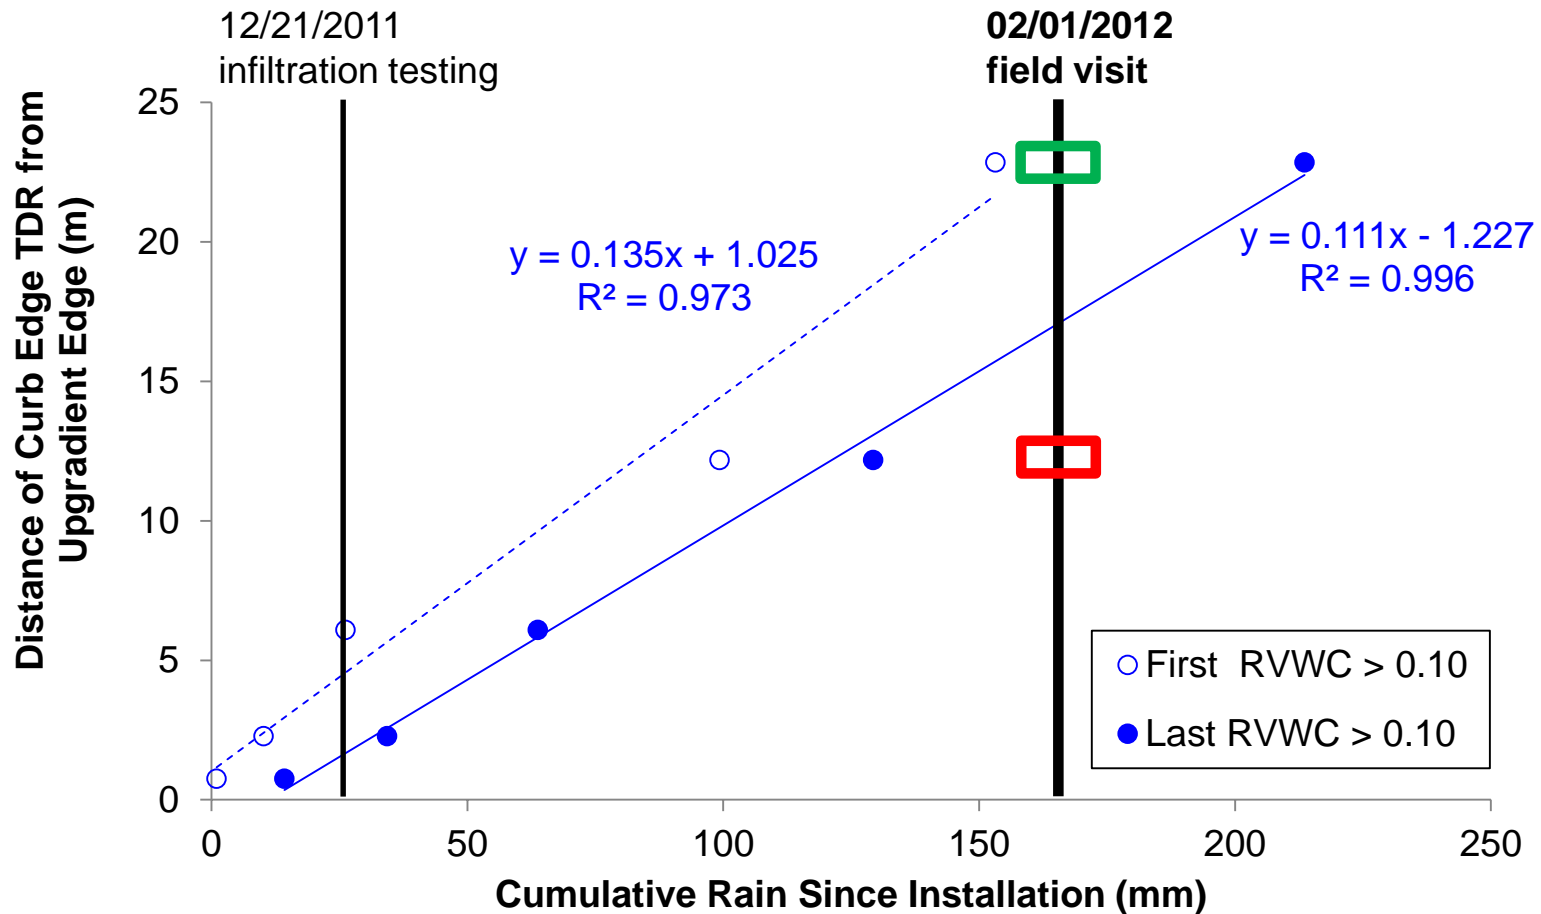
# Infiltration tests and field visits were used to support the threshold selection.

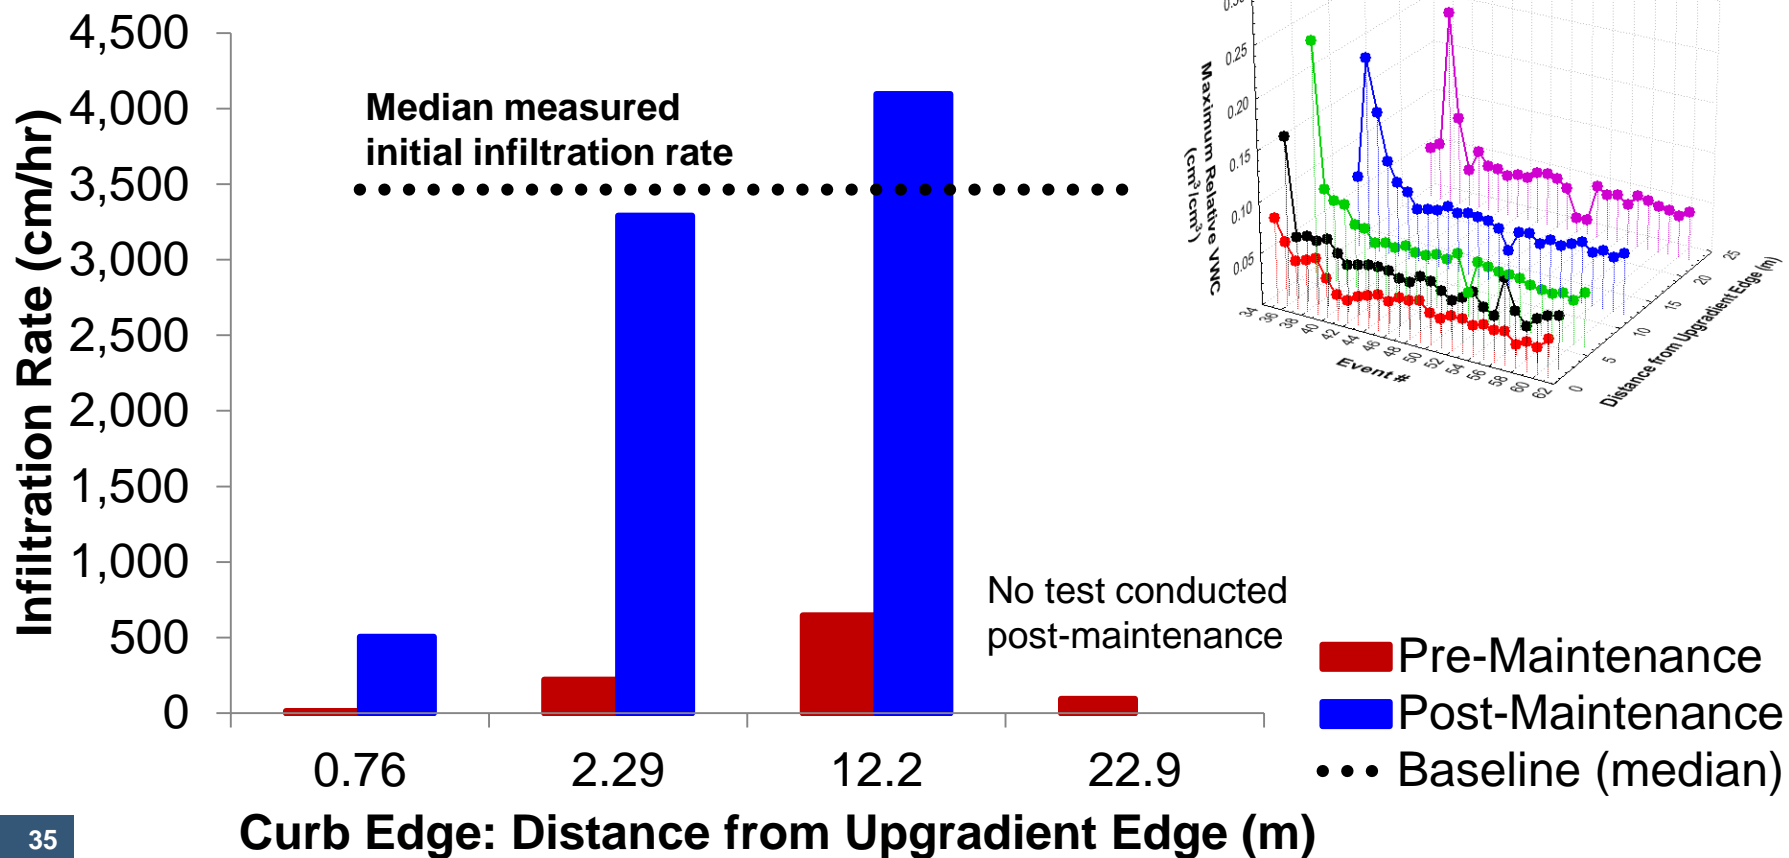
# Manual infiltration tests supported electronic measurements.

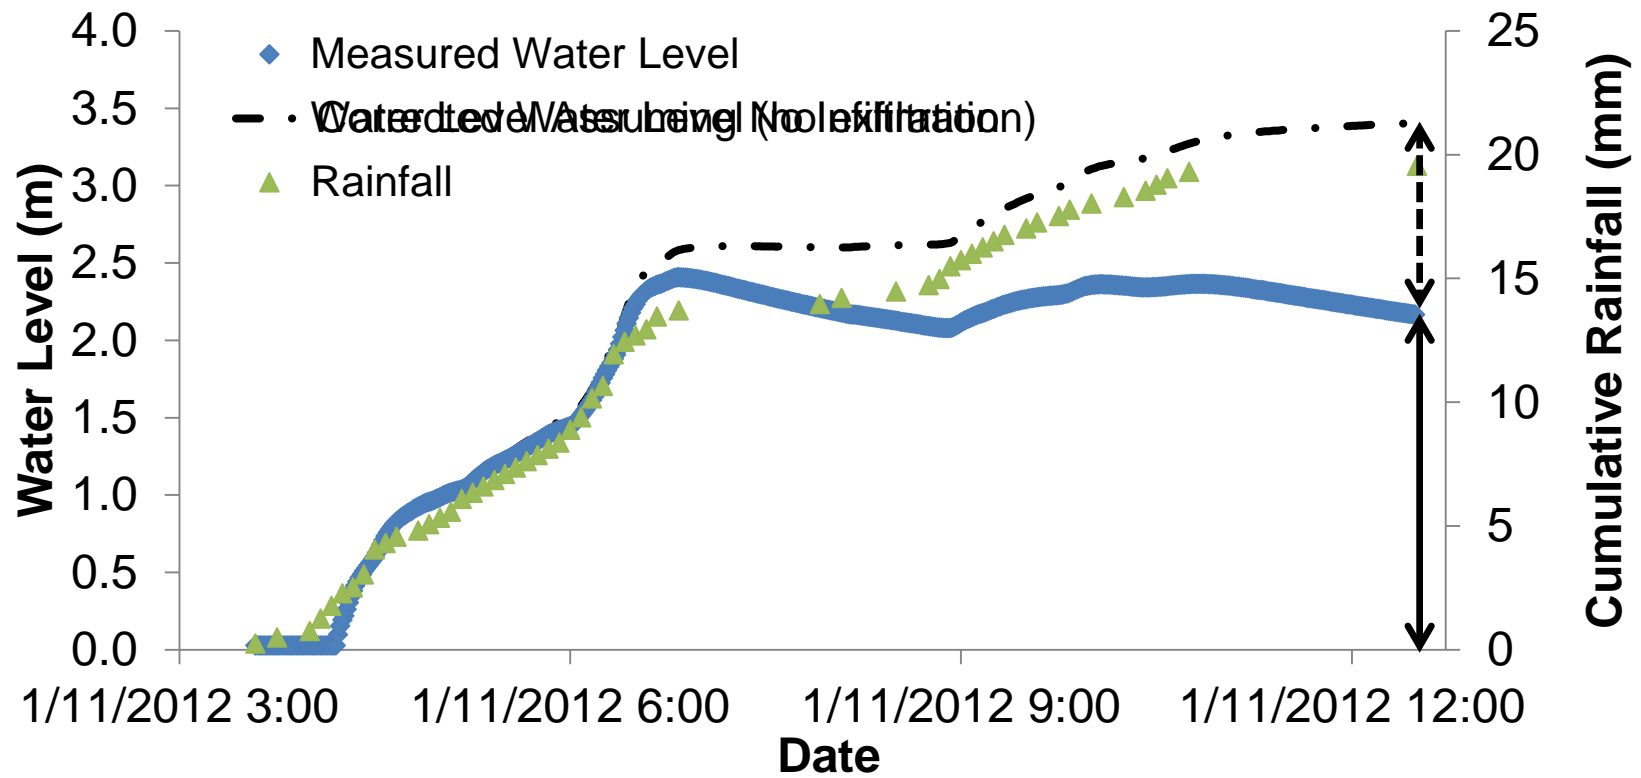
## Water level was adjusted for intra-event exfiltration to calculate volume captured.

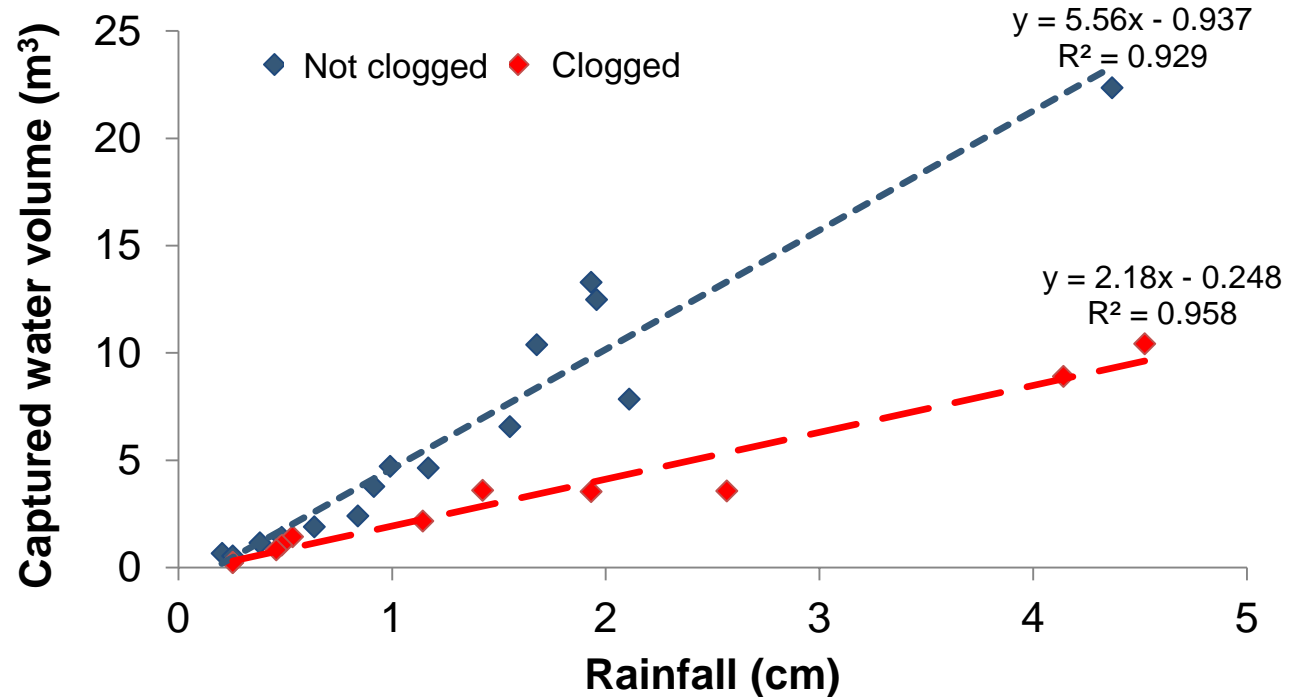
## The data fall into two groups “not clogged” and “clogged.”

Louisville control 19H  
Level data at 1-minute intervals  
Rainfall data at 5-minute intervals MSD gauge TR05

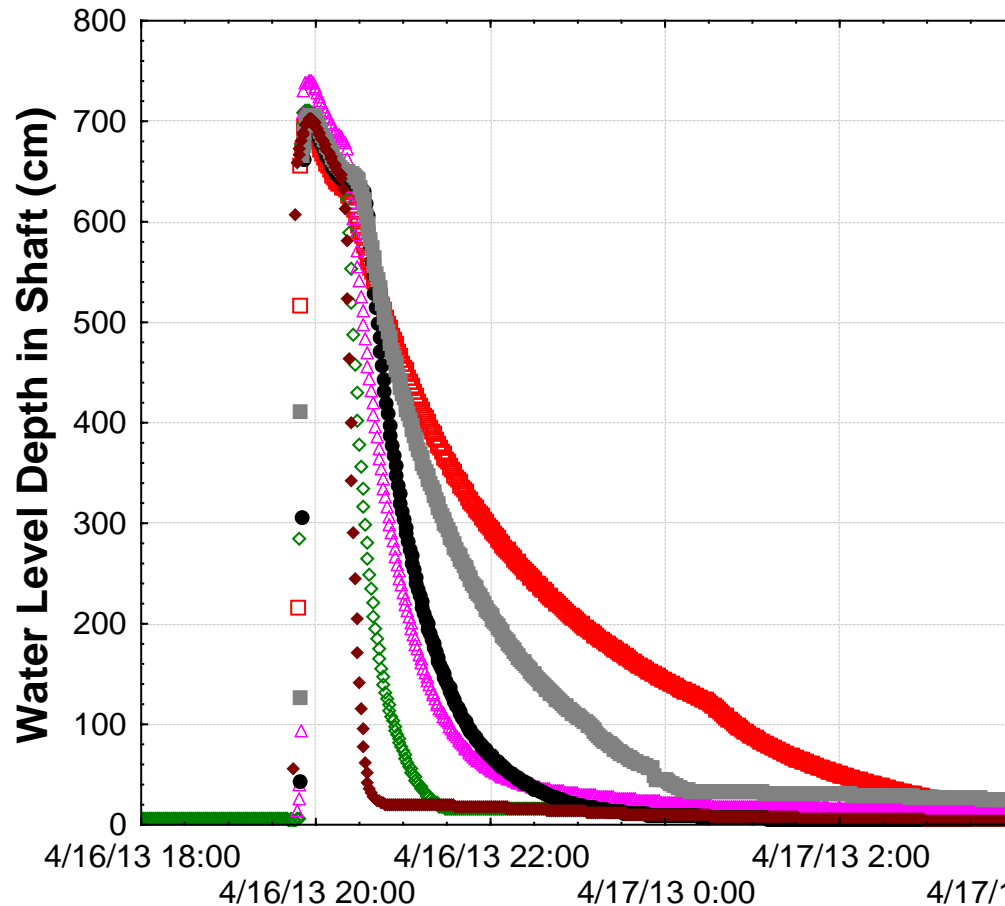
**When full, the 21–22 ft deep shafts in 14D can drain completely within 30 minutes to 5 hours.**

Louisville Control 14D  
Event Size: 18.6 mm (0.73 in.)

Shaft #1 not depicted because internal berm interfered with shaft filling.

Based on water level measured in storage gallery, this entire event infiltrated (maximum water level was 47 cm).

- #2
- ◇ #3
- △ #4
- #5
- #6
- ◆ #7

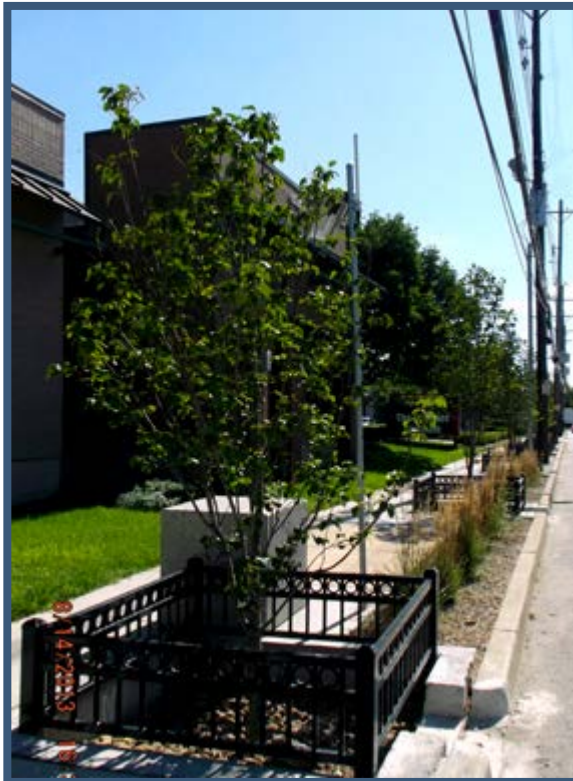
**We instrumented two sets of three tree boxes that were installed in groups of two or three with a connecting infiltration trench.**

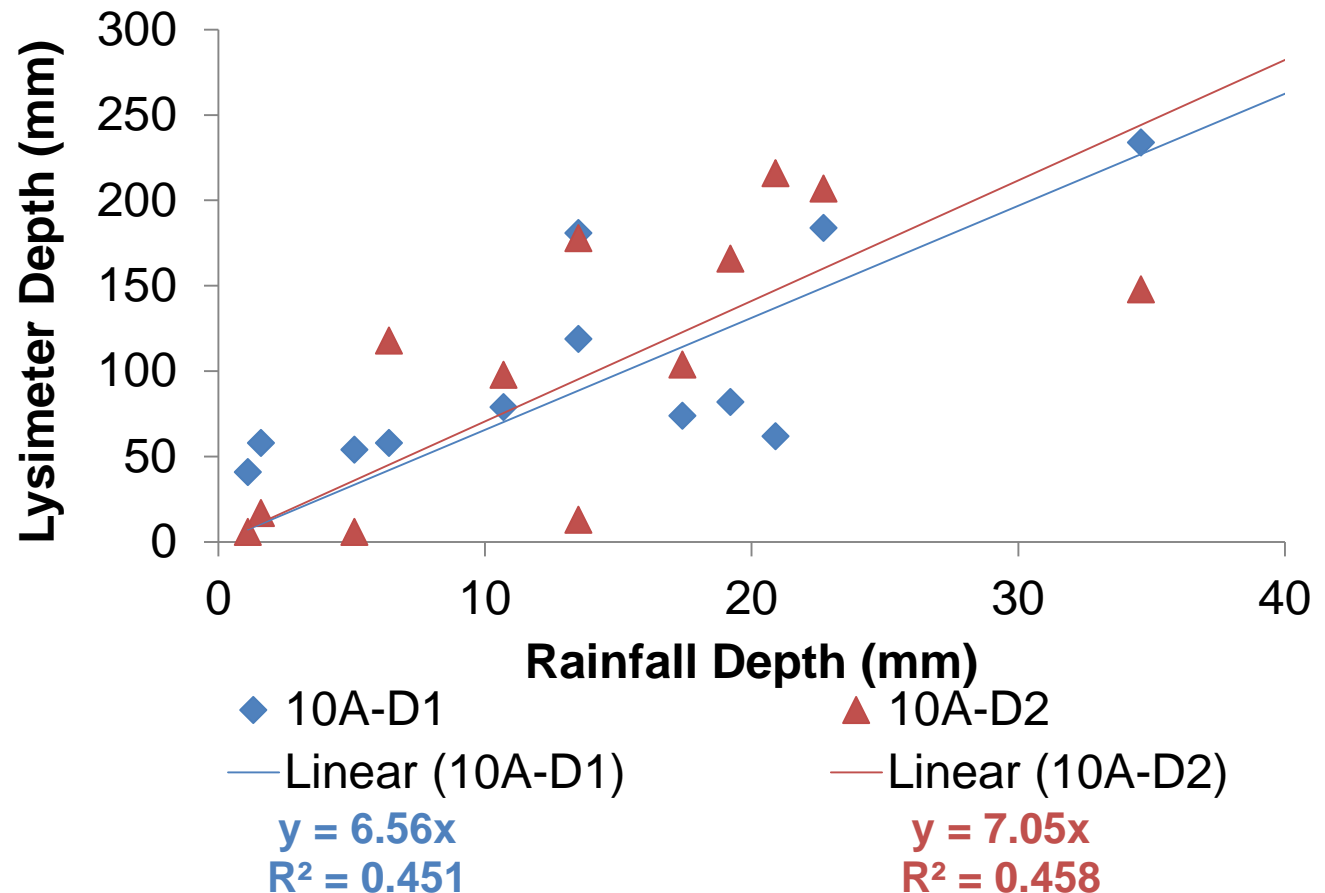
The passive capillary lysimeter measured the hydraulic loading ratio of infiltrating runoff into the tree box media.

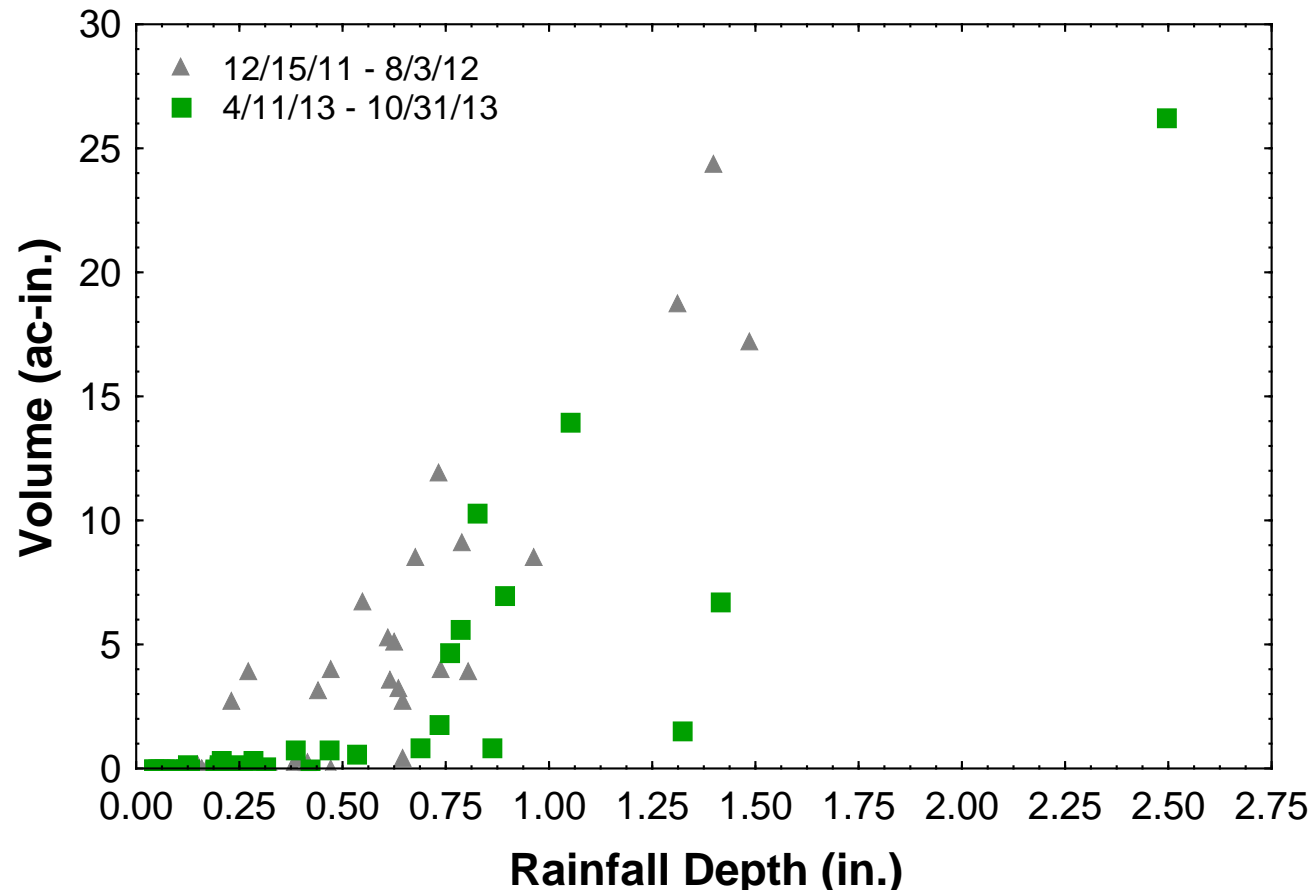
### Measured overflow from CSO 130

## So far, GI appears to manage all rain events through about 0.7 inches in this basin.

The target for this basin is to eliminate CSO from all rain events less than 1.09 inches. (1.09 inch is the 9<sup>th</sup> largest rain event in the negotiated rain year.)

There is still ongoing work to disconnect rooftops from the CSS. Some GI practices came on line after April 2013.
