Green Infrastructure at the Edison Environmental Center - Permeable Pavement

*Thomas P. O'Connor, P.E., BCEE
Environmental Engineer
Water Resources Recovery Branch
Water Systems Division
Edison, NJ*

Permeable Pavement and Bioinfiltration Research and Demonstration Site

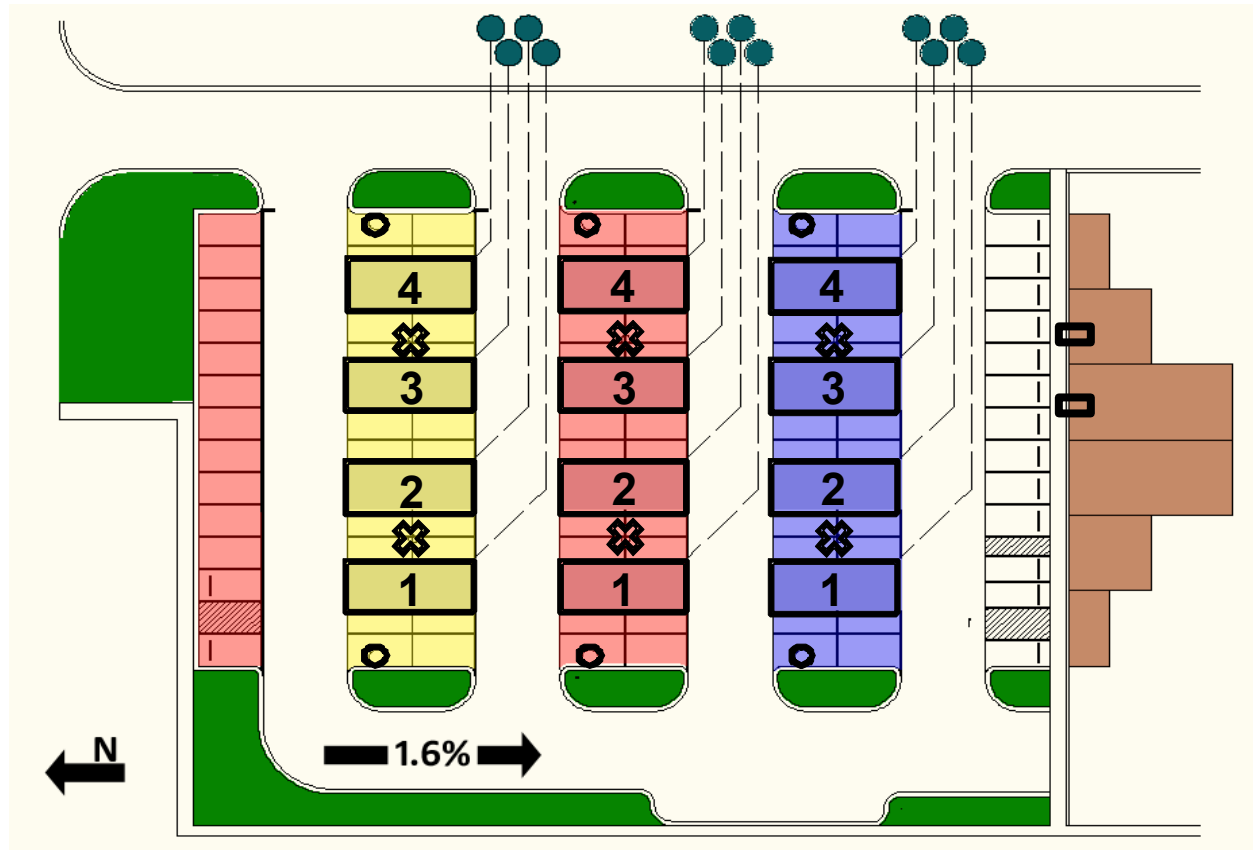
Final design incorporated monitoring capabilities for 3 permeable surfaces.

| Permeable pavers | Pervious concrete | Porous asphalt | Rain gardens |
| Buried distribution pipes | Tree islands | Hot mix asphalt | Curb cuts |
| Buried well/piezometers | Collection tanks | Buried Water Content Reflectometers | |

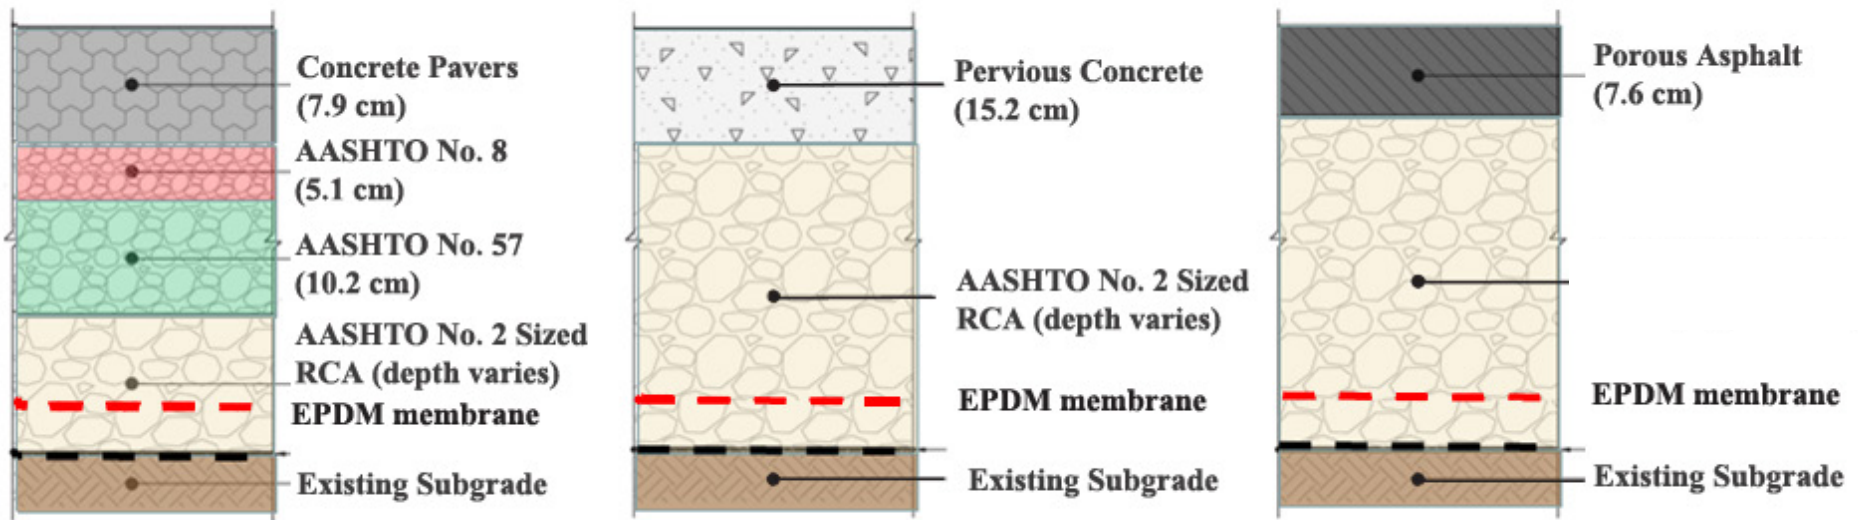
Vertical cross sections of permeable surfaces vary slightly from material to material.

Not to scale

Based on engineering drawings from Morris & Ritchie Associates, Inc. 2009

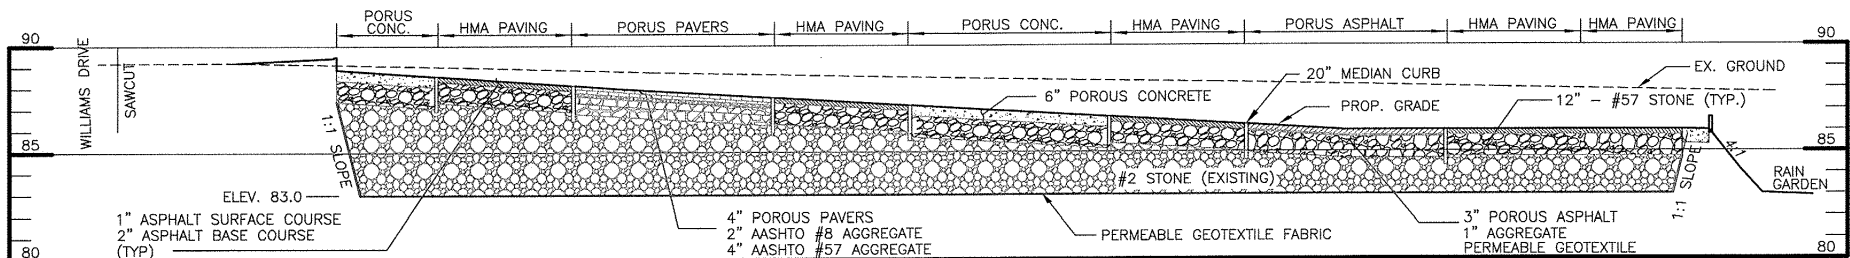
SECTION A-A

Depth to EPDM membrane ~ 16 in.

SCALE: H: 1" = 20'
V: 1" = 5'

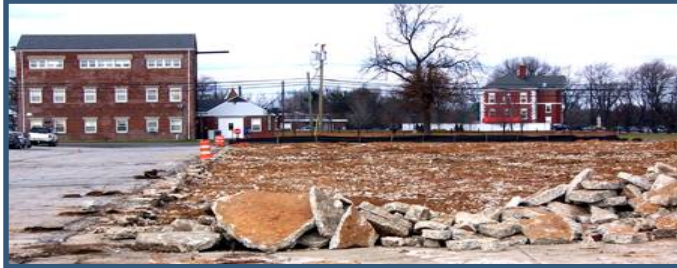
November 26, 2008

Construction began late 2008 with opening in October 2009.

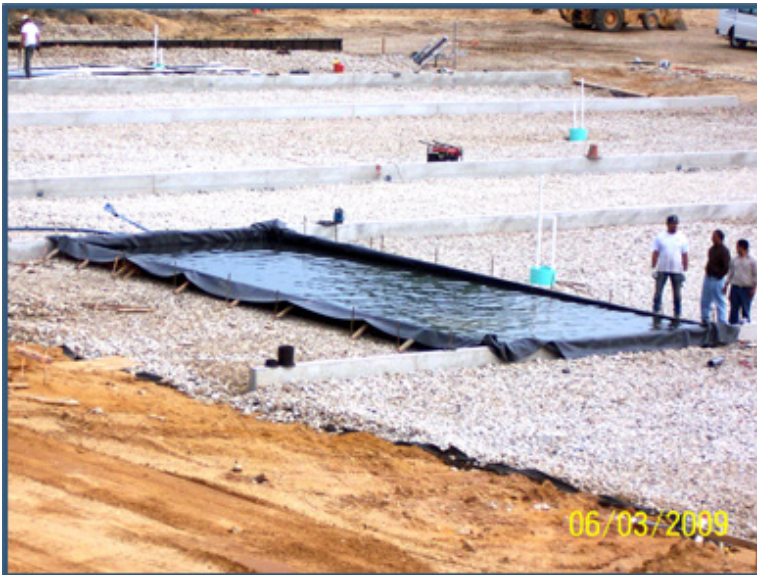
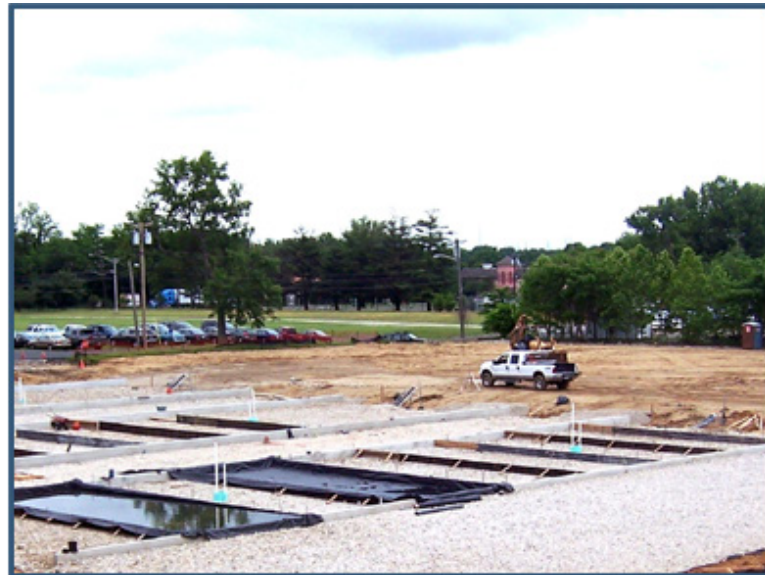
Four equally-sized and spaced lined sections collect infiltrating water from each permeable surface.

Lined sections 15'6" w x 18' long

Infiltrate drains from lined sections to 5,700 L (1,500 gal) tanks on east side of the 0.4 ha (1 acre) parking lot where it can be sampled. Tanks designed to collect 38 mm (1.5 in) event before bypass.

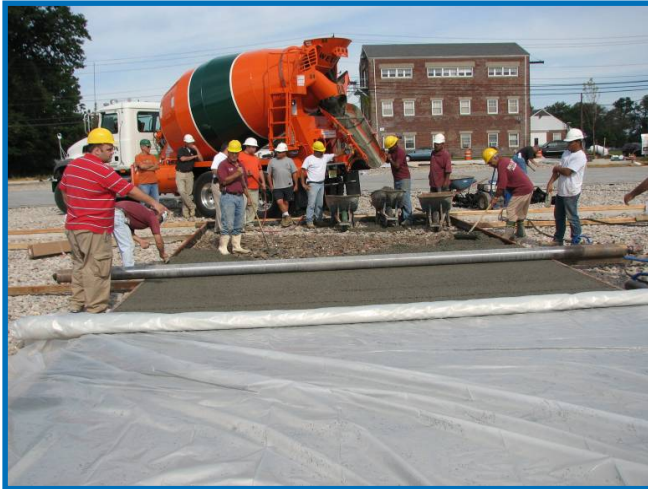
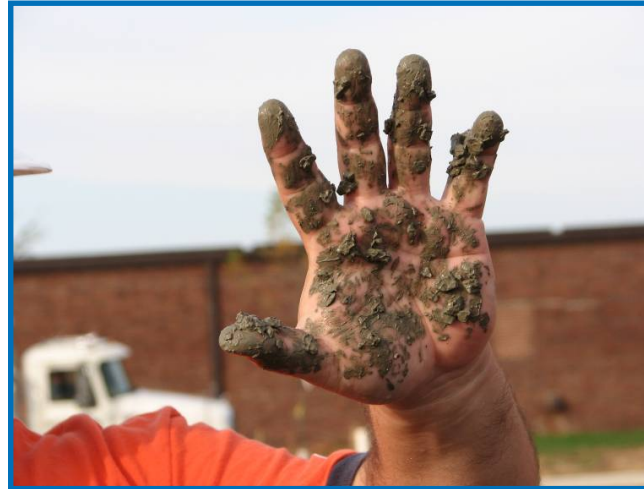
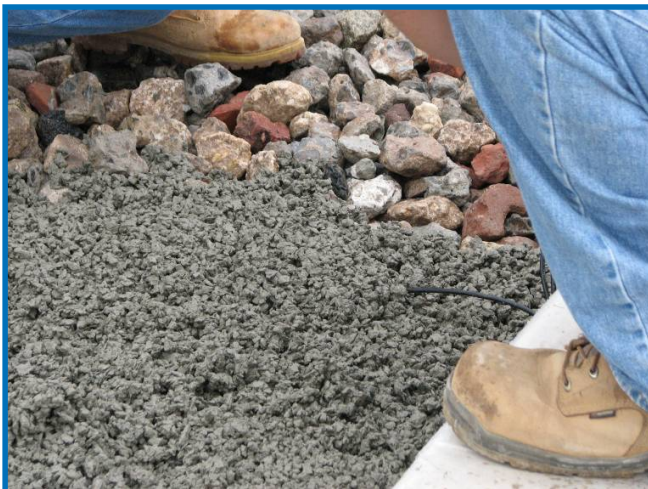
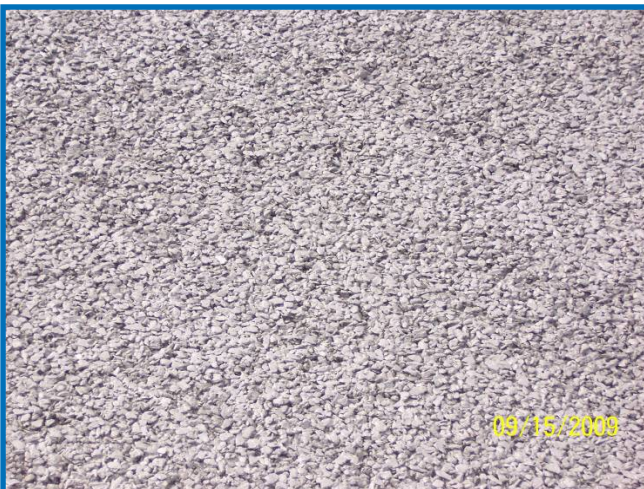
Pervious concrete (PC) was poured over two days and cured under plastic for a week.

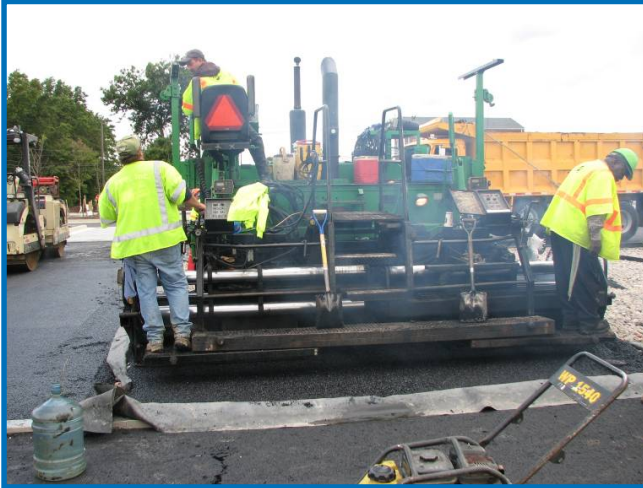
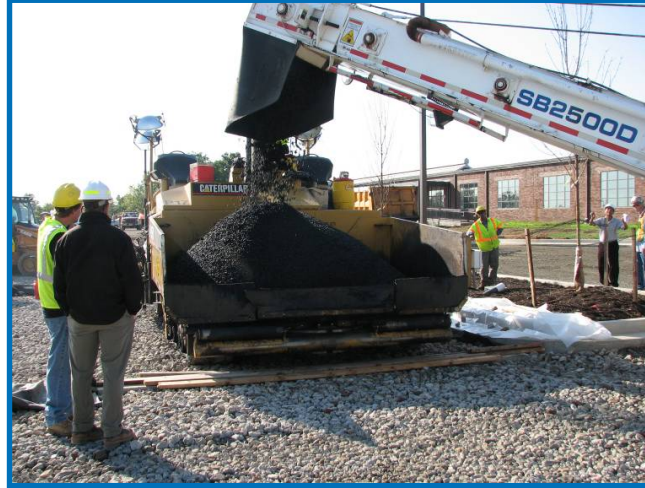
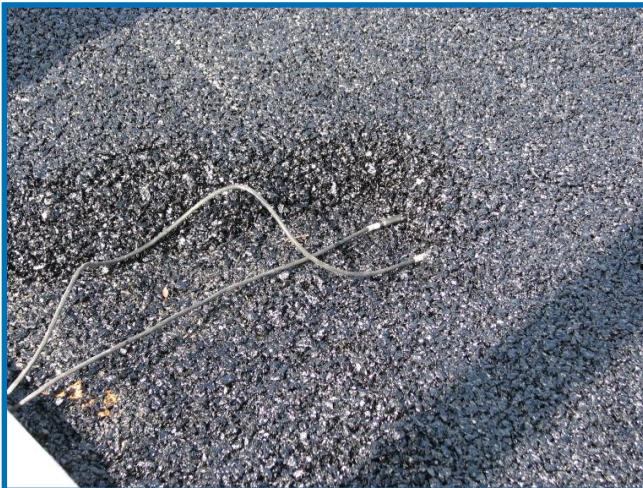
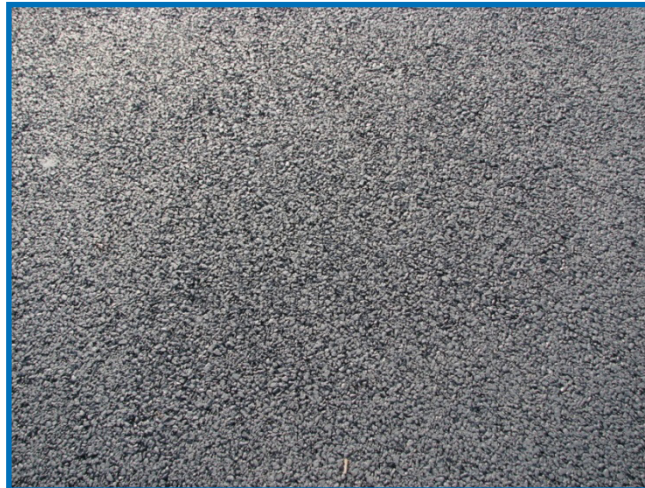
Placing the porous asphalt (PA) took two days.

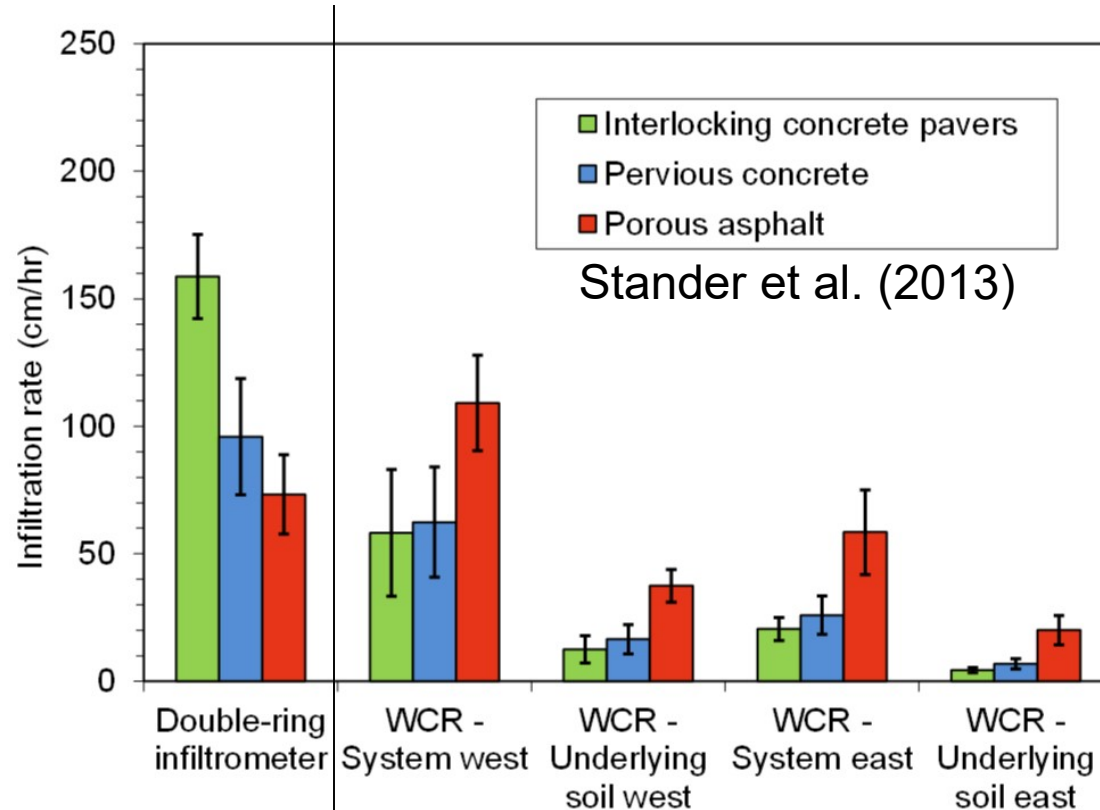
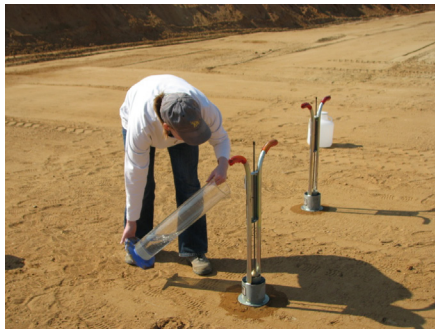
Underlying Pre-construction Soil Infiltration Testing Compared to Post-construction In-situ Moisture Measurements

Pre-construction infiltration test

Post-construction soil moisture measurements

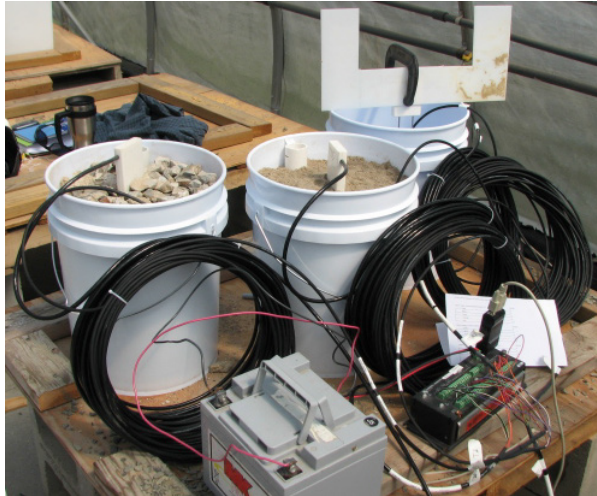
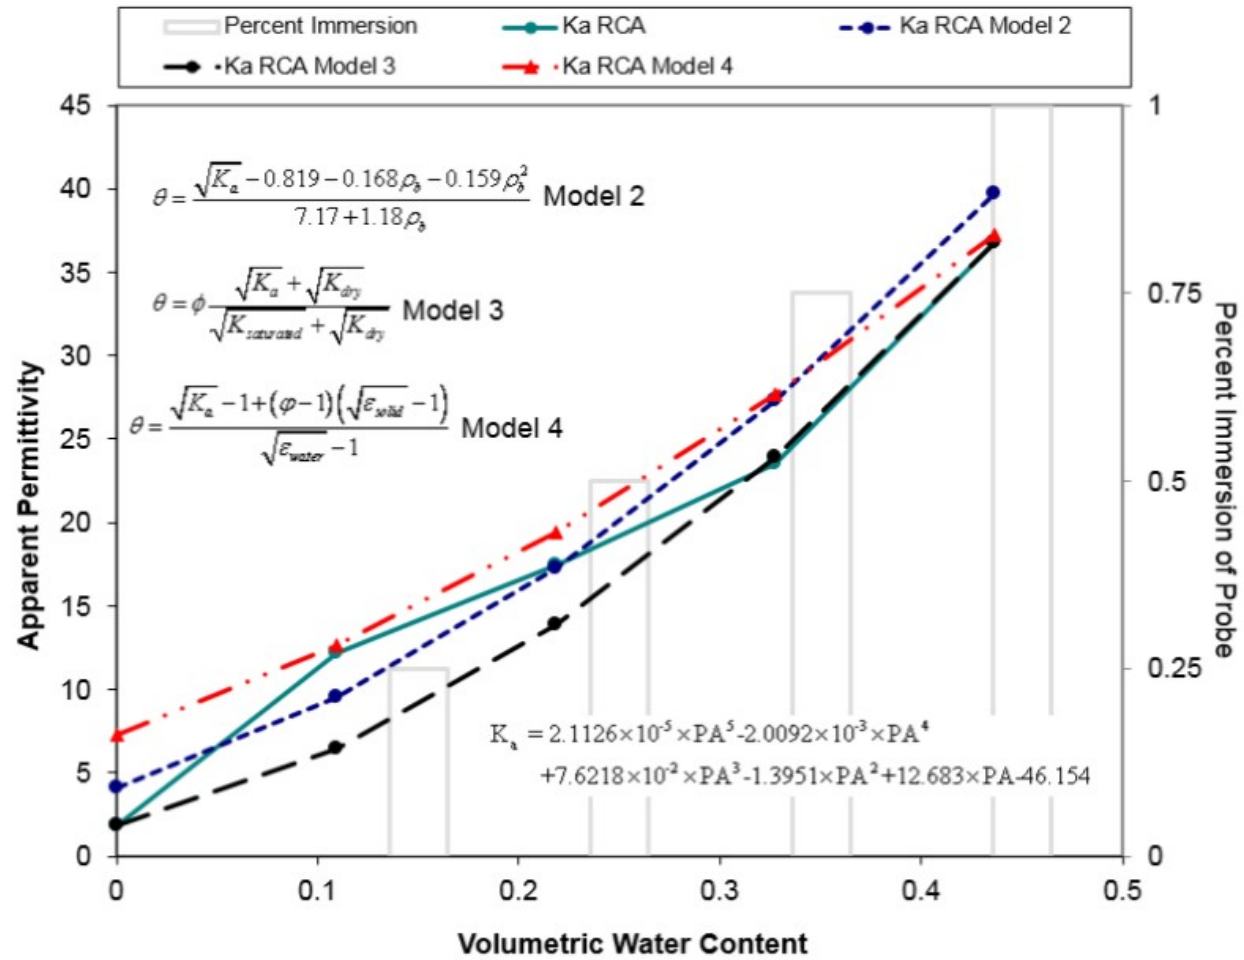
Calibration of Water Content Reflectometers in Large Aggregate

**Calibration led
to interpretation
of data – on
afternoon of 3/13/10
> 19% water content
or > 10 Ka apparent
permittivity implies
saturation or
inundation in
portion of storage
gallery.**

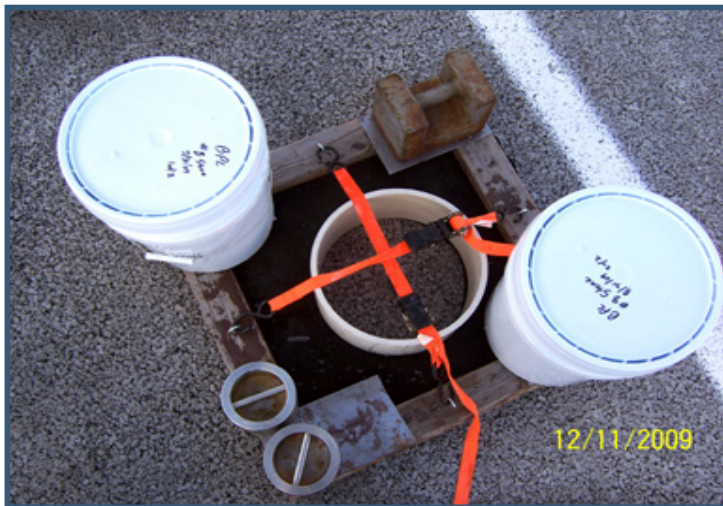
Initial Surface Infiltration Rates

Modified ASTM C1701 apparatus

Surface type	Initial surface infiltration rate (cm/hr \pm 1SD)	Literature reported infiltration rate (cm/hr)
Permeable Interlocking Concrete Pavers	2440 \pm 305	2000 (Bean et al., 2007)
Pervious Concrete	4220 \pm 876	4000 (Bean et al., 2007)
Porous Asphalt	147 \pm 43	430 (Ferguson, 2005)

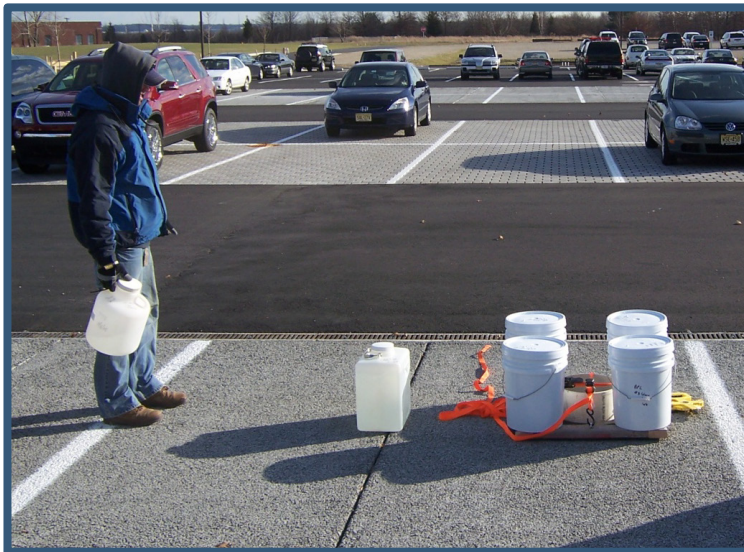
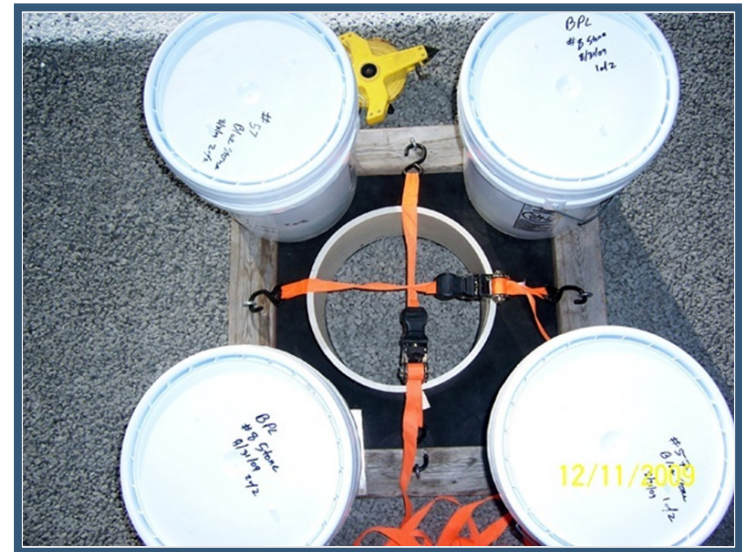
Measured surface infiltration rates using modified version of ASTM C1701 at monthly intervals for three years.

Modifications were:

- (1) how the seal was achieved between the ring and the surface;
- (2) added temperature measurements of surface and water.

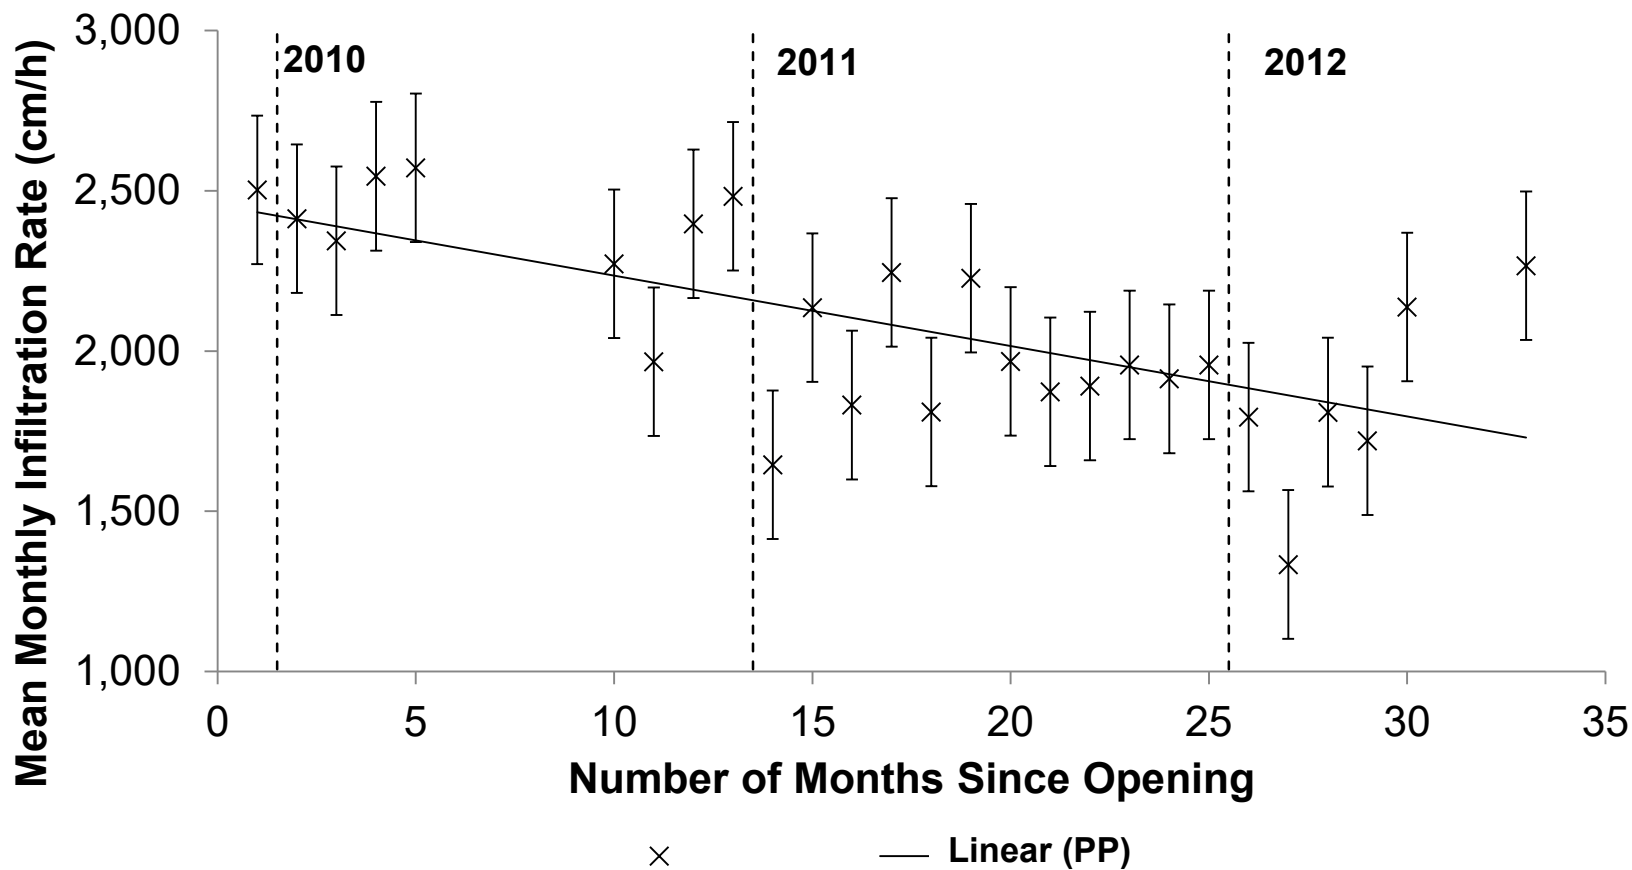
Infiltration decreases with time for surfaces that receive runoff from driving lane.

Error bars represent standard error.

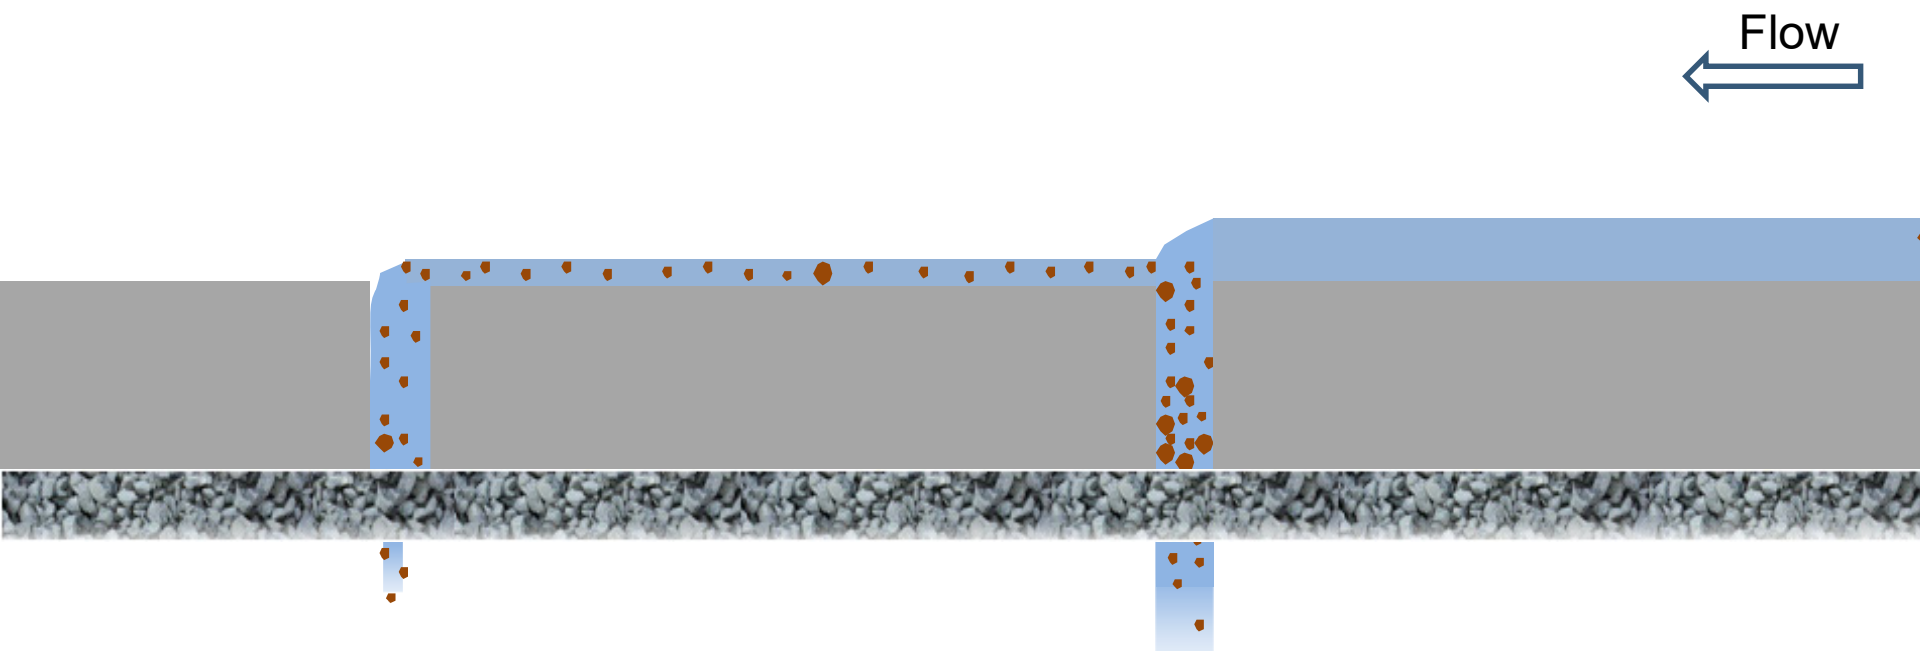
Hypothesis of the mechanics of the infiltration/clogging processes.

**As gaps fill with sediment,
location of highest infiltration
area move downgradient.**

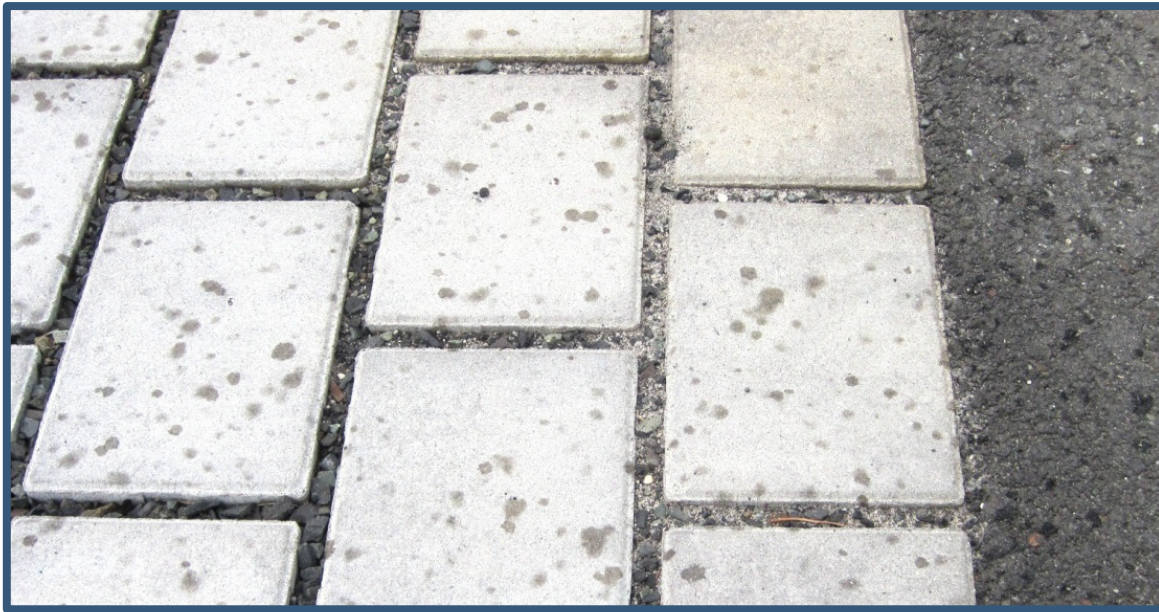
Sediment accumulates (and clogging progresses) from the upgradient edge.

No sediment

Sediment

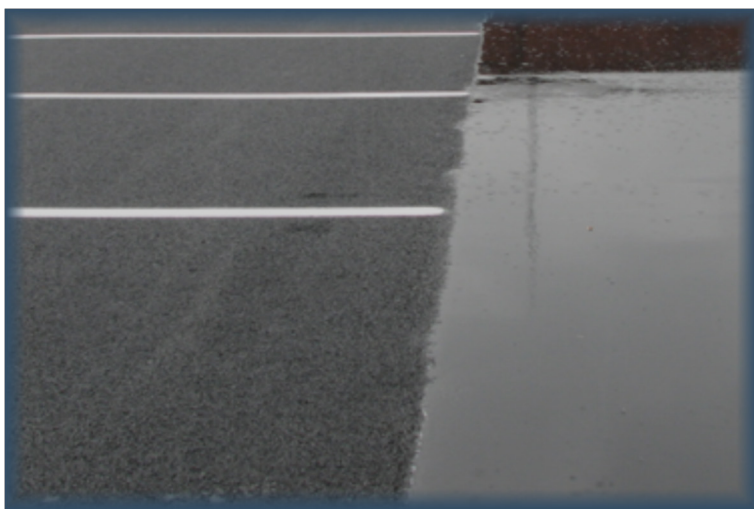
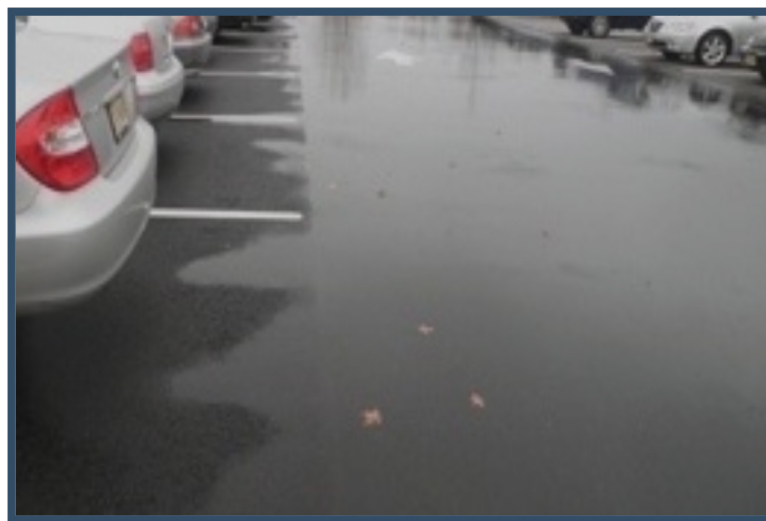
Inspection of porous asphalt supports proposed mechanism.

After installation

After use

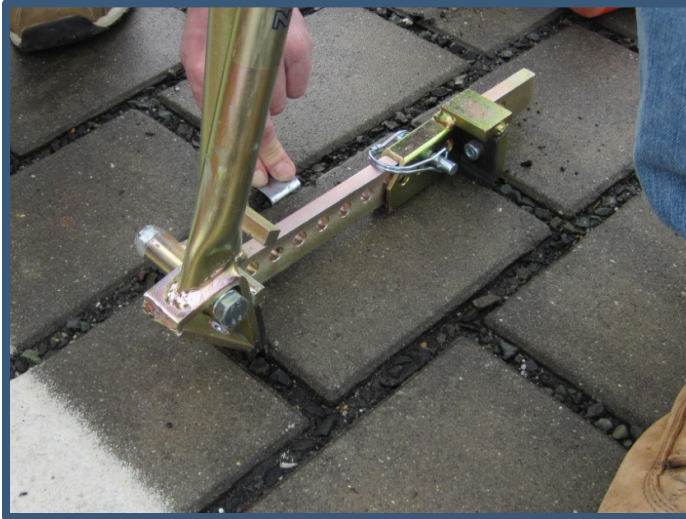
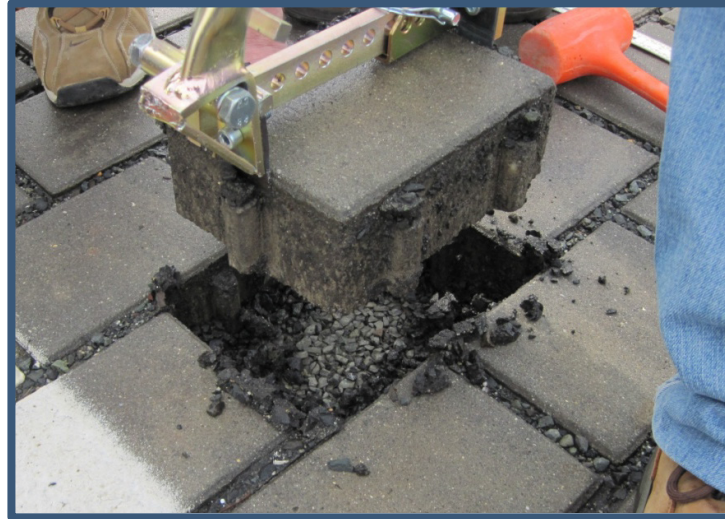
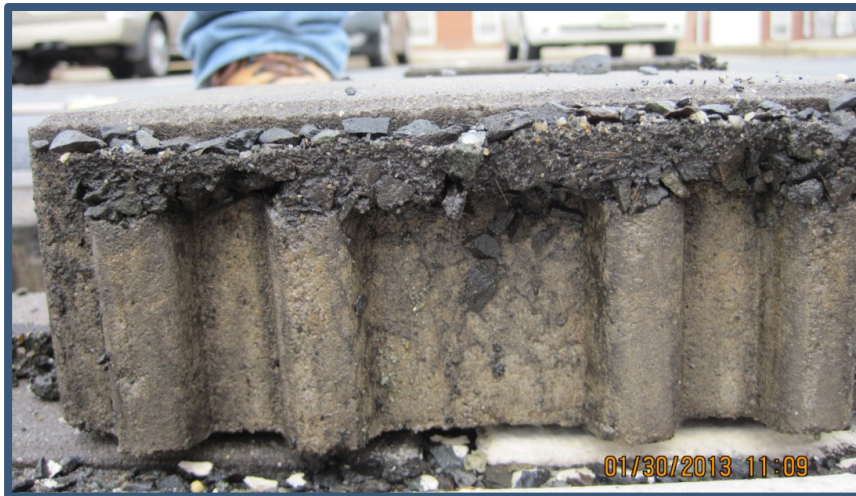
Removal of pavers shows how clogging advances filling gaps with fines.

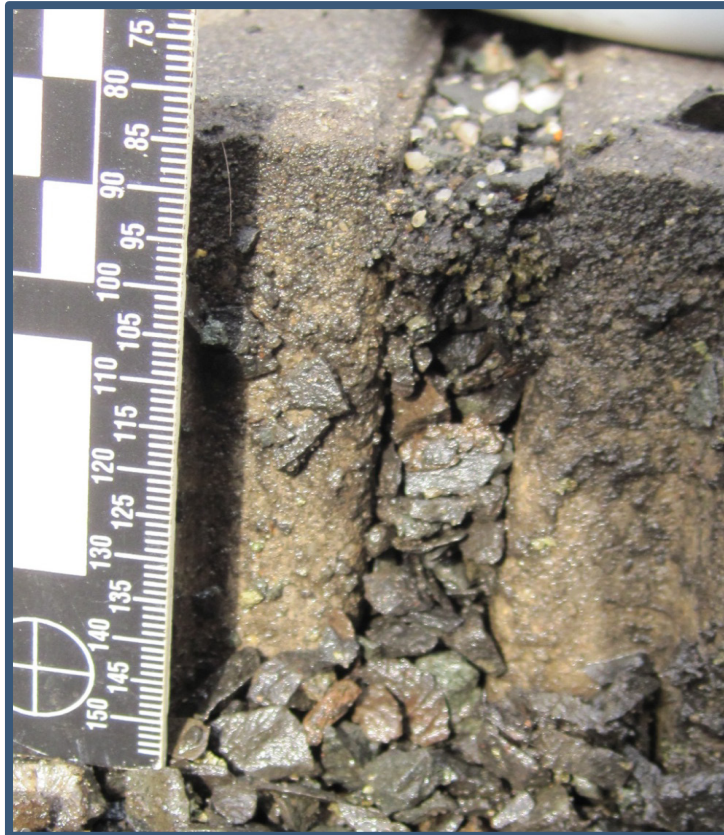
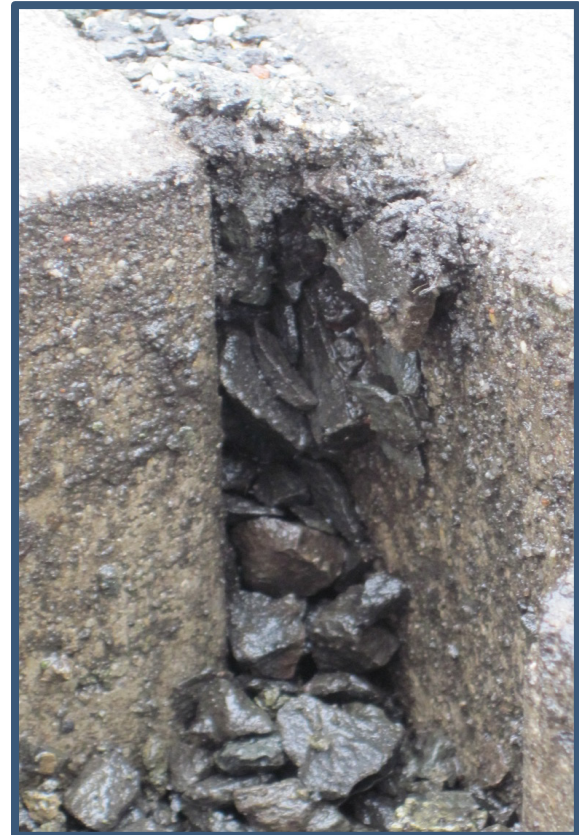
**With aggregate between the pavers,
most fines are trapped
in the top 20 mm.**

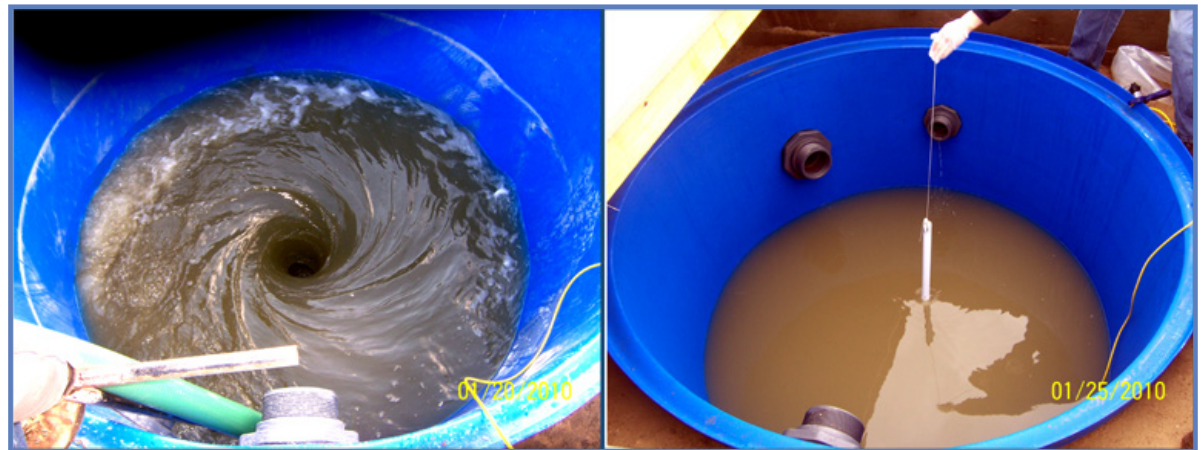
1,500-gallon collection tanks

The permeable pavement parking lot at the EEC allows evaluation of water quality effects.

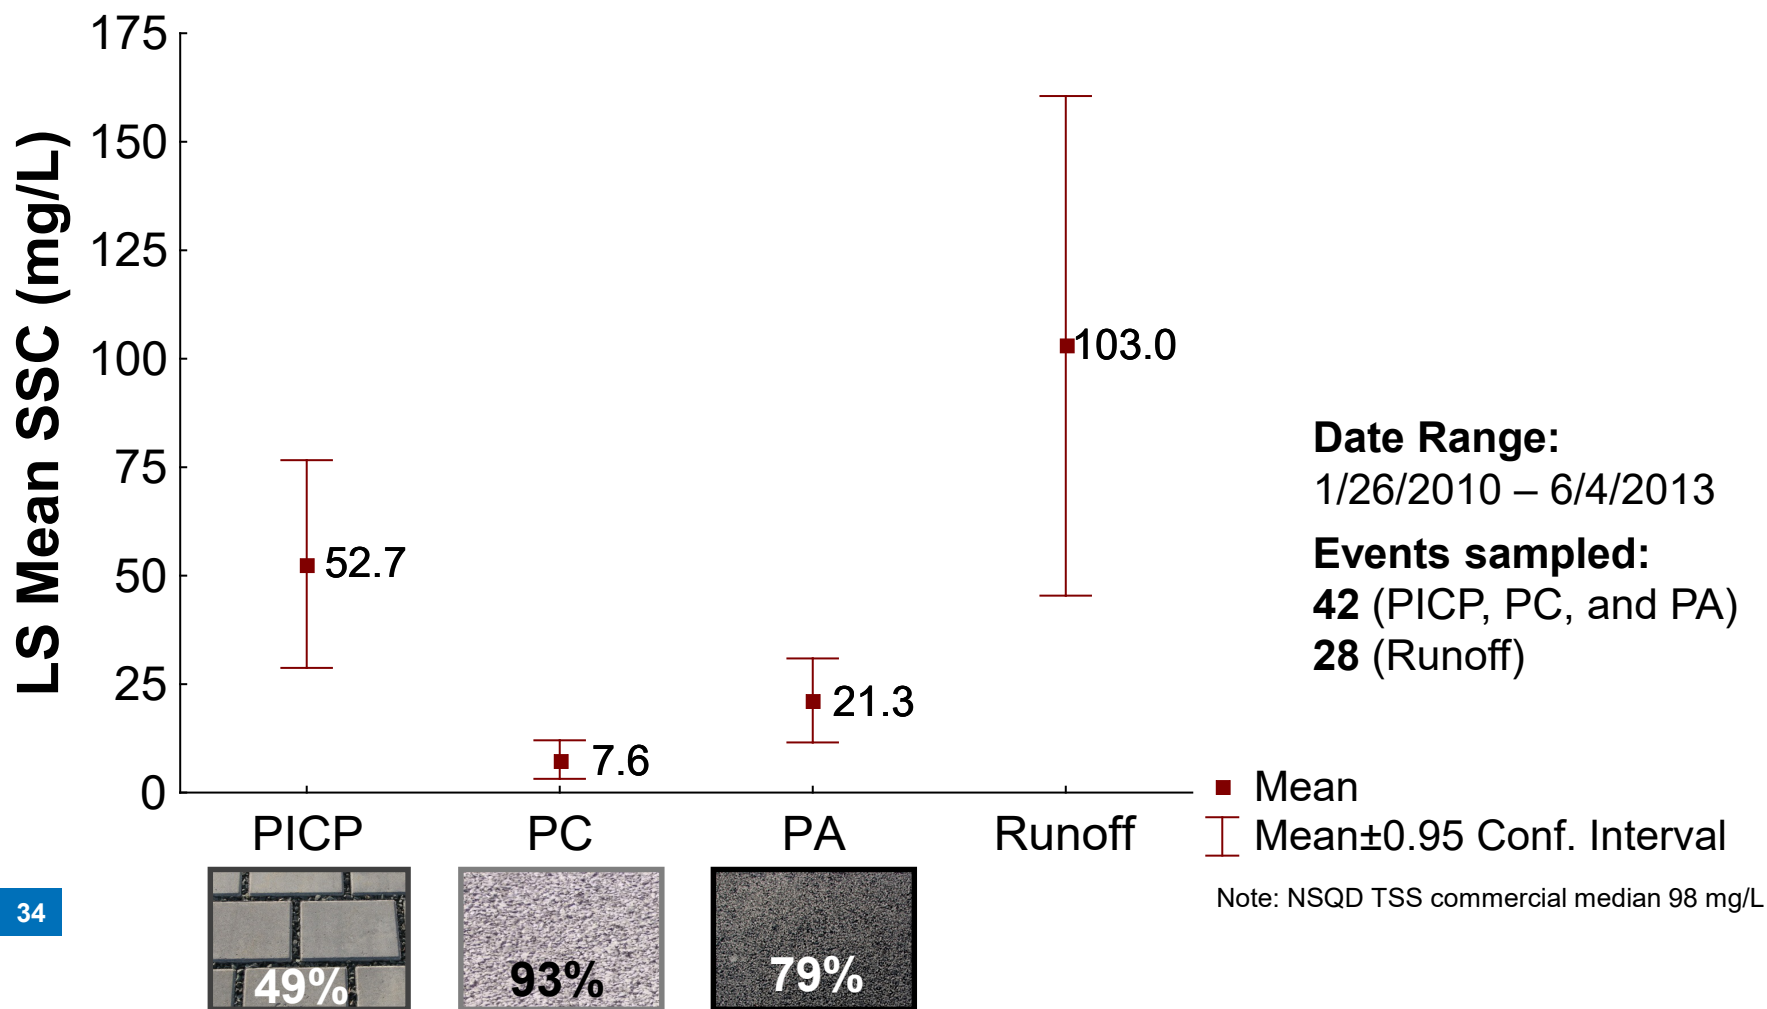
All permeable surfaces reduced suspended sediments concentration (SSC).

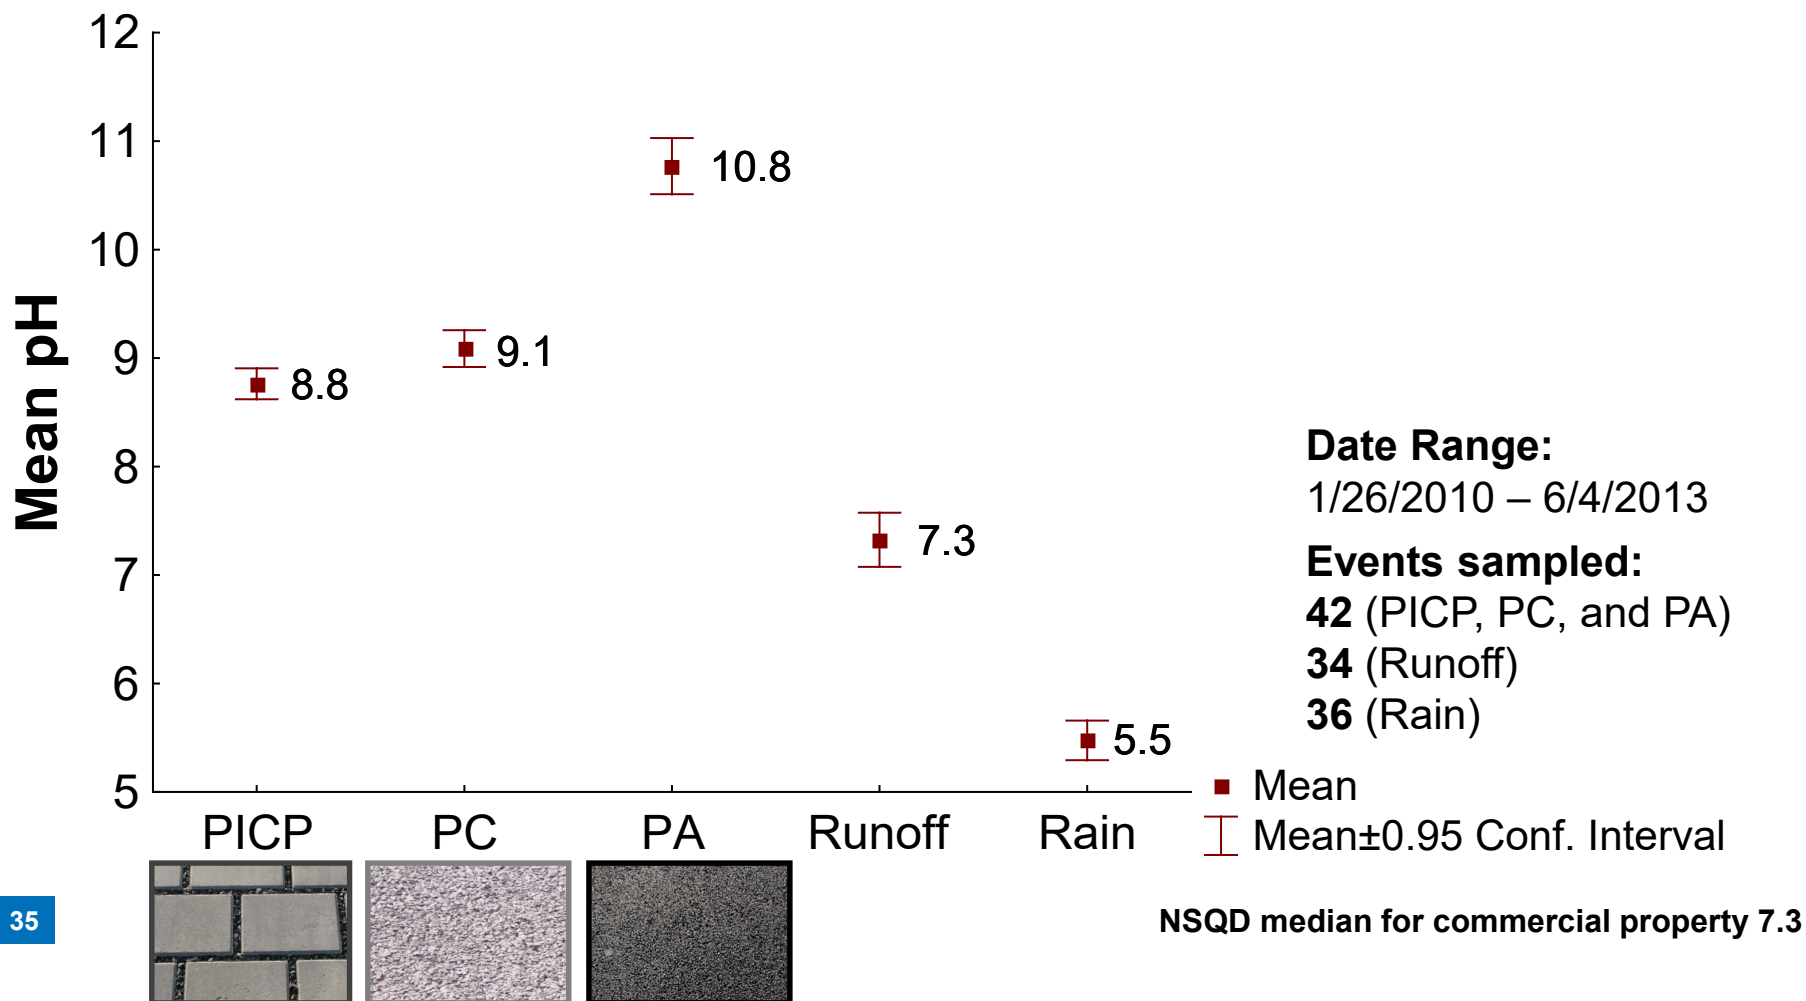
Acidic rainfall is buffered by all pavement surfaces, and PA exfiltrate is surprisingly basic.

Mean pH per surface per sampling event over time

- Asphalt emulsions are suspected cause of high pH.
- Specifications for porous asphalt called for asphalt mix between 4.0% and 4.5% asphalt and addition of a liquid anti-stripping agent.
- Anionic emulsions have pH range of 10 to 12 (Transportation Research Board, 2006) which is range of pH observations for the PA infiltrate.
- Alternatively asphalt emulsions can be cationic with correspondingly acidic pH (e.g., pH 1 to 4) (Transportation Research Board, 2006).

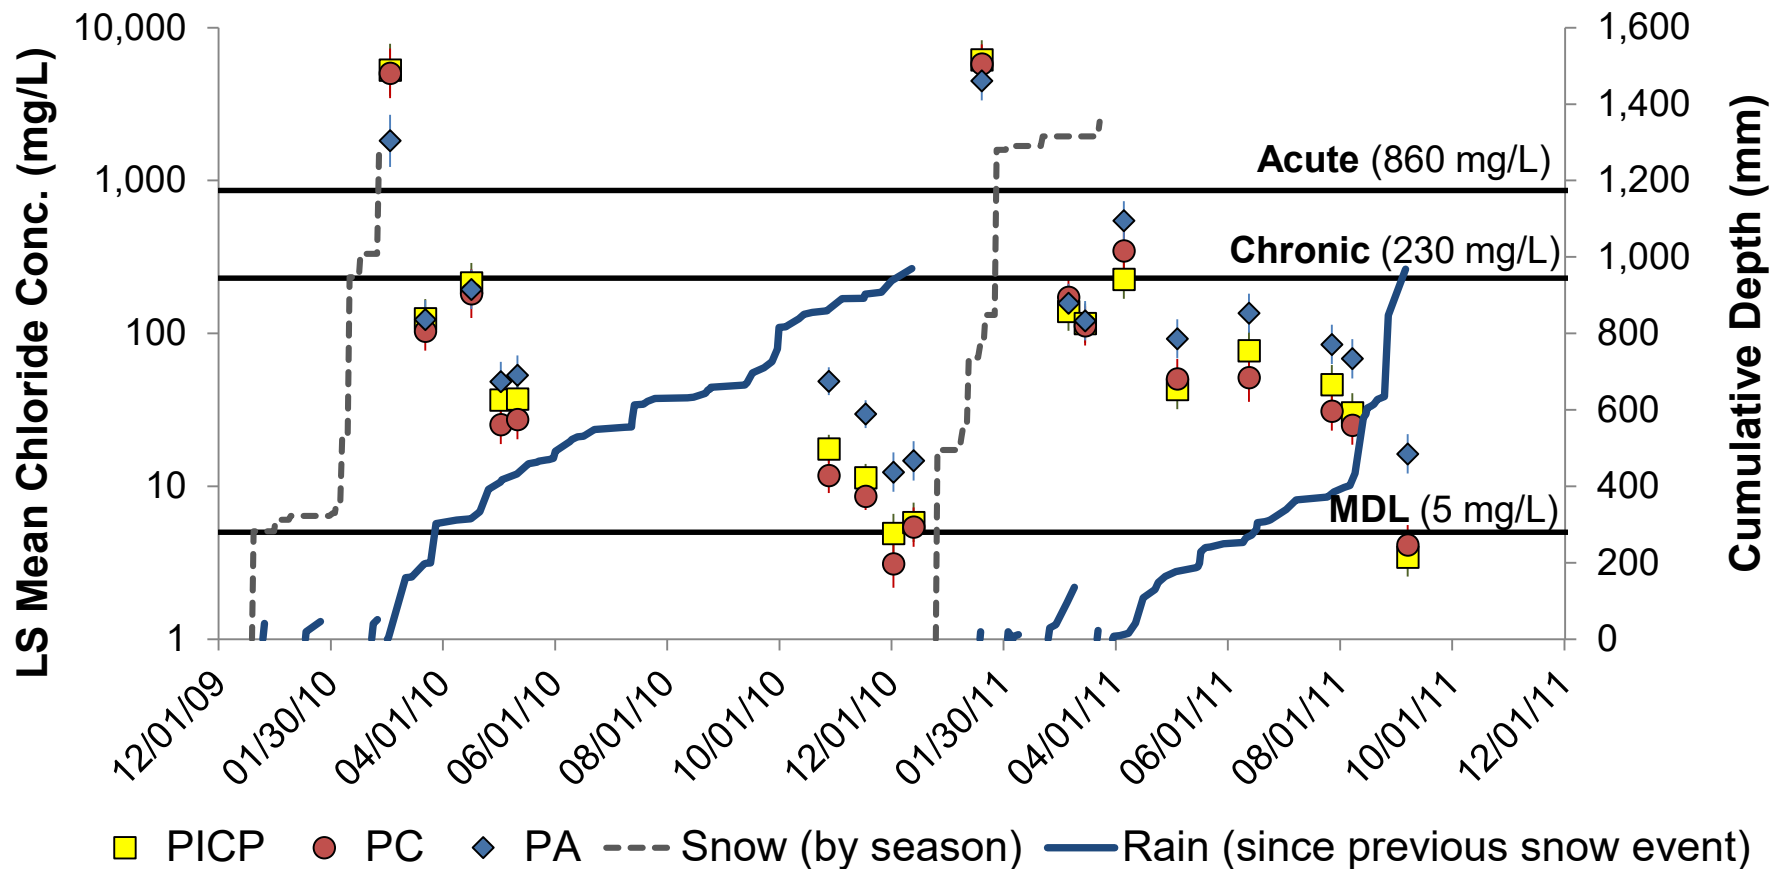
Winter salt application leads to observed chloride concentrations with annual rainfall.

- Chloride concentrations of infiltrate exceeded acute toxicity for freshwater aquatic life (>860 mg/l) in rain events immediately following salt application.
- Chloride concentrations exceeding detection limit (> 5 mg/l) throughout remainder of the year, but did not exceed chronic toxicity threshold (>230 mg/l) after April.
- Porous Asphalt had the slowest release, chloride persisted at larger concentrations in samples collected after April.
- Annually, mean infiltrate concentration observed was largest for the PA pavement.
