Green Infrastructure at the Edison Environmental Center - Permeable Pavement

*Thomas P. O'Connor, P.E., BCEE
Environmental Engineer
Water Resources Recovery Branch
Water Systems Division
Edison, NJ*

Permeable Pavement and Bioinfiltration Research and Demonstration Site

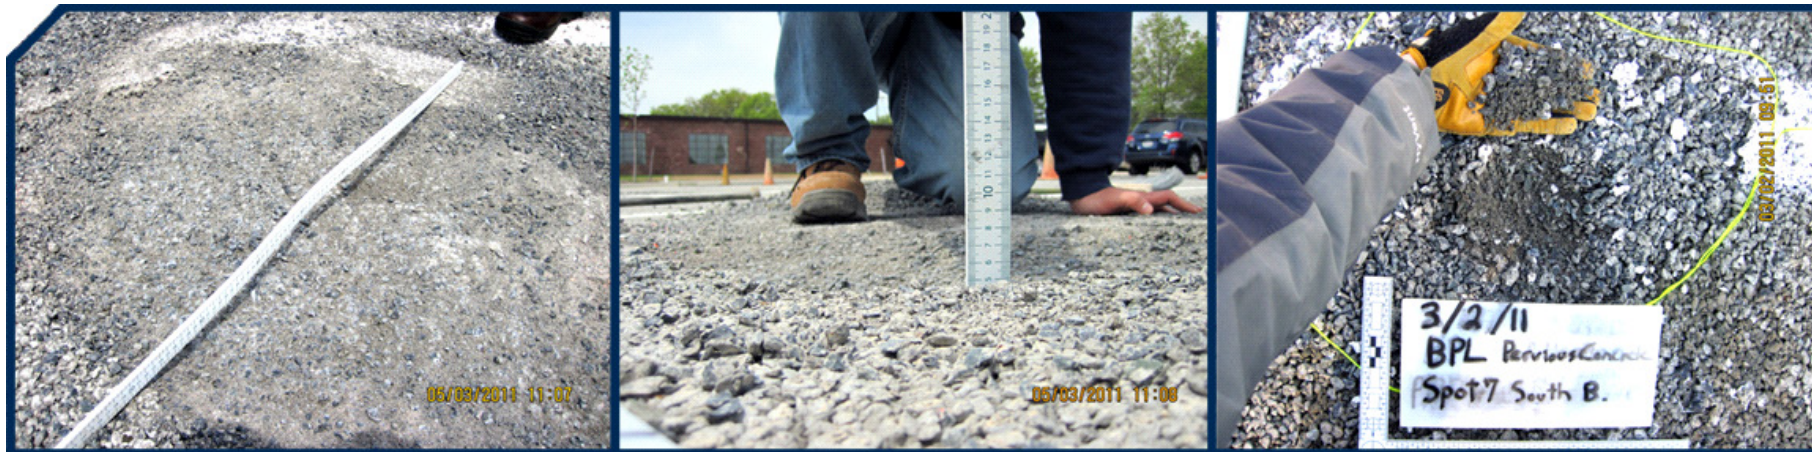
Disaggregation of Pervious Concrete

Large portions of the pervious concrete disaggregated. The problem first became apparent about 18 months after pouring concrete. It was repaired by the contractor in May 2011, but has recurred more extensively in 2014.

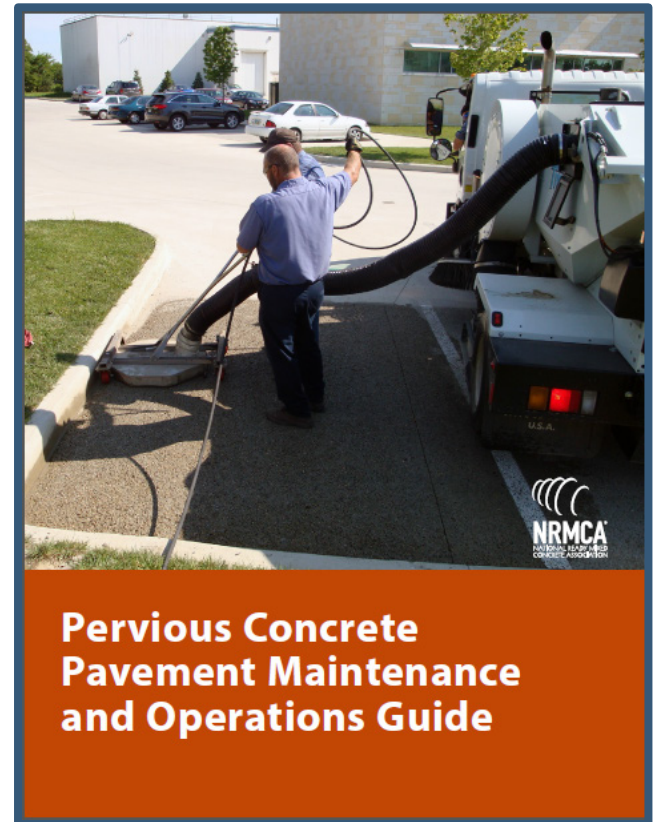
**Pervious Concrete
Pavement Maintenance
and Operations Guide**

National Ready Mixed Concrete Association (NRMCA) revised O&M guidance (2015).

“Deicing chemicals should not be used on any type of concrete in the first year.”

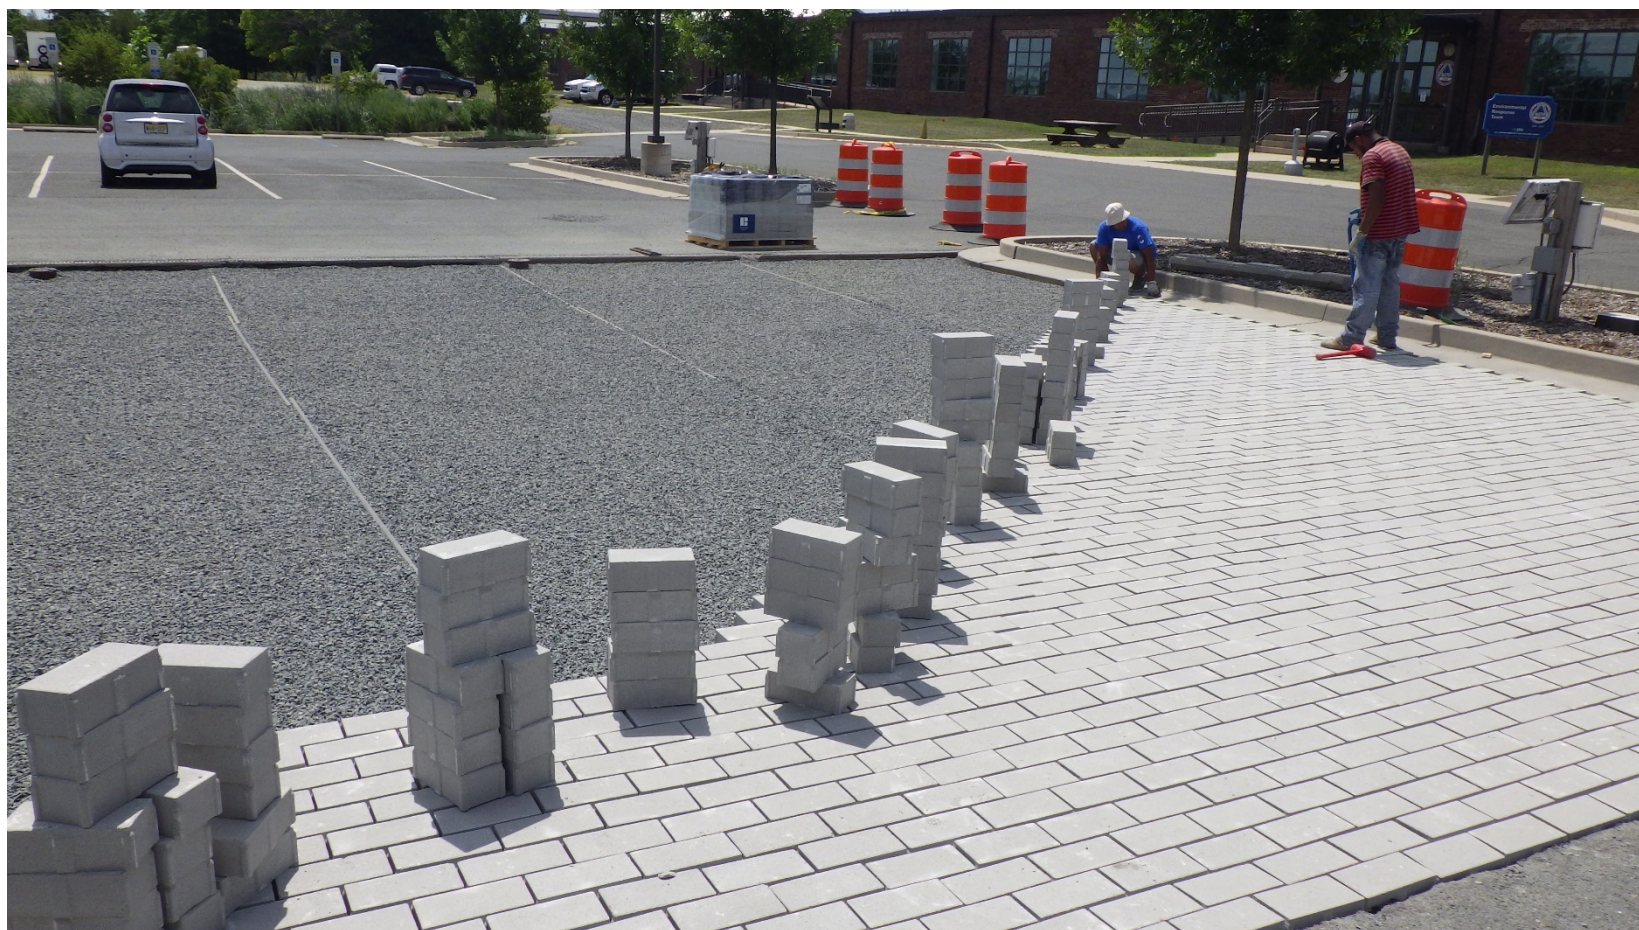
Replacement Surface (2016): Pavers, Compliant with Americans with Disabilities Act (ADA)

Narrower gap
