# **Estimated Summer Hot-Soak Distributions for Denver's Ken Caryl I/M Station Fleet**

## **Final Report Version 8**

Revised by:  
Eastern Research Group, Inc. and  
U.S. Environmental Protection Agency  
December 20, 2013

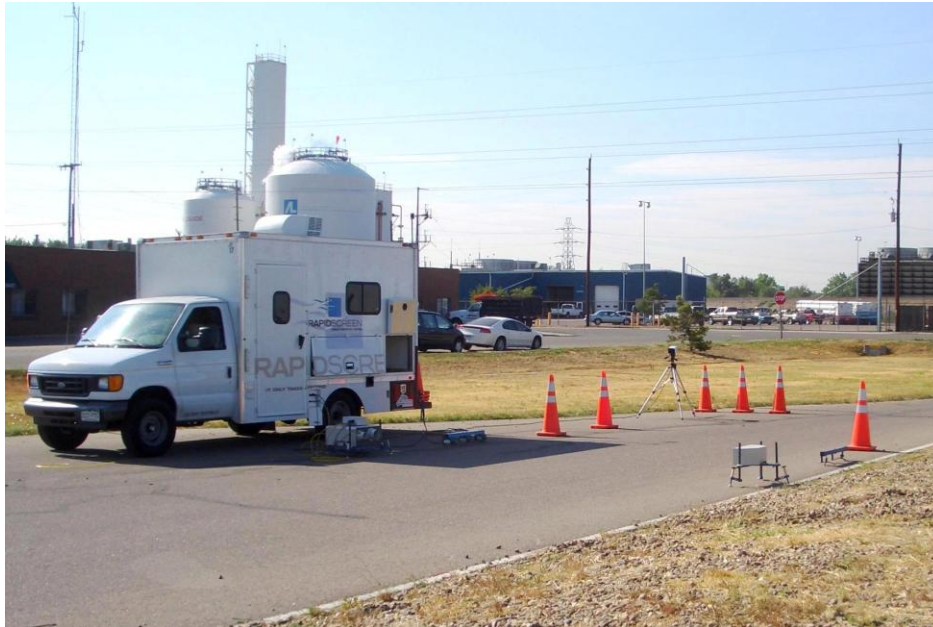
**Figure 3-1. Remote-Sensing Van and Instruments in Operation**

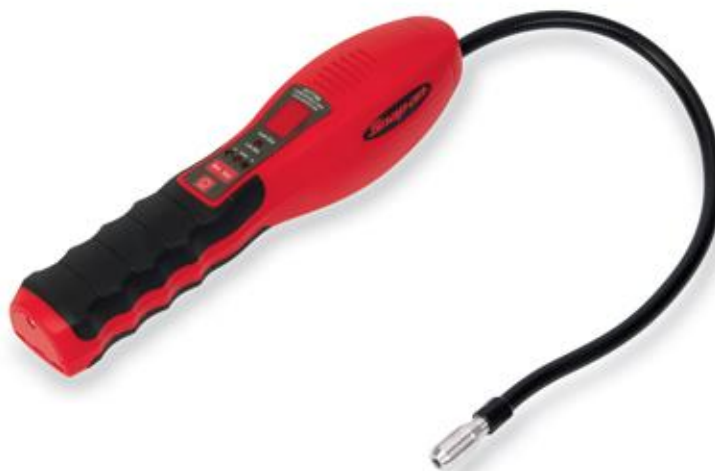
**Figure 3-2. Hydrocarbon Vapor Detector**

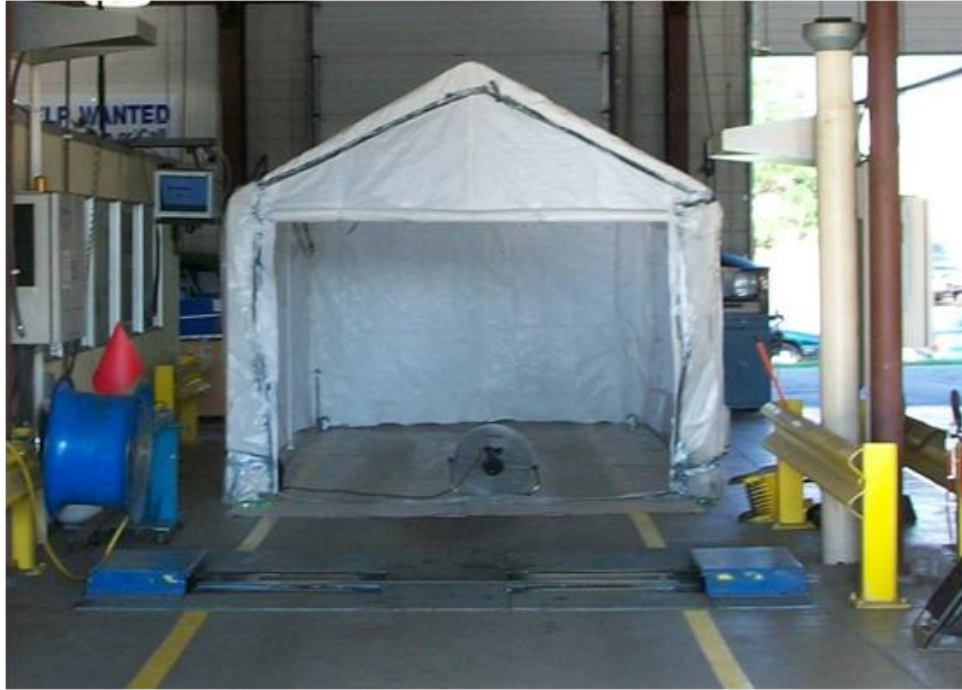
**Figure 3-3. Portable SHED (PSHED) with Door Open**

The PSHED and the test procedure used in this project was designed to mimic the hot-soak portion of the Federal Test Procedure (FTP) used for emissions certification. The full FTP requires several days to conduct conditioning, refueling, and specific tests of diurnal, hot-soak and hot-running emissions. The PSHED procedures resemble the hot-soak portion of the FTP, and were designed to facilitate rapid and cost-effective measurement of emissions from large numbers of vehicles within the I/M facility. Several aspects of the performance of the PSHED are described below.

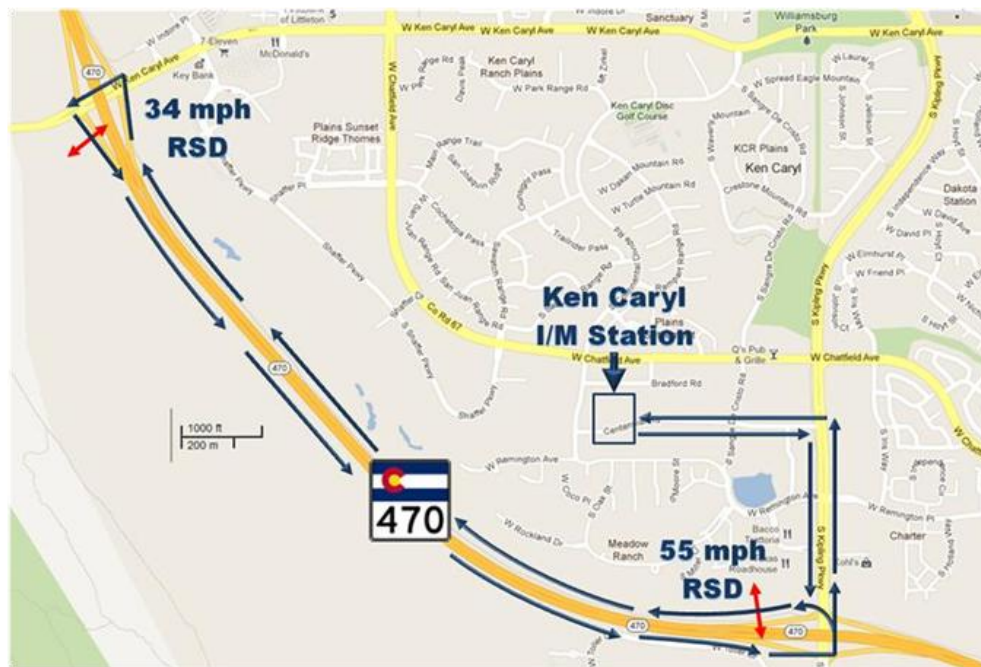
**Figure 3-5. Conditioning Route and Locations of Remote-Sensing Instruments**
