Permeable Pavement Research Highlights

Performance and effectiveness of permeable pavement systems

Michael Borst

Edison Environmental Center
Edison, New Jersey

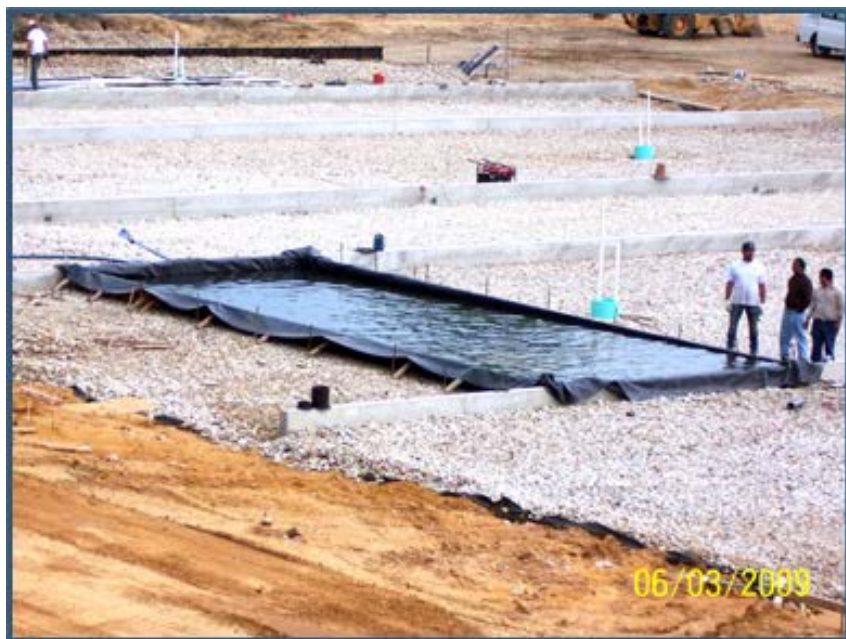
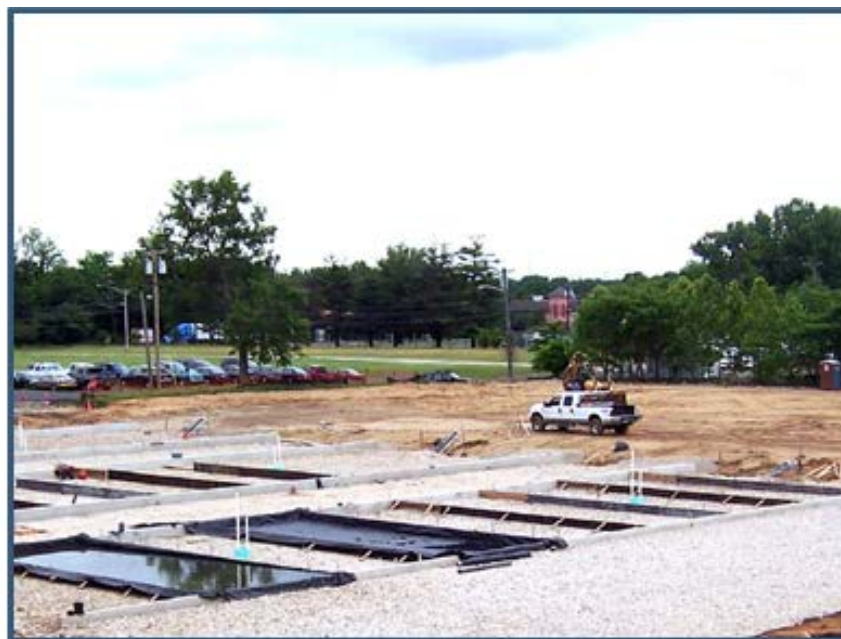
Four equally-sized and spaced lined sections collect infiltrating water from each monitored permeable surface with the balance infiltrating to the underlying soil.

Infiltrate drains from the lined sections to 1,500-gallon tanks on the east side of the parking lot where we can collect samples.

The tanks allow us to collect the entire runoff for rain events through ~38 mm.

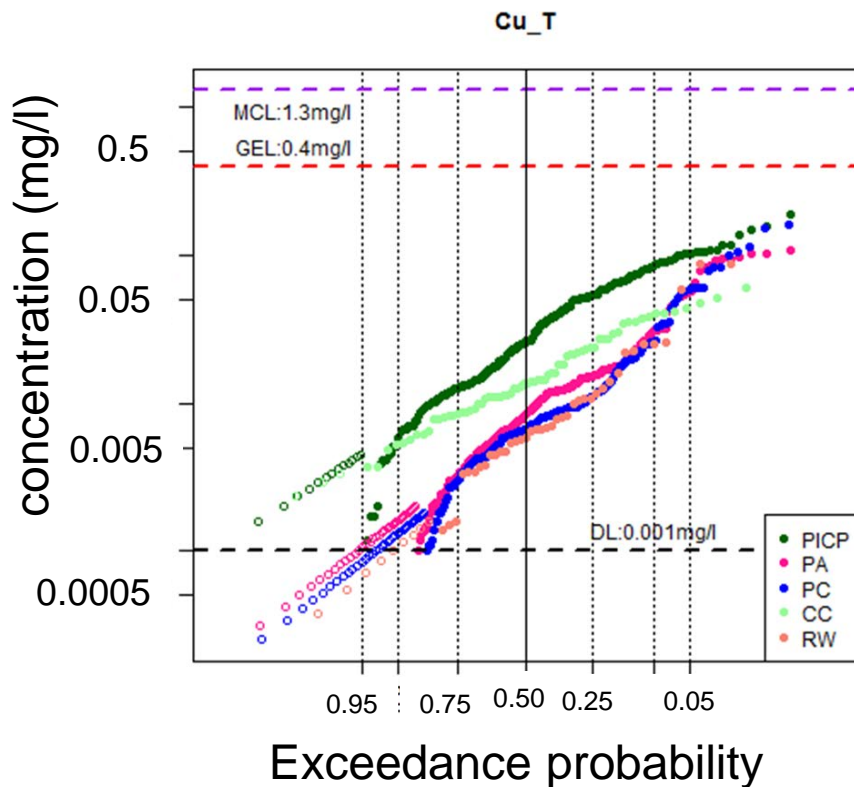
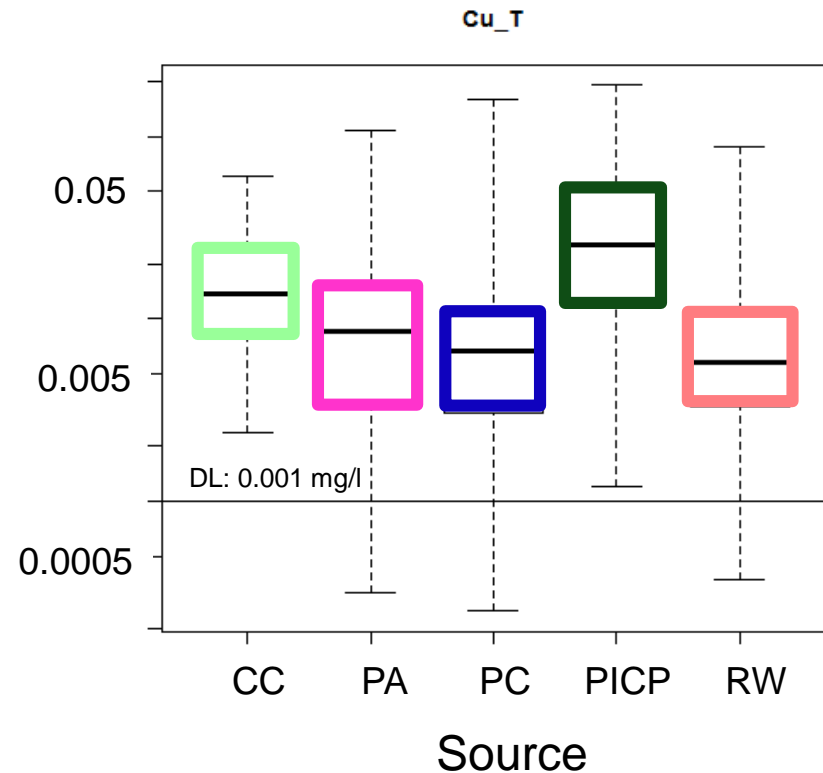
The concentration of priority-pollutant metals were generally less than the groundwater discharge limit.

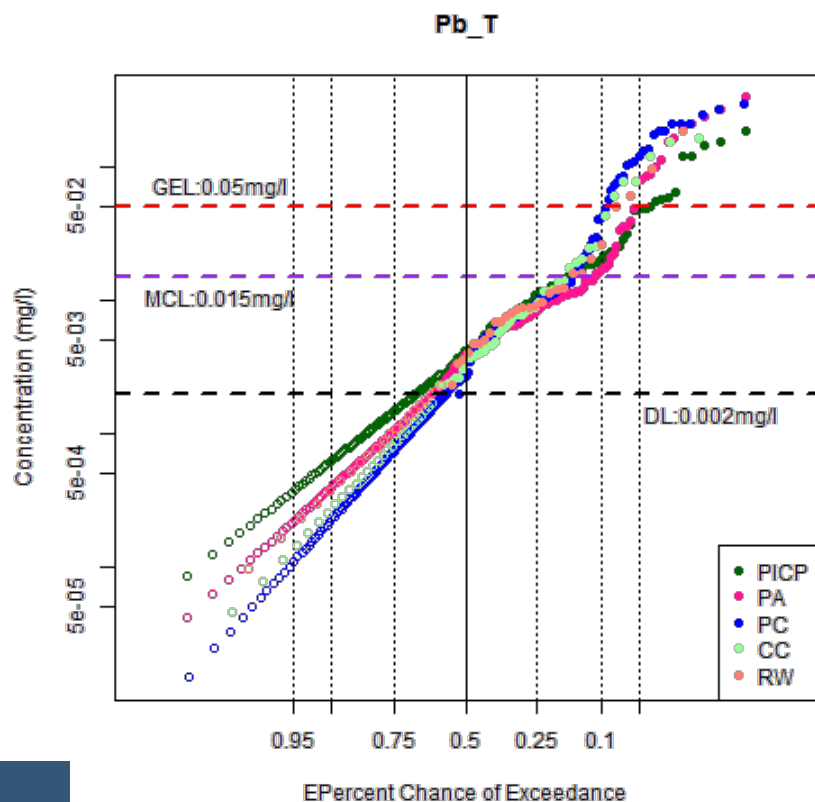
Total lead concentration does not differ across sources and sometimes exceeds regulatory limits.

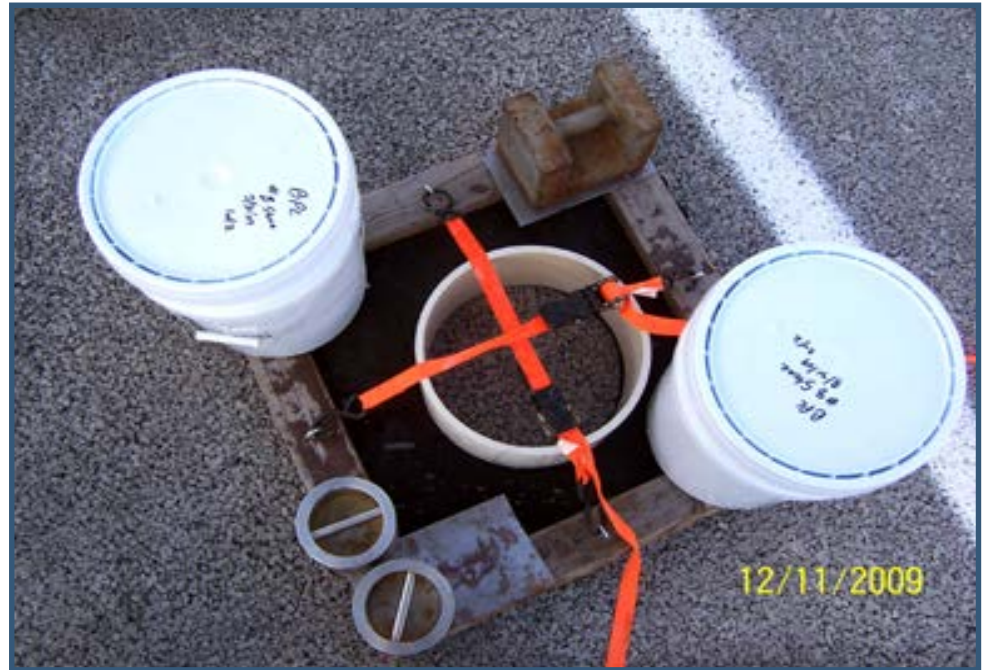
We measured infiltration rate at three randomly selected locations on each half of each surface monthly.

Modified ASTM C1701 apparatus

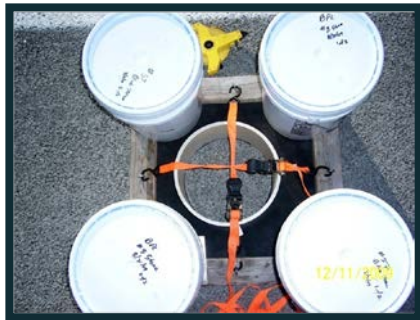
The infiltration rate varies among the four tested surfaces, but all surfaces are sufficient to handle maximum expected direct rainfall rates.

100-year, 5-minute rainfall intensity

- Edison, NJ
20.8 cm/hr (8.2 in/hr)

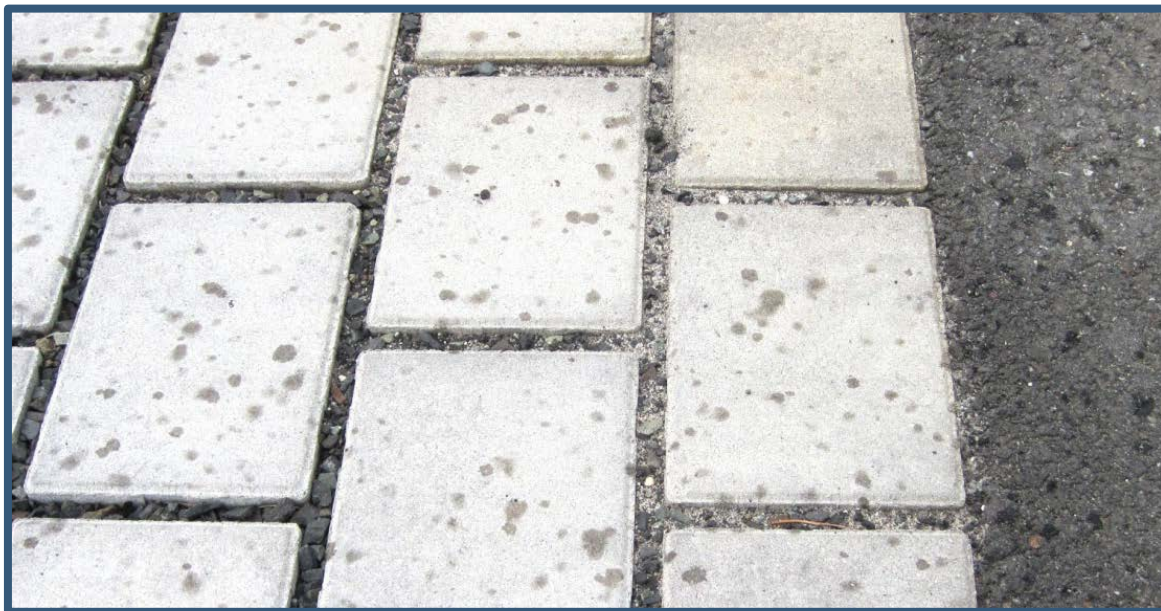
Sediment accumulates (and clogging progresses) from the upgradient edge.

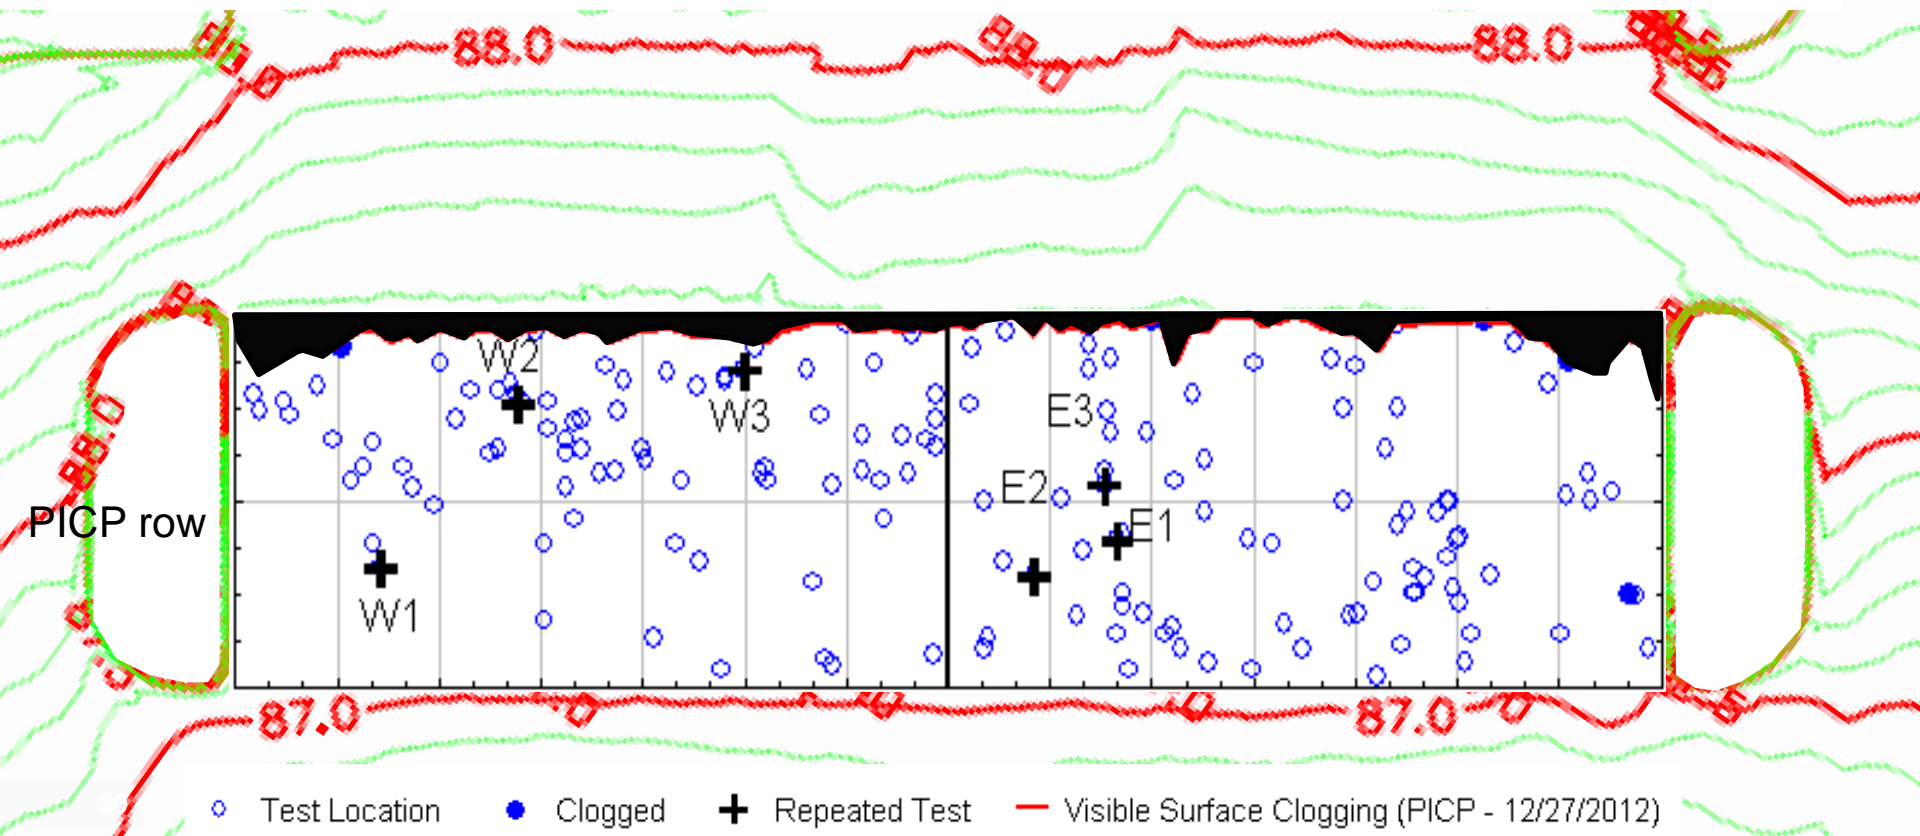
The surface clogging progression varied because of microtopography.

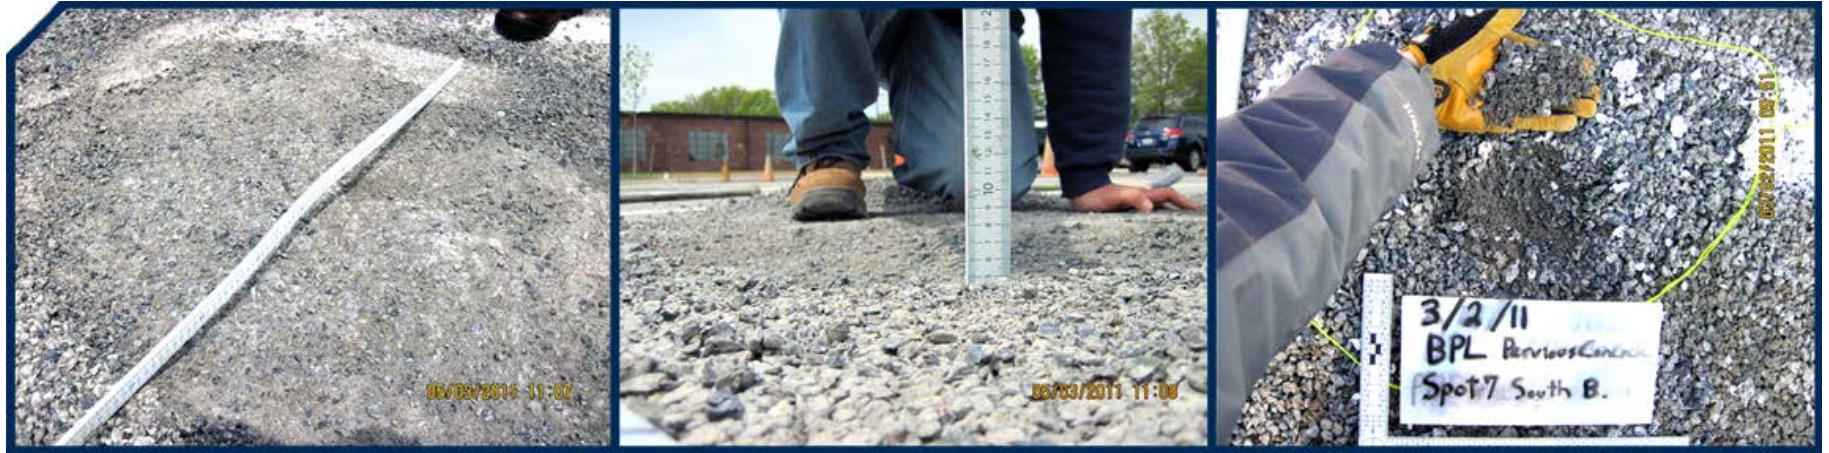
Large portions of the pervious concrete disaggregated.

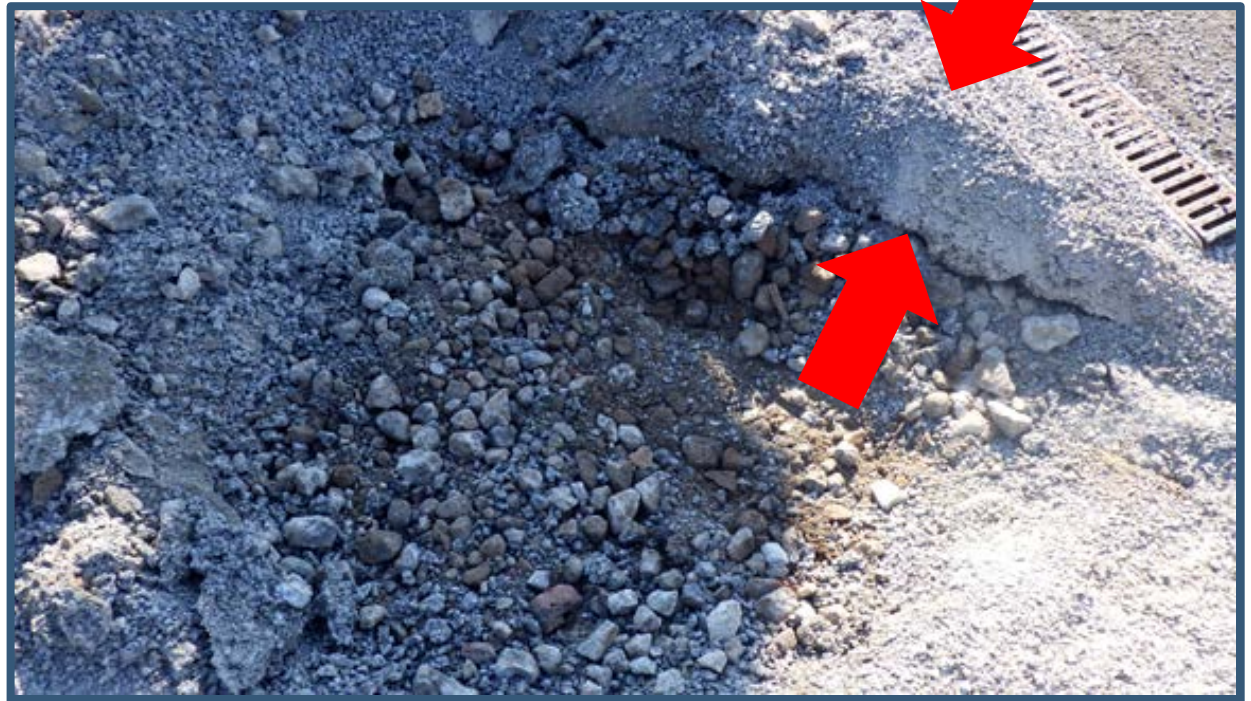
**Although the surface had disaggregated,
there was still substantial material
remaining.**

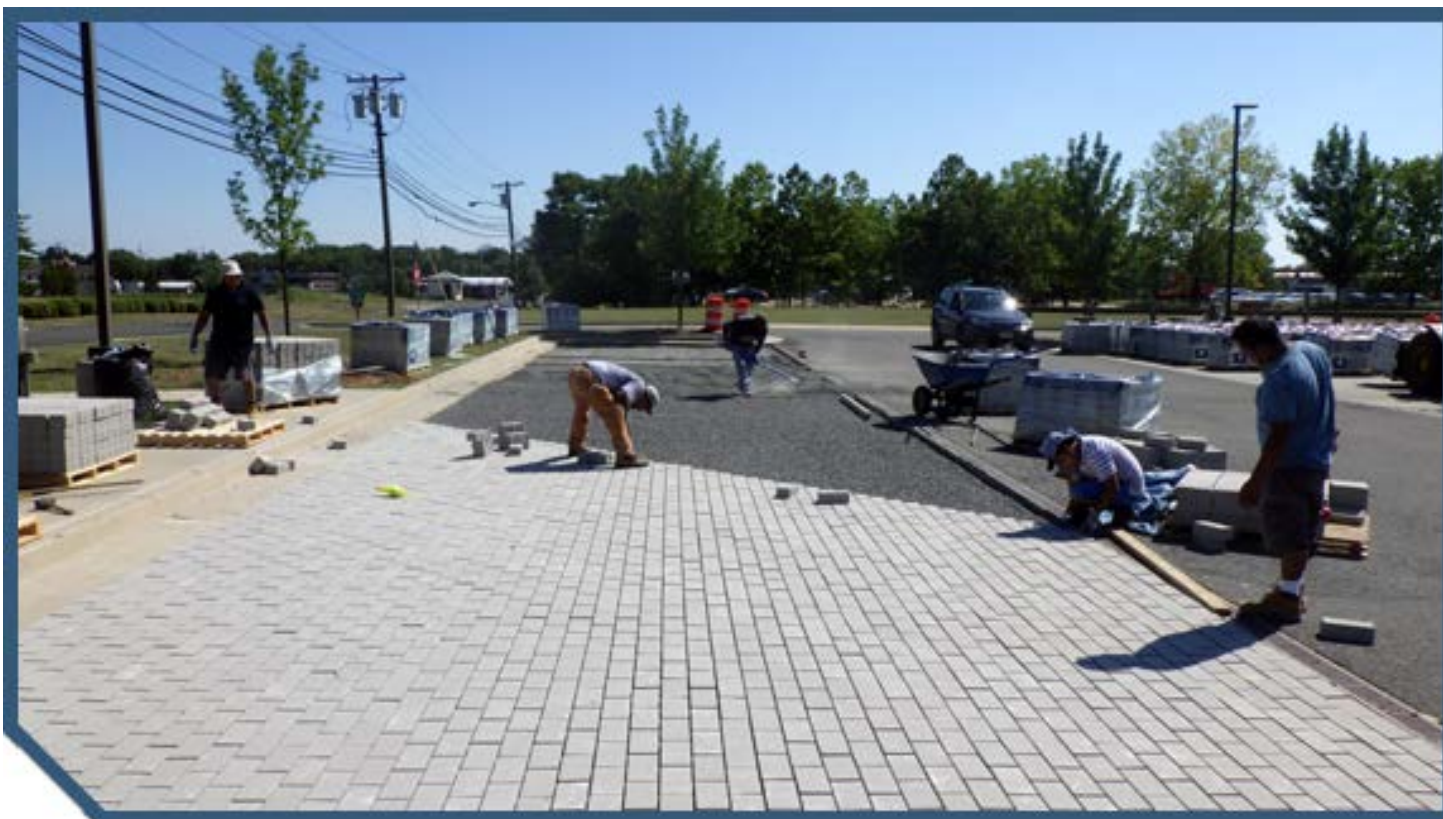
We have replaced the porous concrete sections with pavers.

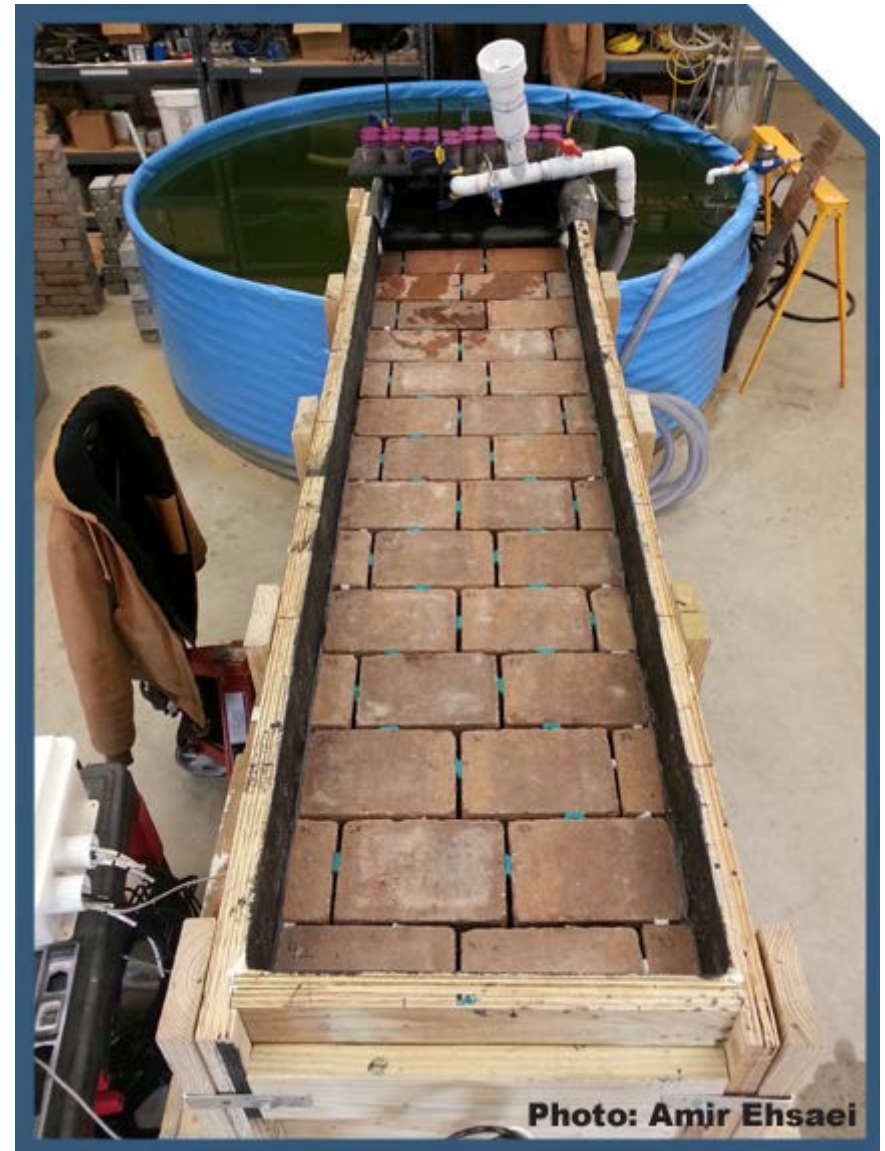
We ran some flume experiments to test the hypothesized mechanisms and influences.

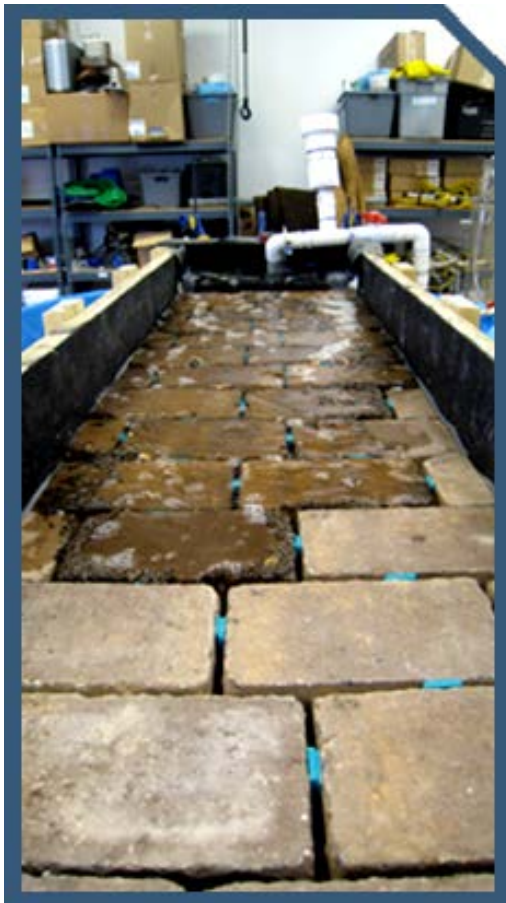
Flume tests show the progressive infiltration of the runoff that leads to the clogging.

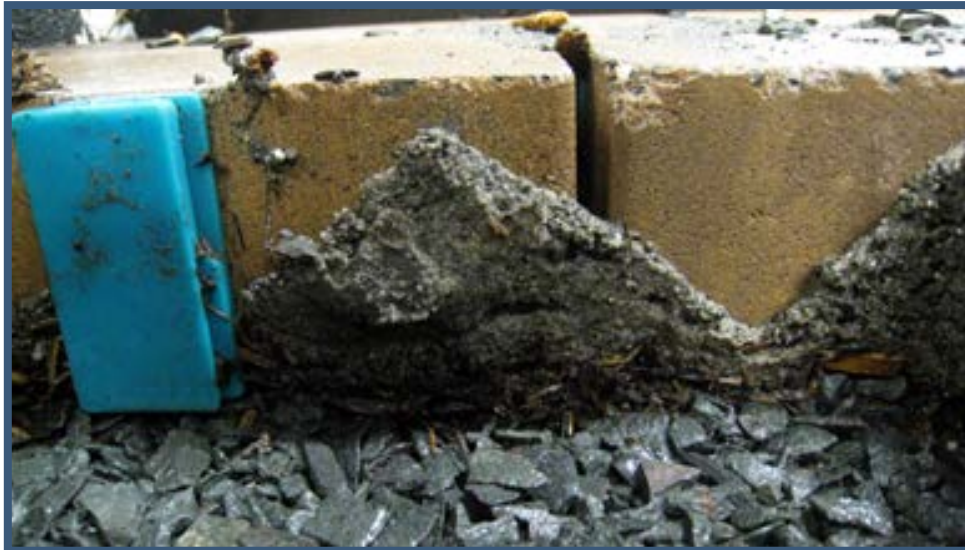
The flume tests are showing the same general pattern of accumulated sediment as observed in the field.

Inorganic material near up gradient edge

Organic material near down gradient edge

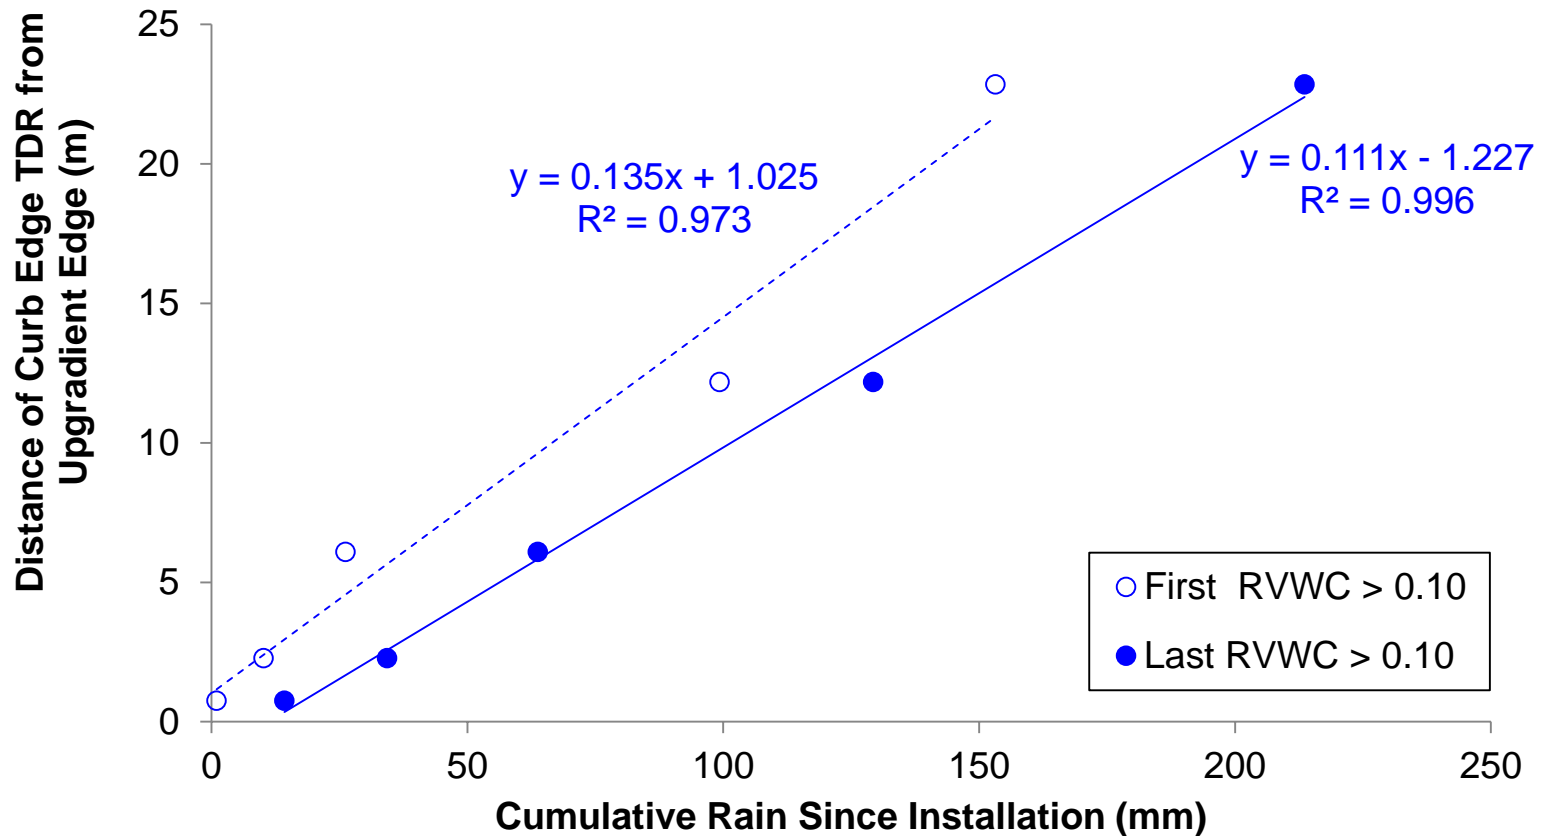
Control Louisville 19G

Installed instruments can be used to determine the control's longitudinal clogging rate.

Response threshold 0.10 RVWC

The initial clogging rate was about 0.123 m per mm (10 ft per inch) of rain.

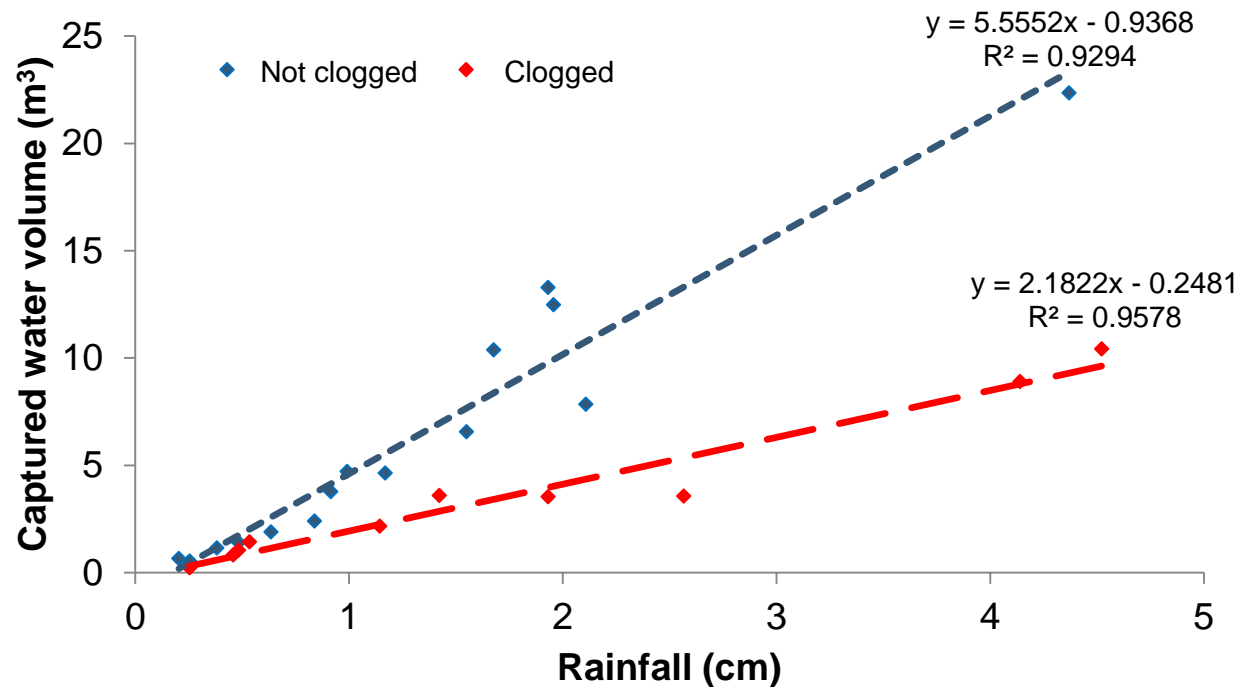
Louisville control 19H
Level data at 1-minute intervals
Rainfall data at 5-minute intervals MSD gauge TR05

Even when clogged, the surface is not sealed.

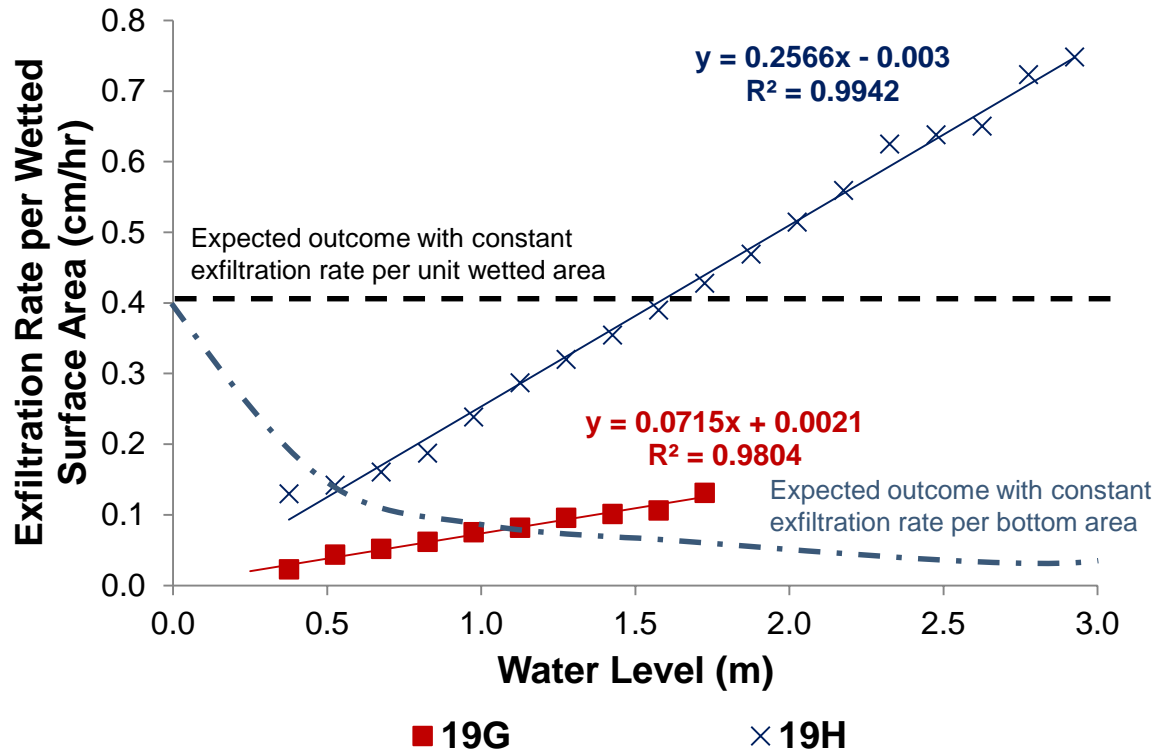
Constant exfiltration across wetted perimeter or base is not supported by the measurements.

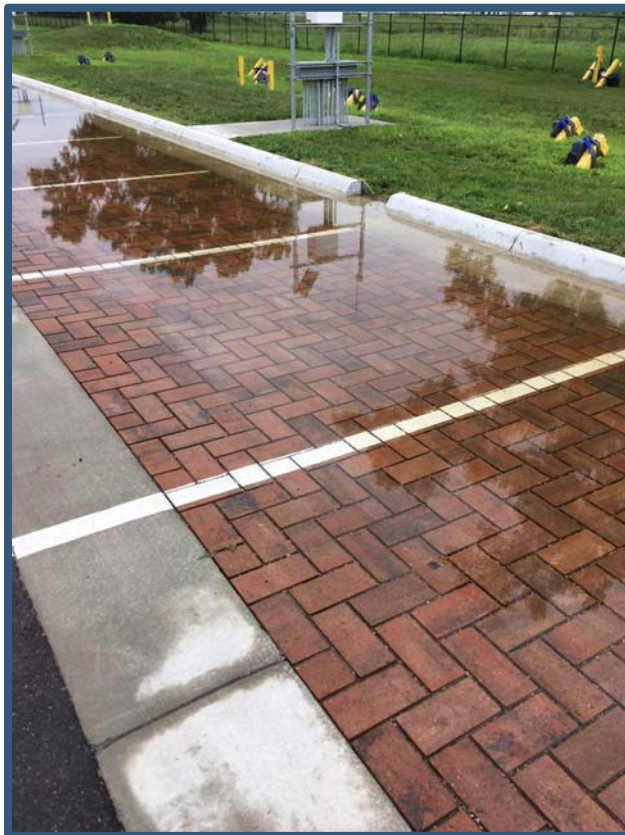
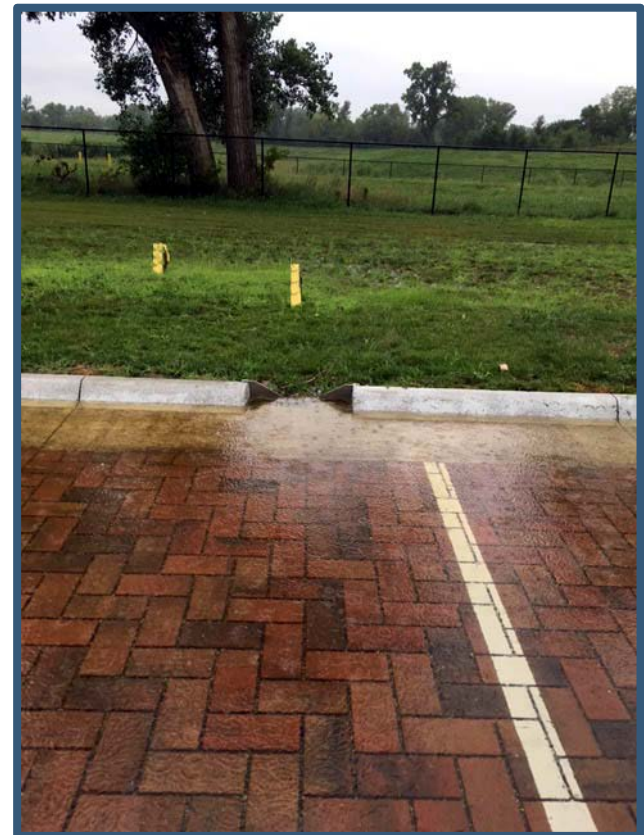
Standing water generally indicates that it is (past) time for maintenance.

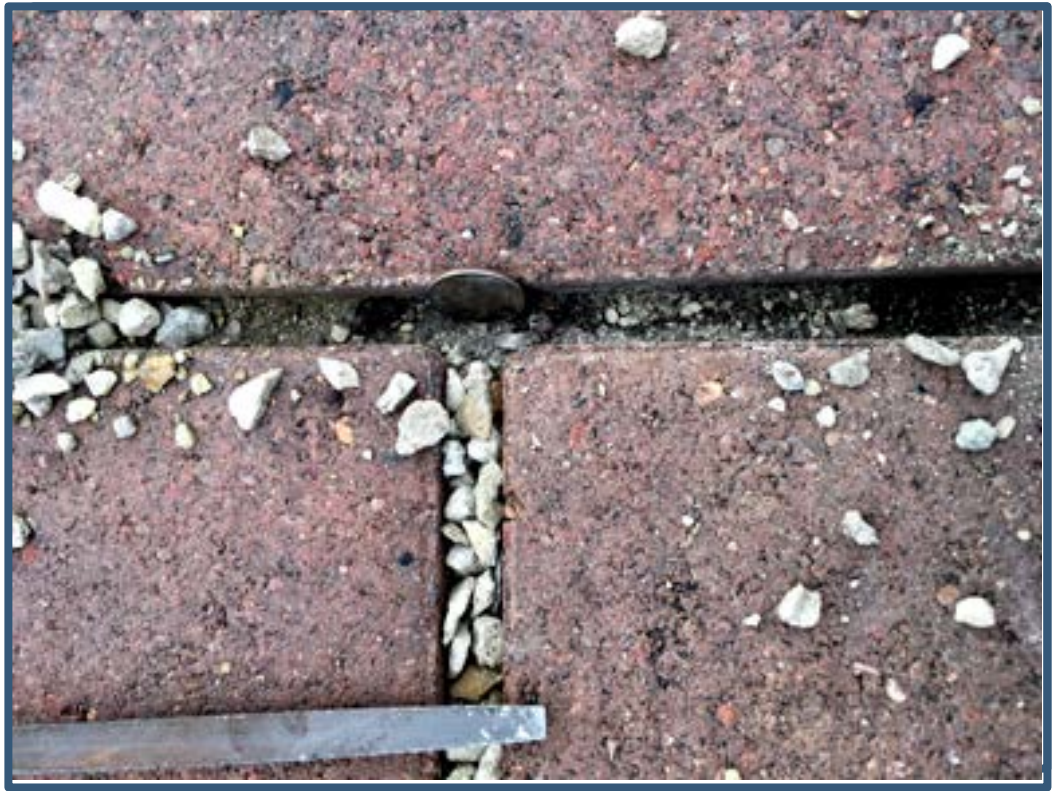
Although clear on the surface, the pathways are clogged at deeper layers.

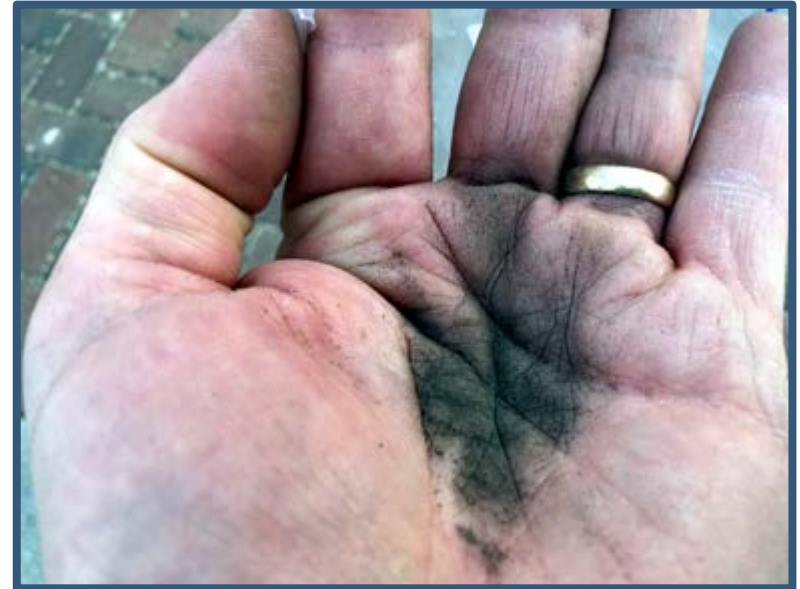
The solids are very fine-grained

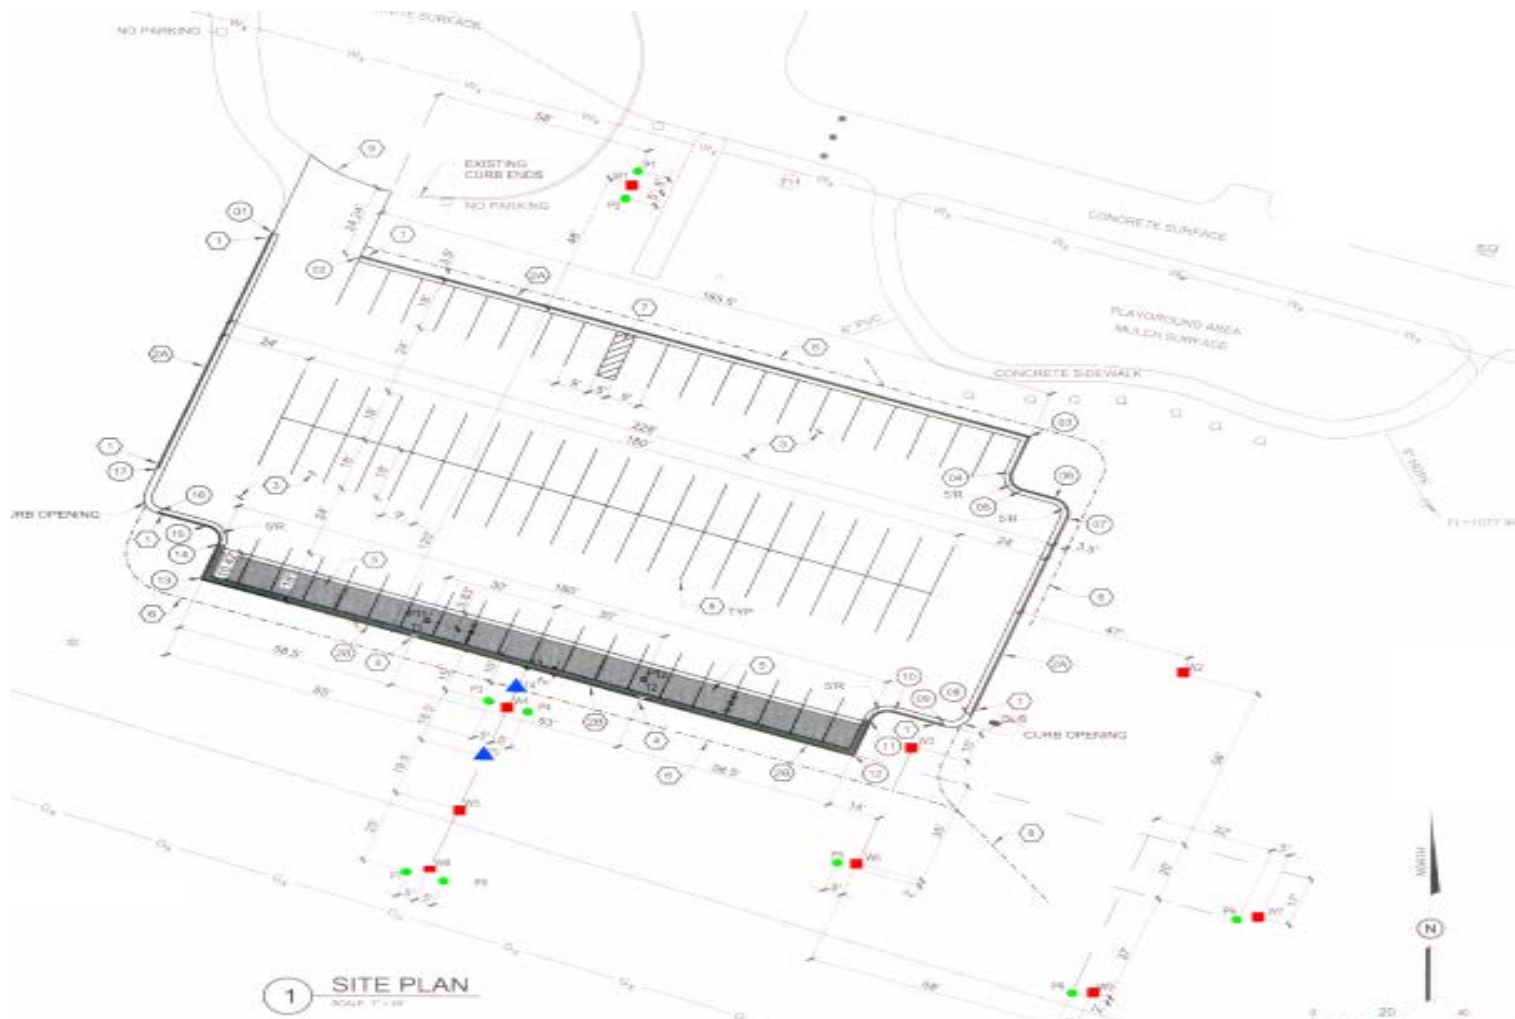
Near field subsurface monitoring.
