Natural Attenuation of the Persistent Chemical Warfare Agent VX on Porous and Permeable Surfaces

U.S. Environmental Protection Agency
Office of Research and Development
National Homeland Security Research Center
Research Triangle Park, NC 27711

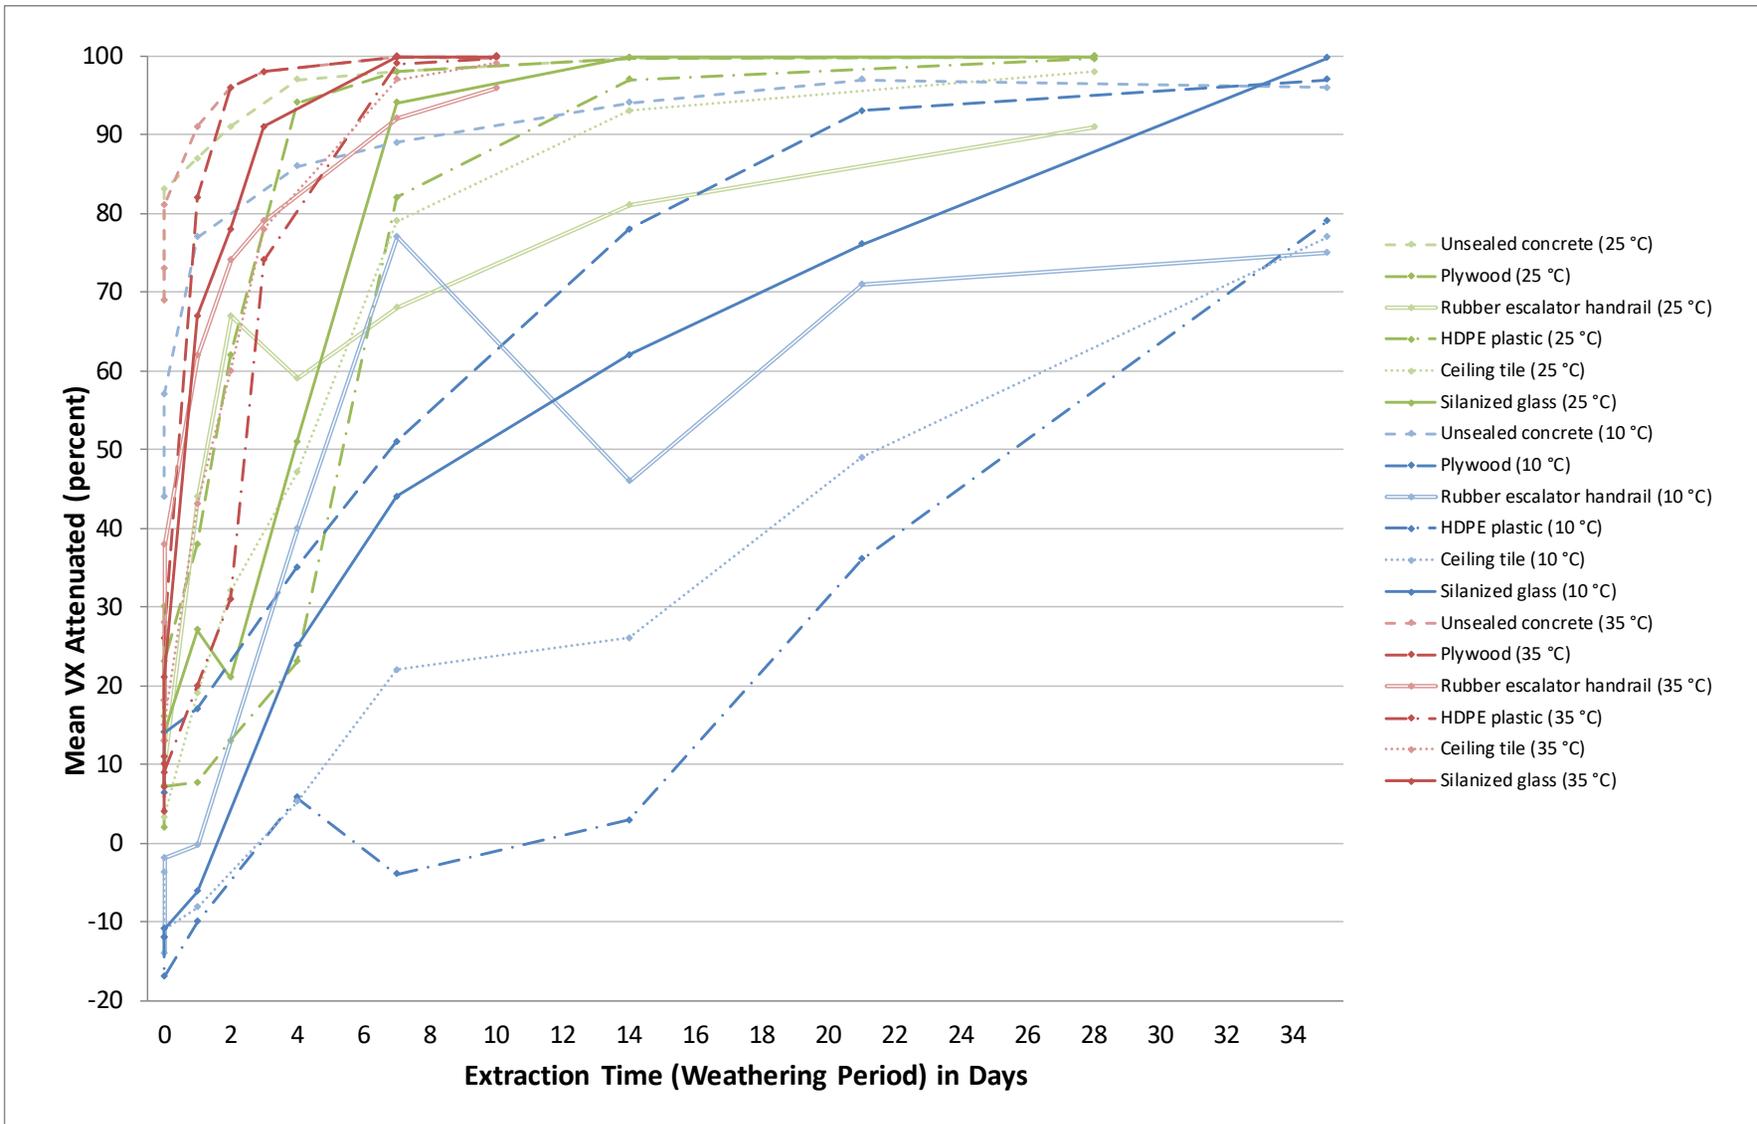
Figure ES-1. Percent of VX attenuated over time versus material and temperature (negative VX attenuation reflects instances when higher VX was recovered from the test coupons than the associated spike controls).

As shown in Figure ES-1, natural attenuation of VX occurred on all six materials under all three temperatures tested. Natural attenuation of VX tended to occur faster at warmer temperatures. For example, at least 90% attenuation on all materials occurred within seven days at 35 °C and within 28 days at 25 °C. At 10 °C, less than 80% VX attenuation occurred on rubber escalator handrail, high density polyethylene (HDPE) plastic, and ceiling tile after 35 days (the longest duration tested).

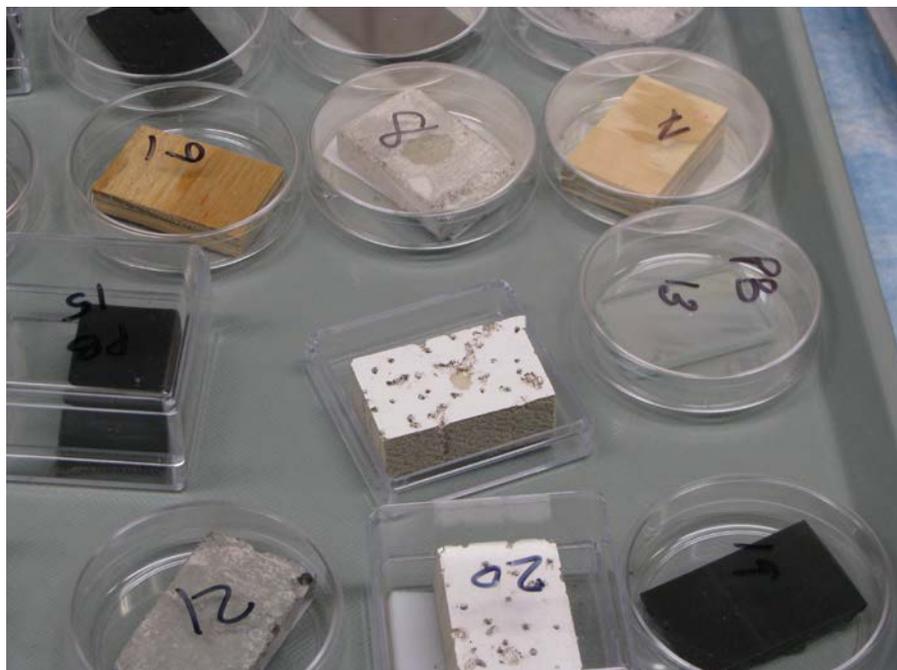
Figure 1. Photograph of coupons associated with the extraction recovery method demonstration showing use of round Petri dishes and square acrylic boxes.

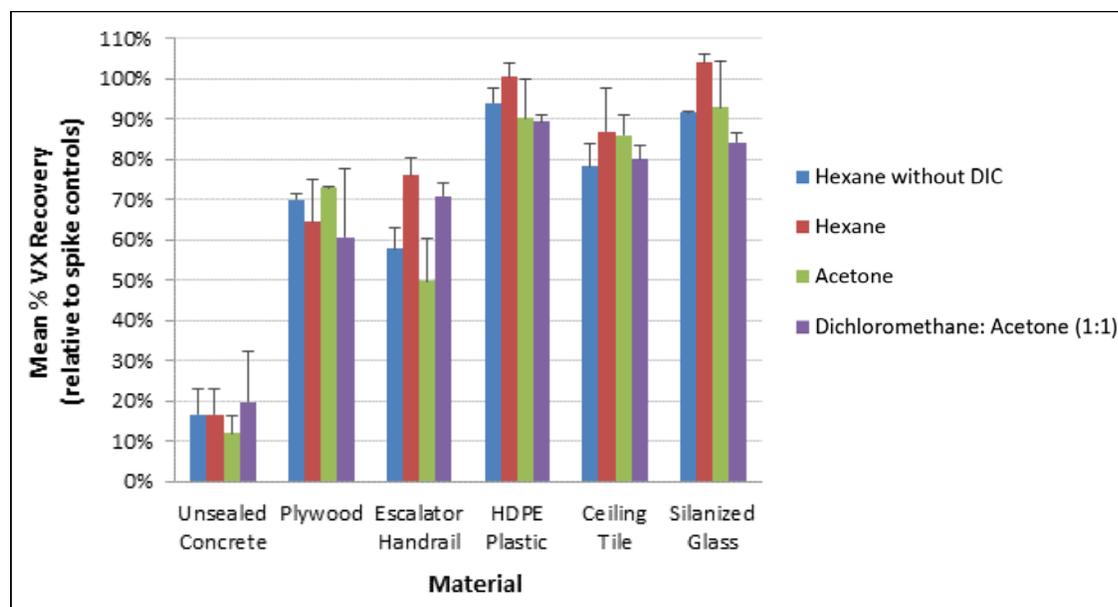
Figure 2. VX recoveries following coupon extraction in various solvents (error bars equal plus one standard deviation).

Per Section 2.7, acceptable recoveries of VX were defined as having mean recoveries relative to the spike control of 70% to 120% with less than a 30% CV between samples. None of the extraction solvents tested achieved 70% VX recovery from unsealed concrete. Mean percent VX recoveries ranged from 12% to 20%, and the CV ranged from 37% to 63%. Low VX recoveries were also obtained from epoxy-sealed concrete in a companion study (EPA, 2016). The poor recoveries might be attributed to strong adsorption and/or degradation of the VX within the concrete (Groenewold et al., 2002). In fact, Groenewold et al. (2002) demonstrated the near complete VX degradation when VX was exposed to crushed concrete. Nevertheless, detectable VX was recovered with all four extraction solvents (ranging from 230 μg to 388 μg) 24 hours after spiking.

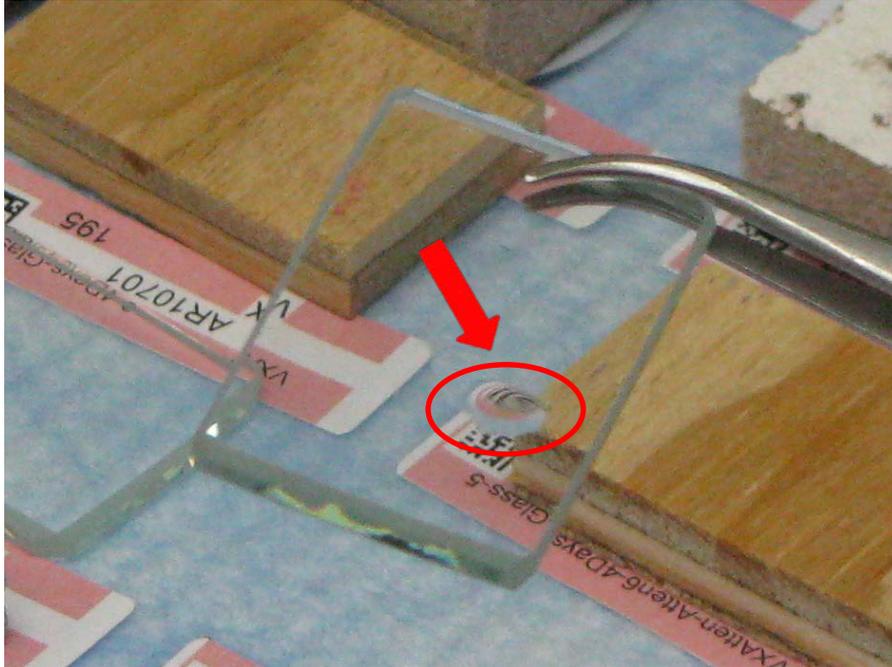
Figure 3. Photograph of silanized glass coupon with VX having a “pancake” appearance.

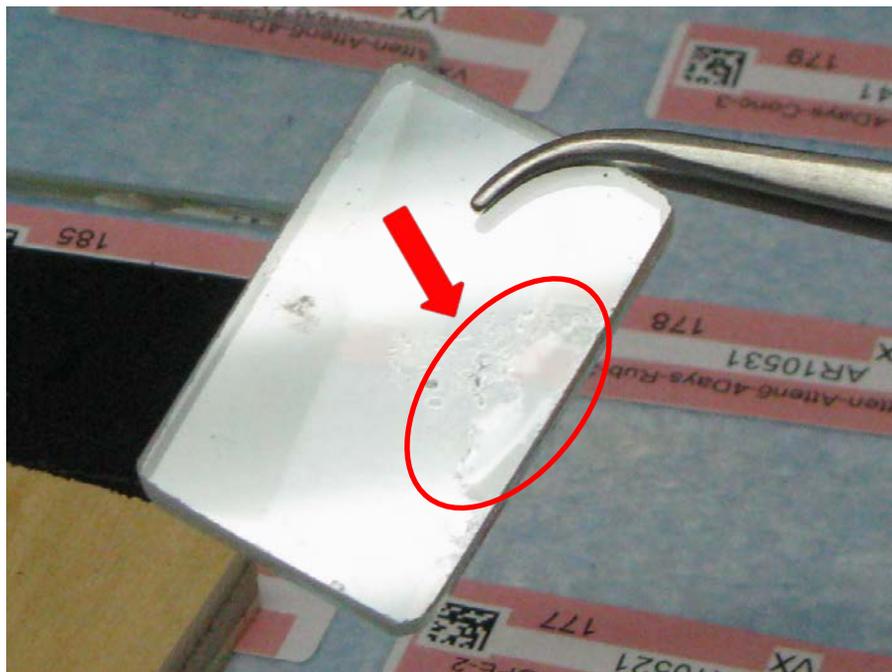
Figure 4. Photograph of silanized glass coupon with VX having a “spread” appearance.

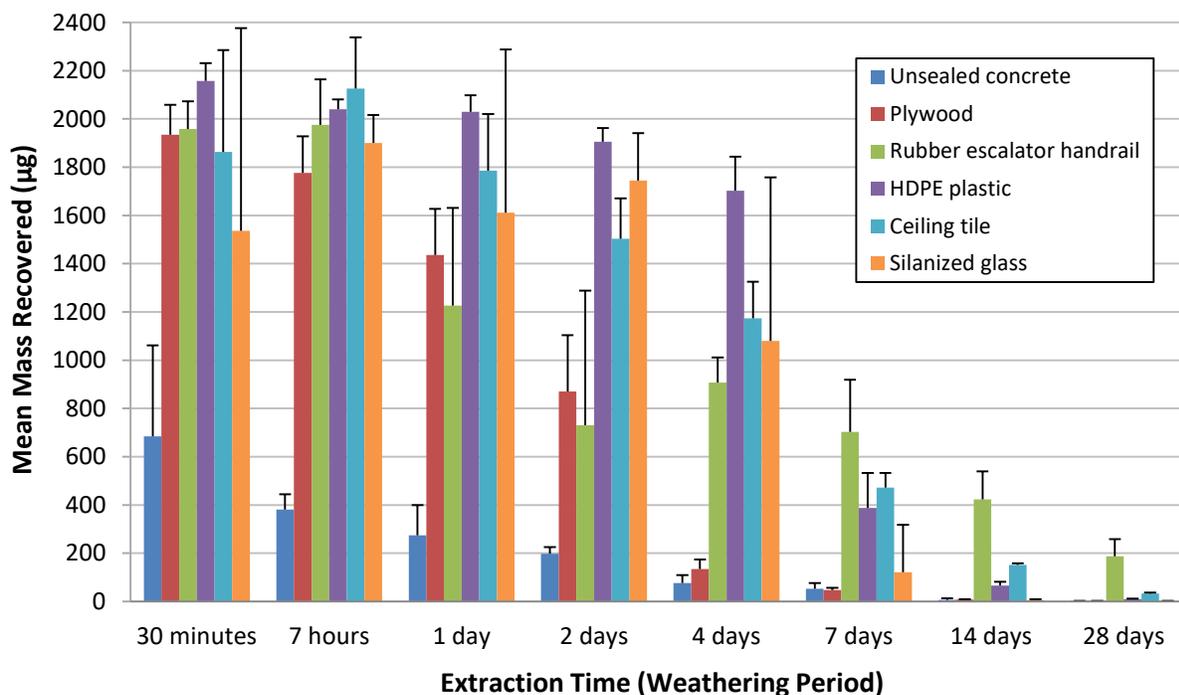
Figure 5. VX recovery at Environmental Condition 1 (error bars equal plus one standard deviation). Initial VX amount is $2200 \mu\text{g}$.

The amount of VX recovered over time is presented in Figure 5 and Table 6. After a 30-min weathering period, the mean VX recoveries were $\geq 1537 \mu\text{g}$ for all materials, except unsealed concrete, which had a mean VX recovery of $684 \mu\text{g}$. The VX recoveries rather steadily decreased from unsealed concrete. The mean VX recovery from plywood was $871 \mu\text{g}$ after two days but rapidly decreased to $134 \mu\text{g}$ after four days. Similarly, rapid decreases in VX recoveries occurred from HPDE plastic, ceiling tile, and silanized glass which had mean recoveries $\geq 1080 \mu\text{g}$ after four days and mean VX recoveries $\leq 472 \mu\text{g}$ from these materials after seven days. The overall decrease in VX was slowest from the rubber escalator handrail, which had mean VX recoveries of $703 \mu\text{g}$ after seven days, $423 \mu\text{g}$ after 14 days, and $187 \mu\text{g}$ after 28 days. VX was recovered from at least some of the replicates of all materials tested after 14 days; the highest mean VX recoveries were from rubber escalator handrail ($423 \mu\text{g}$), ceiling tile ($152 \mu\text{g}$), and HDPE plastic ($66 \mu\text{g}$). The remaining materials had mean VX recoveries $< 10 \mu\text{g}$ after 14 days. After 28 days, VX was detected from at least one of the five replicate coupons for all materials except plywood and silanized glass. Mean VX recoveries remained above $10 \mu\text{g}$ after 28 days for the rubber escalator handrail ($187 \mu\text{g}$) and ceiling tile ($33 \mu\text{g}$).

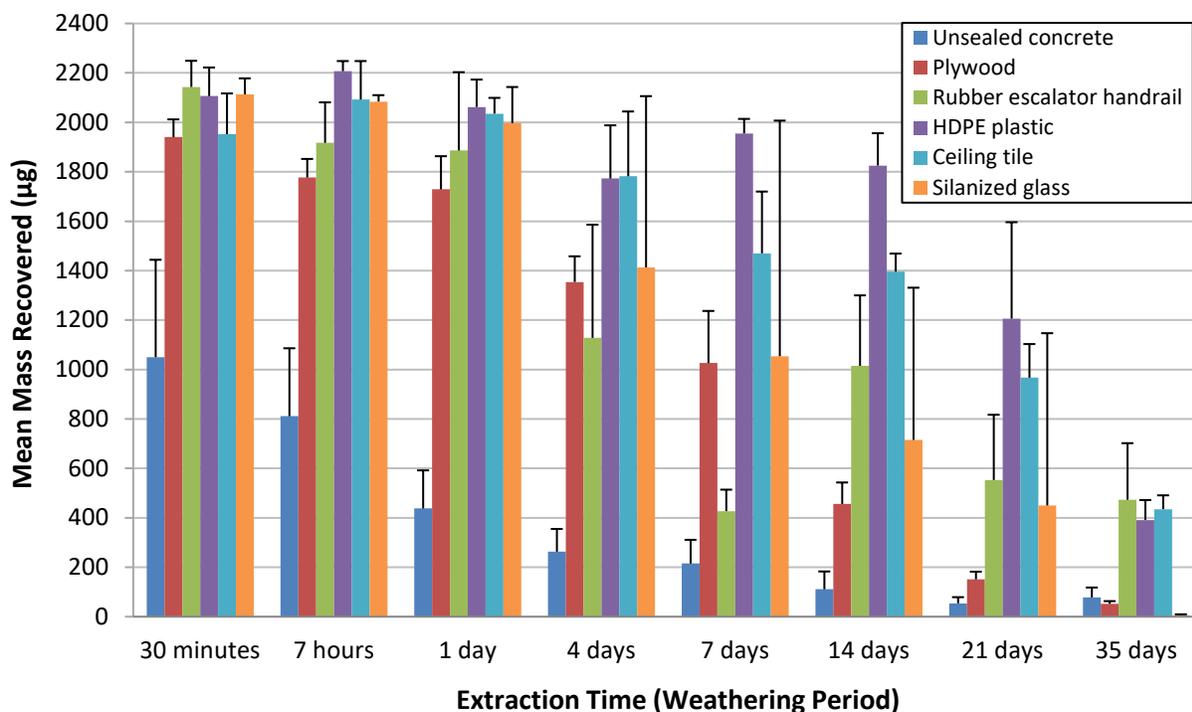
Figure 6. VX recovery at Environmental Condition 2 (error bars equal plus one standard deviation). Initial spiked VX amount is 1900 μg except for plywood (2100 μg).

The amount of VX recovered from the various materials over time is presented in Figure 6 and Table 10. After a 30-min weathering period, the mean VX recovery was ≥1940 µg for all

materials except unsealed concrete, which had a mean VX recovery of 1050 μg . The VX recoveries decreased rather steadily for unsealed concrete, but VX remained detectable after 35 days with a mean VX recovery of 78 μg . The mean VX recoveries from the other materials remained ≥ 1128 μg for at least four days. For plywood and silanized glass, the mean VX recoveries remained ≥ 1026 μg after seven days but then decreased to levels lower than those recovered from unsealed concrete at 35 days (≤ 52 μg). The VX recoveries from rubber escalator handrail, HDPE plastic, and ceiling tile were ≥ 1015 μg after 14 days and remained ≥ 391 μg for the entire study duration. The mean VX recovery from rubber escalator handrail was noticeably lower at seven days (427 μg) than observed at four days (1128 μg) and 14 days (1015 μg). The reason for this lower result is unknown, but a similar incidence of lower VX recovery from rubber escalator handrail also occurred at Environmental Condition 1, where the mean VX recovery at two days (731 μg) was lower than the recovery at one day (1227 μg) and four days (908 μg) (see Table 6).

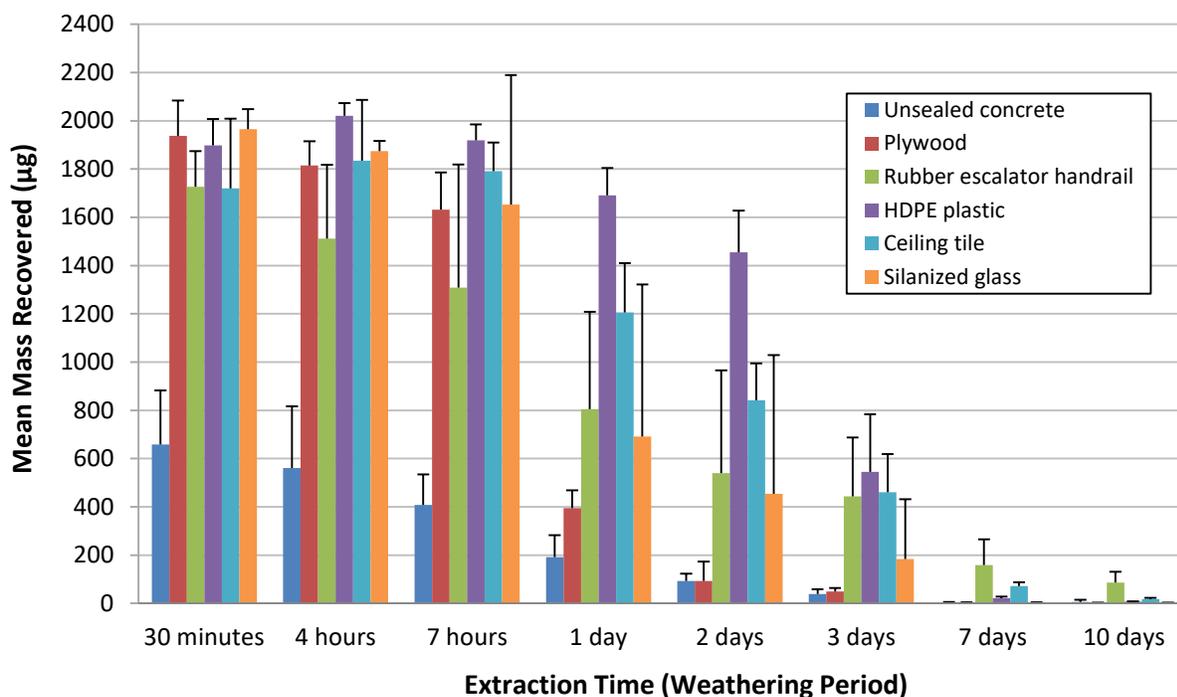
Figure 7. VX recovery at Environmental Condition 3 (error bars equal plus one standard deviation). Initial spiked VX amount is 2100 µg except for plywood (2200 µg).

The amount of VX recovered over time is presented in Figure 7 and Table 14. The mean spike control recoveries for VX during testing at Environmental Condition 3 were 2104 µg from the hexane spike controls and 2218 µg from the acetone spike controls. Hexane was used as the extraction solvent for unsealed concrete, rubber escalator handrail, HDPE plastic, ceiling tile, and silanized glass. Acetone was used as the extraction solvent for plywood.

The mean VX recoveries after 30 min were ≥ 1720 µg for all materials, except unsealed concrete, which had a mean VX recovery of 659 µg. VX recovery from unsealed concrete rather steadily decreased with only one or two replicate coupons detecting VX at seven days and 10 days of exposure (the associated mean VX recoveries were ≤ 6.2 µg). The mean VX recoveries remained ≥ 1308 µg for all other materials after seven hours. For plywood, the mean VX recovery dramatically decreased between seven hours (1631 µg) and one day (395 µg); the VX recoveries from plywood continued to decrease until becoming completely non-detect at 10 days. Similar decreases in mean VX recovery were associated with HDPE plastic between two days (1455 µg) and three days (545 µg) and silanized glass between seven hours (1653 µg) and one day (691 µg). The VX remained detectable from HDPE plastic at low levels (mean VX recovery 7.1 µg) at 10 days, but VX was not detected from silanized glass at 10 days. The mean VX recoveries at seven days and 10 days were highest from rubber escalator handrail (159 µg and 86 µg, respectively) and ceiling tile (71 µg and 18 µg, respectively).

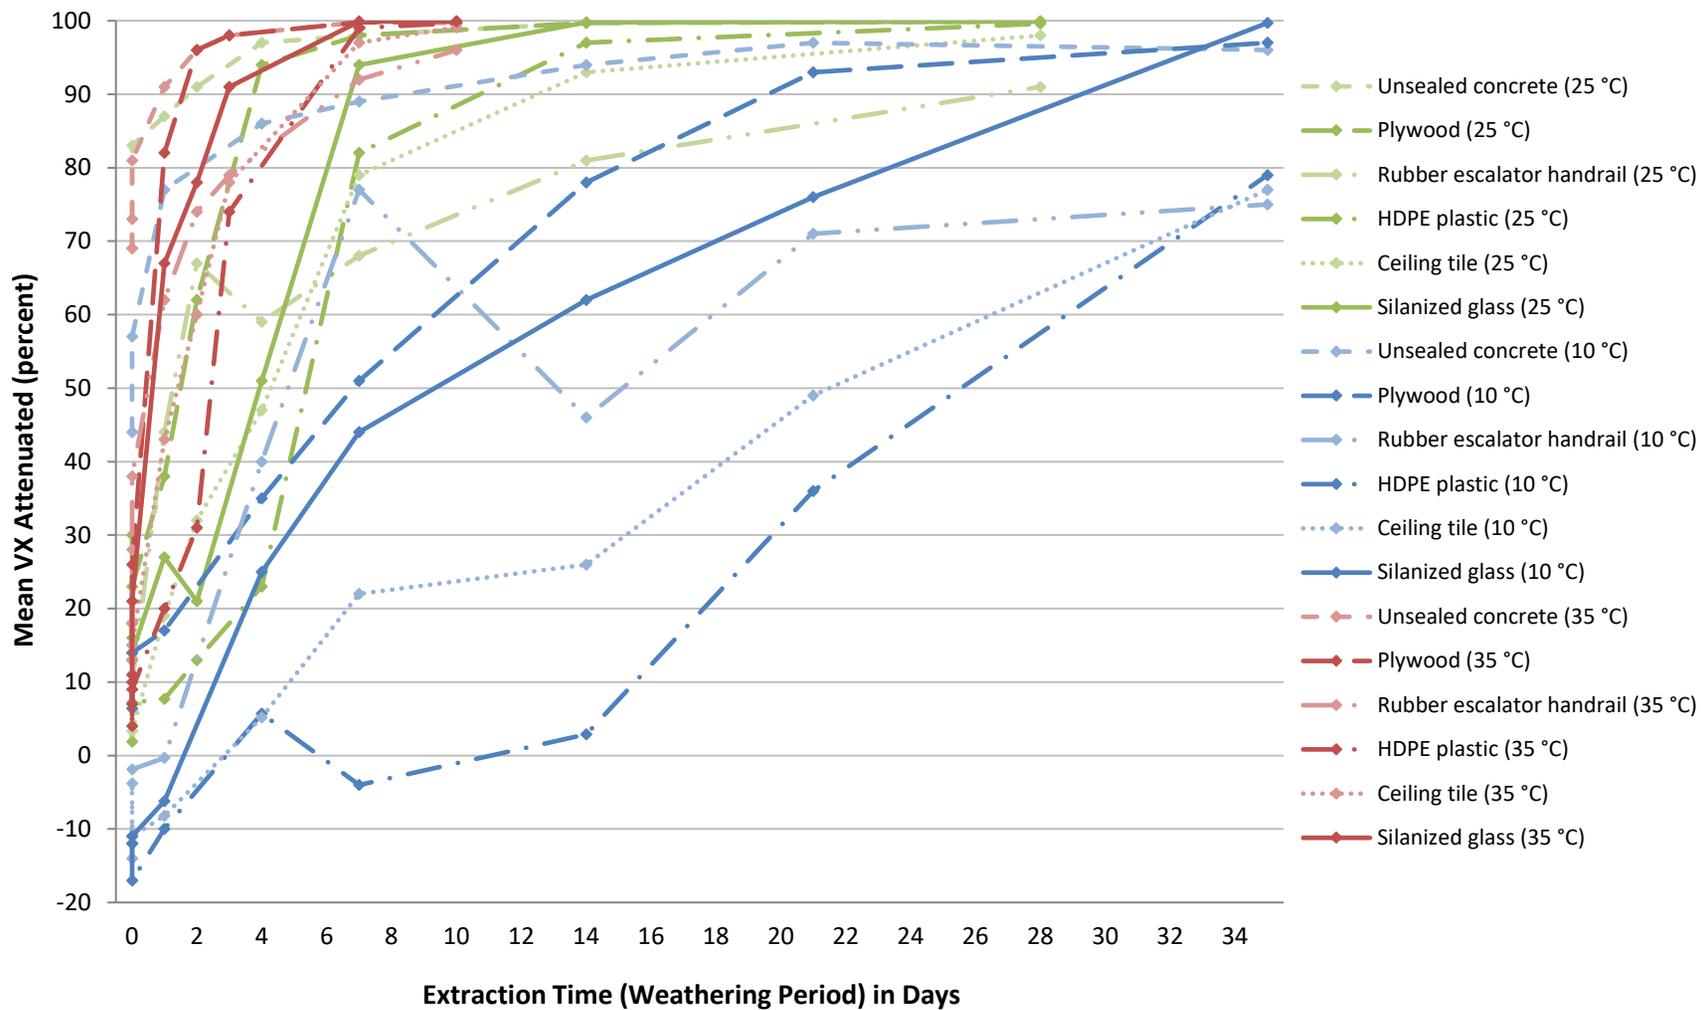
Figure 8. Percent of VX attenuated over time by material and temperature (negative VX attenuation reflects instances when higher VX was recovered from the test coupons than the associated spike controls).

The time required for the natural attenuation of VX to achieve a given attenuation level was also material-dependent. Unsealed concrete was consistently the first material to reach 90% attenuation, followed by plywood, and then silanized glass. Longer amounts of time were consistently required to achieve 90% natural attenuation when associated with rubber escalator handrail, HDPE plastic, and ceiling tile.

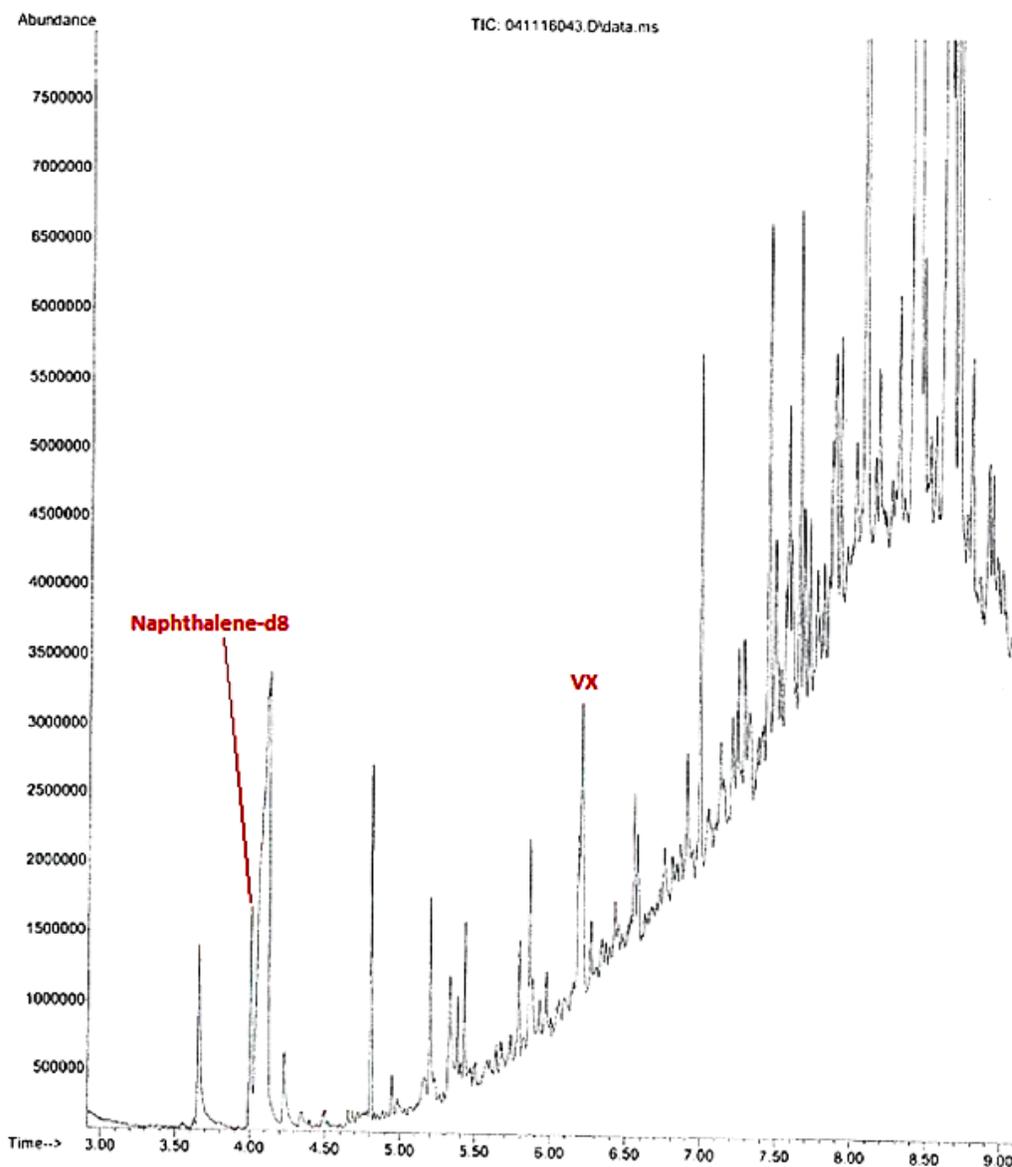
Test – EPA-VX-Attenuation-5 (25°C, 40% RH)

Sample Number – AQ37841 (rubber escalator handrail coupon #5, extracted at 28 days)

VX and IS peaks are identified in the chromatogram

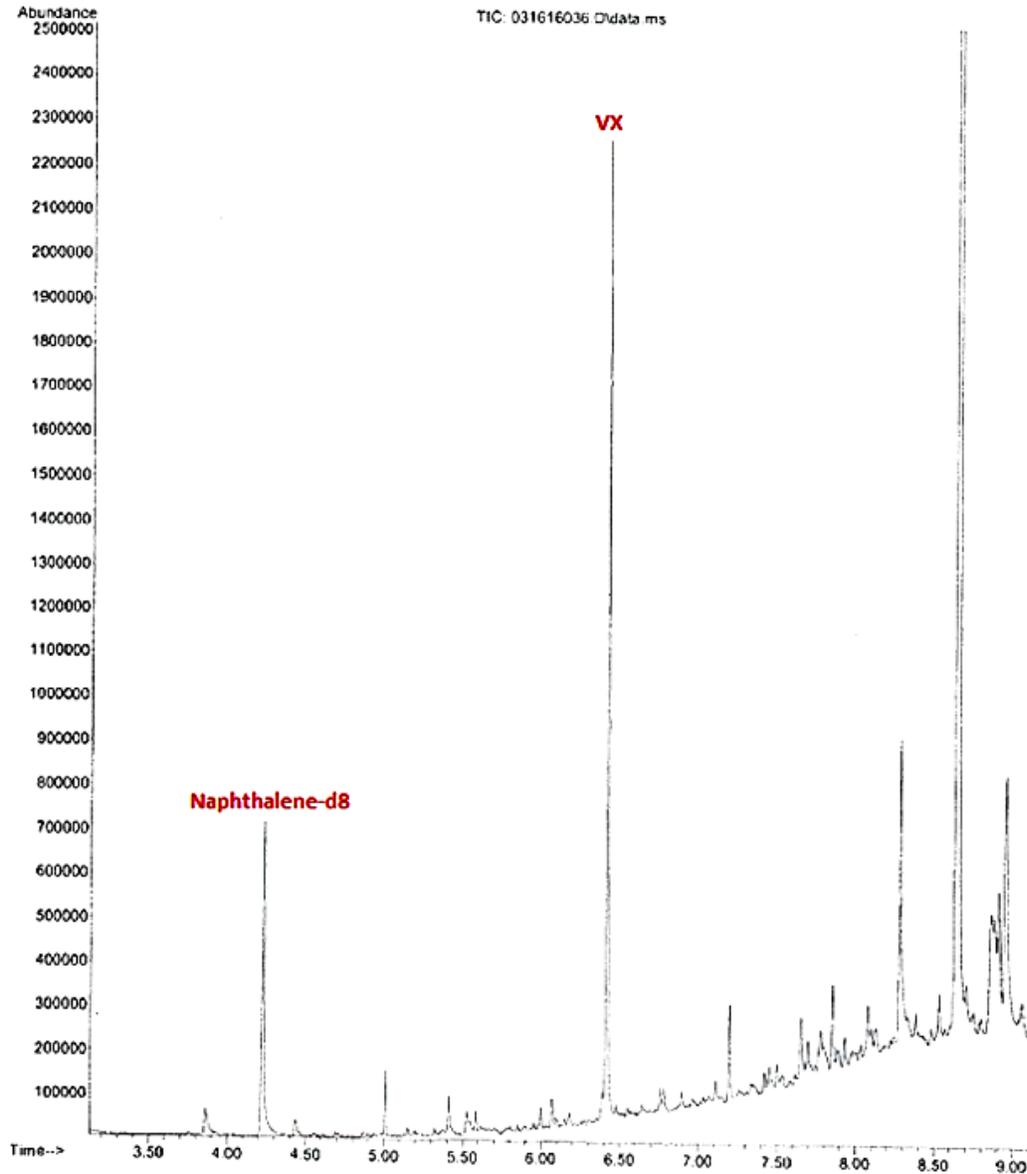
Test – EPA-VX-Attenuation-5 (25°C, 40% RH)

Sample Number – AQ39181 (rubber escalator handrail coupon #5, extracted at 30 minutes)

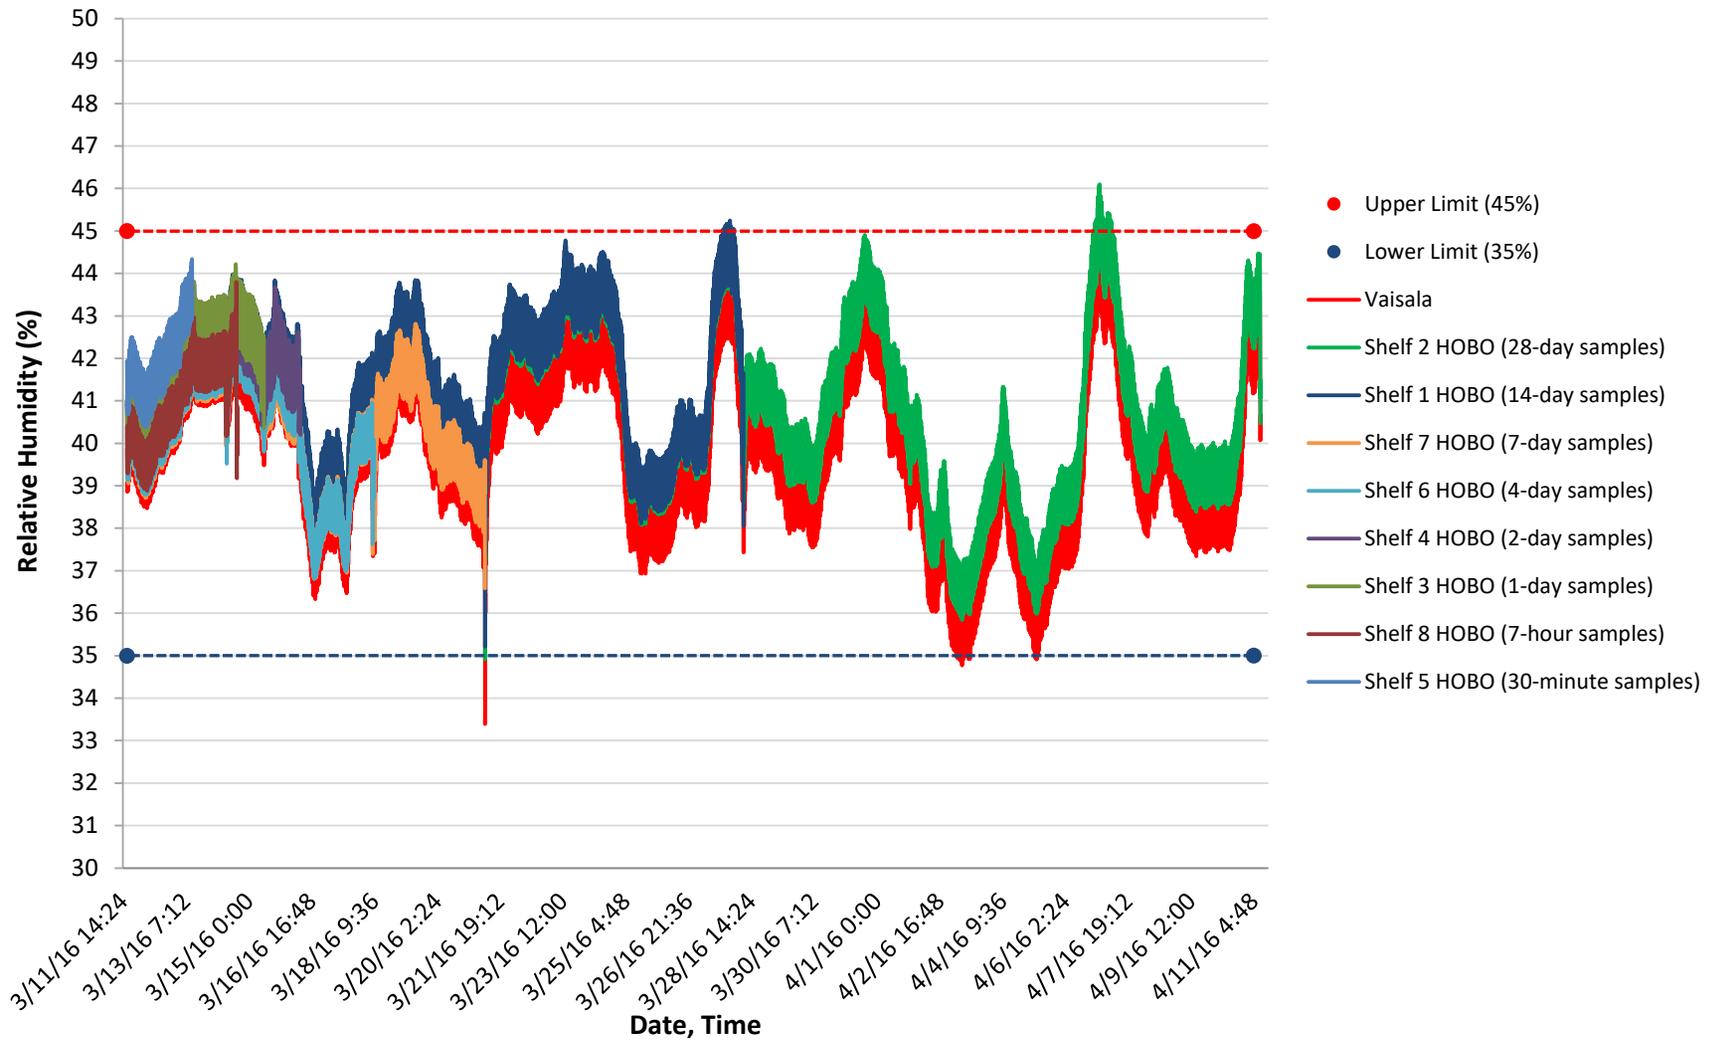
Figure B1. Relative humidity during Environmental Condition 1 testing (environmental conditioning was initiated on March 11, 2016; actual testing began on March 14, 2016 and continued until April 11, 2016).

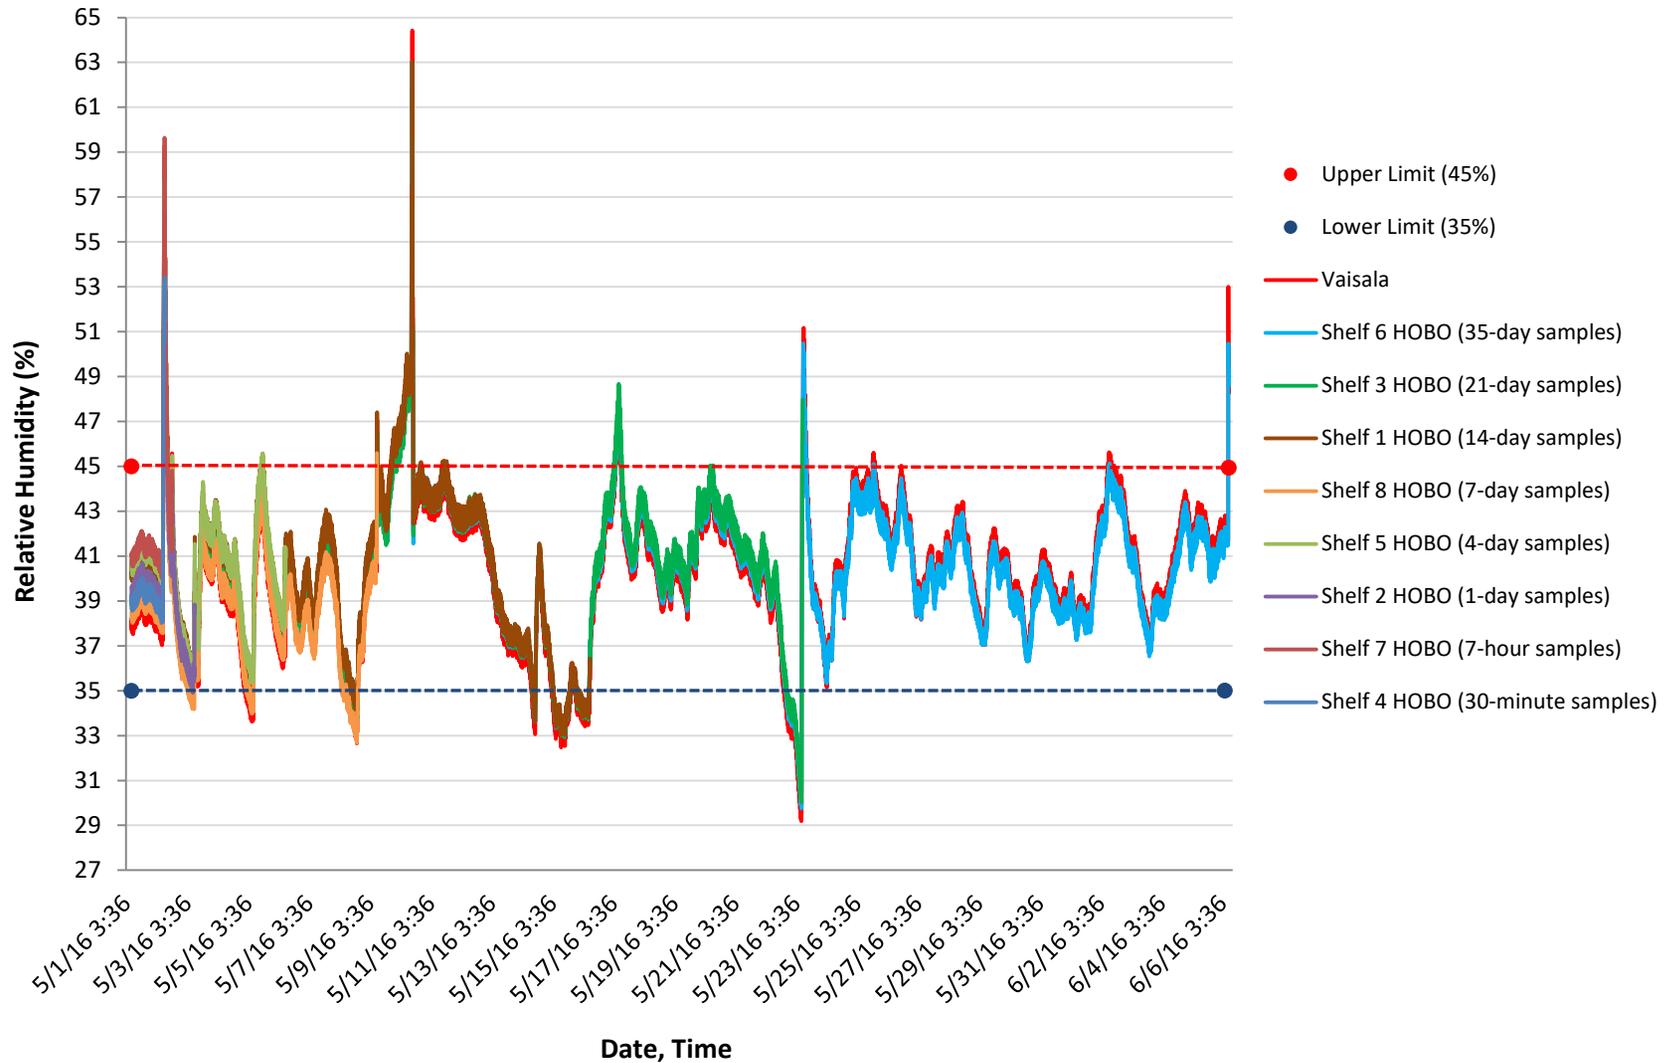
Figure B2. Relative humidity during Environmental Condition 2 testing (environmental conditioning was initiated on May 1, 2016; actual testing began on May 2, 2016 and continued until June 6, 2016).
