# **Destabilization of Lead Pipe Scales in a Long-Term Vacant Home in Cincinnati**

**Michael K. DeSantis**

Pegasus Technical Services, Inc.

Hamilton County Lead and Healthy  
Homes Collaborative – 01/18/2018

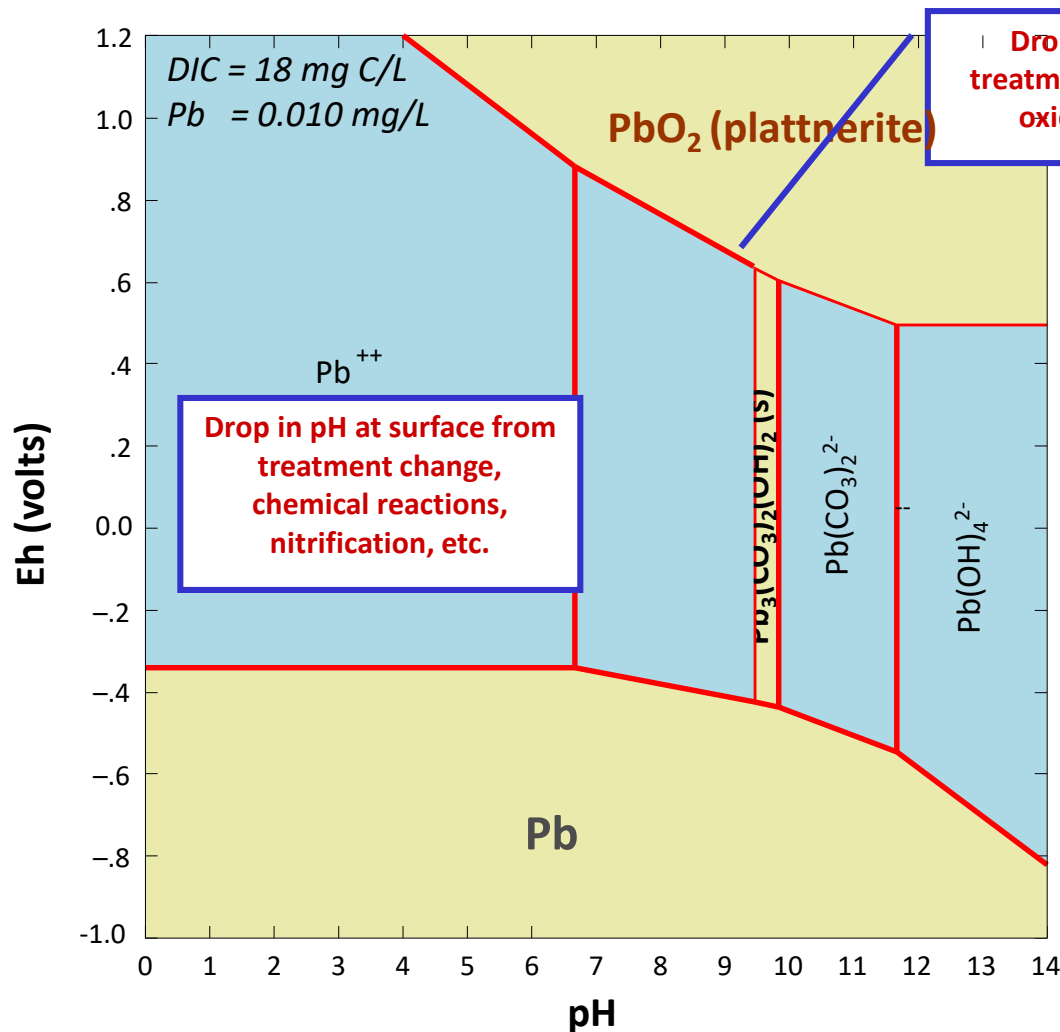
# WAYS TO DESTABILIZE $PbO_2$

Can be reduced back to Pb(II) phases if ORP is not maintained

- chlorine to chloramine
- loss of chlorine residual
  - Reaction with bulk water reductants
  - Reaction with DS and premise plumbing materials

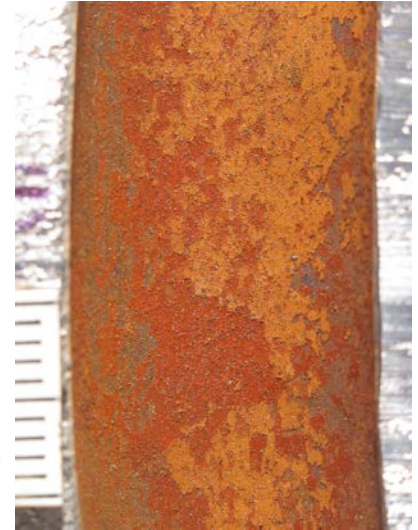
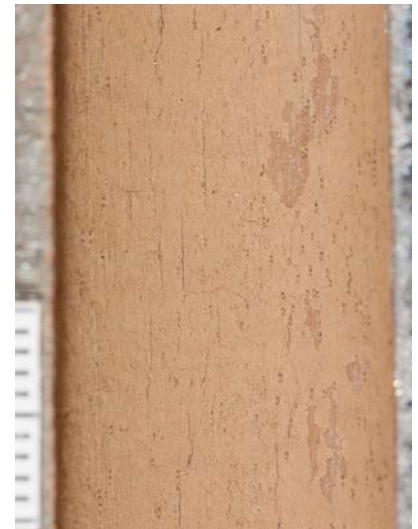
# *Cincinnati LSL scales*

- Stable long-term (many years) water treatment and chemistry with respect to critical water parameters
- 17 LSL samples extracted between early 1990's and 2014
  - 15 show nearly complete scale coverage by  $\text{PbO}_2$
  - 2 show hydrocerussite and other  $\text{Pb(II)}$  phases developed at the scale/water interface, with  $\text{PbO}_2$  underneath.

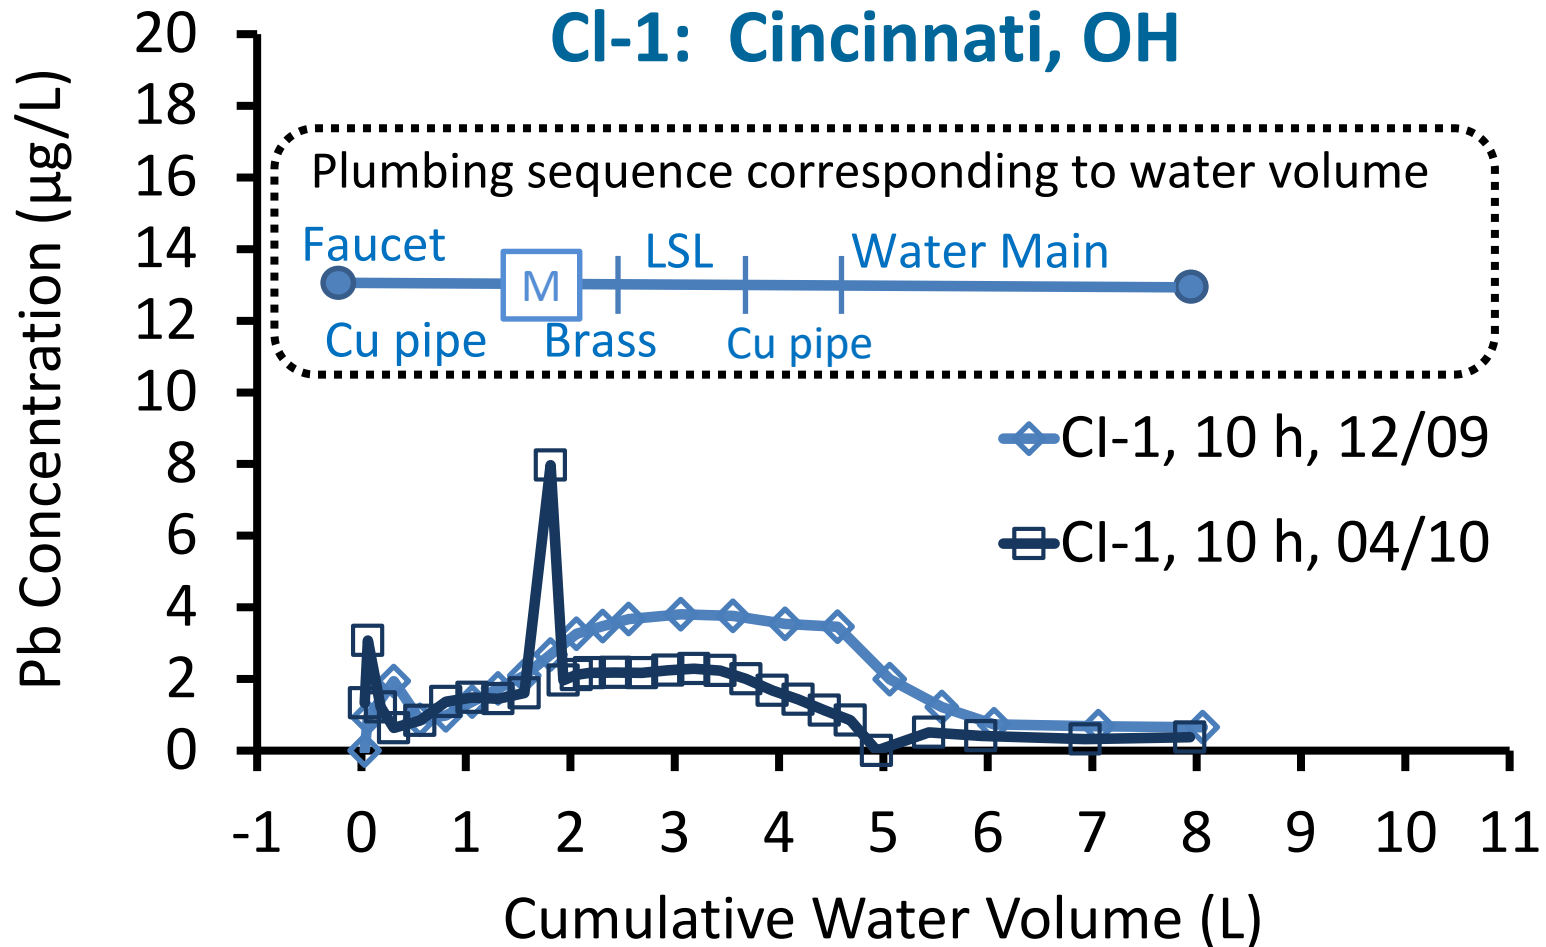
# DETAILED SEQUENTIAL SAMPLES

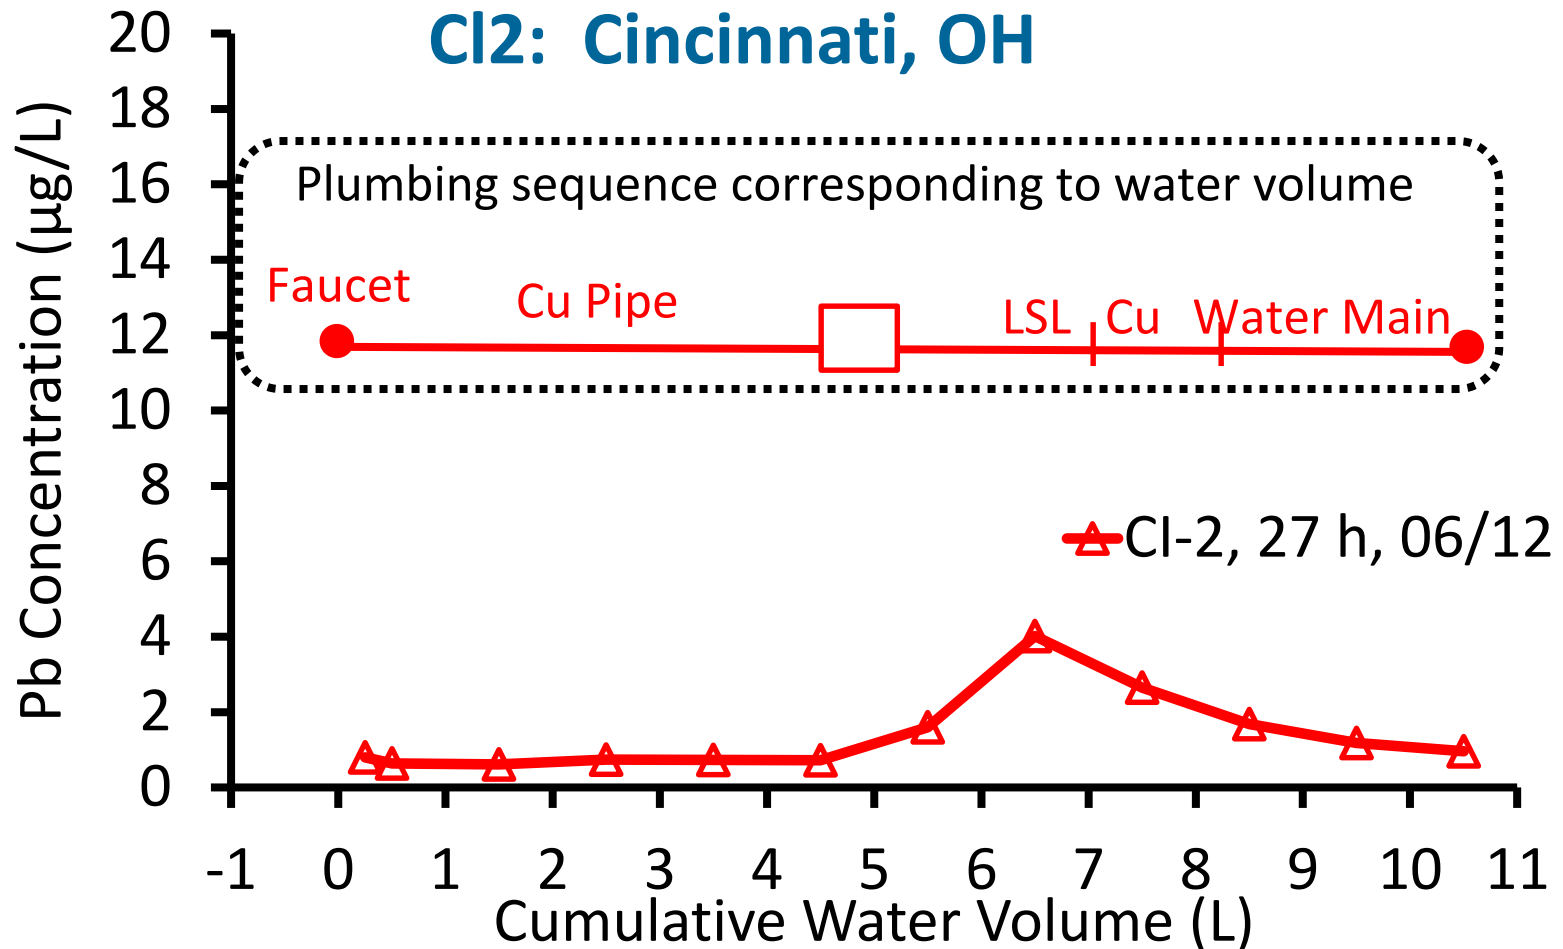
# DETAILED SEQUENTIAL SAMPLES

## CL2: Cincinnati, OH

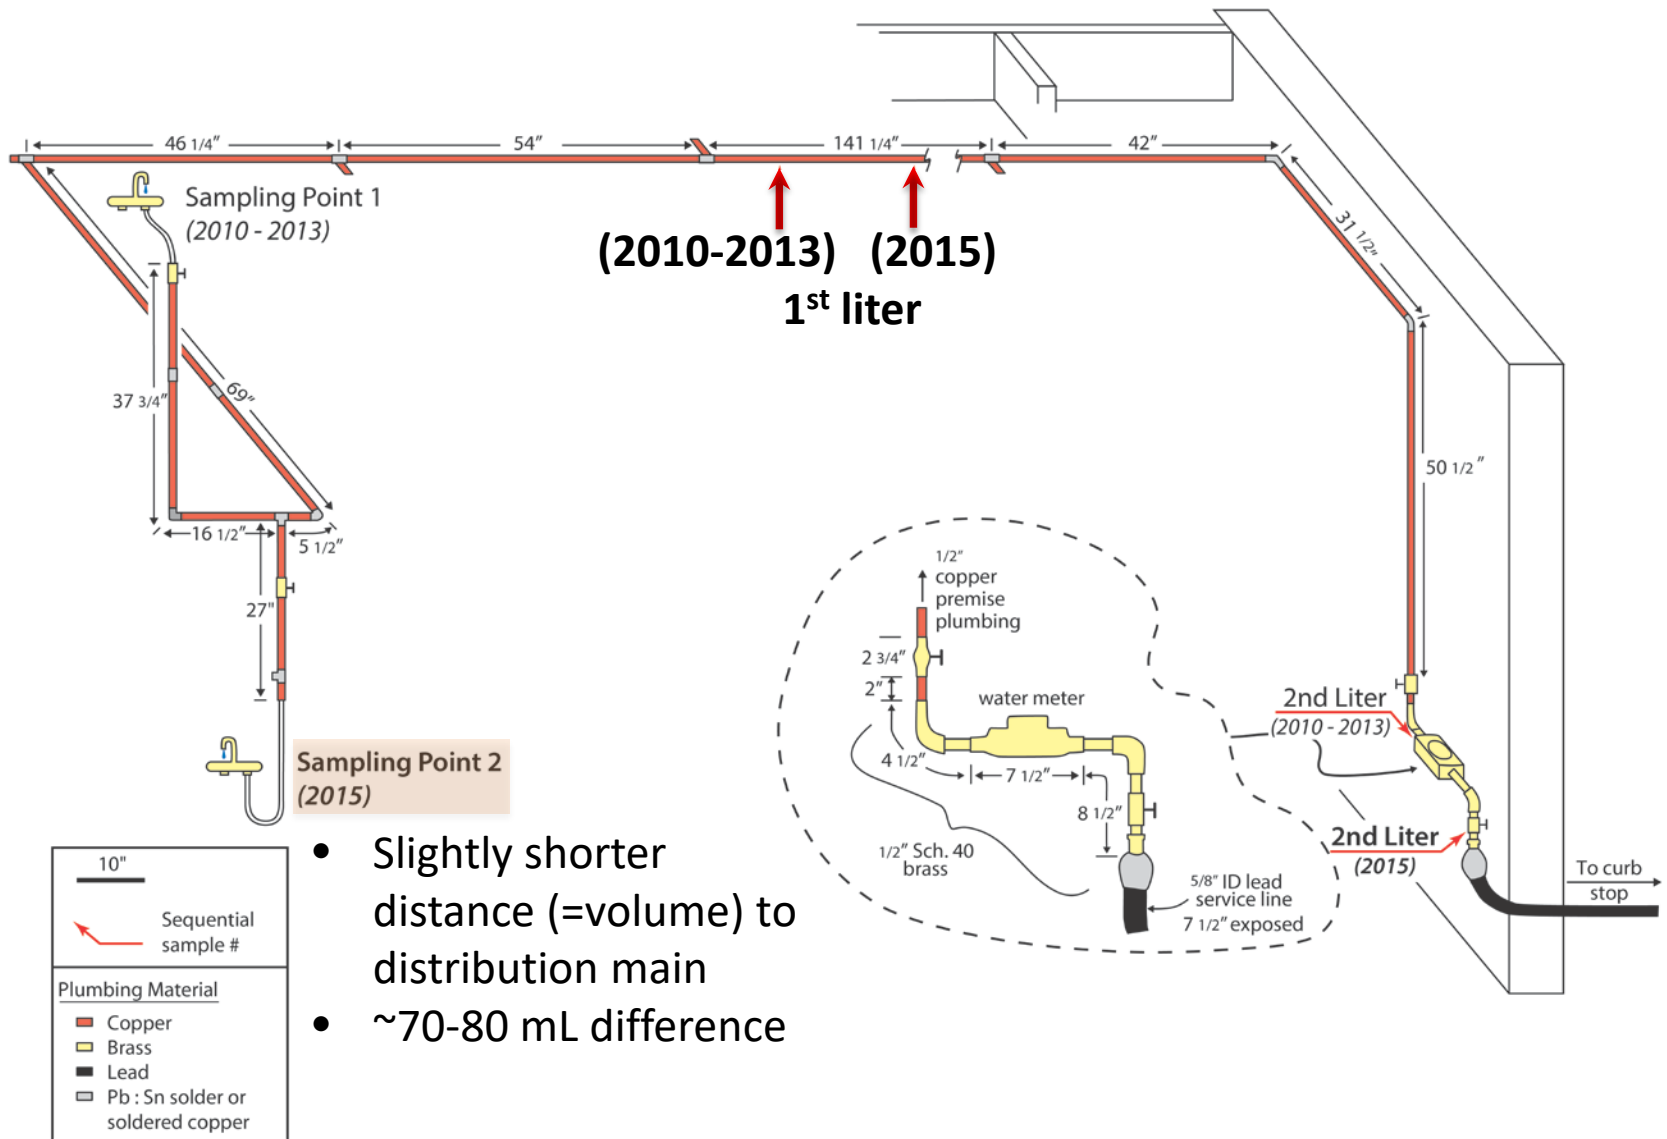
# REVISITING SITE CI-1

- Slightly shorter distance (=volume) to distribution main
- ~70-80 mL difference

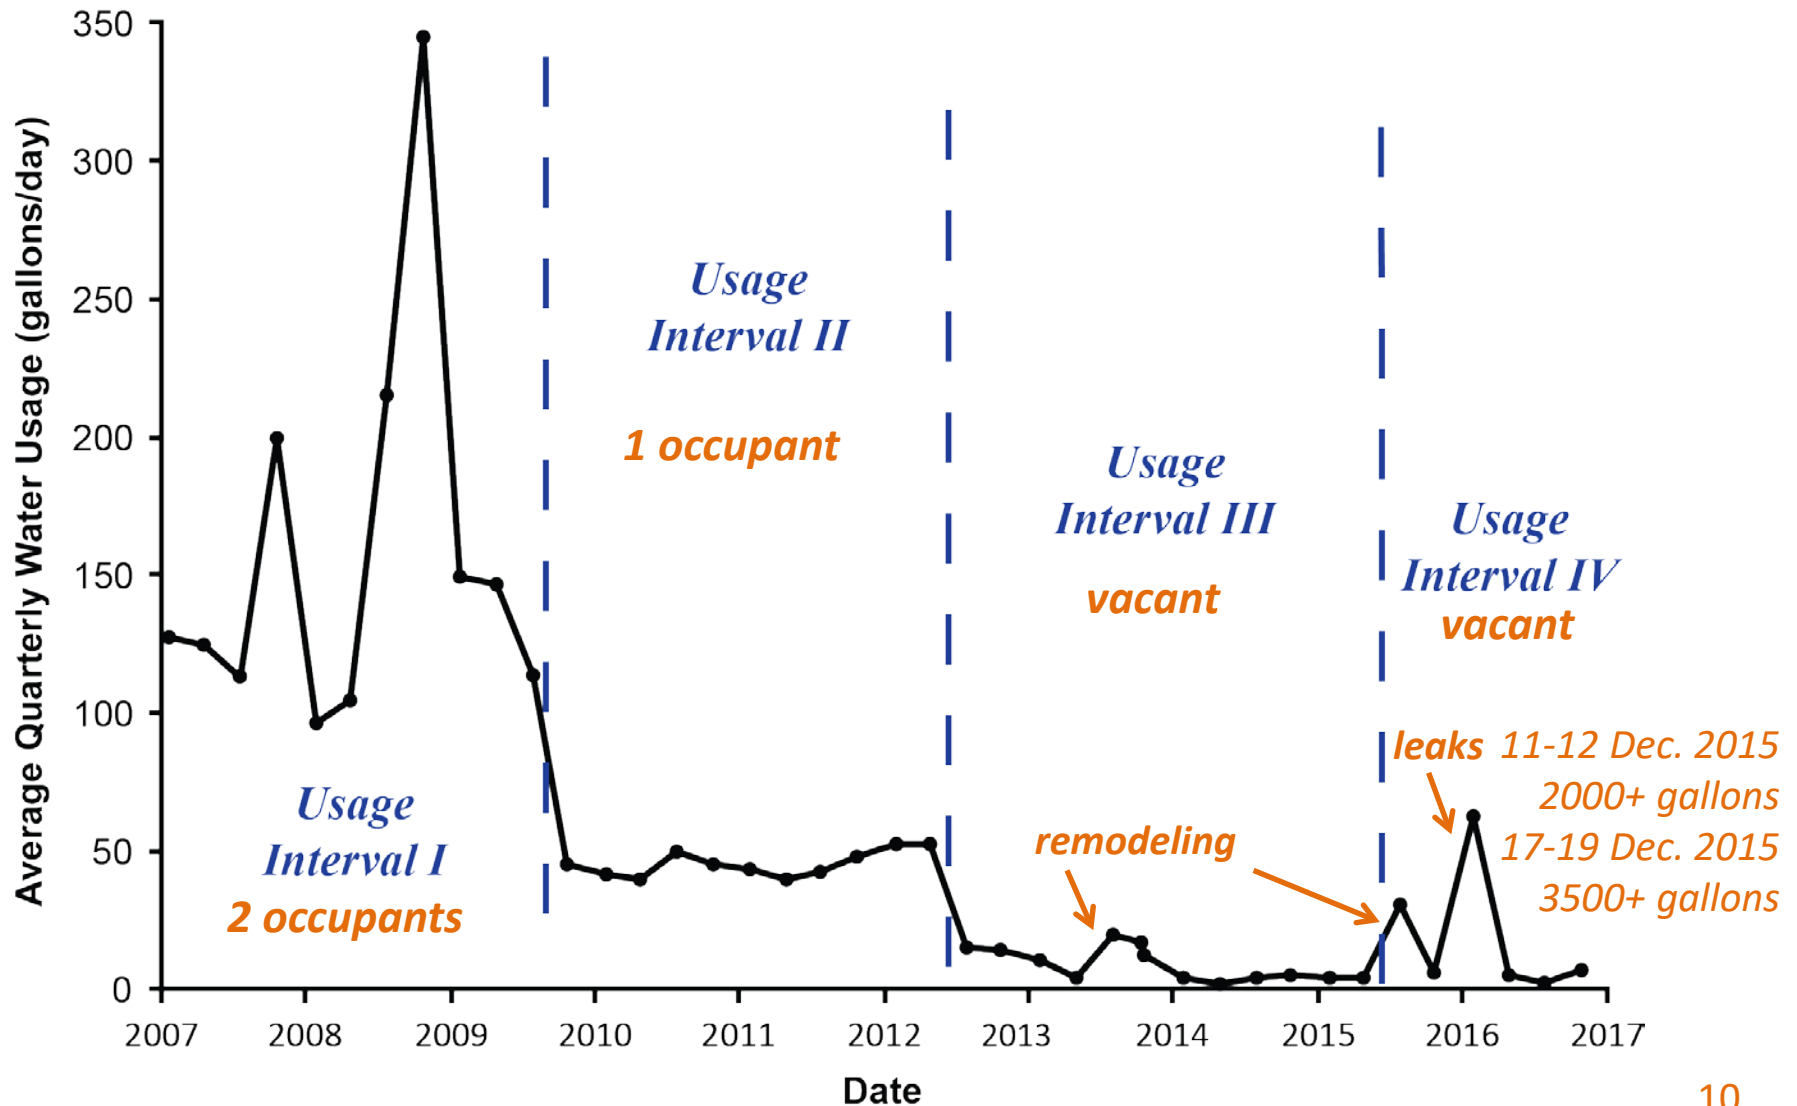
# SITE CI-1 WATER USE: 2007-2017

Based on GCWW quarterly billing records

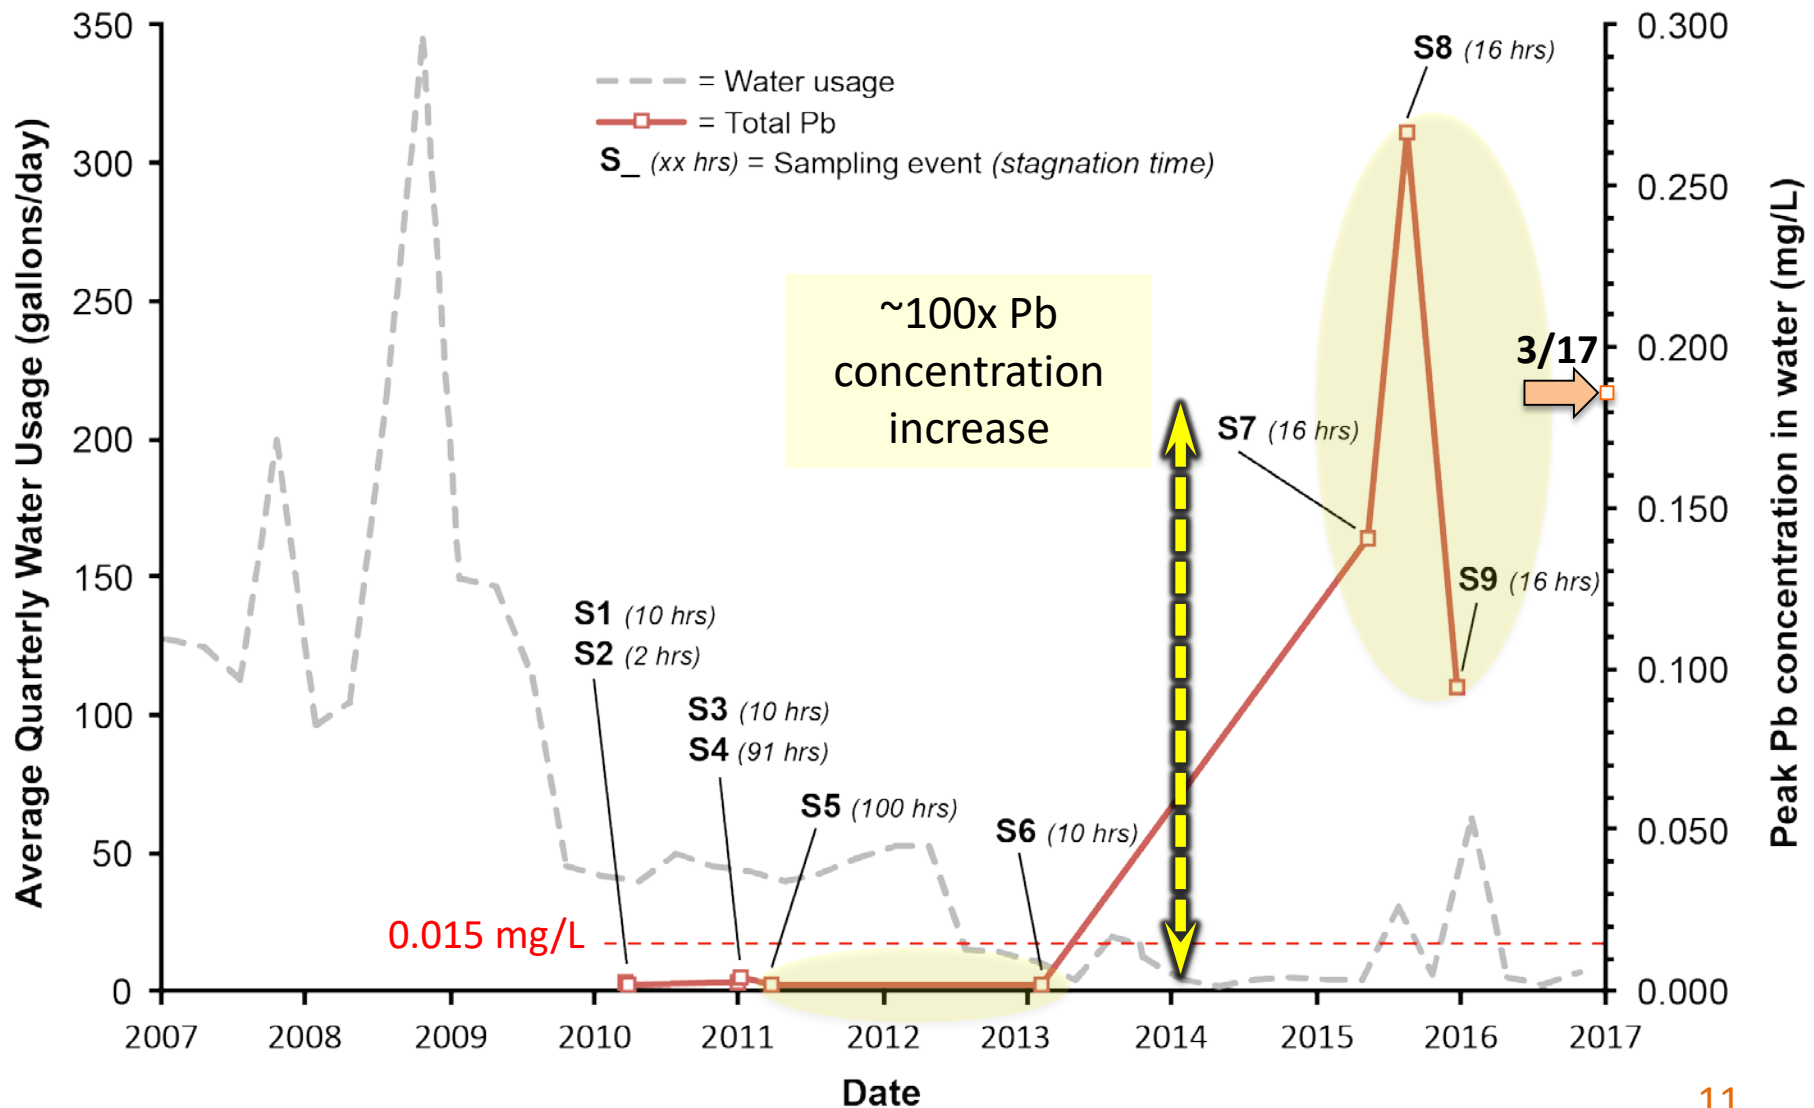
# LEAD LEVELS IN LSL INCREASED

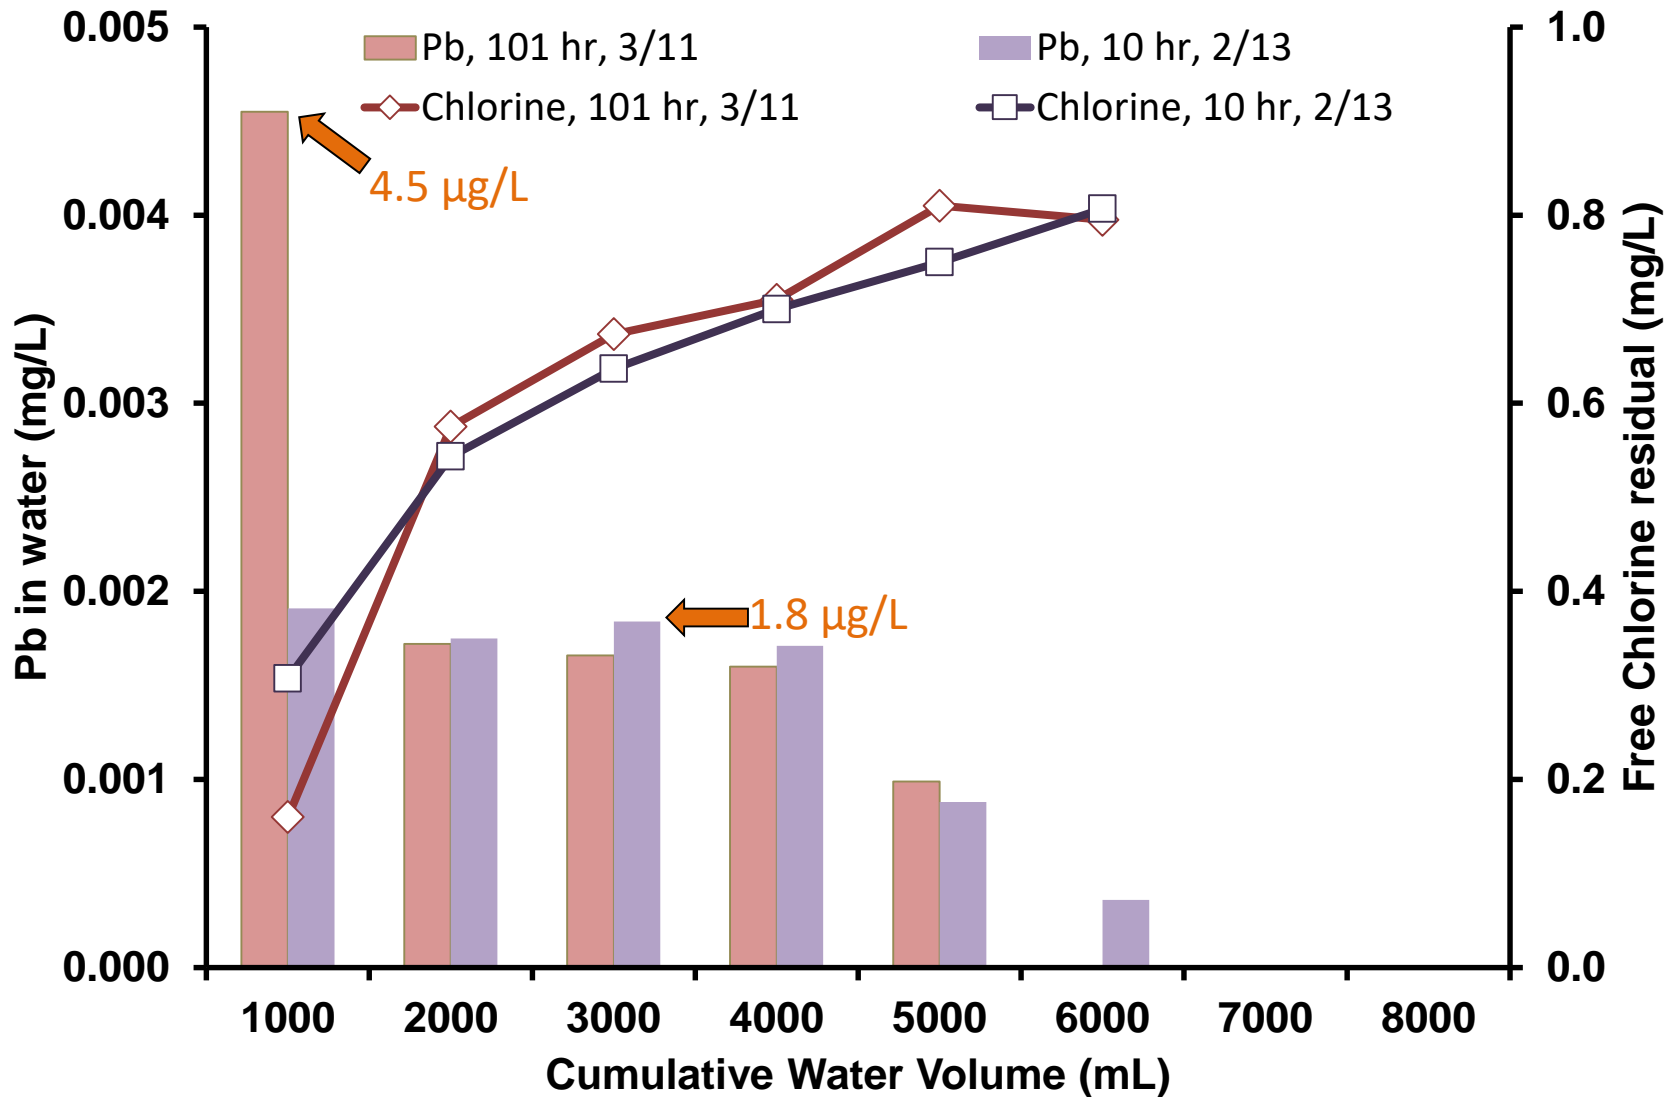
# SEQUENTIAL LITERS 2011-2013

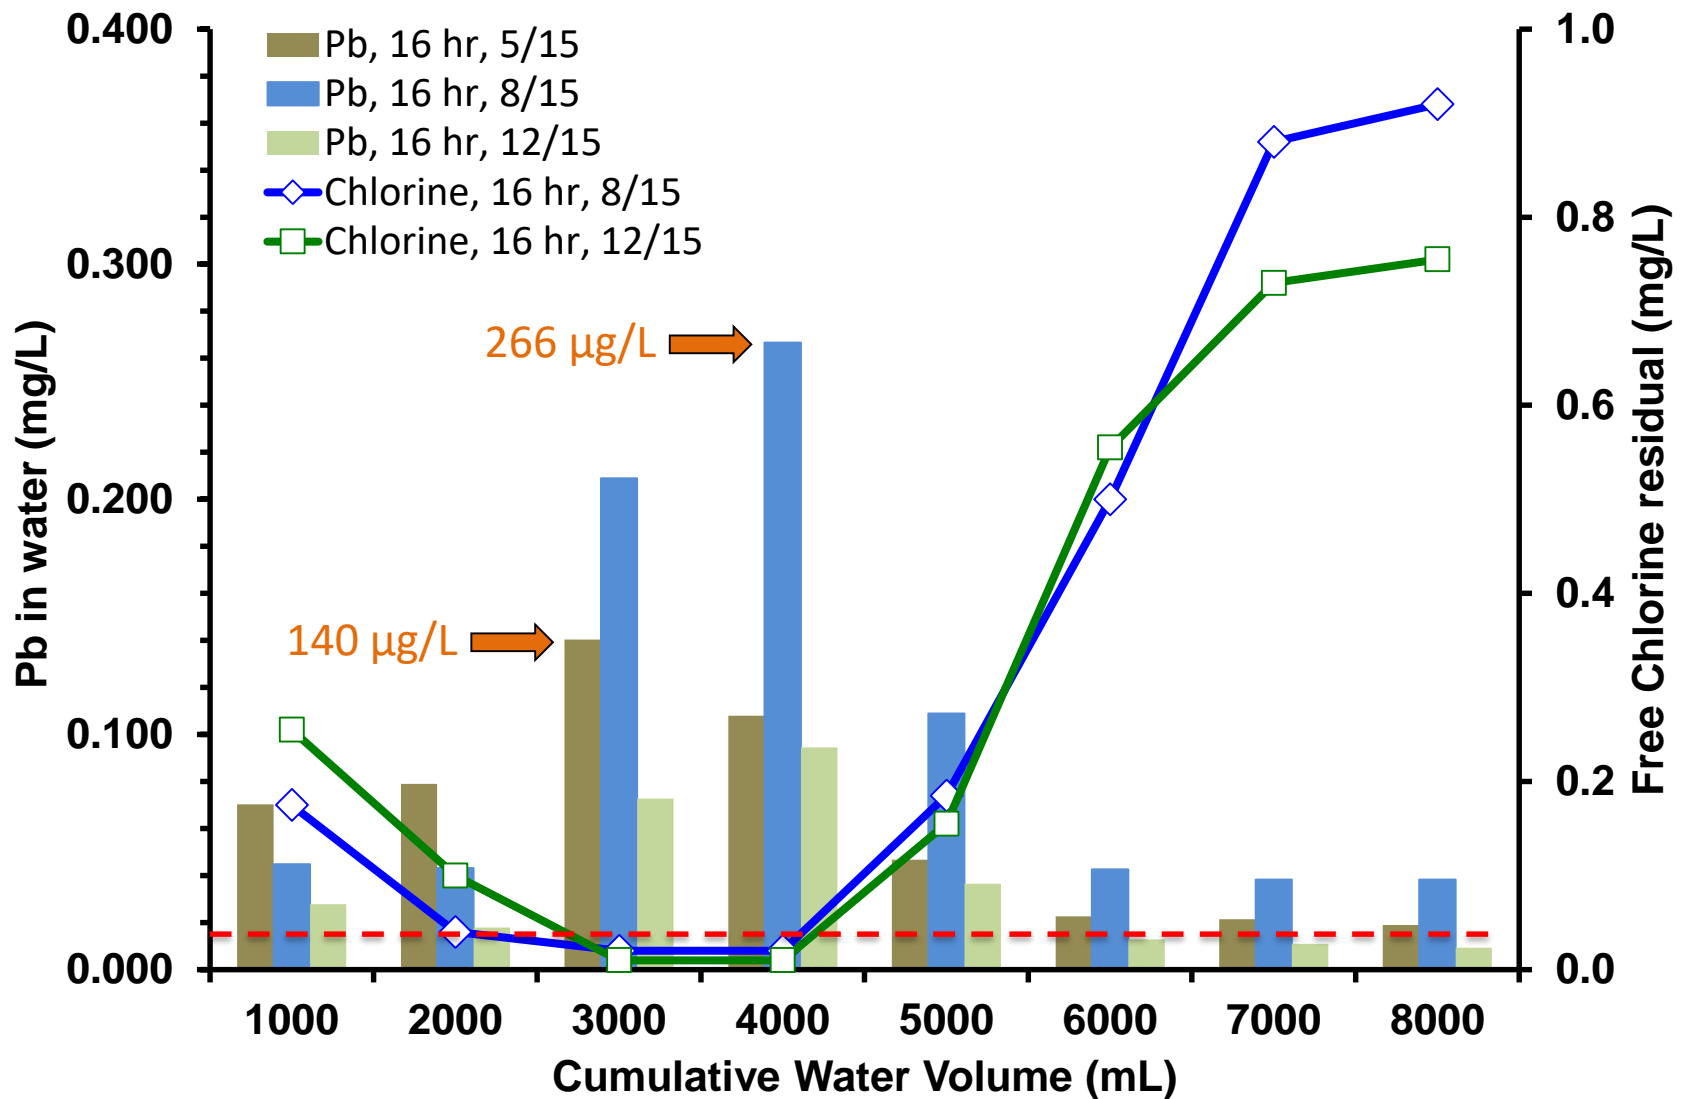
# SEQUENTIAL LITER SAMPLES 2015

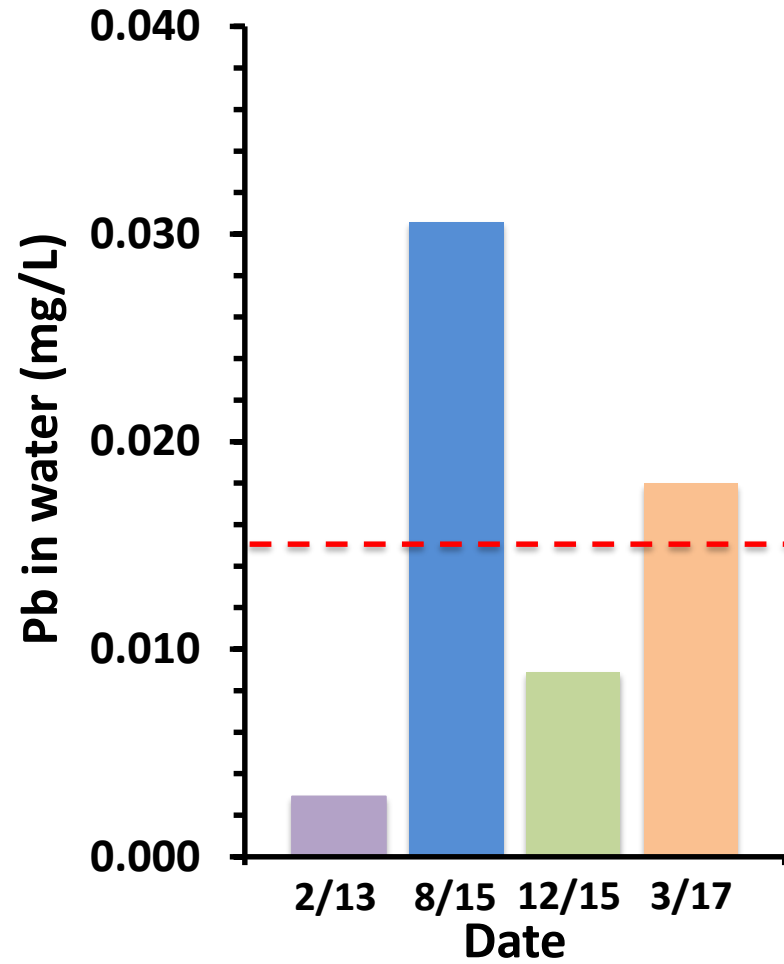
# *LEAD IN 5-MIN FLUSHED SAMPLES*

- No stagnation
- Reflects Pb picked up by water merely passing through pipe.
- 3x to 10x increase from 2013 levels

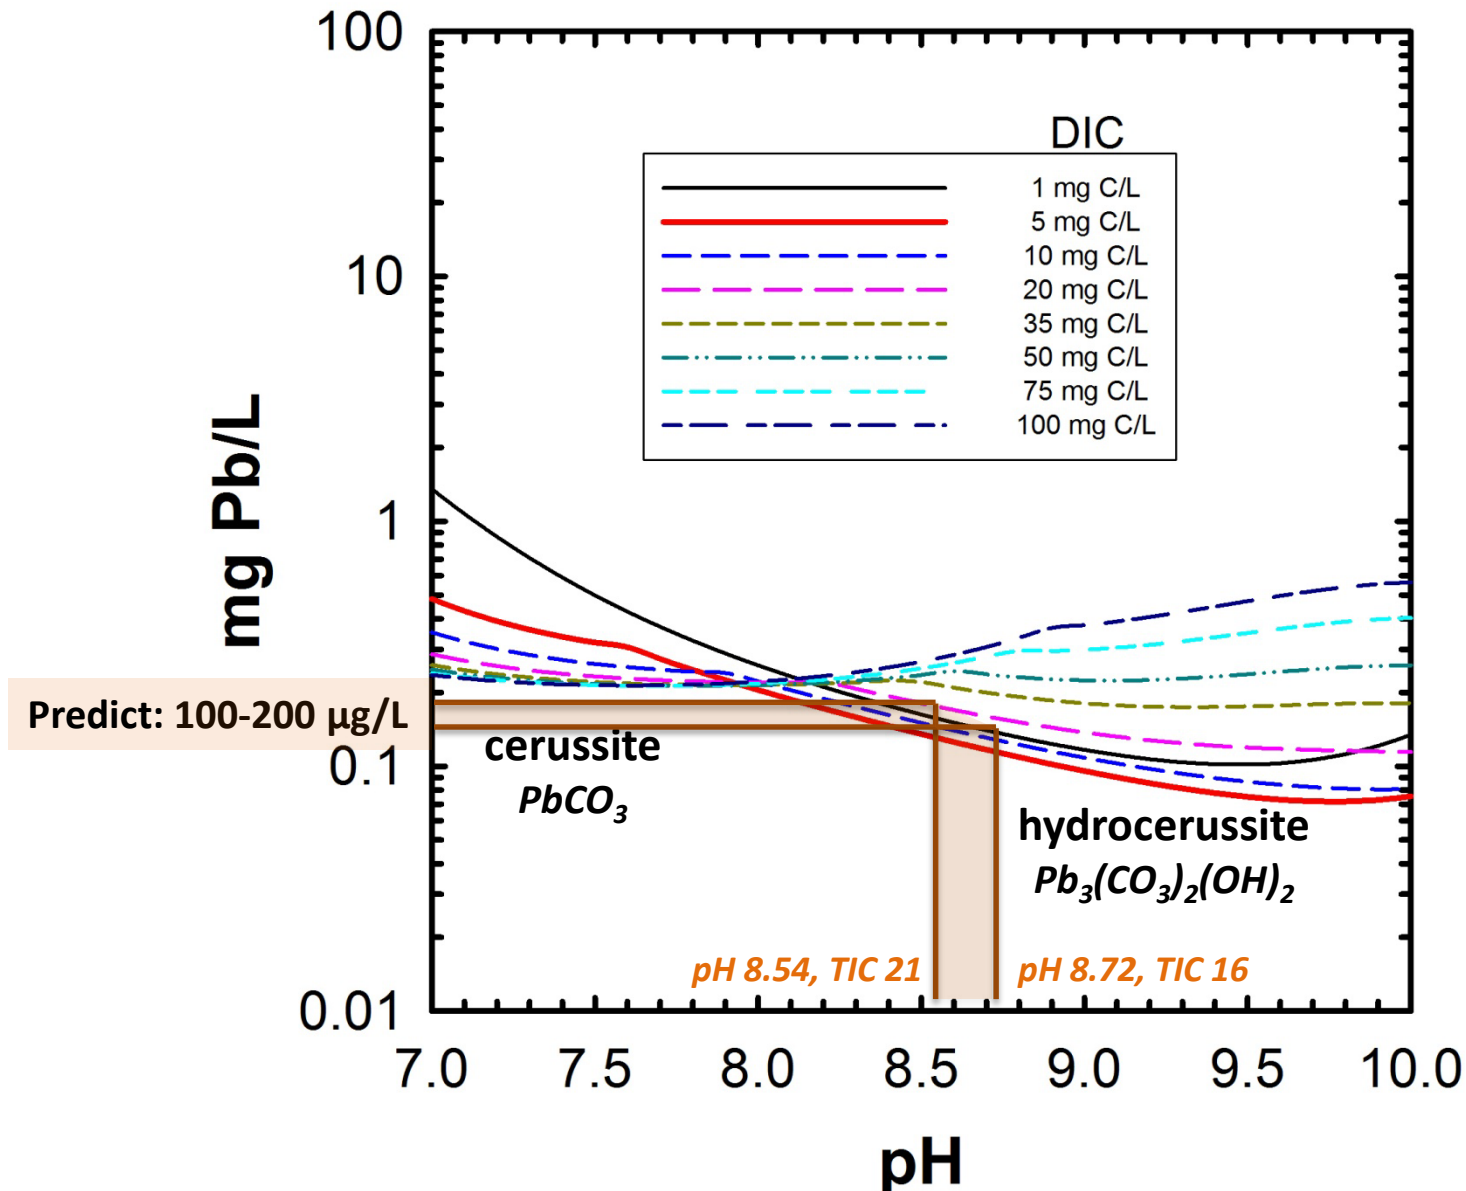
# PHASE PREDICTION FOR Pb LEVELS

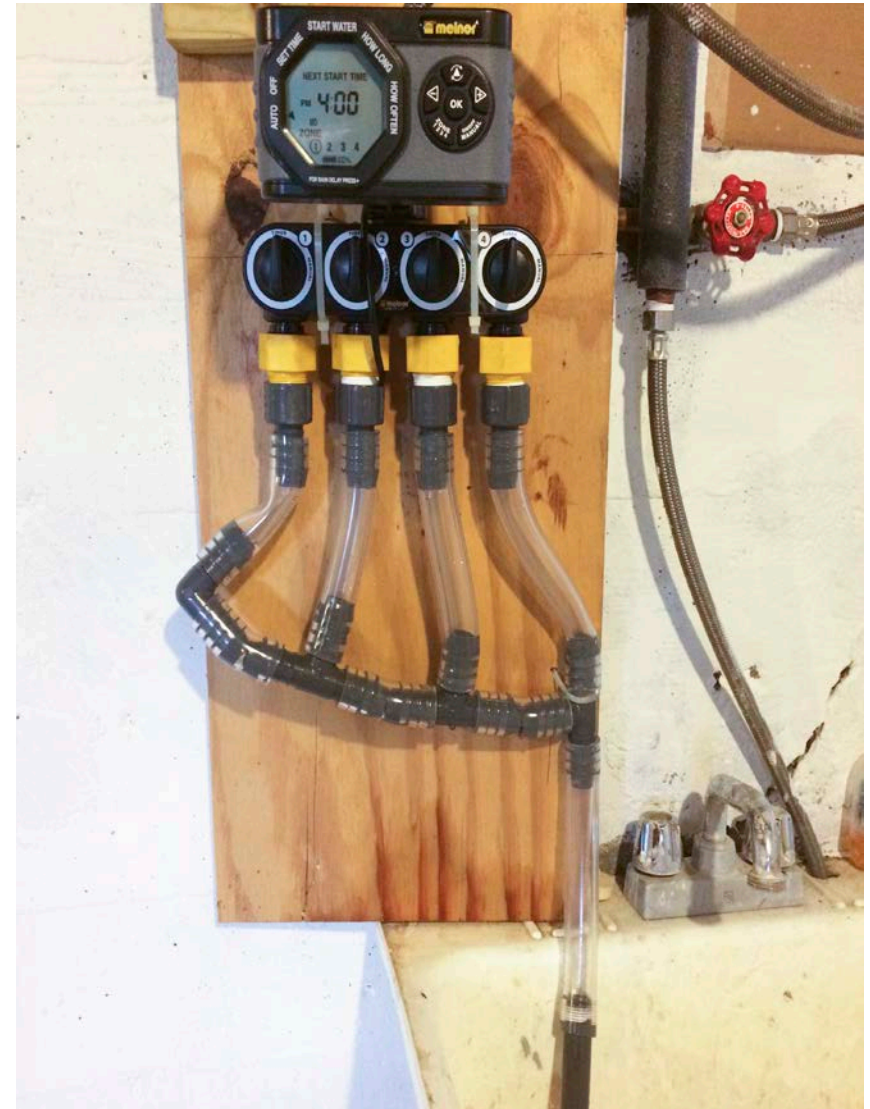
# REHABILITATION

- **Just add water??**
- Irrigation timer connected to premise plumbing near sampling point
  - Flush line for 2 minutes every hour at ~4.25 Lpm
  - ~8.5 liters each flush
  - ~204 liters (54 gallons) per 24 hour period
- Started 5/29/2017
- Periodically evaluate progress by analyzing Pb level and chlorine residual in service line

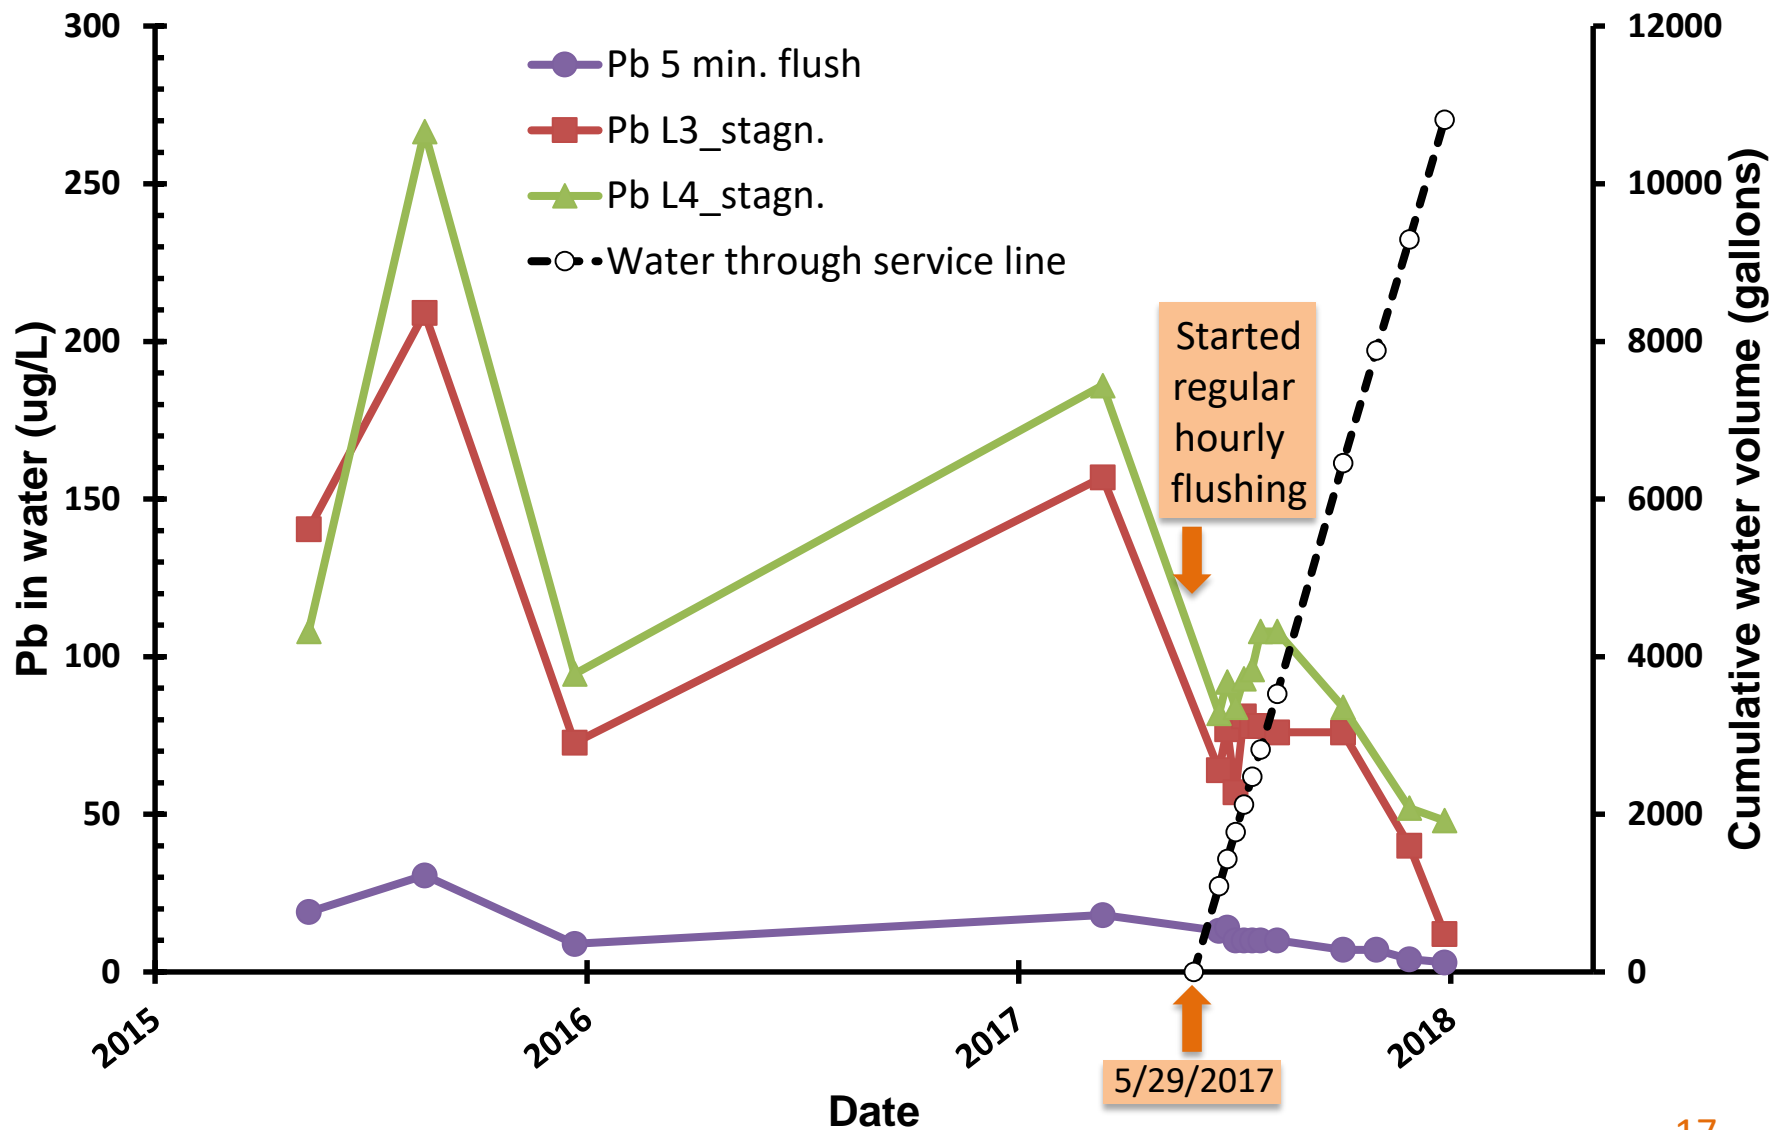
# PROGRESS

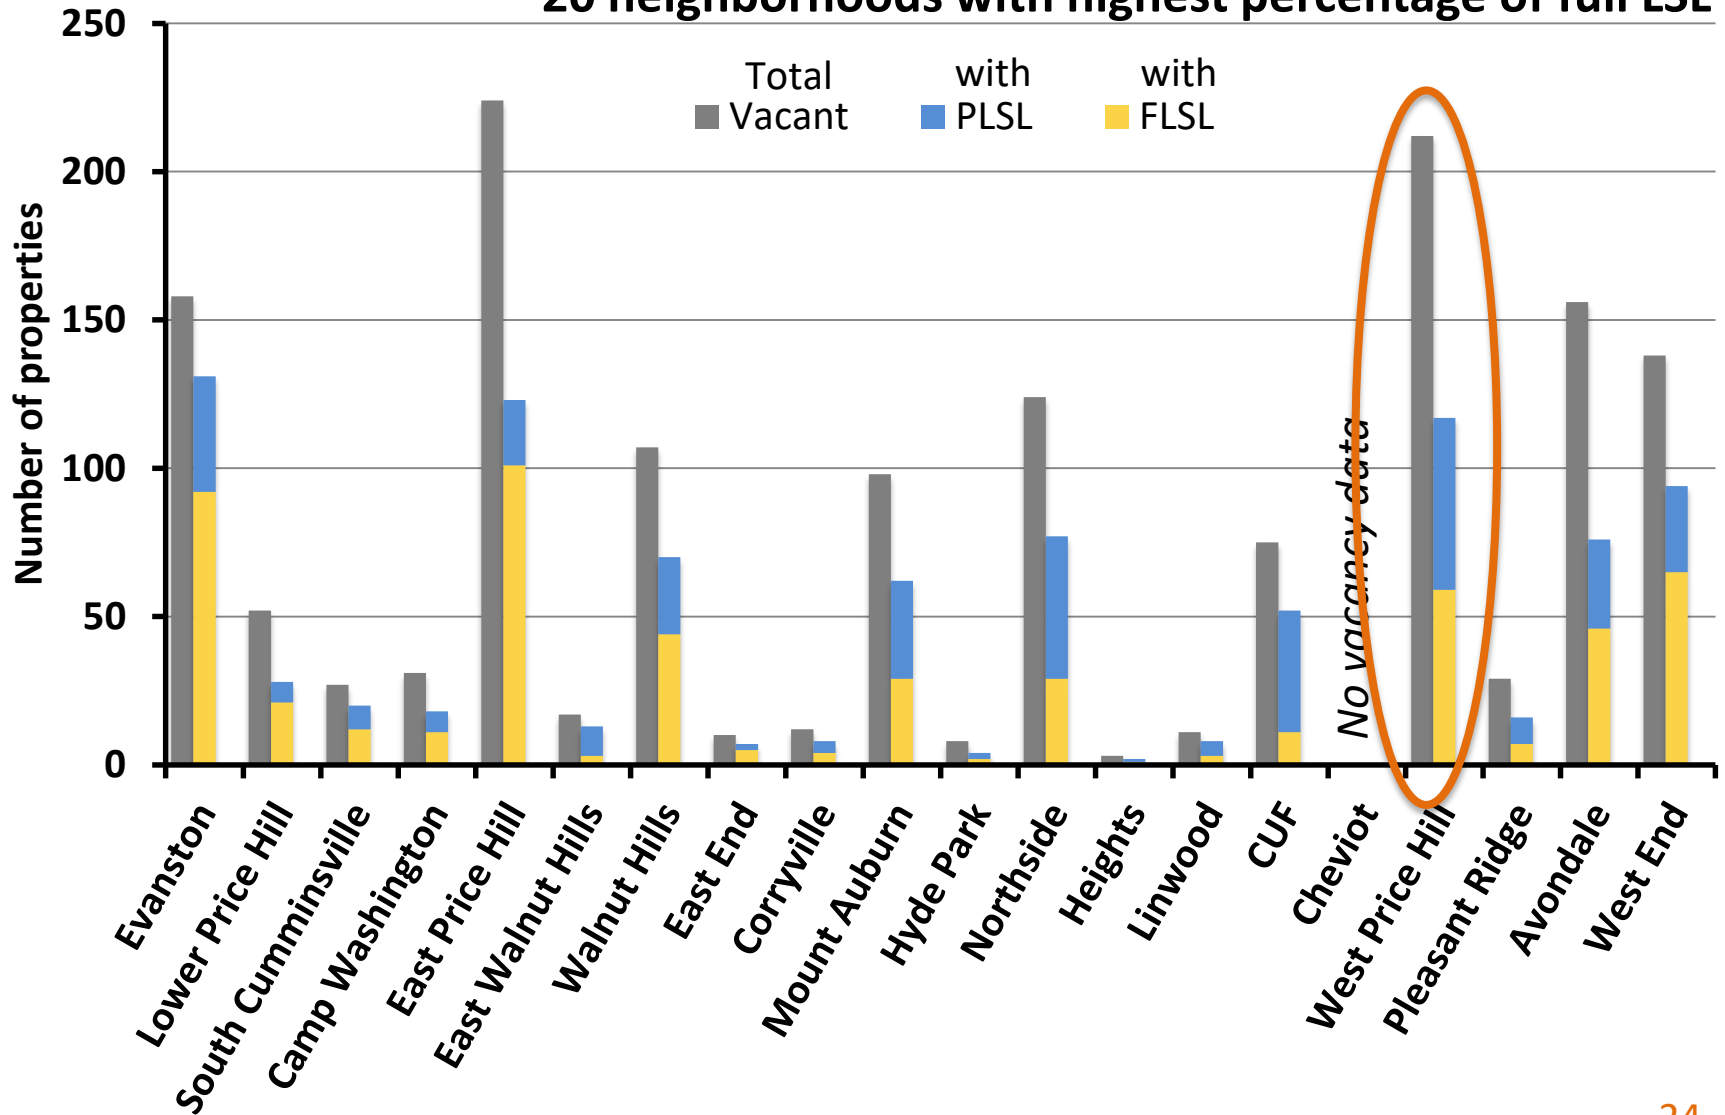
# VACANT BUILDINGS WITH KNOWN LSL

20 neighborhoods with highest percentage of full LSL
