# Some results of EPA Research on Permeable Pavement

*Michael Borst*

*U.S. Environmental Protection Agency*

*Site visit from NYC DDC, NYC DOT, and HD Inc.  
August 7, 2017*

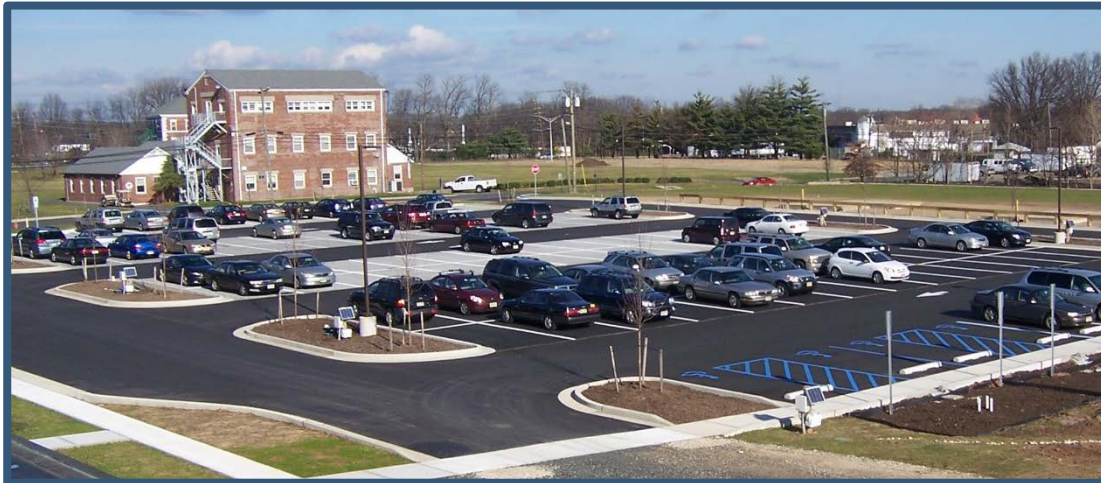
**EPA Facility Parking Lot**  
*Edison, New Jersey*

**In 2009, EPA designed and built a 1-acre parking lot for facility staff and visitors that was surfaced with three types of permeable pavement.**

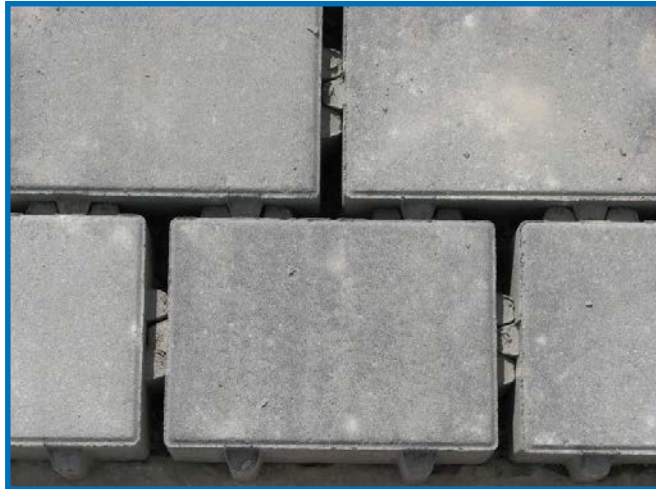
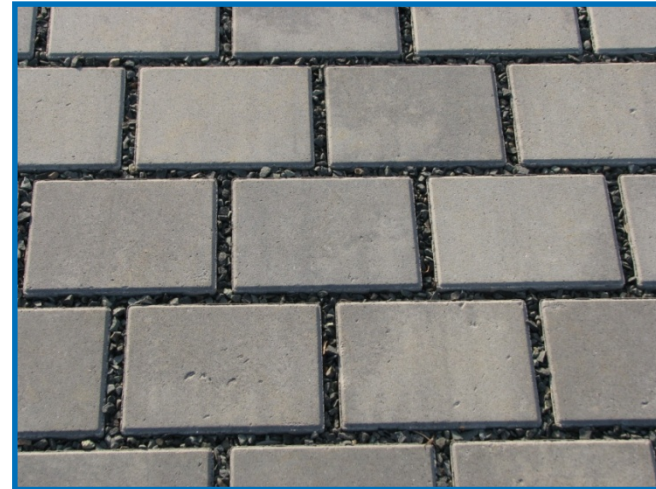
# Interlocking concrete paver installation took a little more than a week.

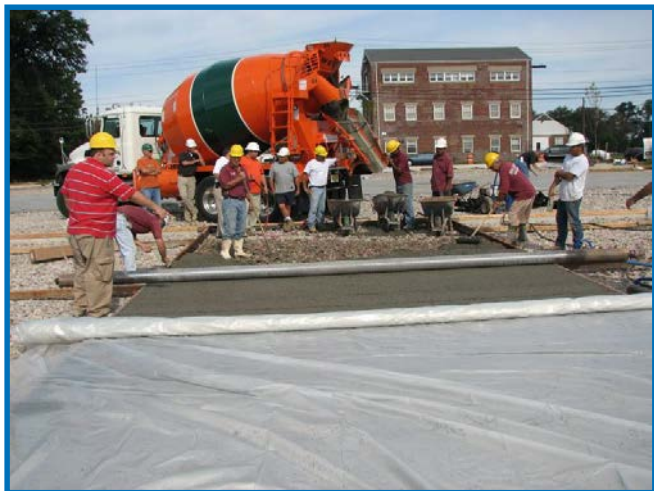
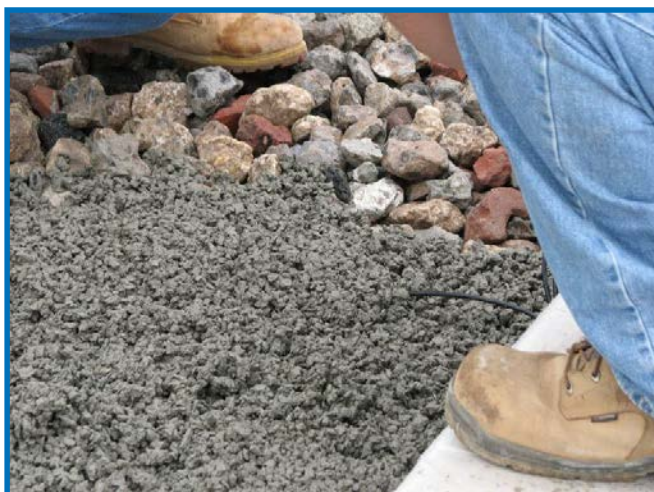
# The porous concrete pour took two days followed by a week of covered cure time

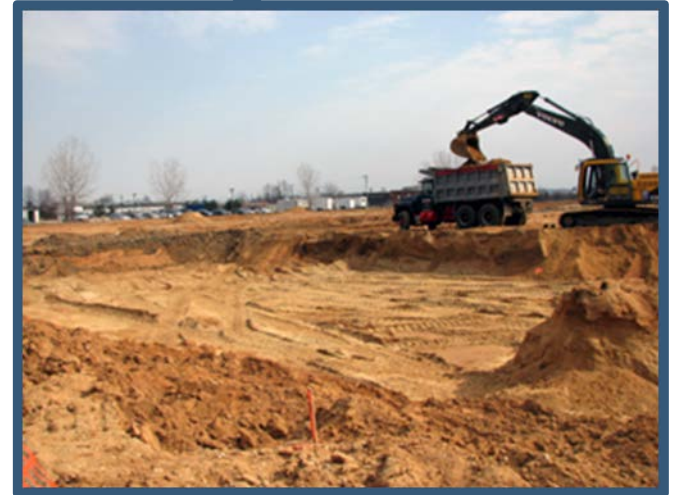
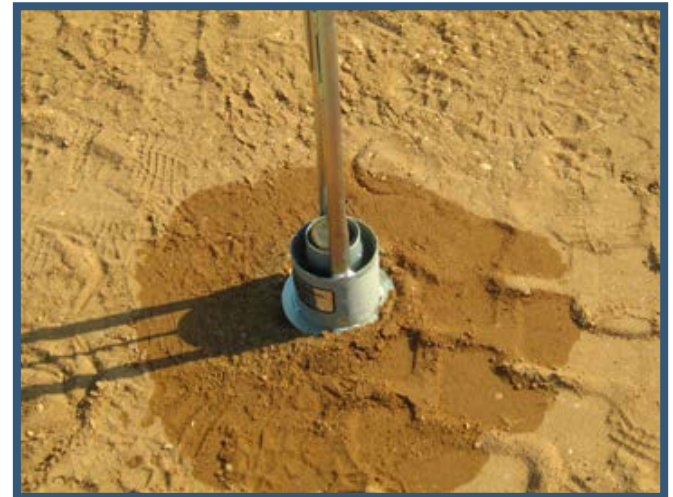
## Post excavation testing showed large infiltration rates for the underlying soil.

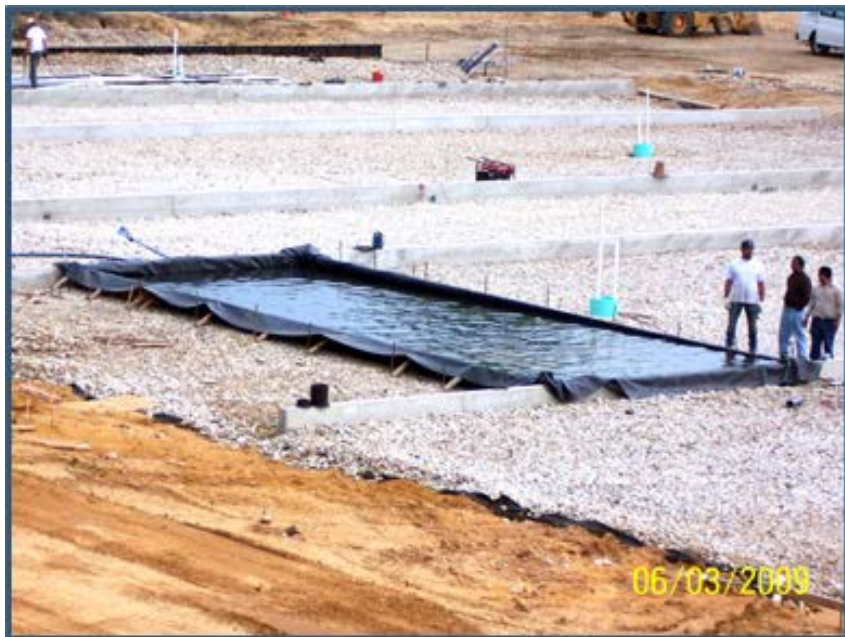
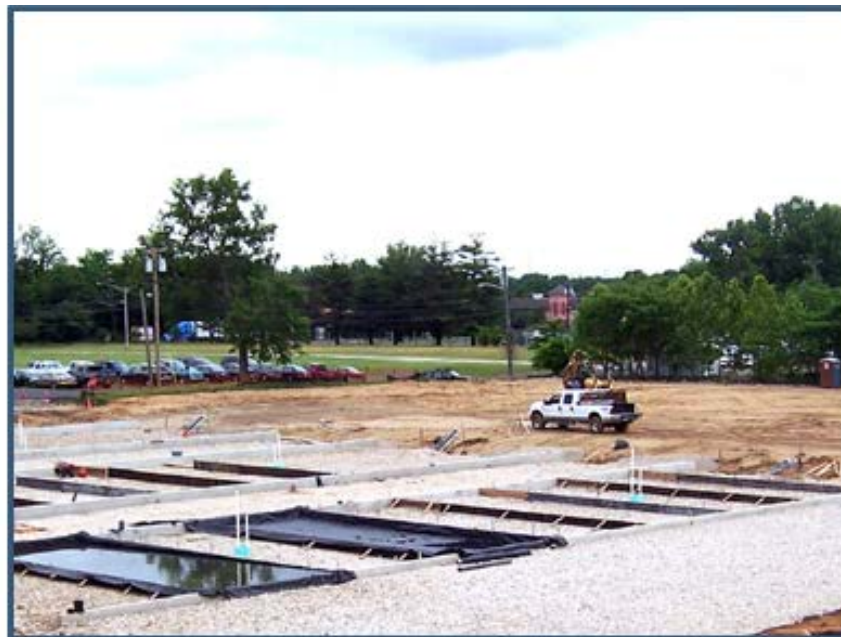
**Four equally-sized and spaced lined sections collect infiltrating water from each monitored permeable surface with the balance infiltrating to the underlying soil.**

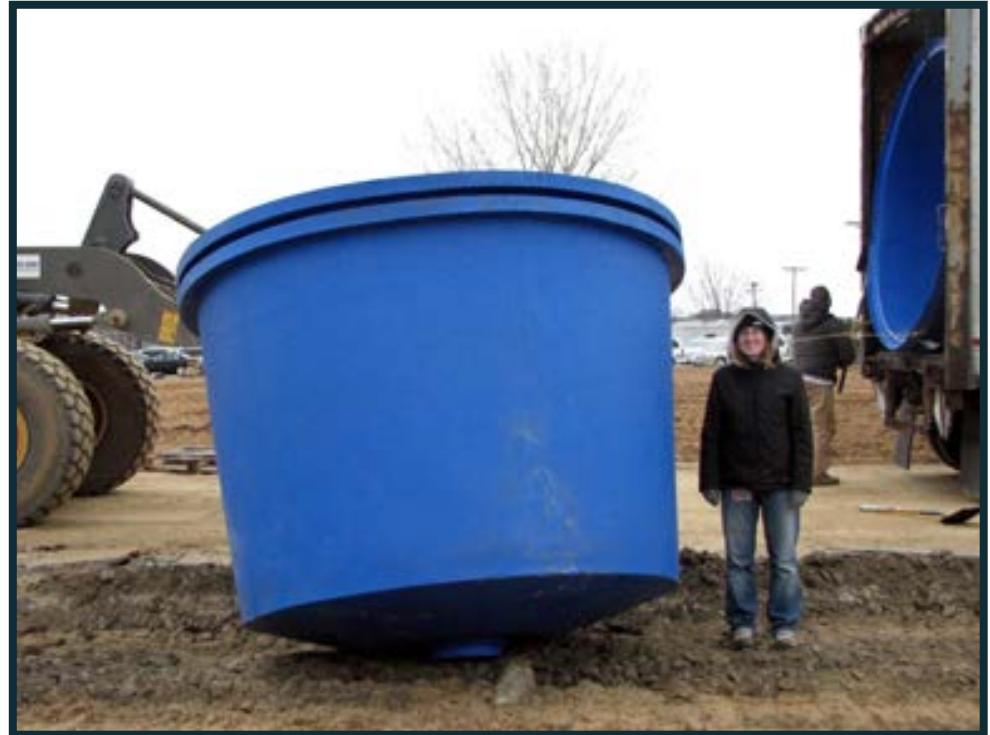
**Infiltrate drains from the lined sections to 1,500-gallon tanks on the east side of the parking lot where it can be sampled.**

**The tanks are designed to collect a 1.5-inch rain event before bypassing.**

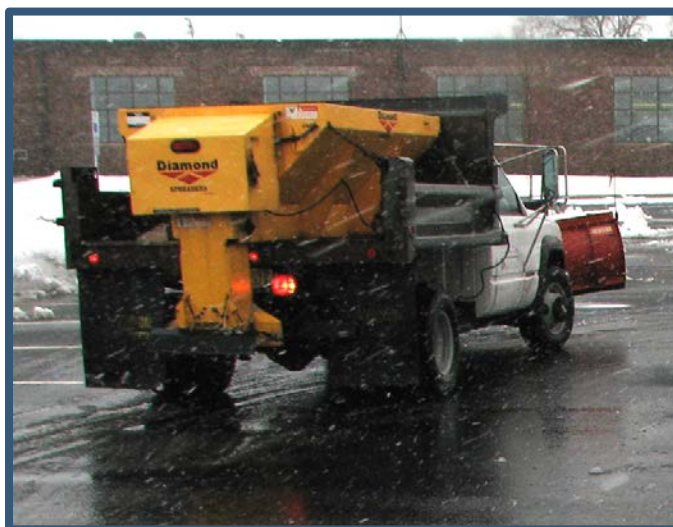
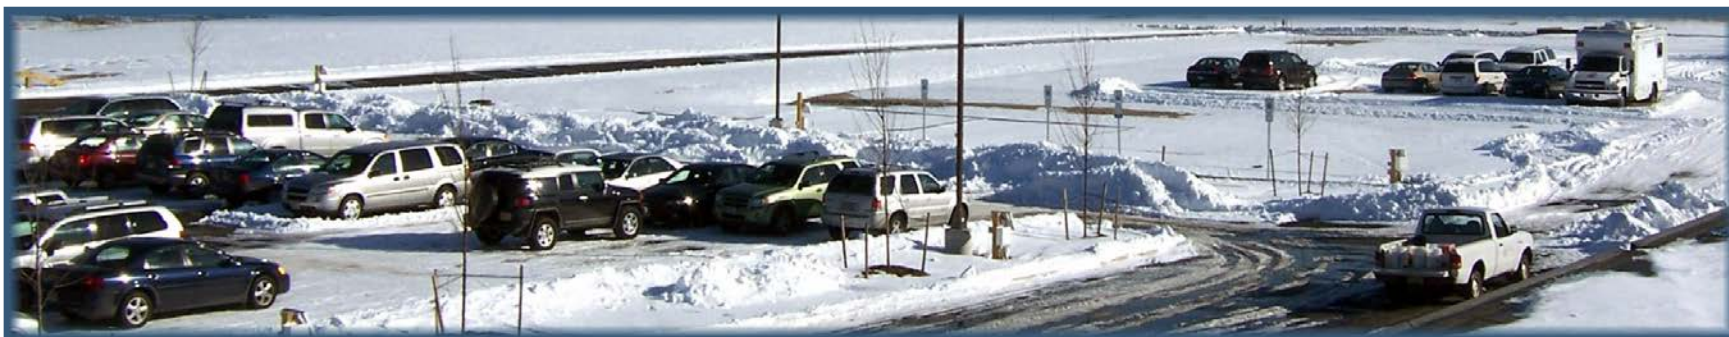
**We manage snow and ice with calcium chloride  
(with no sand) and a rubber edged plow blade.**

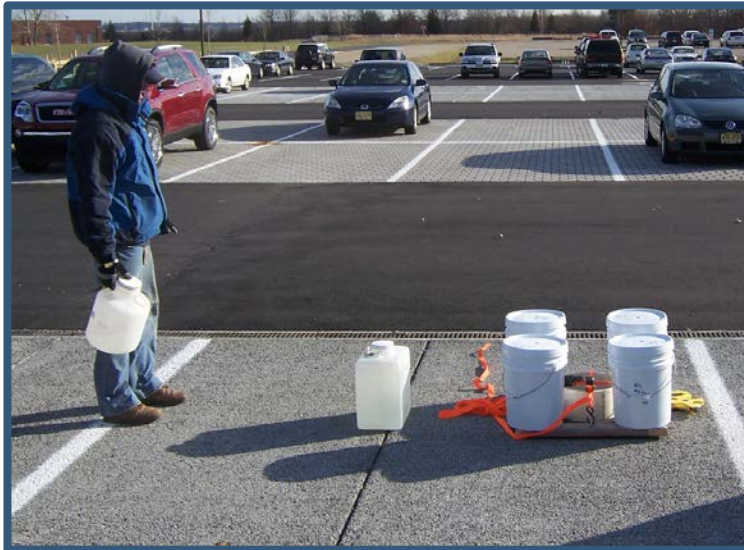
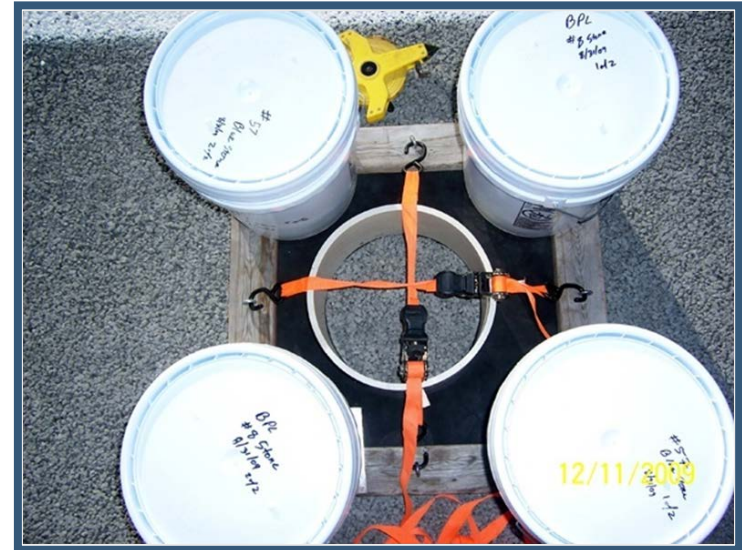
**We measured surface infiltration rates using a modified version of ASTM C1701 at roughly monthly intervals for about three years.**

Modifications were

- (1) how the seal was achieved between the ring and the surface
- (2) added temperature measurements of surface and water.

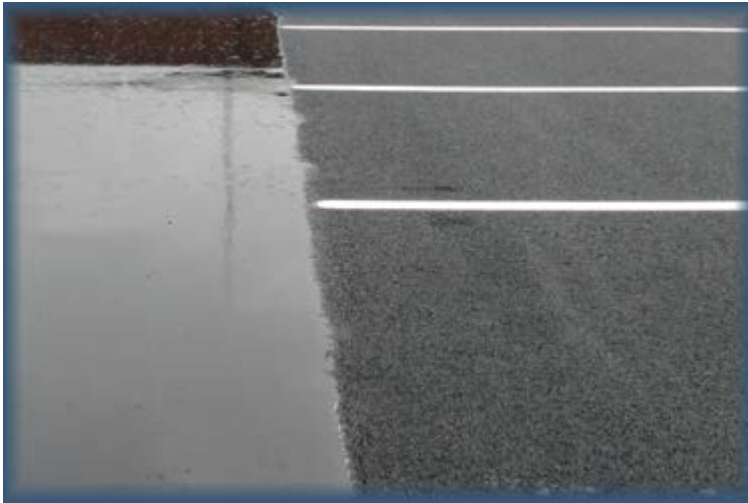
# Inspection supports the proposed mechanism.

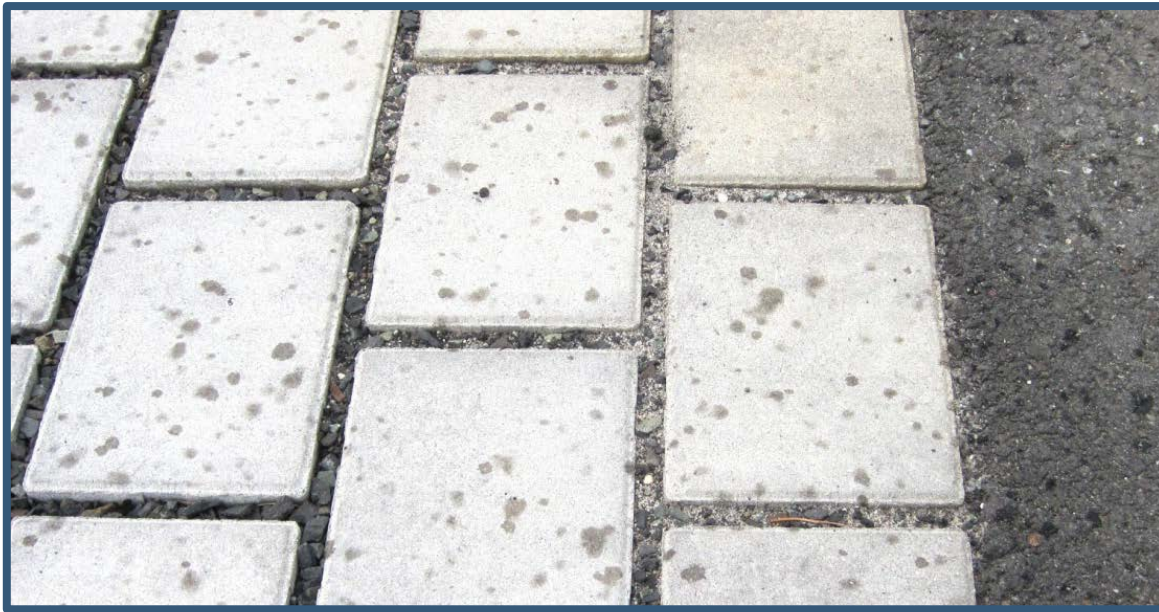
**The progressive accumulation was also visible in the PICP section.**

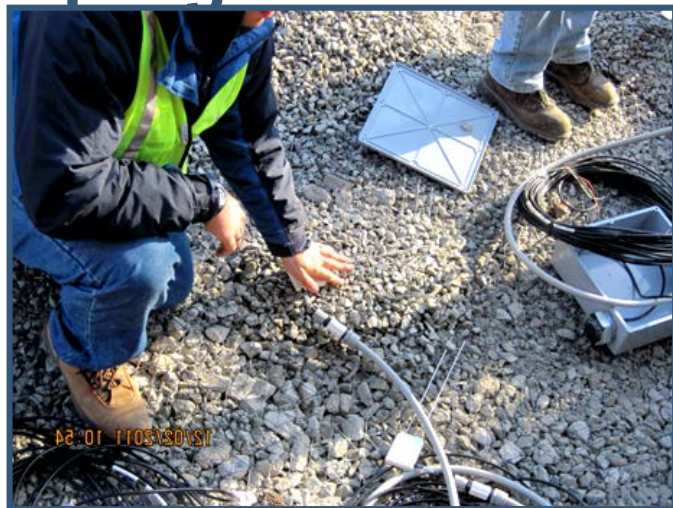
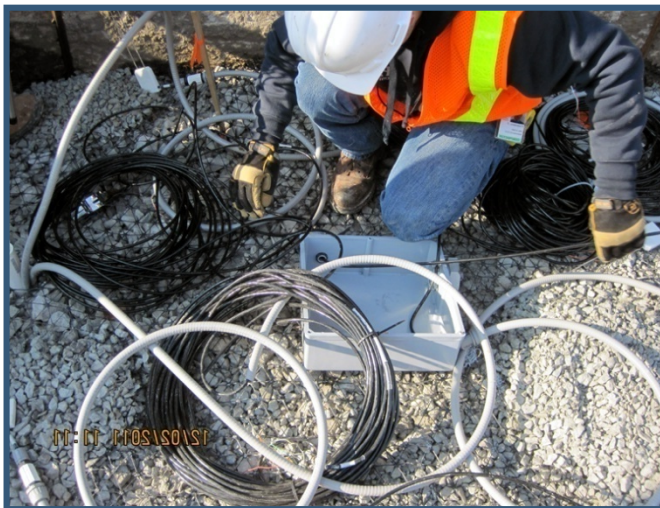
**Time Domain Reflectometers (TDRs) were installed 40 cm below the paver surface in the aggregate to measure surface clogging progression.**

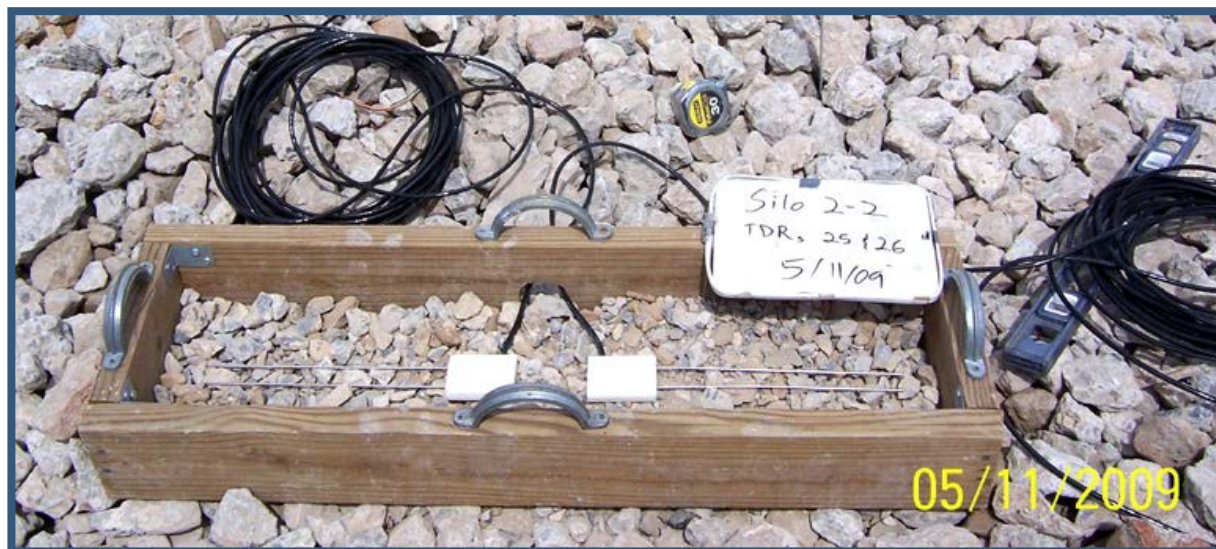
The foundational research<sup>1</sup> linking the TDR response to moisture content was done in mineral soils, not gravel so the output value is the “Relative Volumetric Water Content” (RVWC).

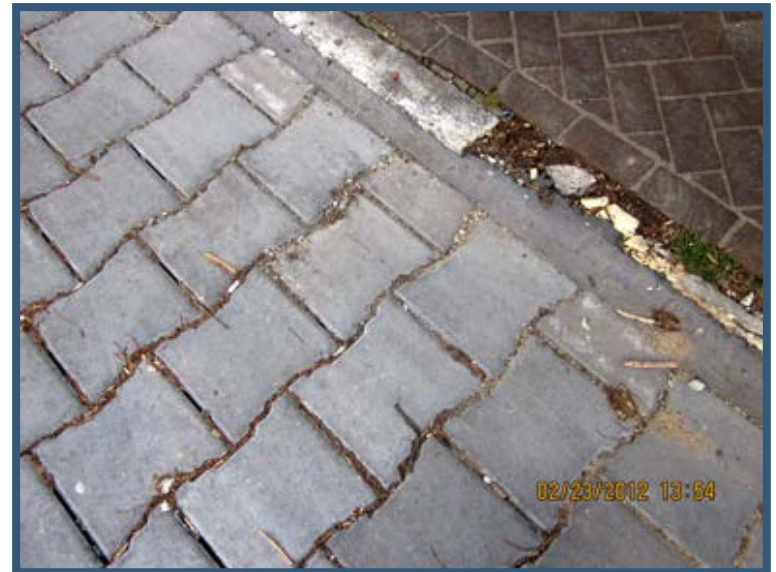
**Street slopes (longitudinal and transverse) and curbs (height and condition) are important considerations when placing the controls in a curb and gutter system.**

Short curbs by design (or resulting from multiple resurfacing without milling) will limit the working flow width of the control.

Steeper slopes concentrate flow and use less surface area.

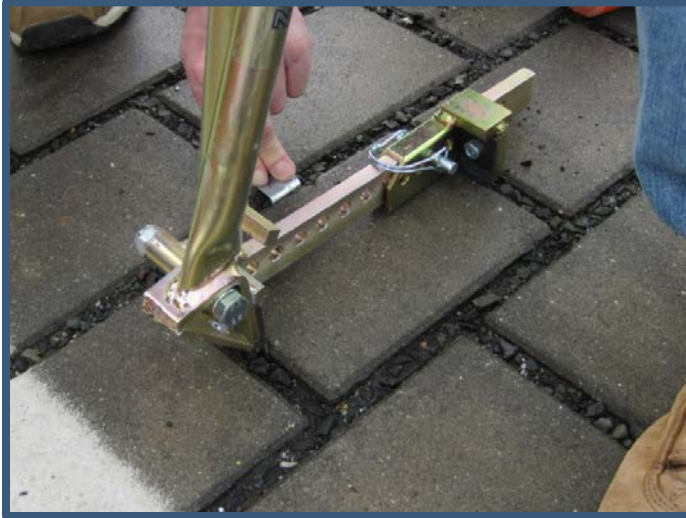
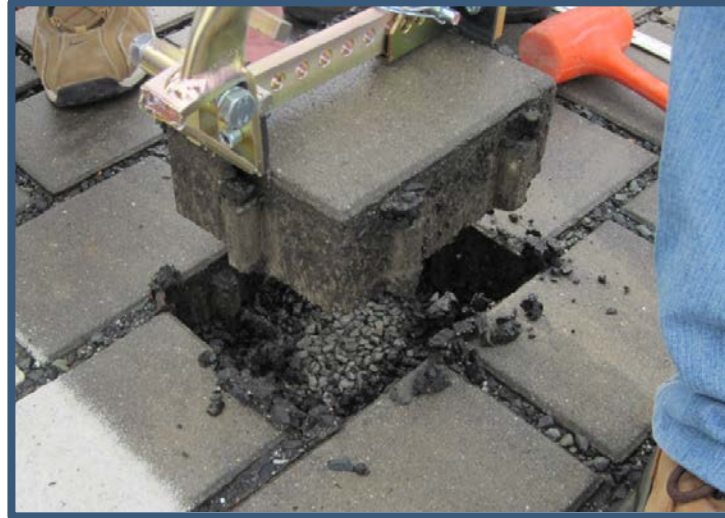
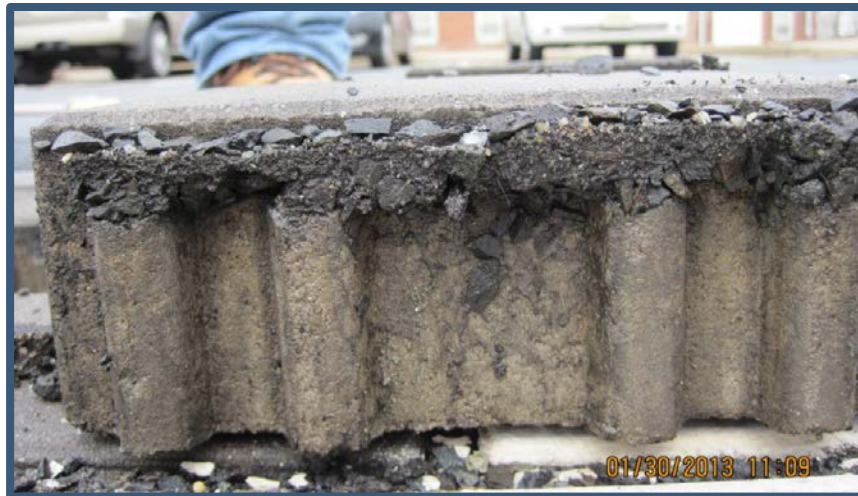
# Removing pavers at selected locations shows how clogging advances with gaps filled and small debris loading.

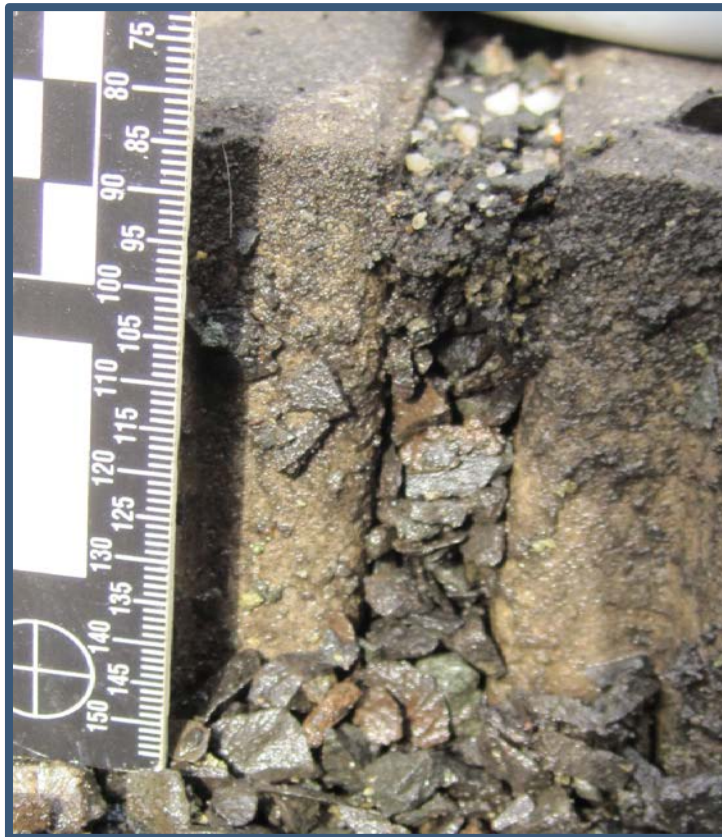
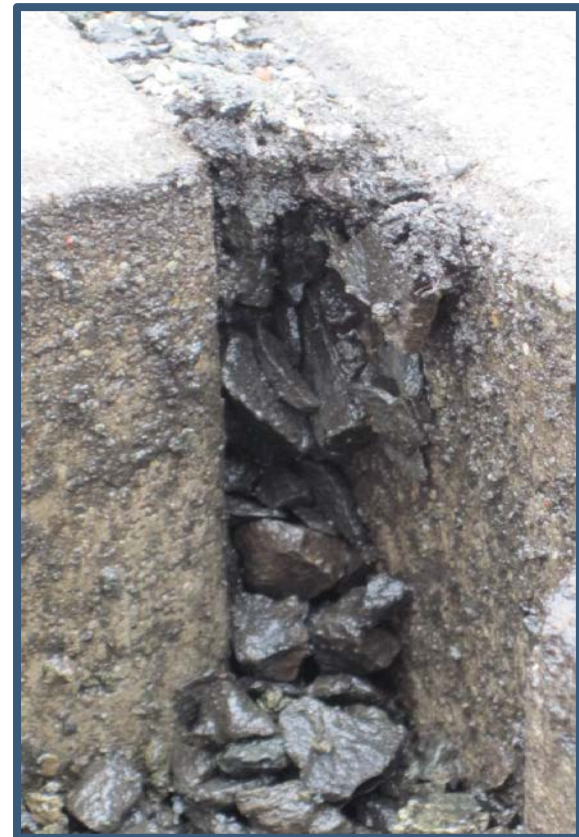
**With aggregate between the pavers, most of the fines are trapped in the top 20 mm.**

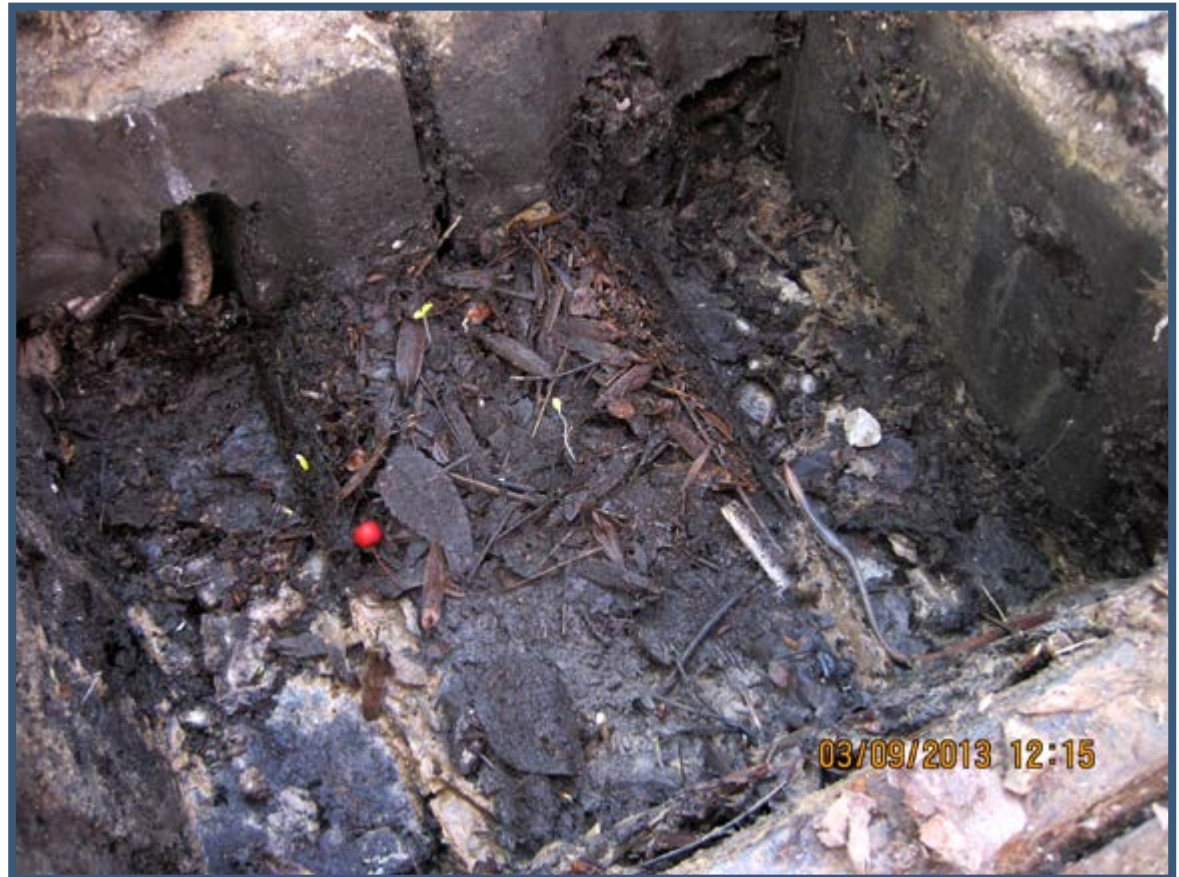
**When pavers are installed without interstitial gravel, sediment progresses the full depth of the paver.**

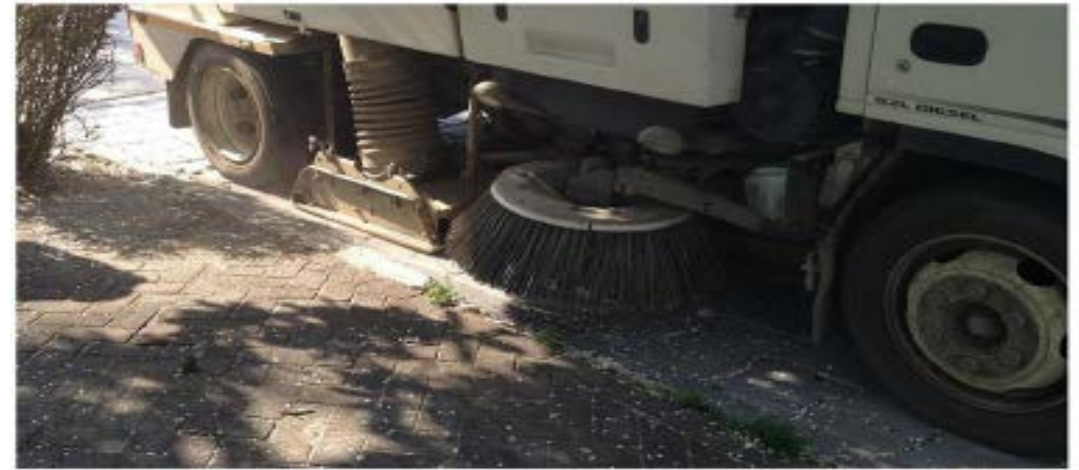
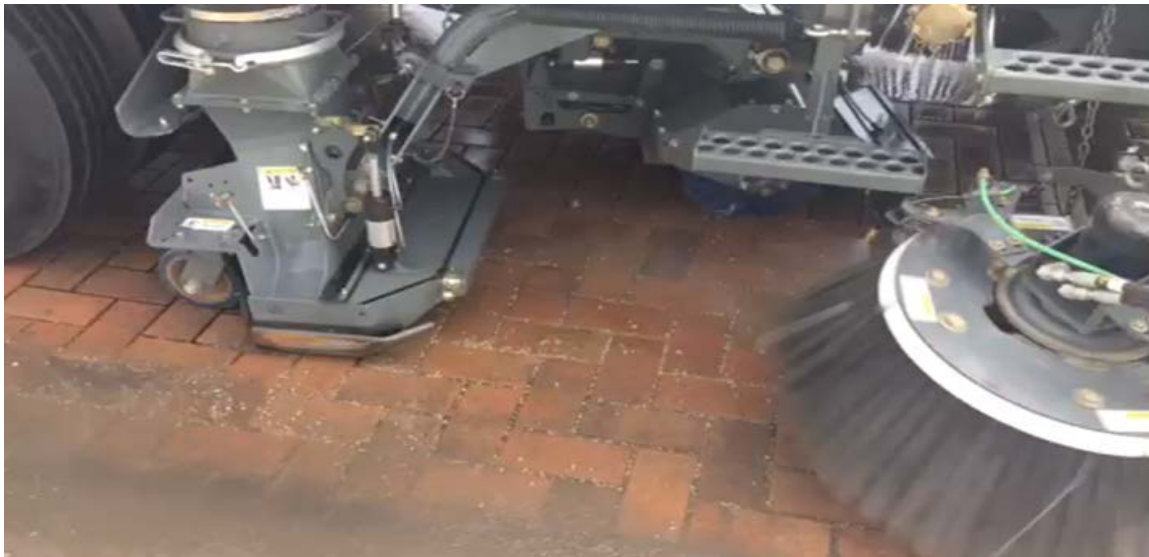
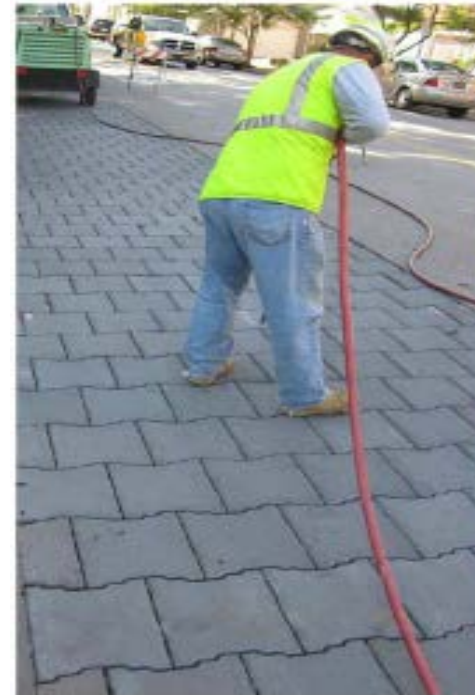
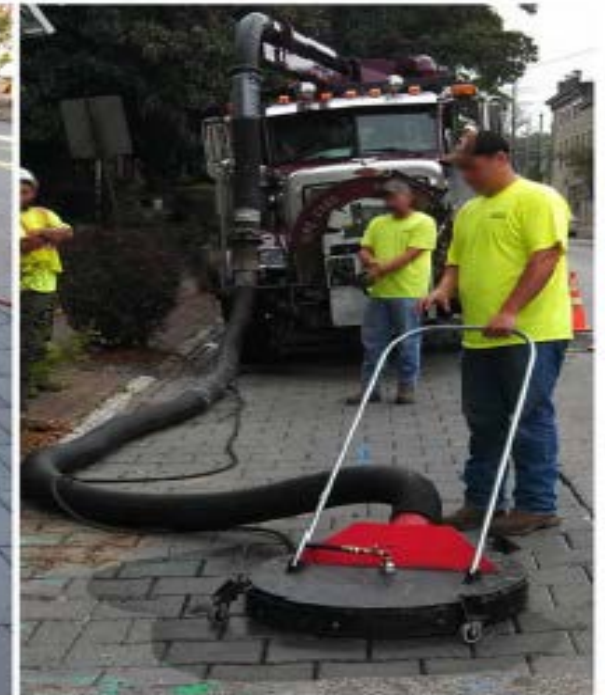
As part of the research in Louisville we looked at three maintenance techniques.

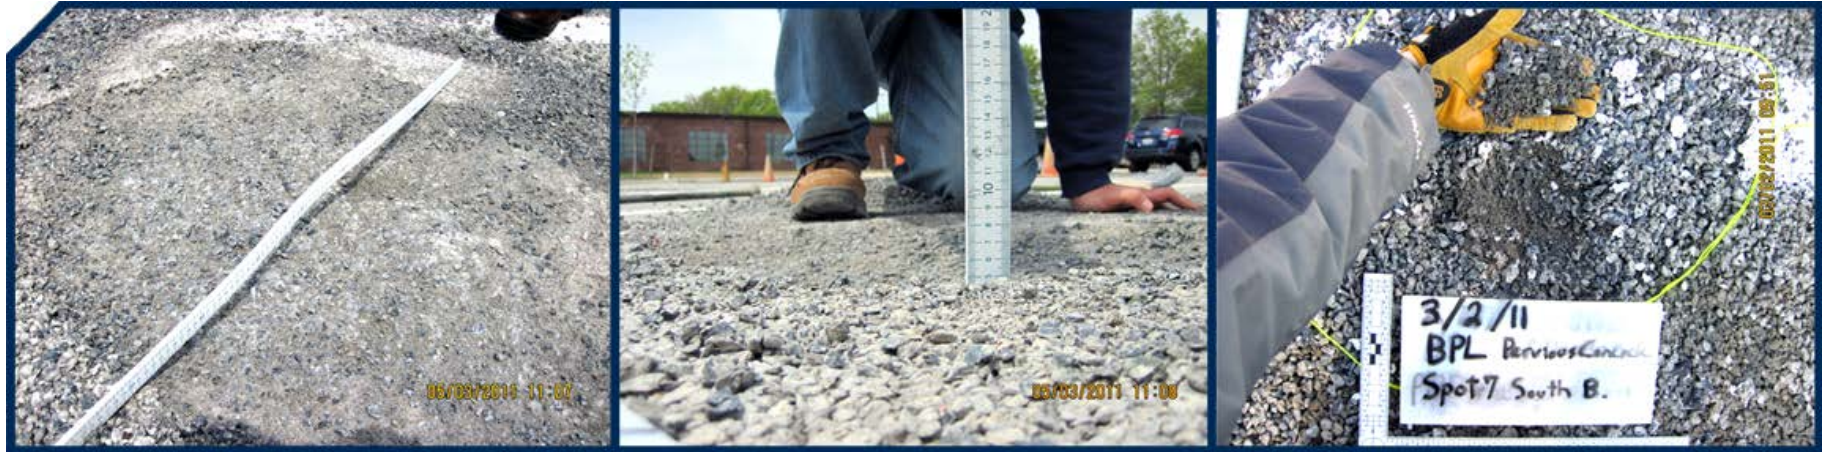
# Large portions of the pervious concrete at the Edison site disaggregated.

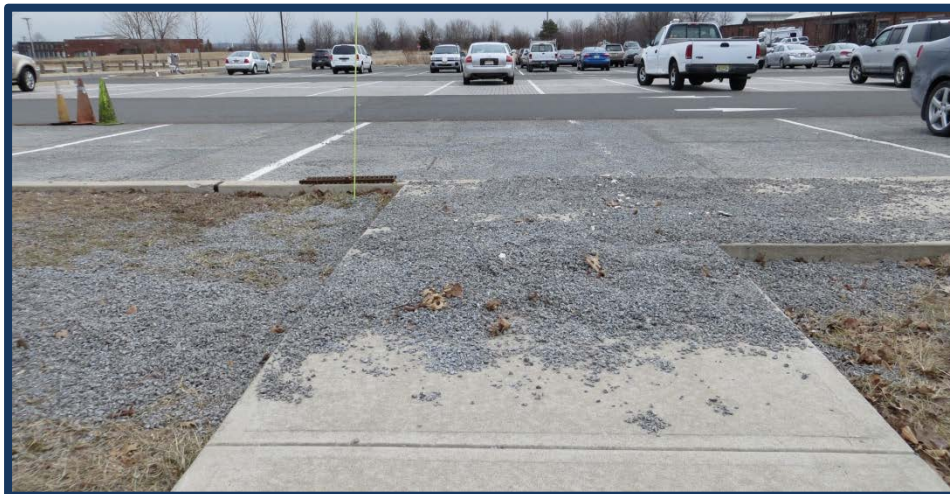
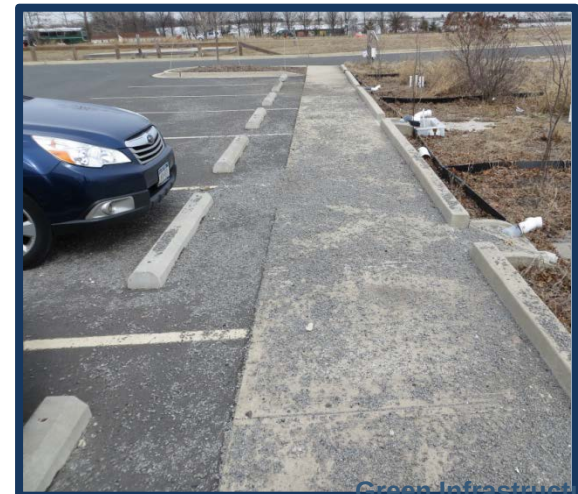
The problem first became apparent about 18 months after pouring concrete. It was repaired by the contractor in May 2011, but has recurred.

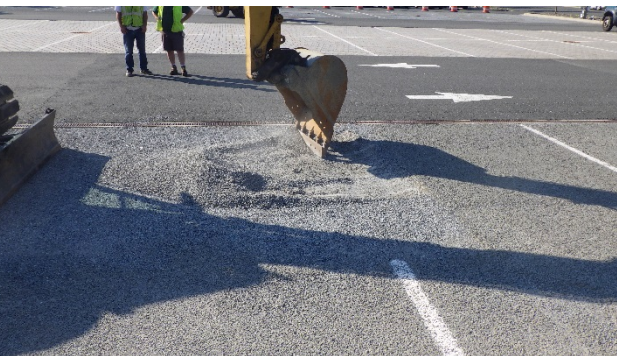
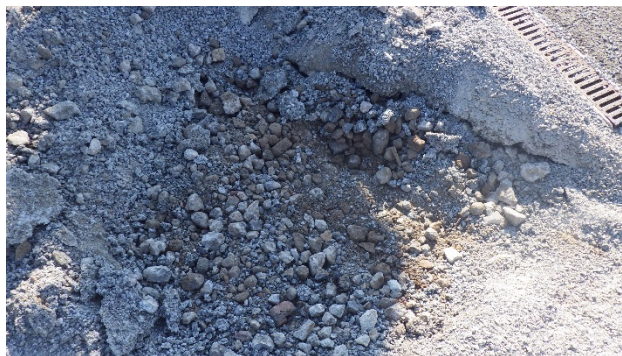
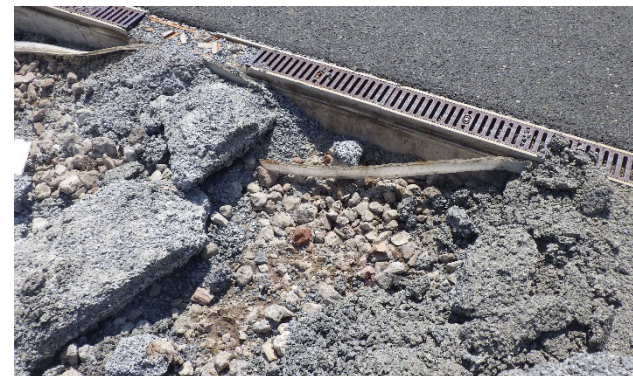
## The raveling did not penetrate the full depth of the porous concrete.
