Permeable Pavement Research Highlights

Performance and effectiveness of permeable pavement systems

Michael Borst

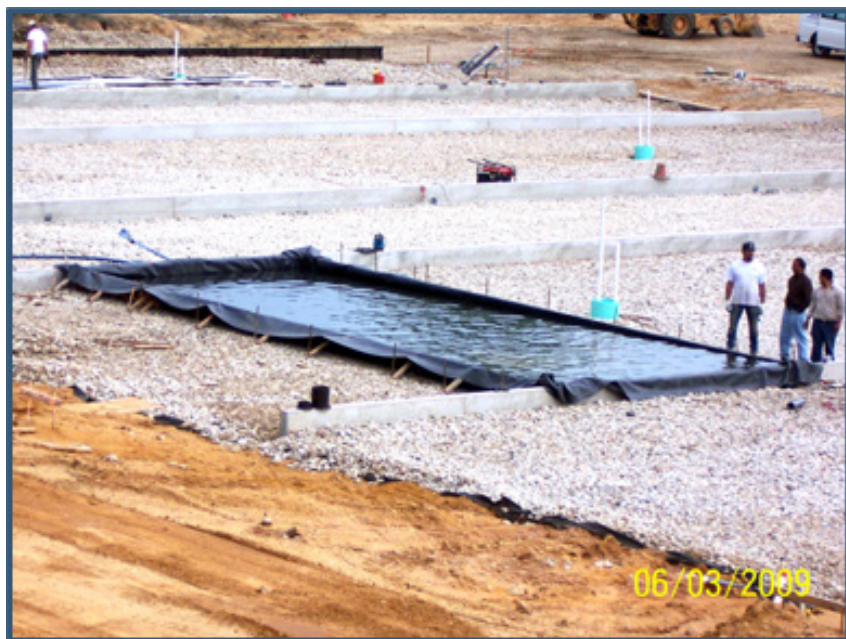
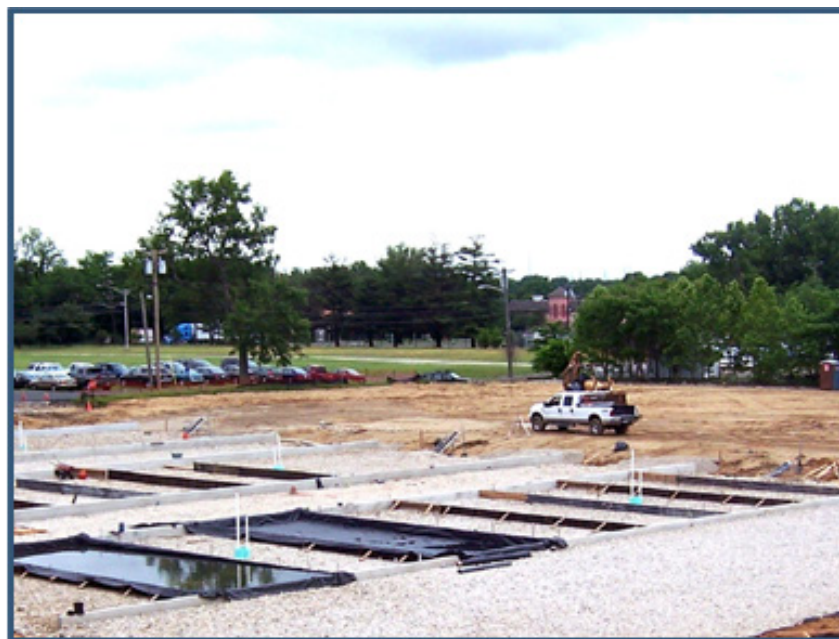
Four equally-sized and spaced lined sections collect infiltrating water from each monitored permeable surface with the balance infiltrating to the underlying soil.

Infiltrate drains from the lined sections to 1,500-gallon tanks on the east side of the parking lot where we can collect samples.

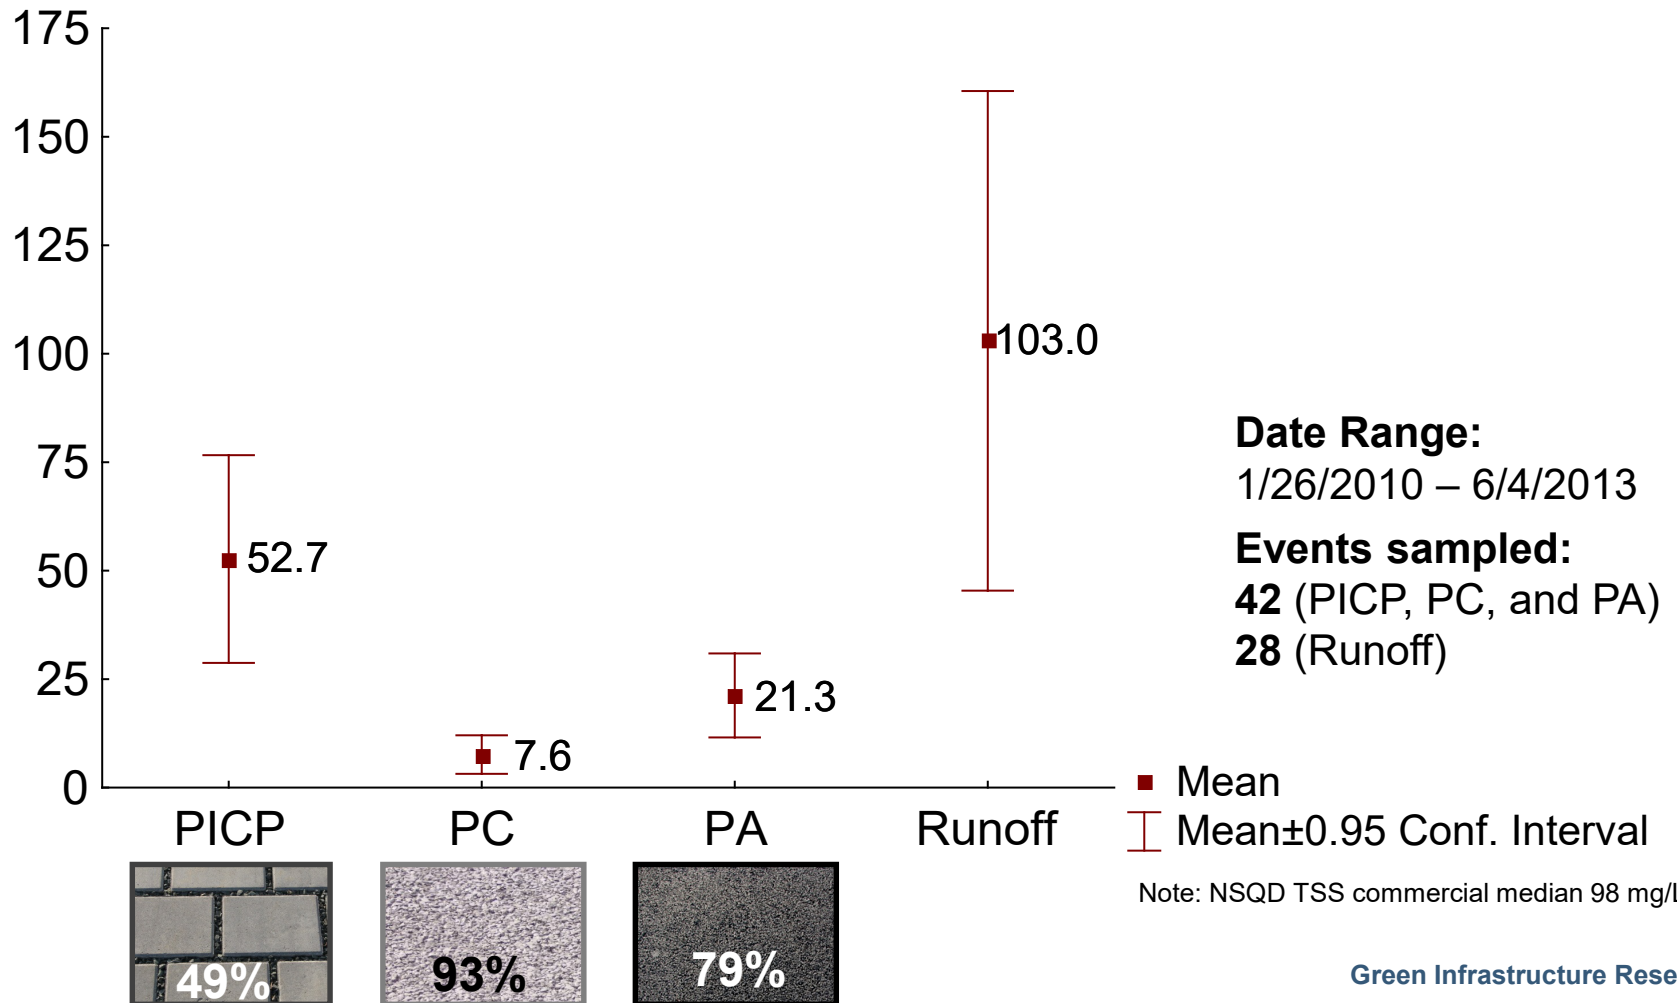
All permeable surfaces reduced Suspended Solids Concentration (SSC) to different degrees.

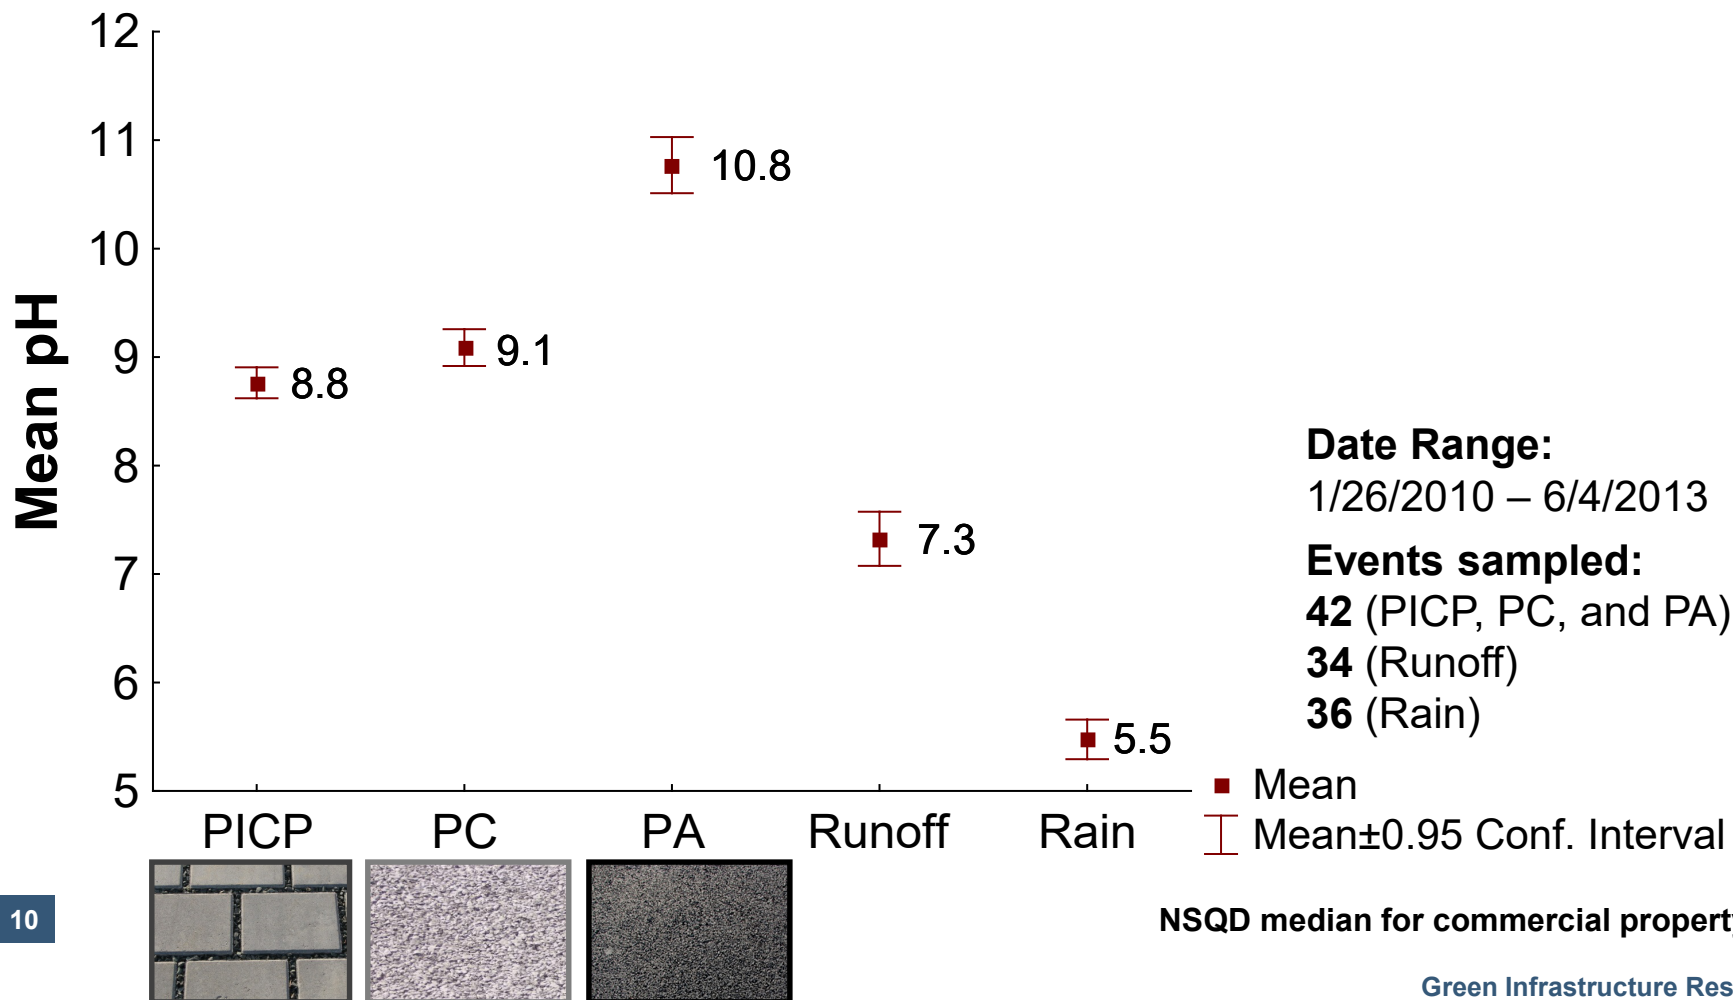
Acidic rainfall is buffered by all pavement surfaces, and PA exfiltrate is surprisingly basic.

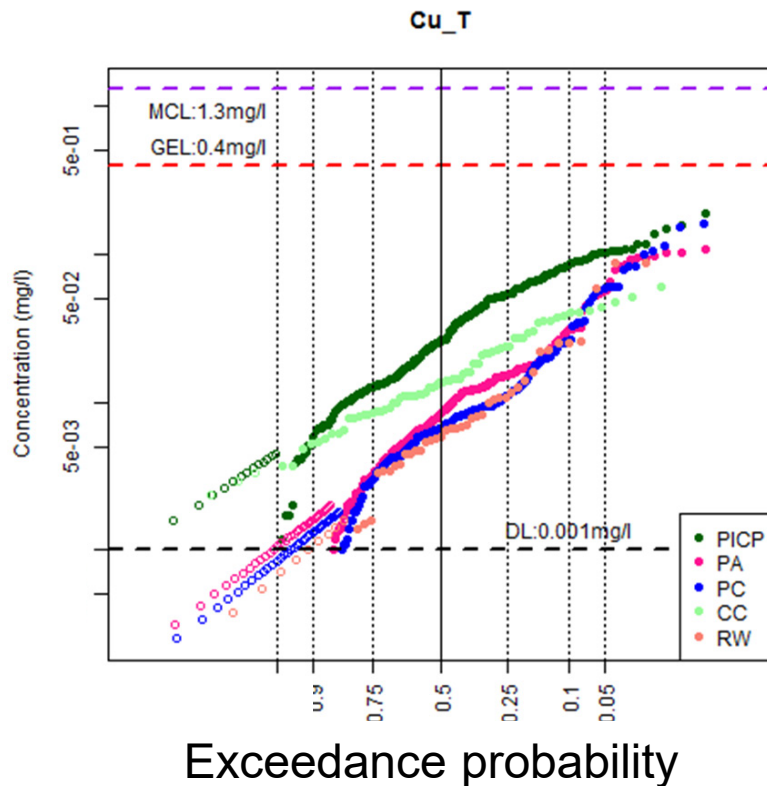
The concentration of priority-pollutant metals were generally less than the groundwater discharge limit.

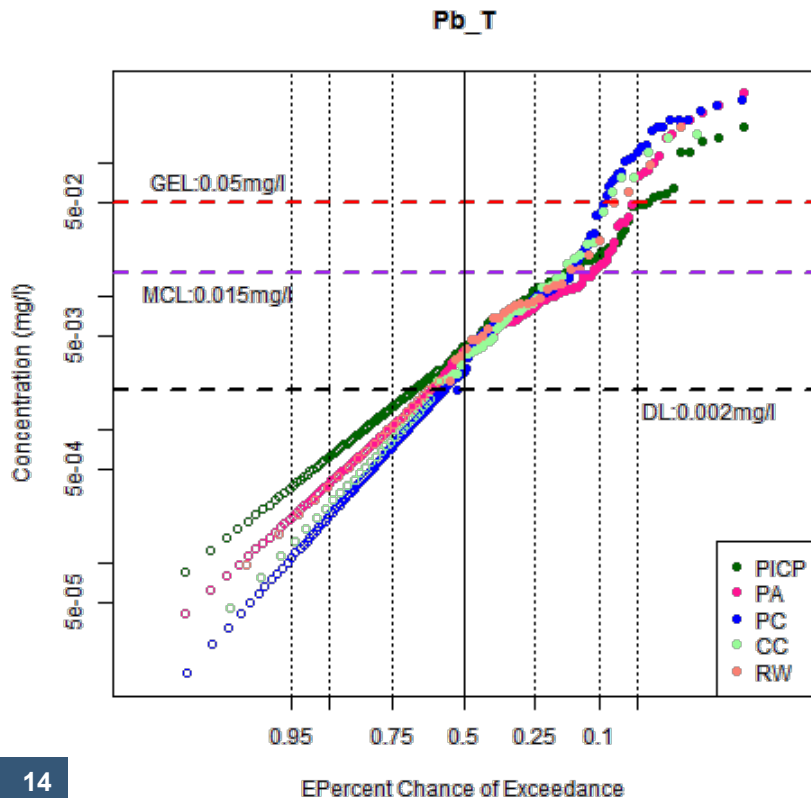
Total lead concentration does not differ across sources and sometimes exceeds regulatory limits.

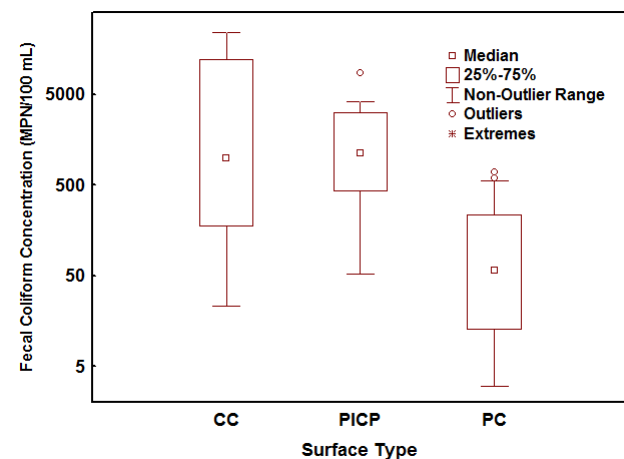
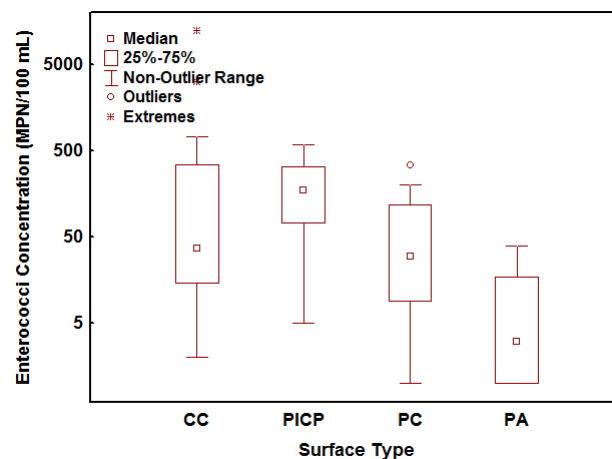
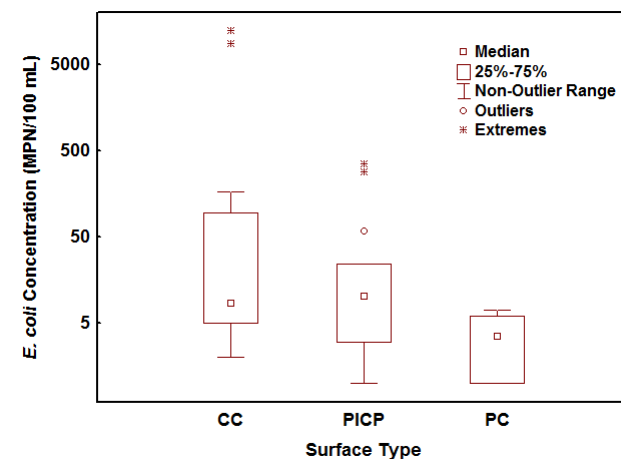
PA infiltrate consistently showed the smallest concentration of microbial indicators

Fecal coliform and *E. Coli* not detected in PA infiltrate.

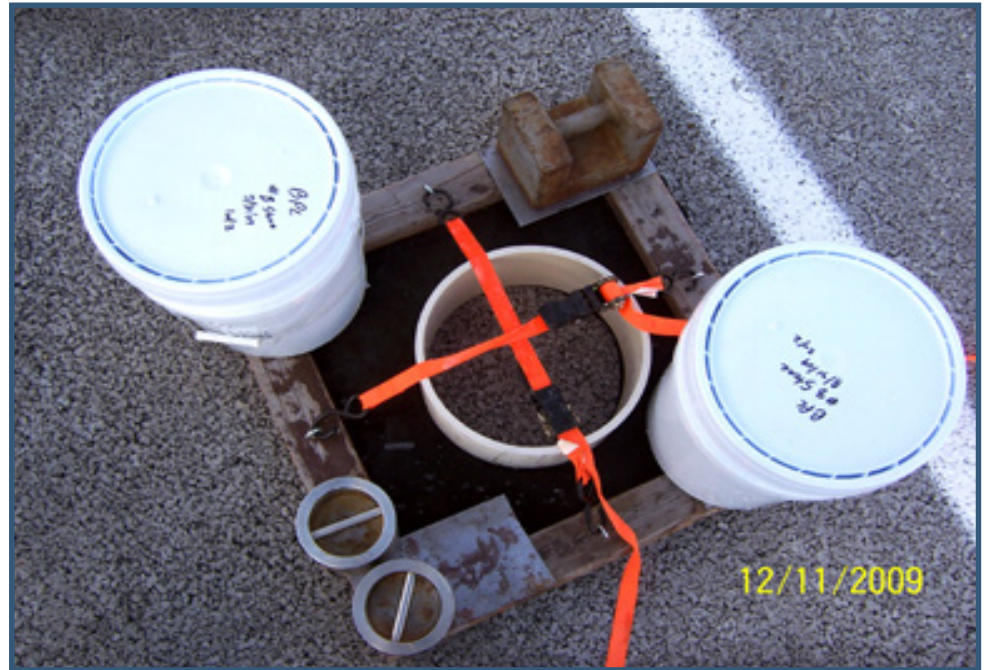
We measured infiltration rate at three randomly selected locations on each half of each surface monthly.

Modified ASTM C1701 apparatus

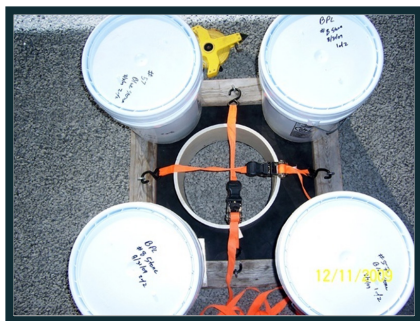
The infiltration rate varies among the four tested surfaces, but all surfaces are sufficient to handle maximum expected direct rainfall rates.

100-year, 5-minute rainfall intensity

- Edison, NJ
20.8 cm/hr (8.2 in/hr)

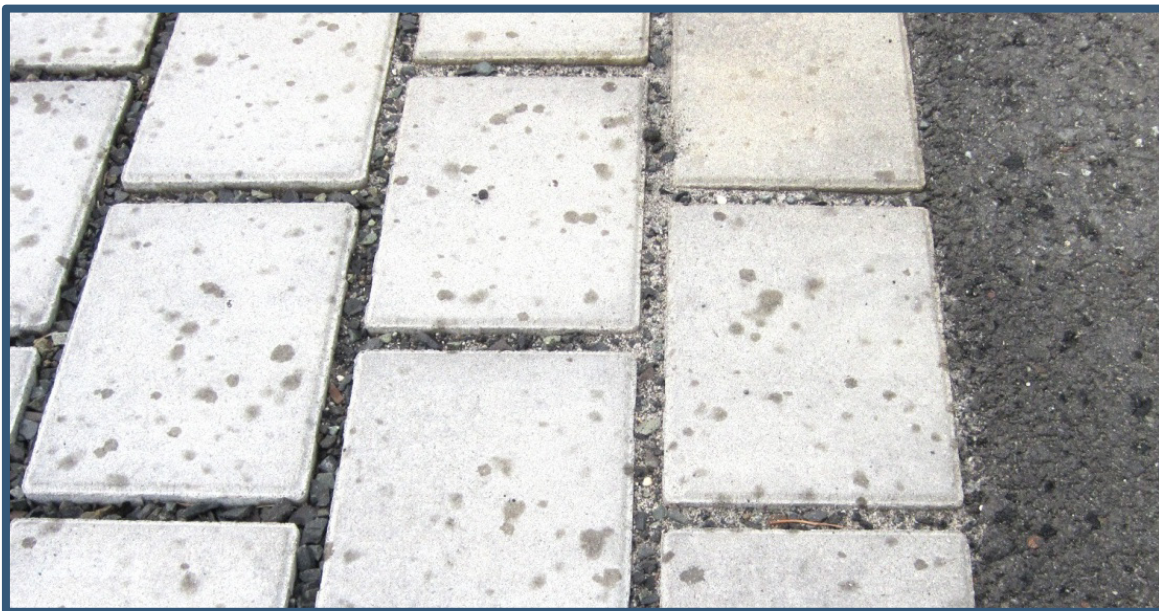
Sediment accumulates (and clogging progresses) from the upgradient edge.

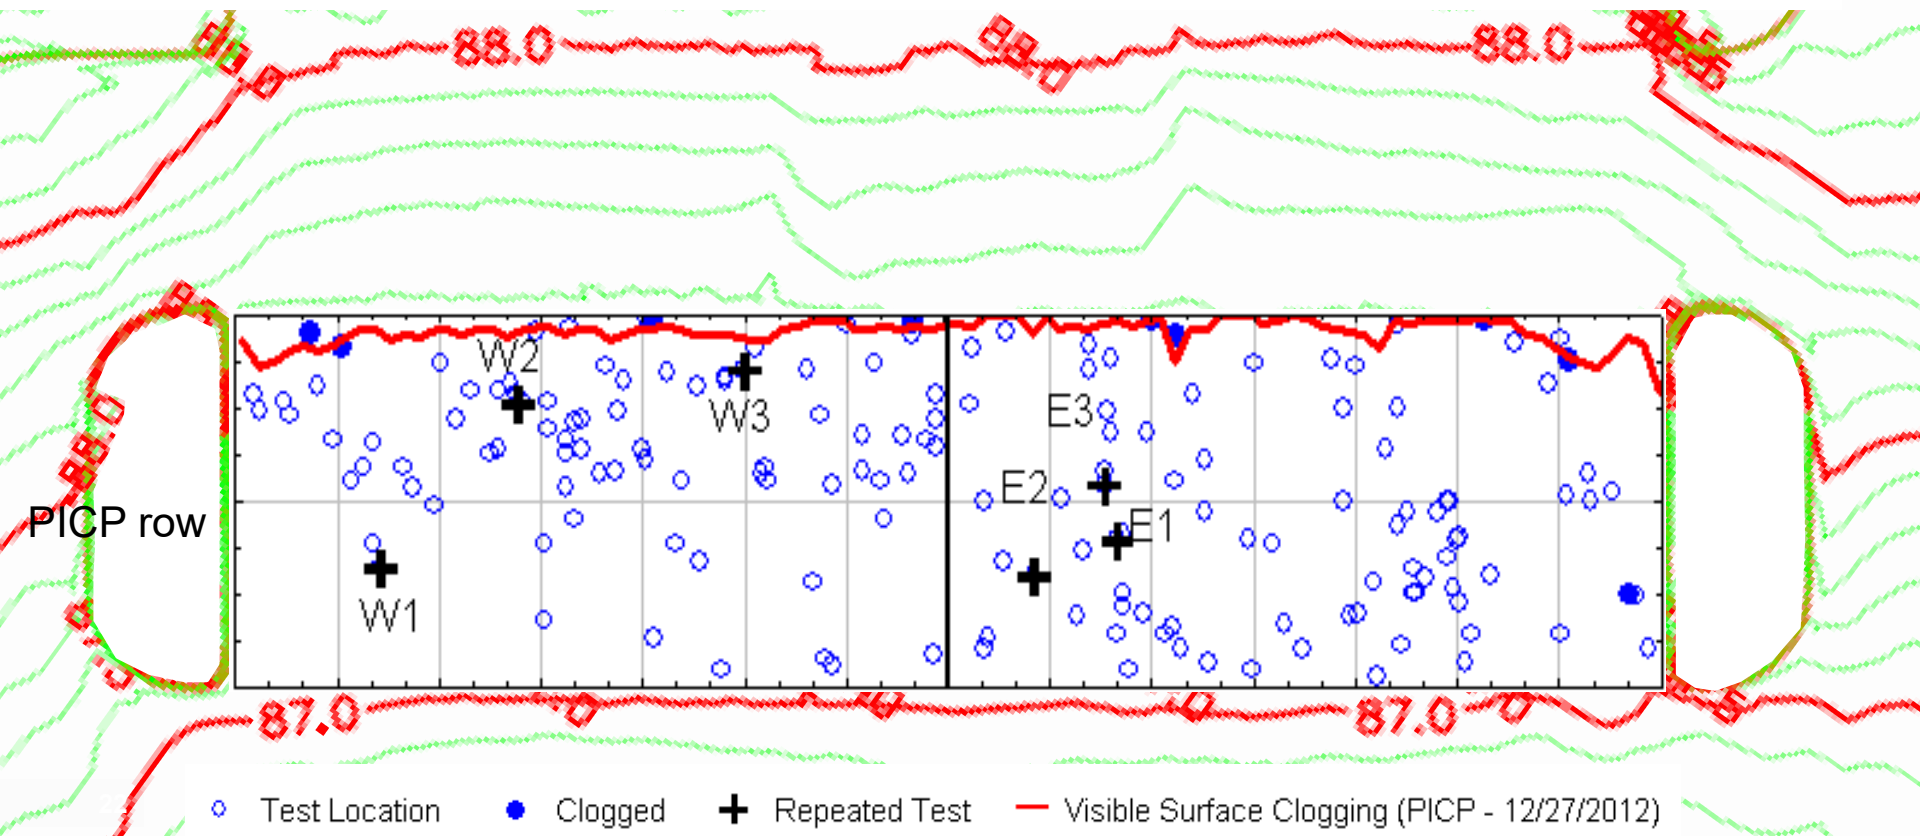
The surface clogging progression varied because of microtopography.

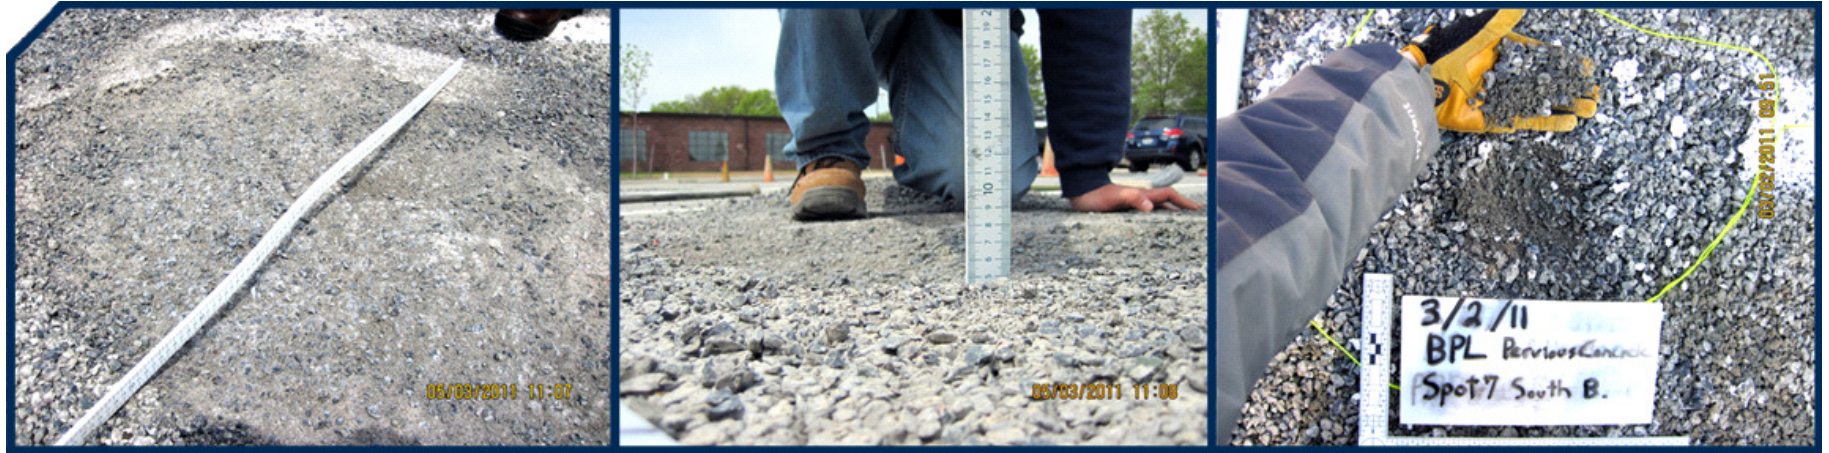
Large portions of the pervious concrete disaggregated.

The problem first became apparent about 18 months after pouring concrete. It was repaired by the contractor in May 2011, but it recurred.

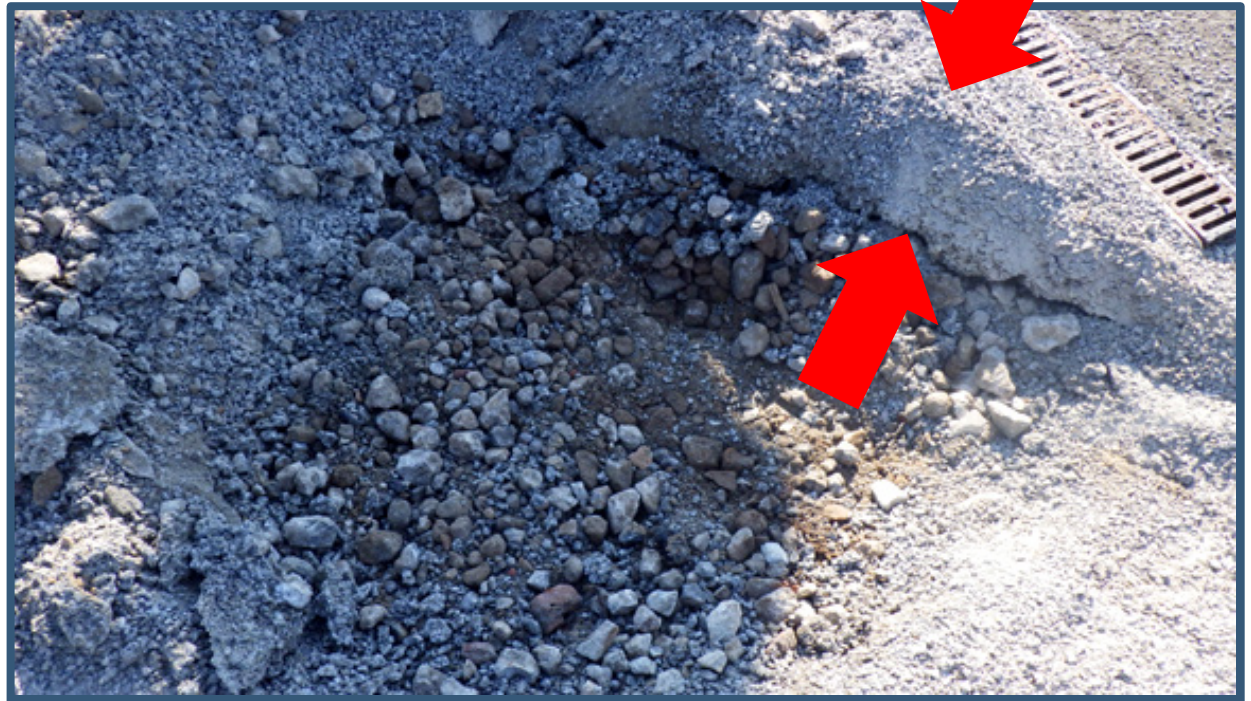
**Although the surface had disaggregated,
there was still substantial material
remaining.**

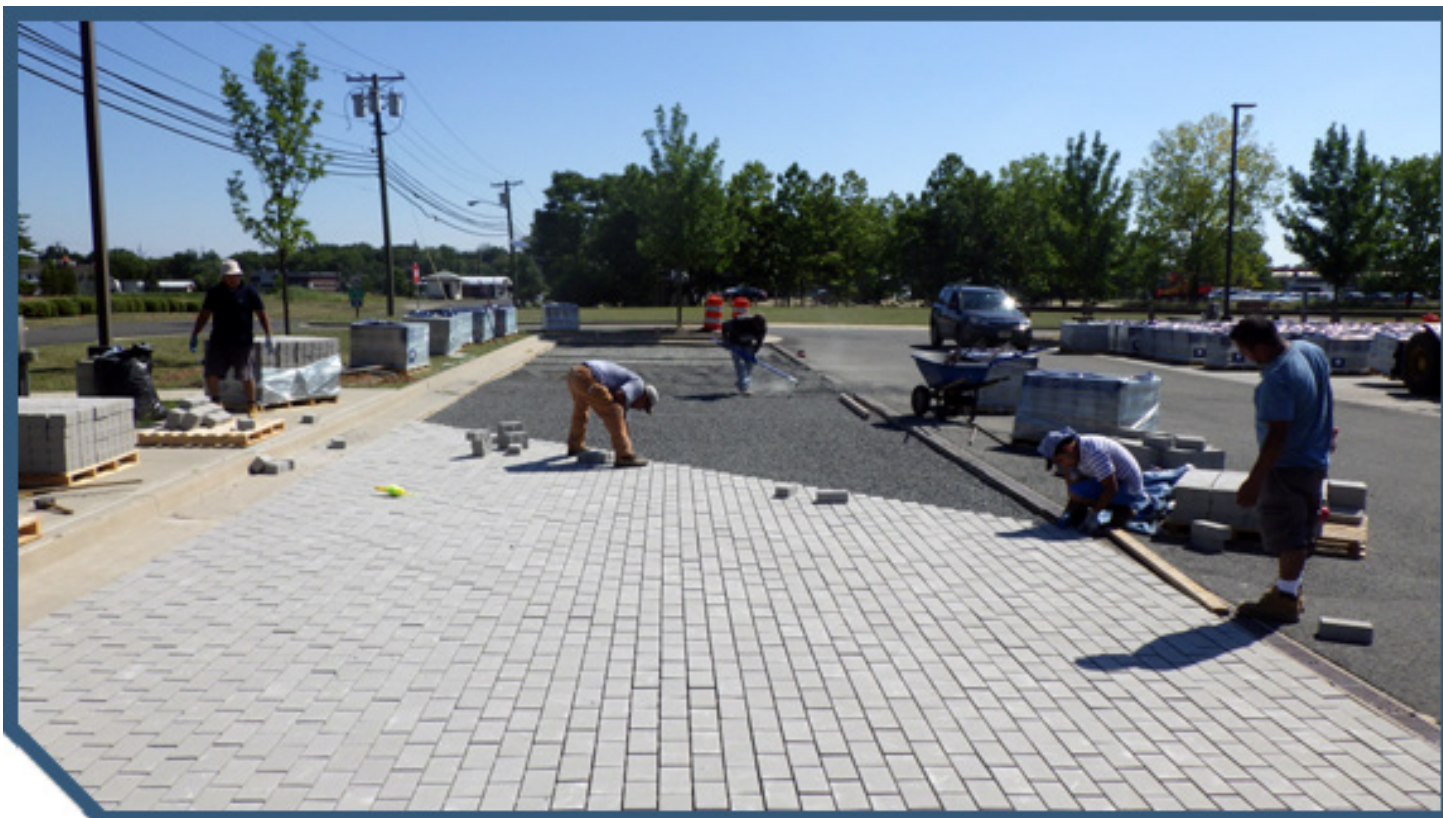
We have replaced the porous concrete sections with pavers.

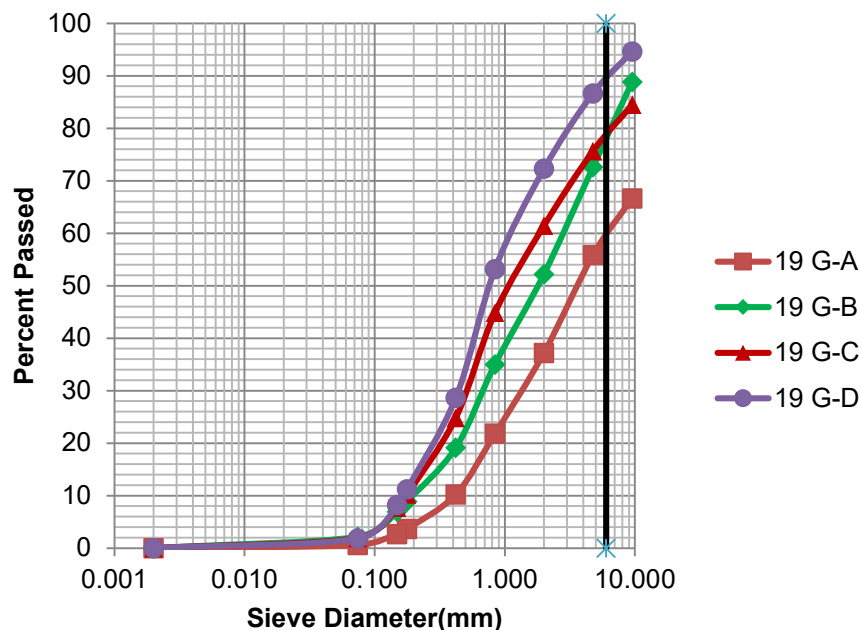
Recovered sediment particle size analysis shows initial accumulation of fines in the upgradient sections.

Mar. – May 2012
(9 in. cum. rainfall)

Dec. 2011 – May 2012
(19 in. cum. rainfall)

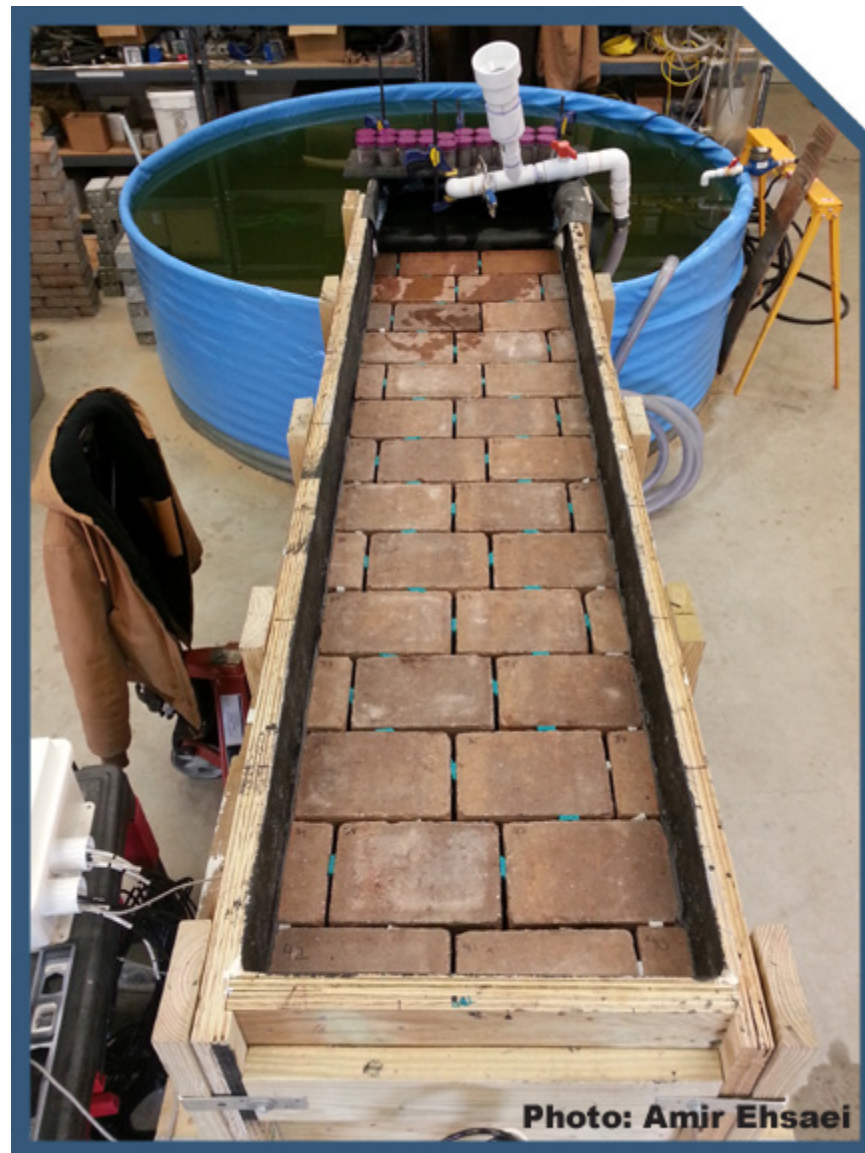
We ran some flume experiments to test the hypothesized mechanisms and influences.

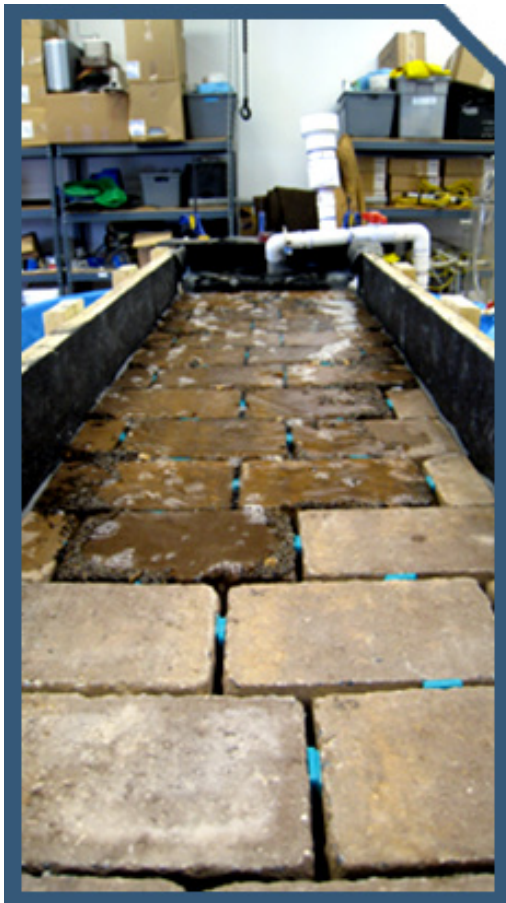
Flume tests show the progressive infiltration of the runoff that leads to the clogging.

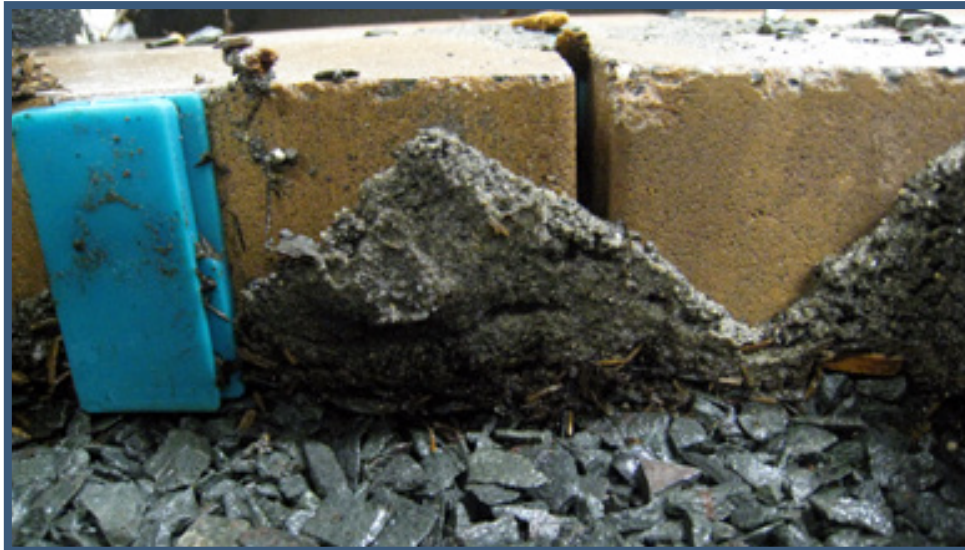
The flume tests showed the same pattern of accumulated sediment as observed in the field.

Inorganic material near up gradient edge

Organic material near down gradient edge

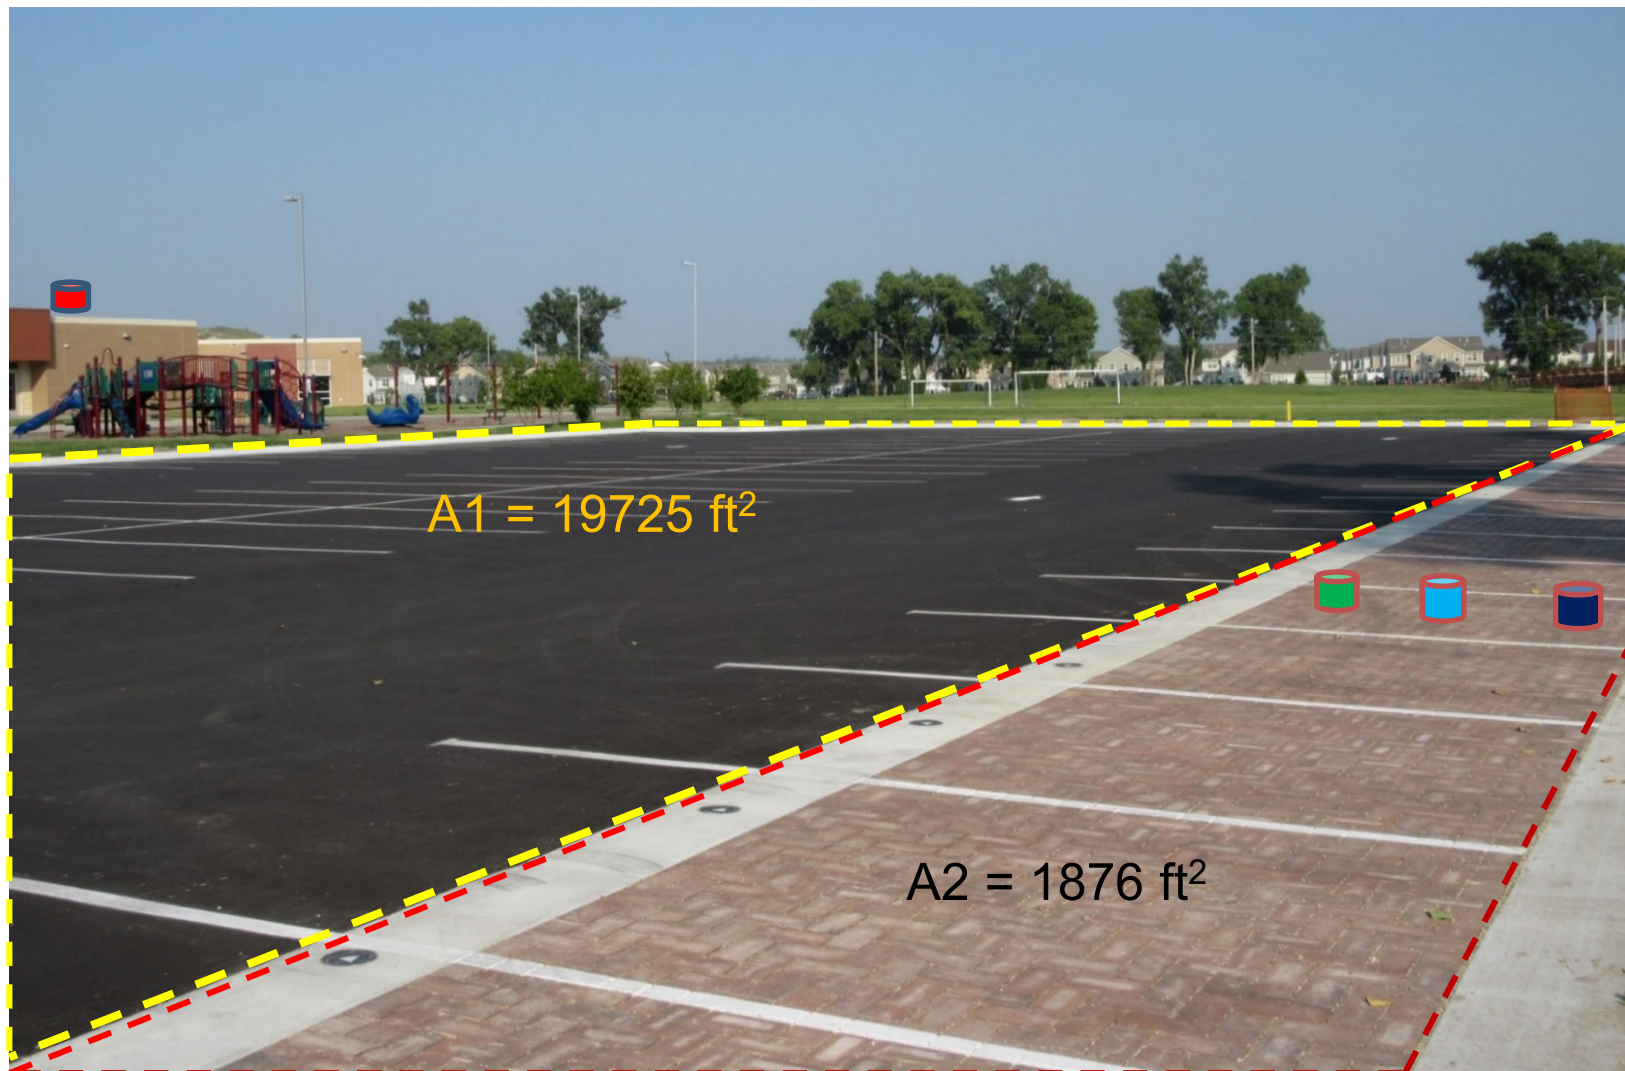
Clogging investigation by buried rain gauges
