# **Decontamination of *Bacillus* Spores from Drinking Water Infrastructure with Physical Removal (Pigging)**

Jeffrey Szabo and John Hall  
U.S. Environmental Protection Agency  
Cincinnati, OH 45268

Interagency Agreement DW-89-92381801  
Office of Research and Development  
Homeland Security Research Program  
Cincinnati, OH 45268

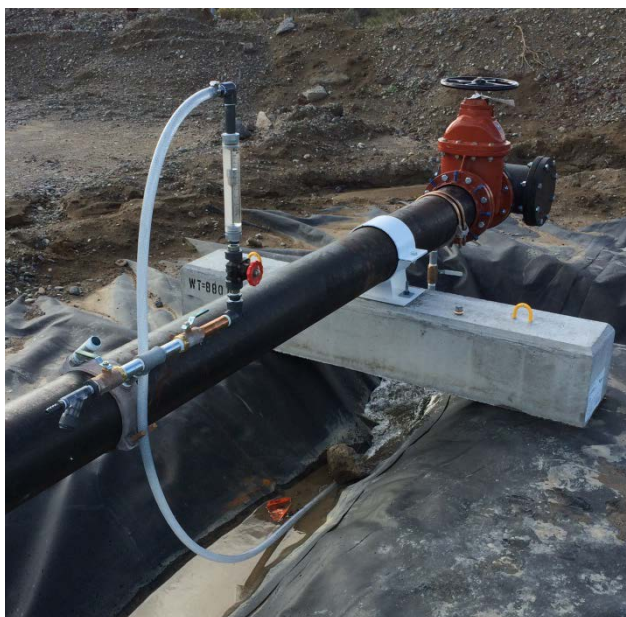
Drinking water supplied to WSTB is chlorinated ground water that also supplied the surrounding INL facilities. The WSTB incorporates approximately 450 feet (137 m) of 8 inch (20 cm) diameter cement-lined pipe. The 8 inch (20 cm) pipe system is constructed directly over the lined drainage ditch for spill/ leak containment (as shown in Figure 2). The total volume of the WSTB was estimated to be around 1,150 gallons (4,353 L). The valve near the end of WSTB along with the flow meter (shown in Figure 3) was used to regulate and maintain flow.

**Figure 3: Water Security Test Bed system flow regulator.**

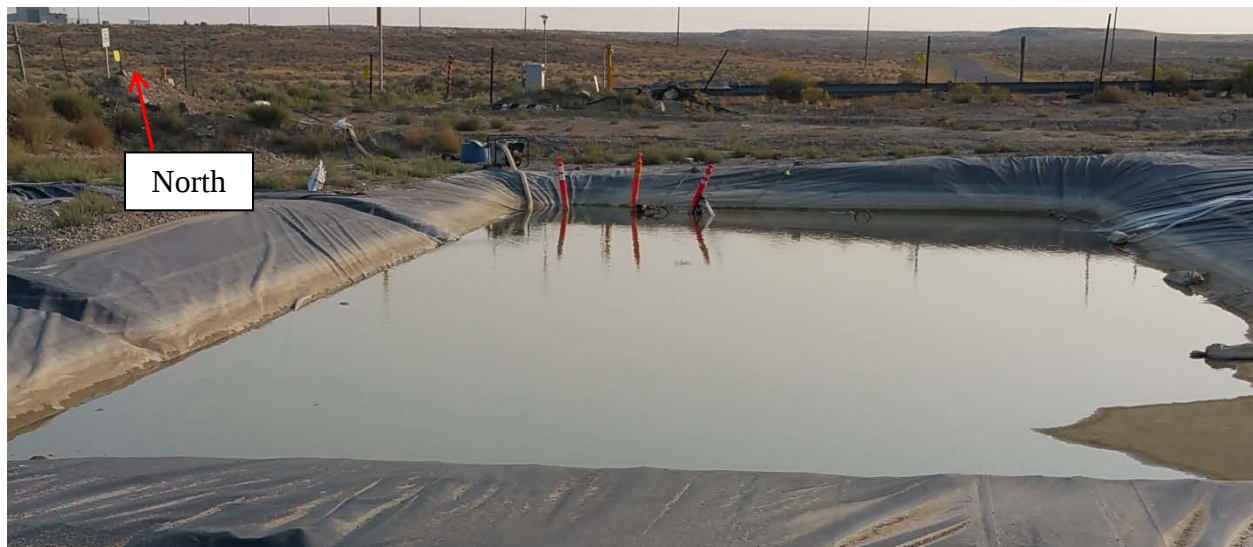
The effluent water and ice slurry from the WSTB system was discharged to a lagoon (Figure 4) which has a total water storage capacity of 28,000 gallons (105,980 L).

**Figure 4: Water Security Test Bed discharge lagoon.**

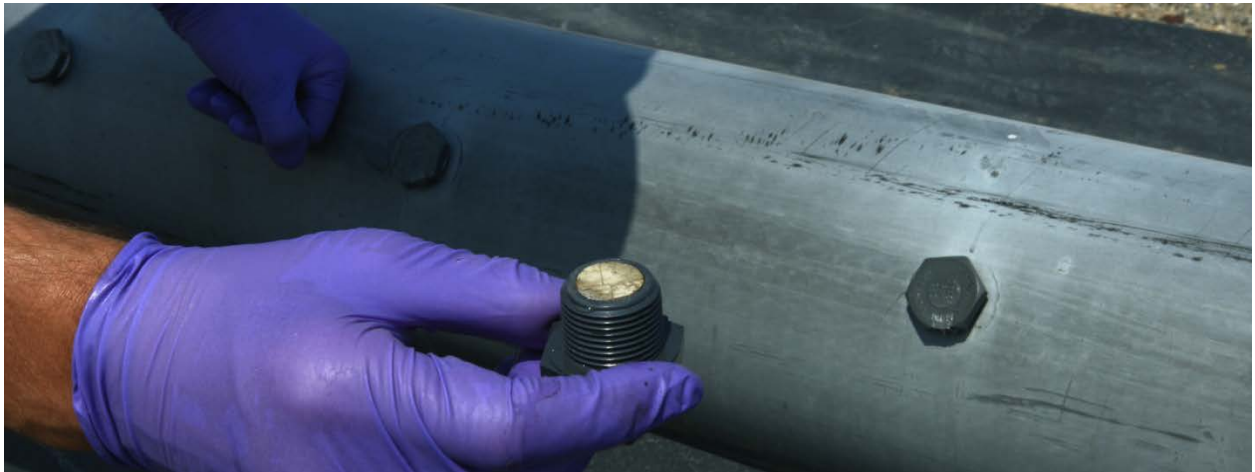
The 20 small coupons (22/32 of an inch [1.8 cm] in diameter and 0.371 square inches [2.4 square centimeters] in area) were cut from the cement mortar-lined iron pipe obtained from INL and set into threaded plugs that were inserted into the PVC-coupon section of the pipe. Figure 6 shows a picture of the threaded coupon that was inserted into the pipe main. Furthermore, as seen in

**Figure 6: Extracted pipe coupon.**

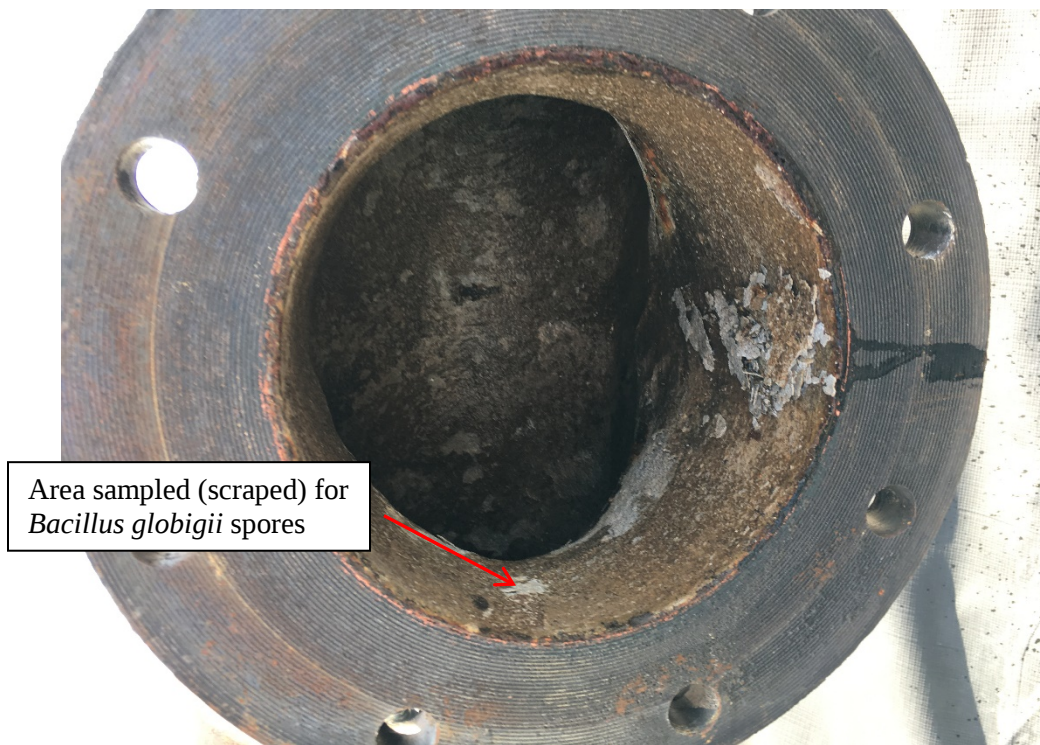
Figure 7, sampling could also be performed by removing pipe caps and directly sampling the pipe interior.

**Figure 7: 450-ft Water Security Test Bed pipe interior.**

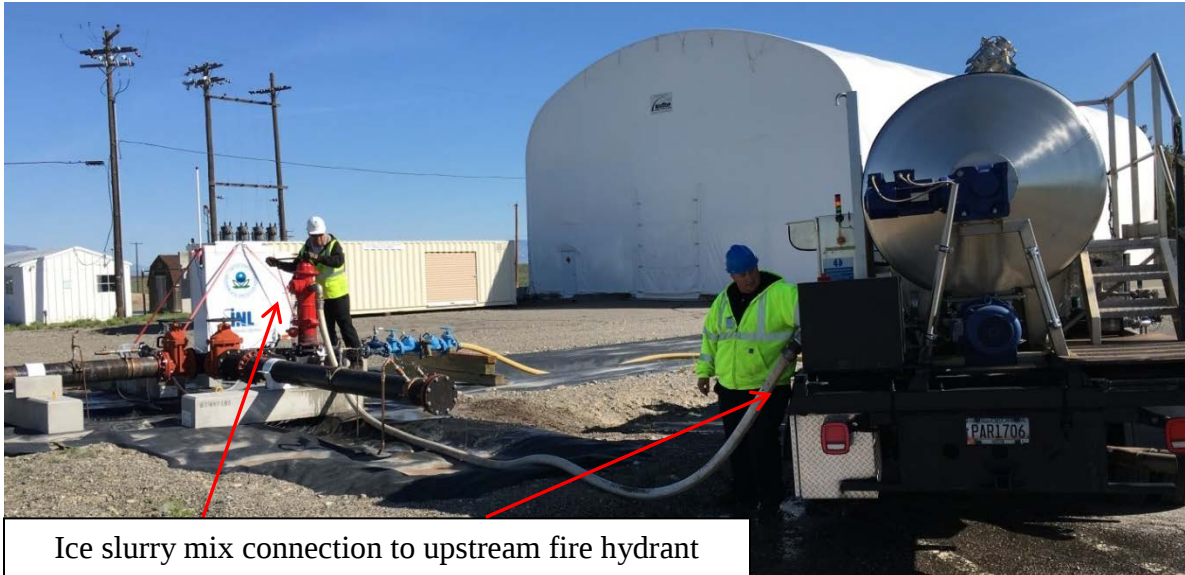
Before decontamination took place, the flow to main WSTB pipe was shut off, and the pipe depressurized. The ice pigging crew then connected hose to deliver slurry mix to upstream hydrant (Figure 9).

**Figure 9: Ice slurry injection into the upstream fire hydrant.**

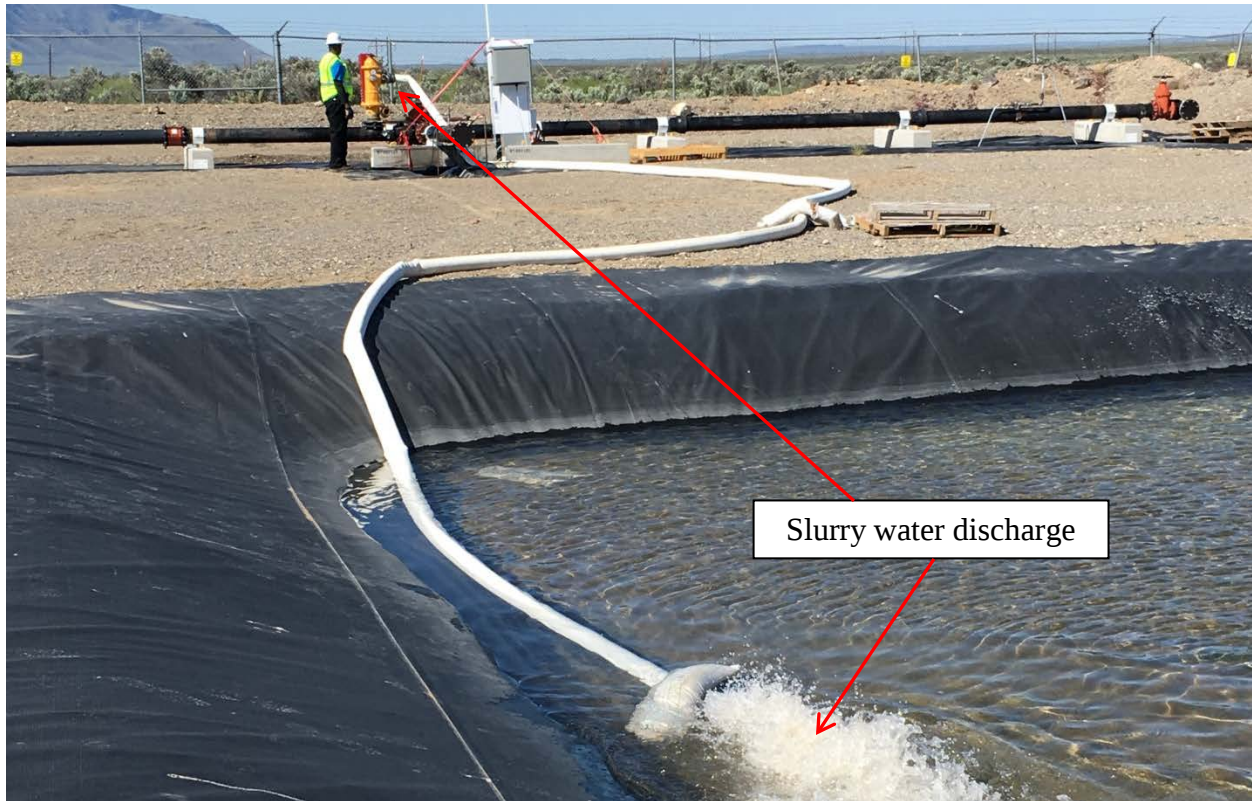
**Figure 11: Slurry water downstream discharge.**

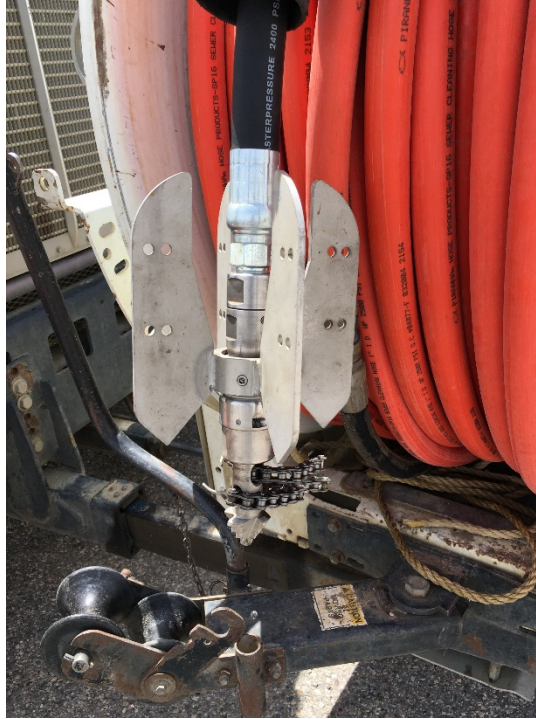
**Figure 14: Chain cutter nozzle attached to the combination truck high pressure hose.**

In order to achieve the appropriate amount of chain rotation and scouring action, water must be supplied from a combination truck, which is shown in Figure 13. Big Sky provided the Vactor<sup>®</sup> truck and the operator for this chain cutting experiment. In the wastewater industry, combination trucks are commonly referred to as “Vactor trucks” after one of the manufacturers of these vehicles. Combination trucks have a dual function. The hose on the front can vacuum solids out of a sewer and pump them into the tank on the back. The truck can also store approximately 1,300 gallons (4,921 L) of potable water, and pump it through a high pressure hose at up to 2500 psi (170 atm) and 80 gpm (302 L/min). Water at a flow of 70 gpm (265 L/min) and 2300 psi (157 atm) pressure were used to operate the chain cutter inside of the 450 foot (ft) section of the WSTB pipe. Figure 14 shows the chain cutter installed at the end of the high pressure hose.

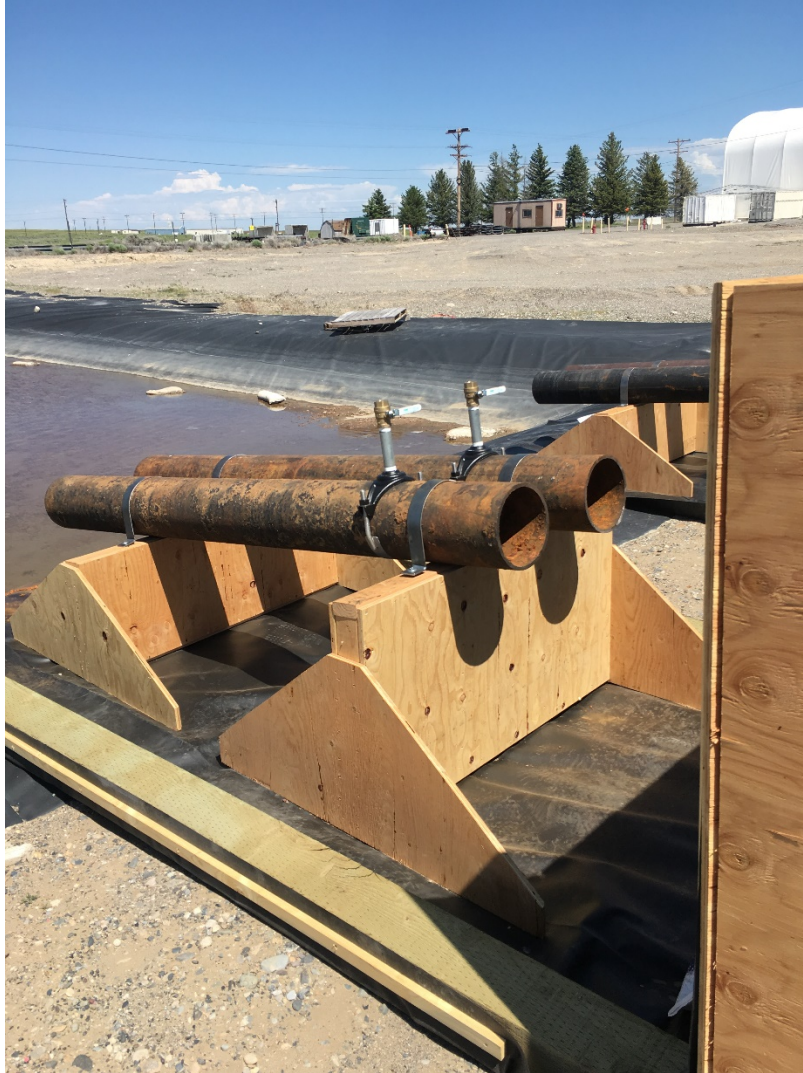
In addition to the 450 ft pipe, individual sections of pipe were pigged with the chain cutter. The individual pipe setup is shown in Figure 17, and the pigging process is shown in Figure 18. Pigging of the individual pipe sections took place in the same manner as the 450 ft pipe, with the exception that the water pressure and flow were reduced to 25 gpm and 1200 psi. Two types of pipe were pigged. One was the same cement-mortar lined iron pipe used in the 450 ft WSTB pipe. The other was iron pipe with heavy corrosion on the interior. This pipe was obtained from the District of Columbia Water and Sewer Authority (DC Water). All pipe surface samples taken from the individual pipes were direct scrapings of the inner surface. Figure 19 shows the scouring of the cement-mortar pipe after pigging, with some of the cement-mortar coating removed.

**Figure 17: Individual pipe sections next to the Water Security Test Bed lagoon.**

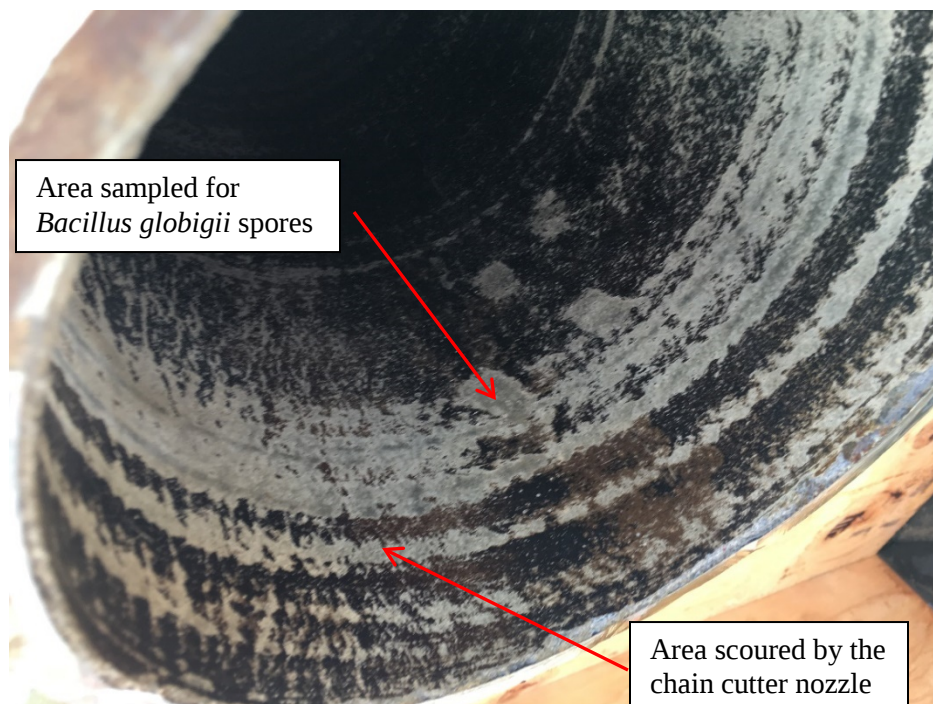
**Figure 19: Inside of the cement-mortar lined pipe section after pigging with the chain cutter.**
