# Decontamination of *Bacillus* Spores from Drinking Water Infrastructure with Physical Removal (Water Jet Pigging) and Assessment of Pipe Relining Technologies

Jeffrey Szabo, John Hall and James Goodrich  
U.S. Environmental Protection Agency  
Cincinnati, OH 45268

Interagency Agreement DW-89-92381801  
Office of Research and Development  
Homeland Security Research Program  
Cincinnati, OH 45268

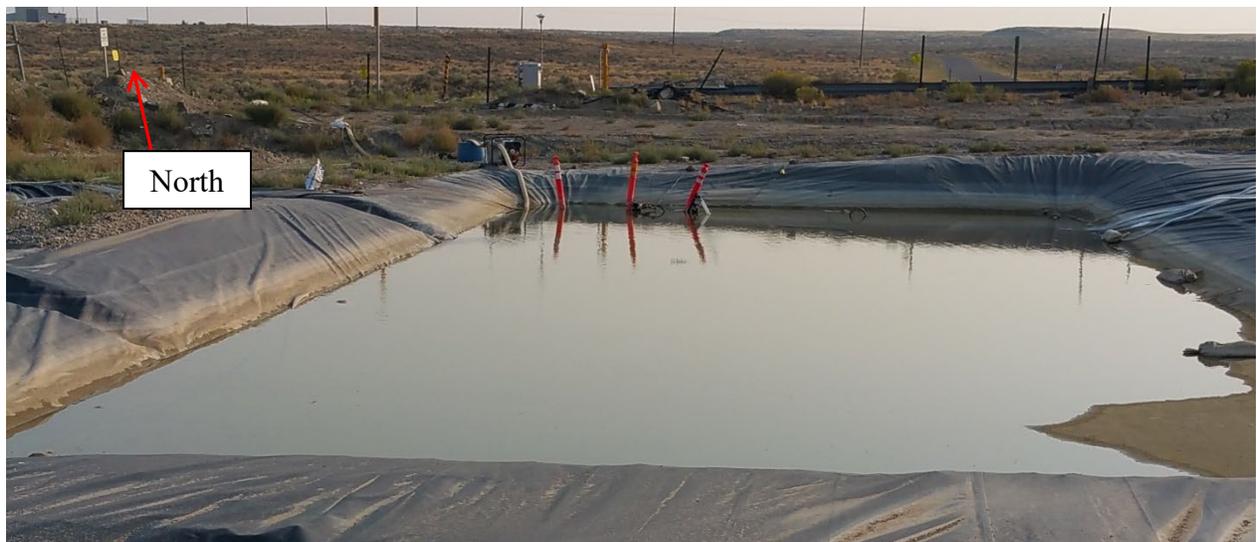
**Figure 3: Water Security Test Bed discharge lagoon.**

Drinking water supplied to the WSTB is chlorinated ground water that also supplied the surrounding INL facilities. The WSTB incorporates approximately 450 feet (137 m) of 8-inch (20 cm) diameter cement-mortar lined ductile iron pipe. The 8-inch (20 cm) pipe system is constructed directly over the lined drainage ditch for spill/ leak containment (as shown in Figure 2). The total volume of the WSTB was estimated to be around 1,150 gallons (4,353 L). The effluent water from the WSTB system was discharged to a lined lagoon (Figure 3) which has a total water storage capacity of 28,000 gallons (105,980 L).

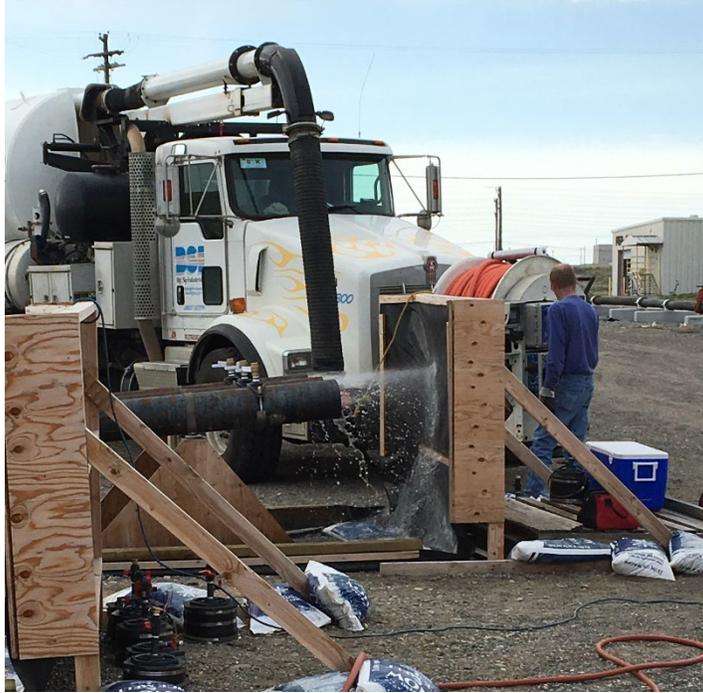
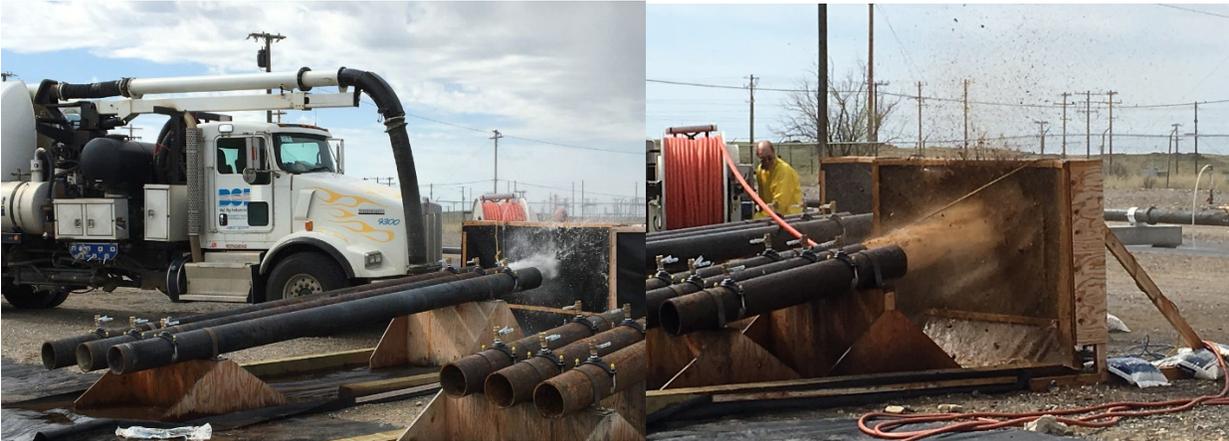
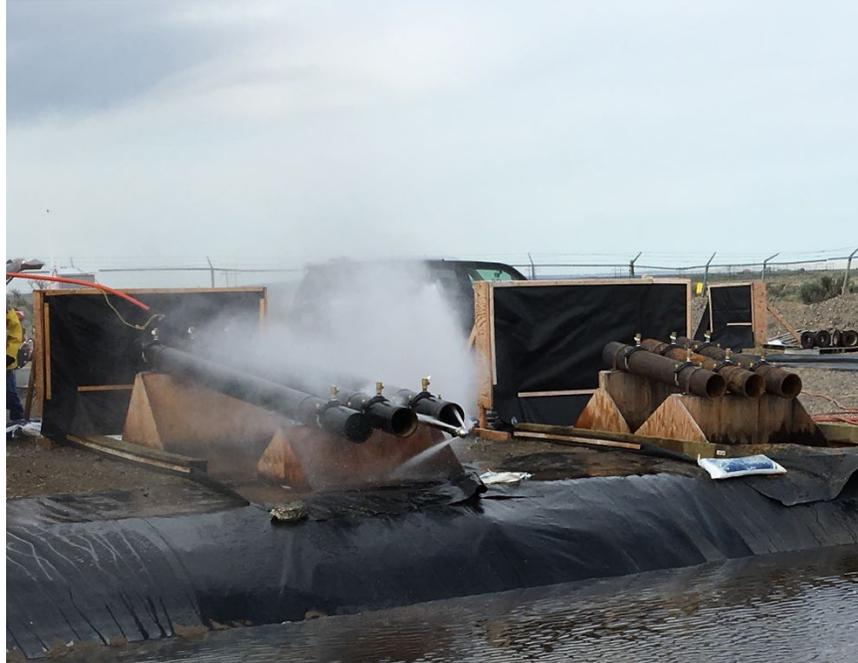
Images showing the process of pigging the individual pipe section are shown in Figure 8 through Figure 10. After the combination truck was filled with water and the nozzle was installed on the hose, the nozzle was placed inside of an individual pipe section. When the high pressure water pump on the combination truck was turned on, the water began flowing through the nozzle, and the nozzle began spinning and spraying water. High pressure water exited through an opening in the rear of the chain cutter nozzle, and this pressurized water flow propelled the chain cutter down the pipe. The nozzle was operated at a pressure of 2,300 psi and a flowrate of 70 gpm. These are approximate values that might have varied during operation of the nozzle. Once pigging of a pipe was complete, the nozzle was pulled back through the pipe, inserted into another pipe, and the process repeated. Pigging was performed with one pass through the pipe. However, if visible corrosion or other adhered material was observed after one pass, a second pass with the nozzle was performed.

**Figure 8: Water jet nozzle inserted into a pipe section.**

**Figure 9: Spray coming out of a pipe section as the water jet nozzle travels down the pipe.**

**Figure 10: Jet sprayer nozzle exiting a pipe section.**

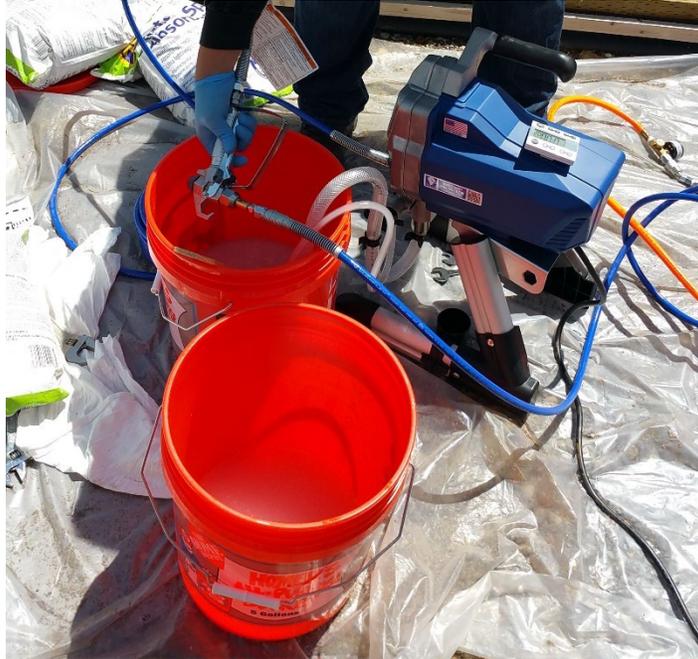
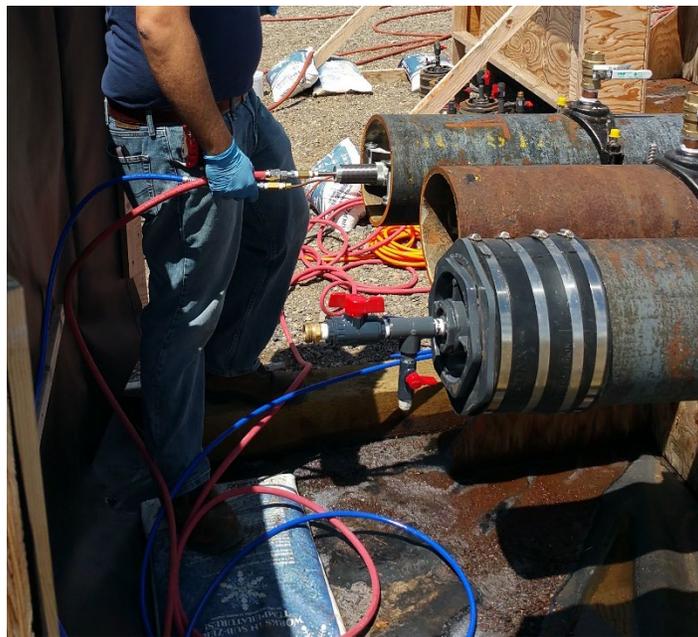
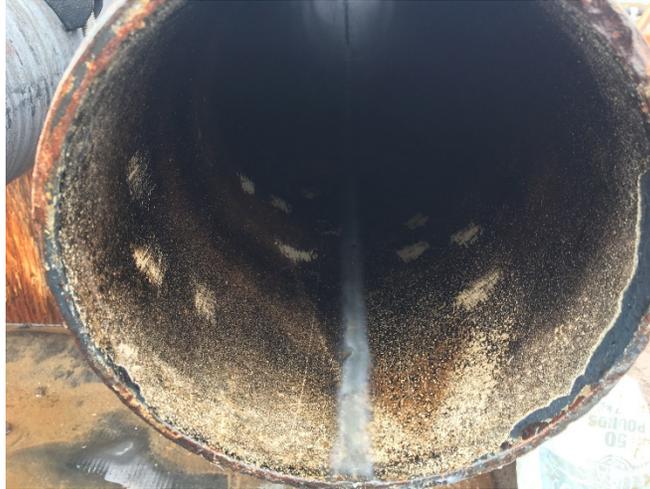
Application of Oceanit DragX coating is illustrated in Figure 11 through Figure 13. The pipe was pigged with the water jet sprayer prior to coating (see section 2.3 for more detail), but the Oceanit site personnel scrubbed the pipe interior with a wire brush to remove any remaining debris. Then, the proprietary nanocomposite coating was mixed in a bucket. A hose was inserted into the bucket, and the coating was pumped to an air driven spin coater that was pulled through the pipe. The coating cured overnight and was visually inspected the next morning for trapped air bubbles or bare spots (none were detected).

**Figure 11: Mixing the Oceanit DragX coating in a bucket.**

**Figure 12: Rotary air sprayer inserted into the pipe to apply the DragX coating.**

**Figure 13: DragX coated pipe after curing overnight.**

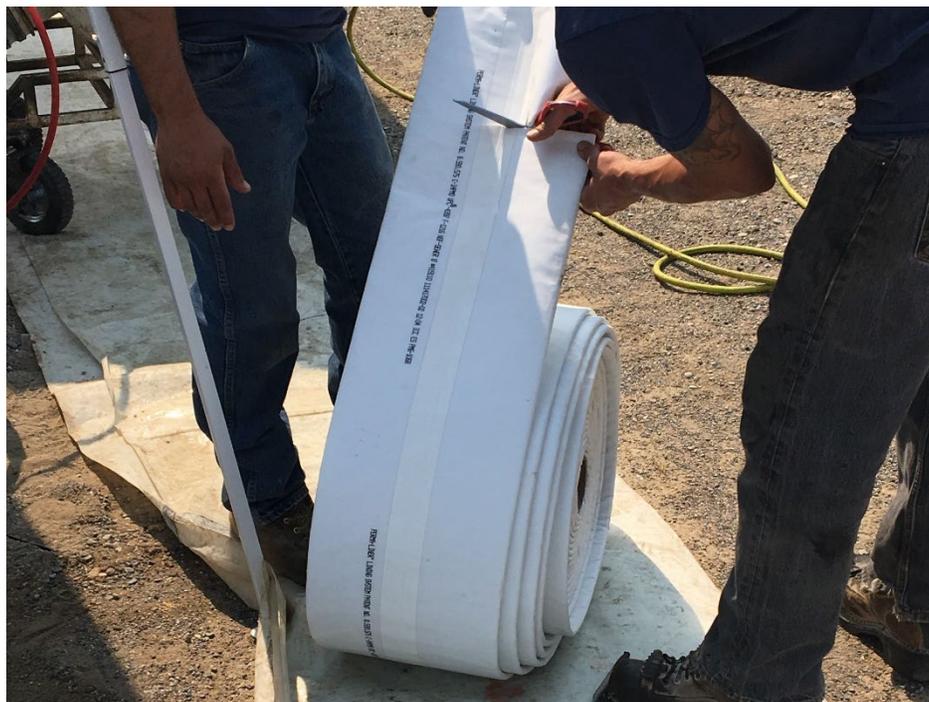
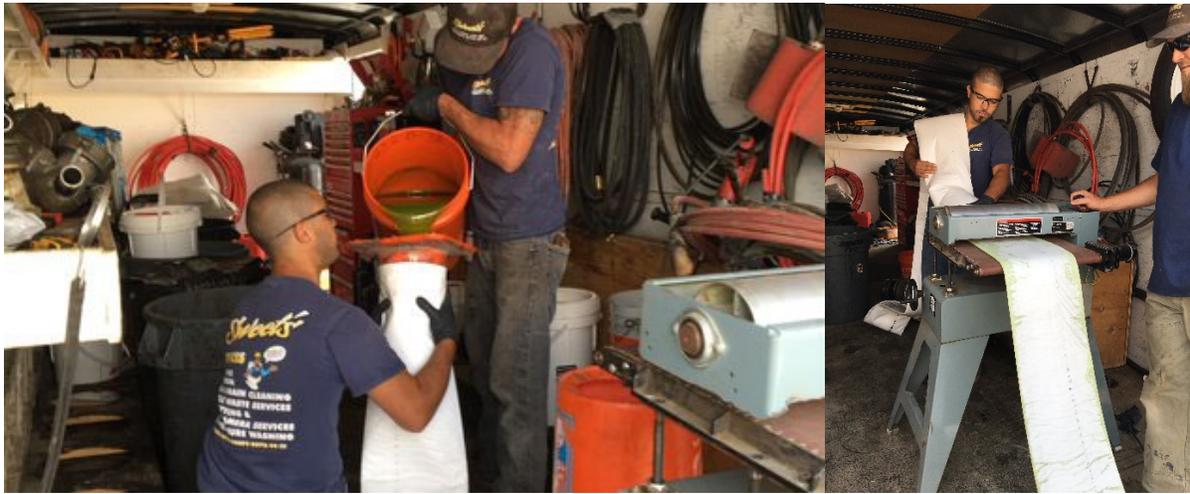
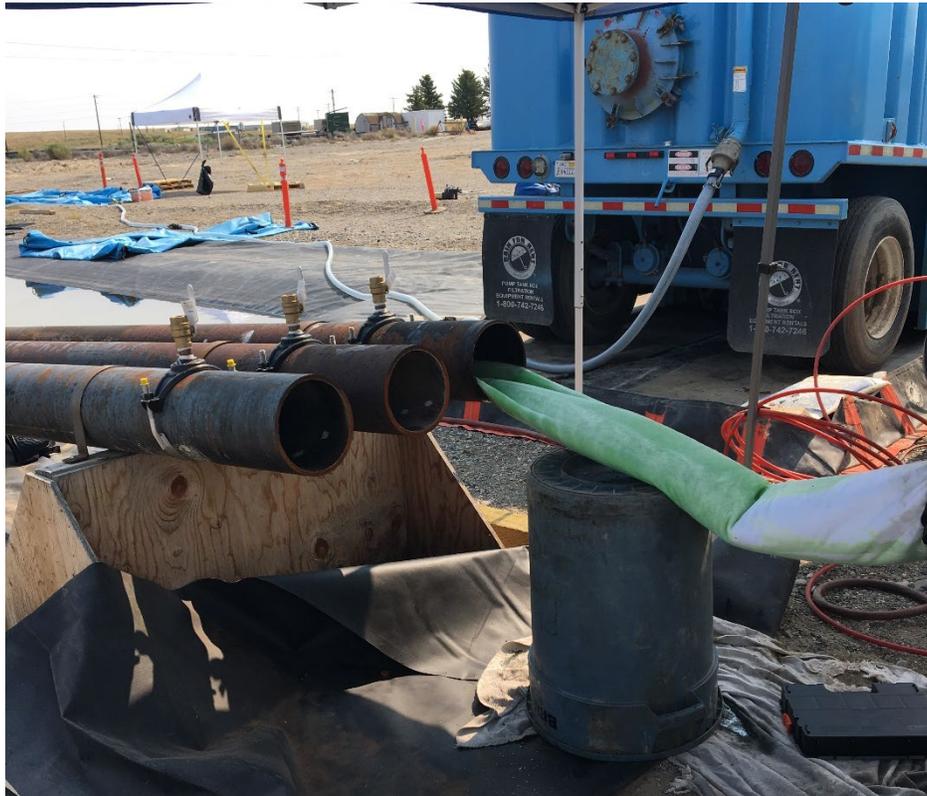
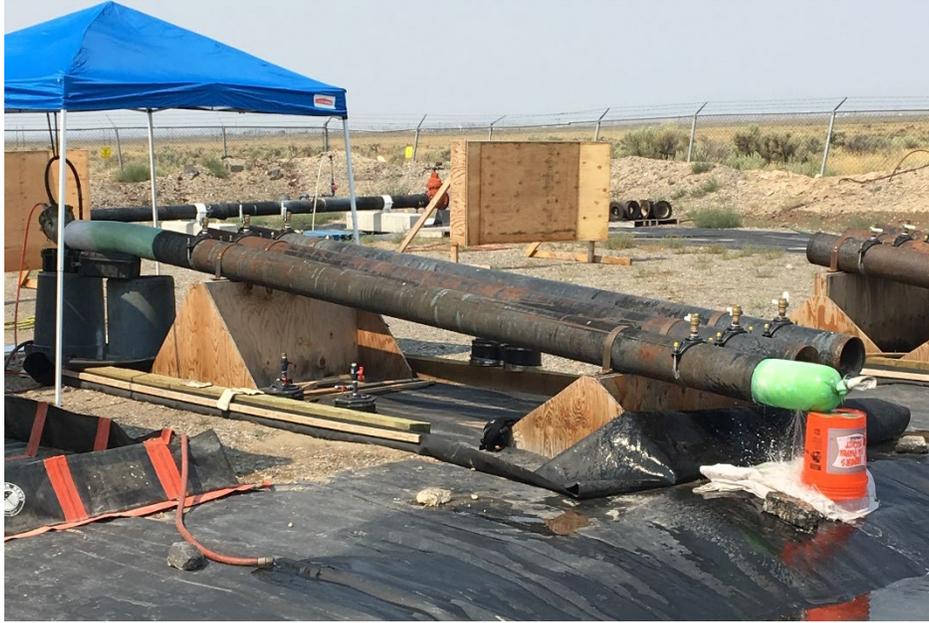
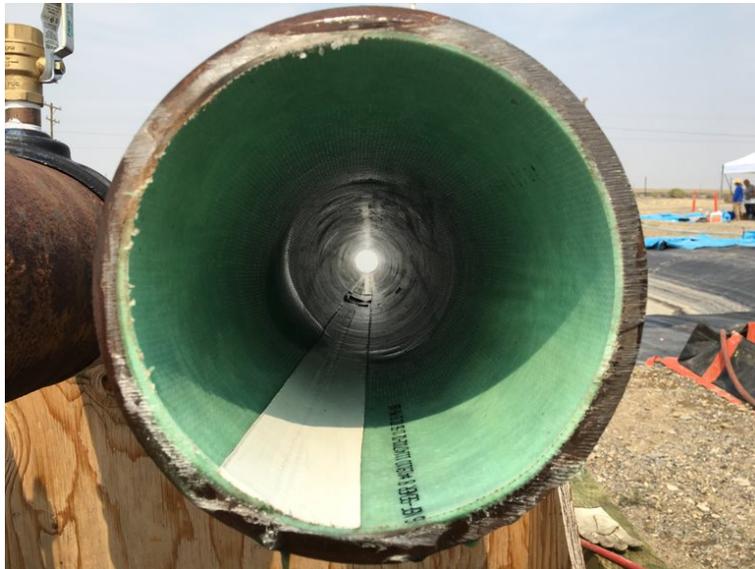
The application of CIPP is illustrated in Figure 14 through Figure 18. First, a flexible fabric sock was unrolled and cut to the length of the pipe. The sock was then soaked in a proprietary resin, and the resin-soaked sock was pulled through the pipe section. The sock was then tied at one end, and hot water pumped into the sock so that it fully inflated and was forced against the iron pipe interior. Over approximately four hours, the hot water cured the liquid resin, which was transformed into a rigid lining. The CIPP was then drained and sawed off at the ends so that the new interior pipe was flushed with the iron pipe.

**Figure 14: Flexible CIPP sock being cut to the length of the iron pipe.**

**Figure 15: Flexible CIPP fabric sock being soaked in resin.**

**Figure 16: Resin soaked CIPP sock being pulled through the iron pipe.**

**Figure 17: CIPP filled with hot water and in the process of curing.**

**Figure 18: Finished CIPP sawed off to the length of the iron pipe.**

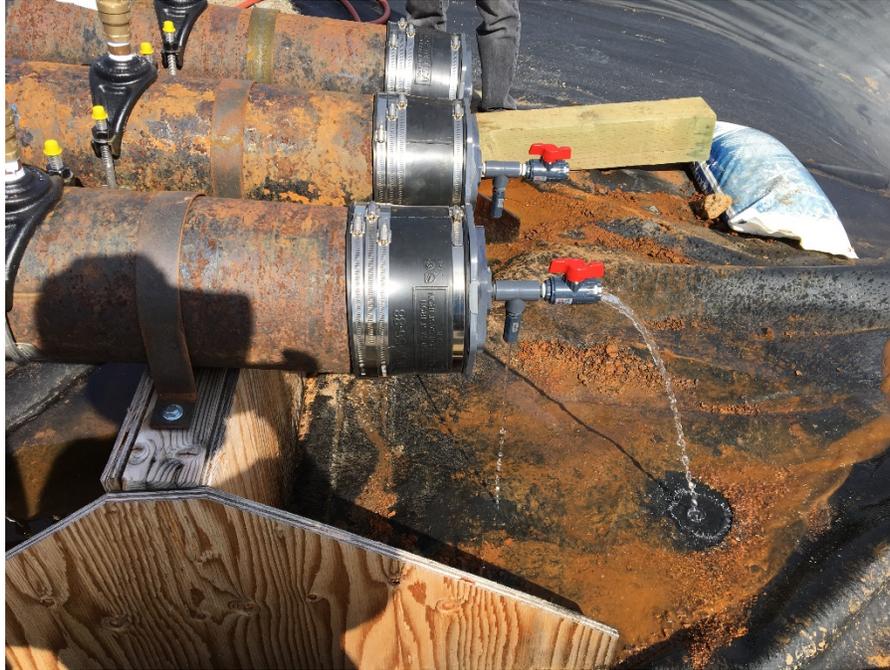
**Figure 20: Draining the pipe sections.**
