DRINKING WATER PIPELINE AND PREMISE PLUMBING DECONTAMINATION OF *BACILLUS GLOBIGII*

James A. Goodrich, Helen Y. Buse, and Jeff Szabo
Biofilm Technologies: Pathways to Product Development
February 4-5, 2020

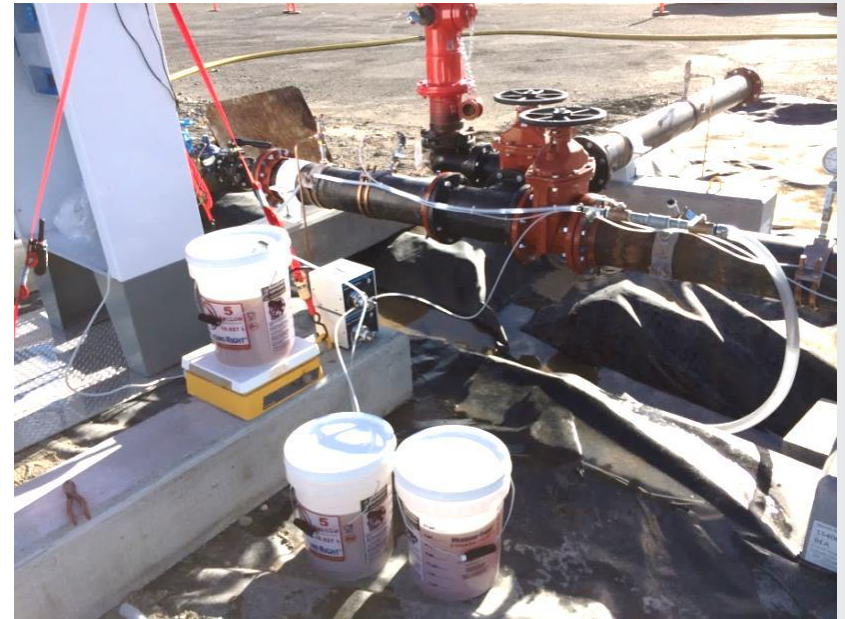
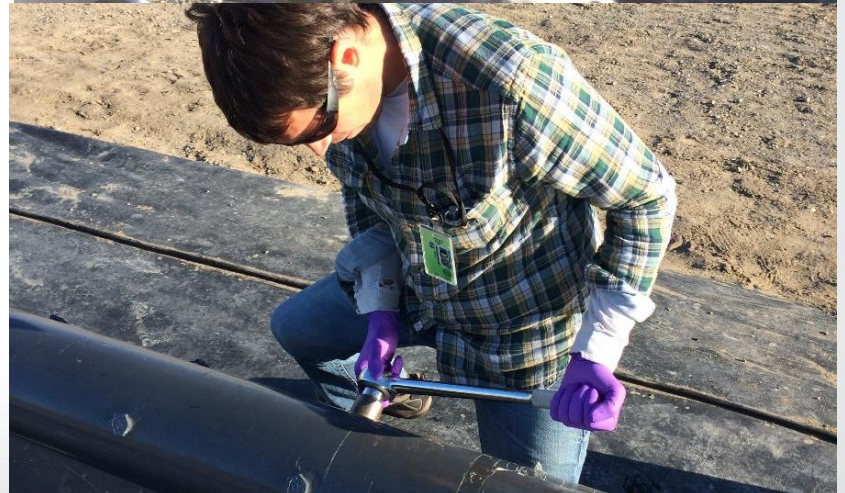
- WSTB pipe was contaminated with *Bacillus globigii* (BG) spores
 - BG injected at 10^6 cfu/ml in the bulk water phase
- Decontamination with chlorine dioxide
 - Target concentrations
 - 25 mg/L per pilot experiments
 - 100 mg/L in the field
 - Chlorine dioxide concentration difficult to maintain due to heat and pipe demand
 - Only 2-log reduction in spores compared to 5-log in the pilot scale experiments

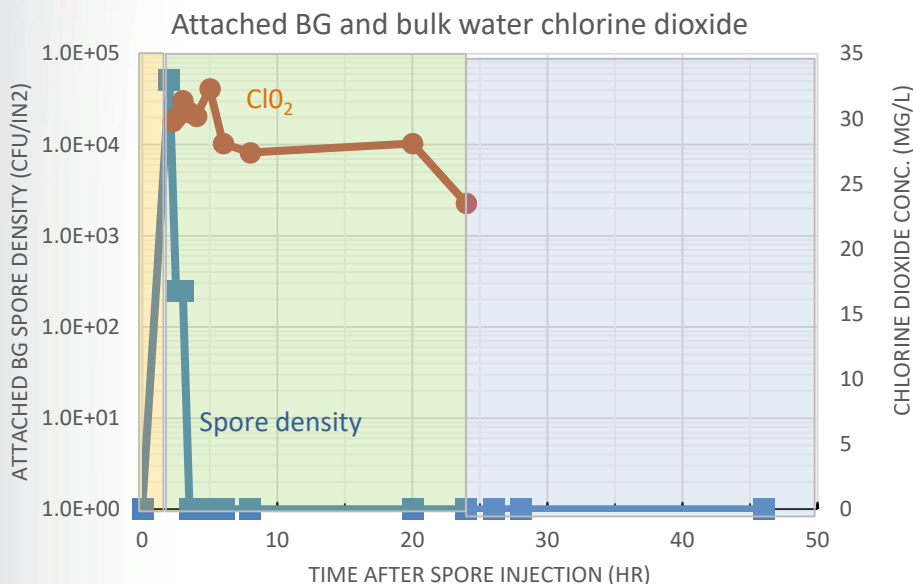
Data from Pilot Scale Decontamination Loop at EPA's Test & Evaluation Facility

- No spores detected on cement-mortar after treatment with 25-30 mg/L ClO_2

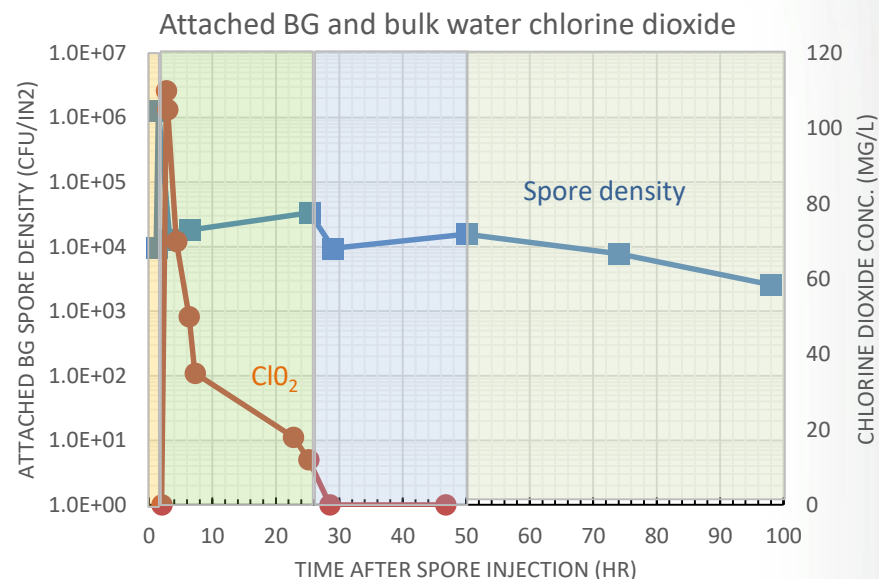
Data from Full Scale WSTB at INL

- Spores persisted on cement-mortar in the presence of up to 100 mg/L ClO_2
- Pipe demand, temperature fluctuation and dead end spaces impacted decontamination
- Spores found on surfaces even after WSTB was mothballed for winter

- Flushing plus disinfection still leaves spores behind
- Spores still viable after winter in dry pipe

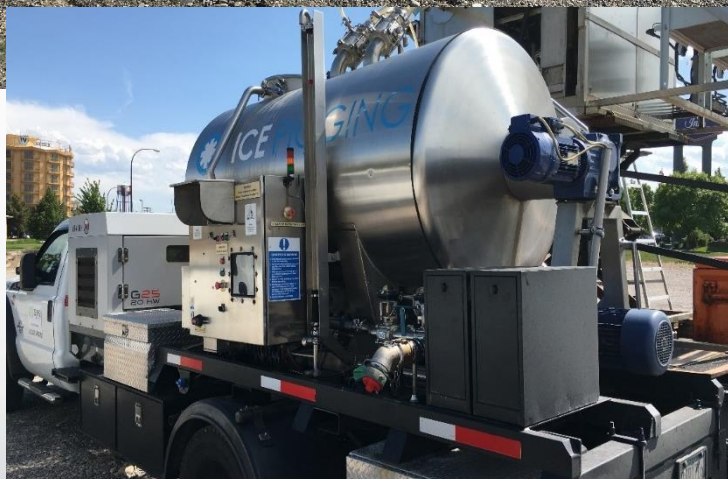
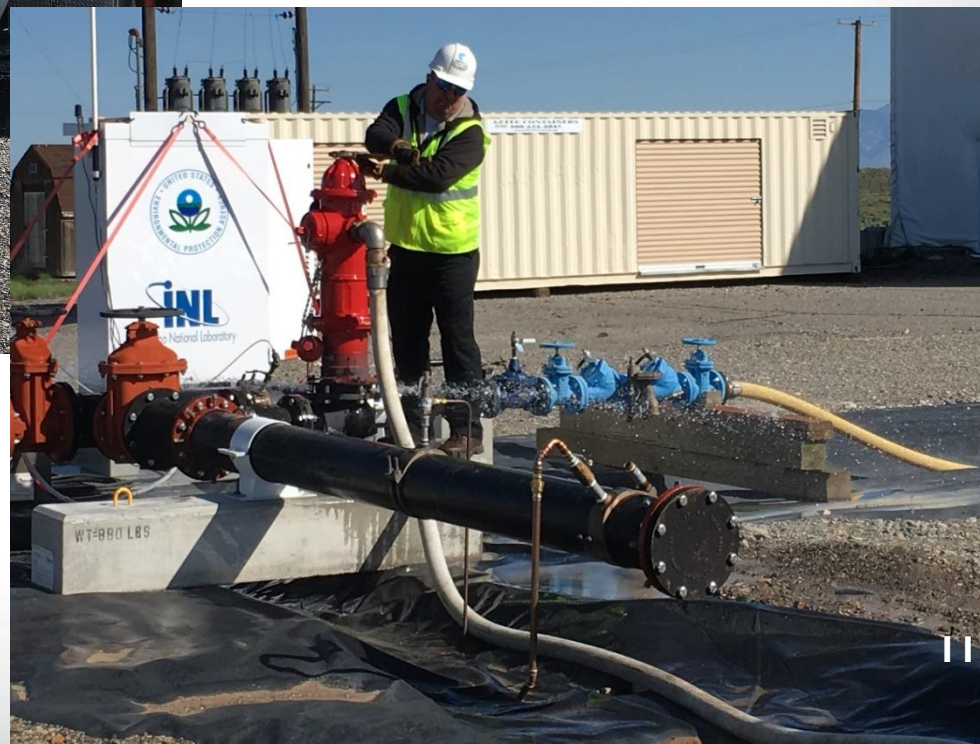
Ice slurry mix connection to upstream fire hydrant

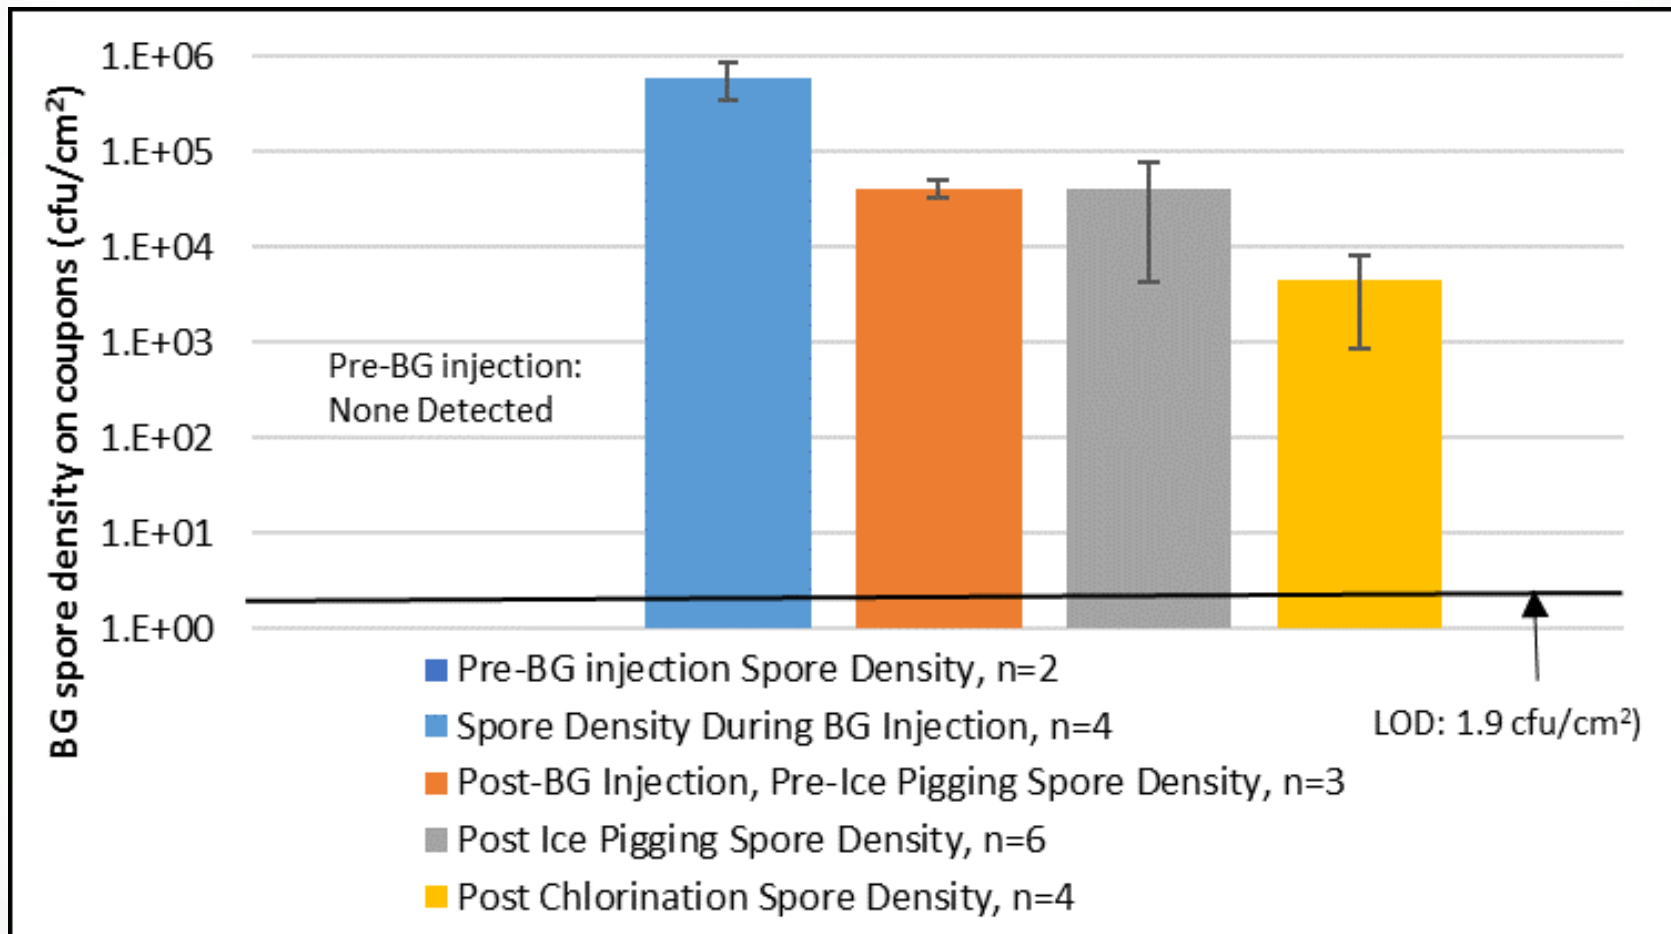
Ice Pigging Decontamination Data

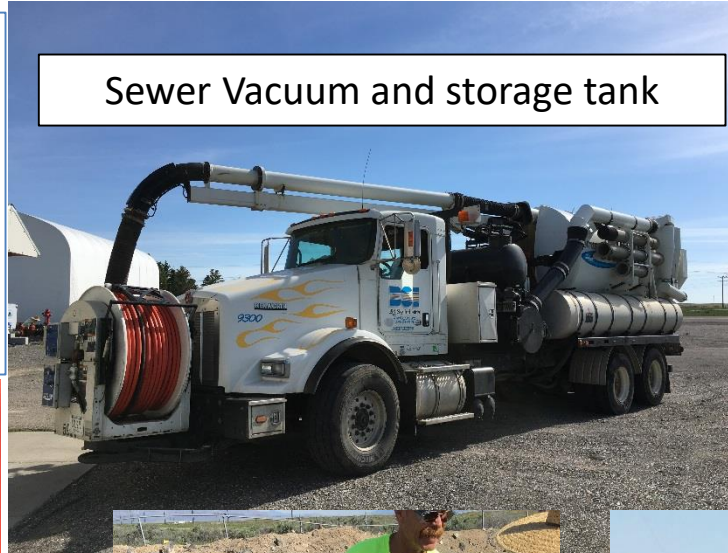
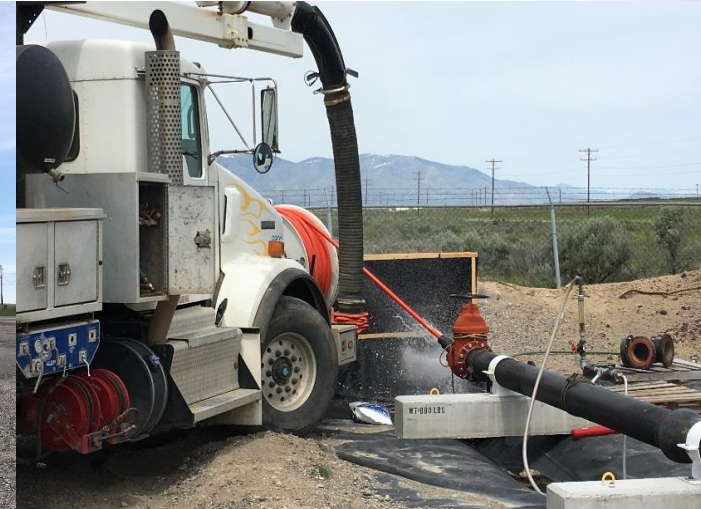
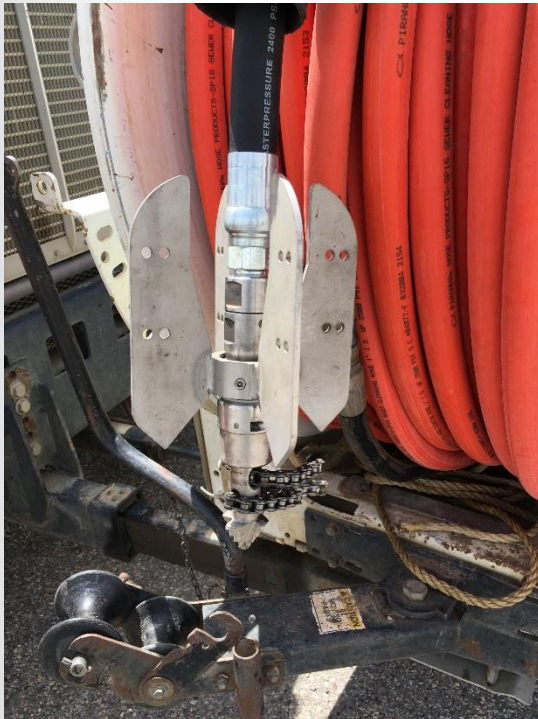
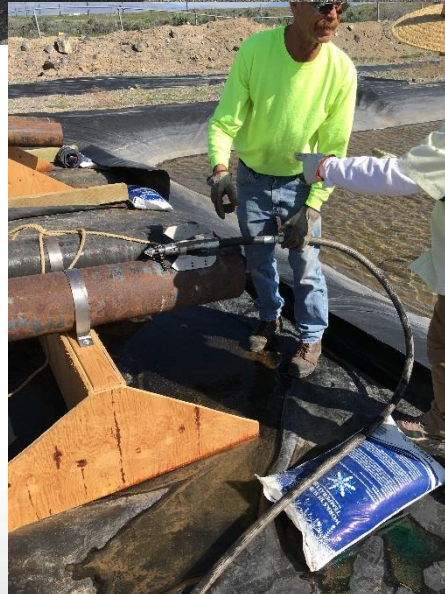
Sewer Vacuum and storage tank

40 year old
Cement Lined

80 year old
Cast Iron

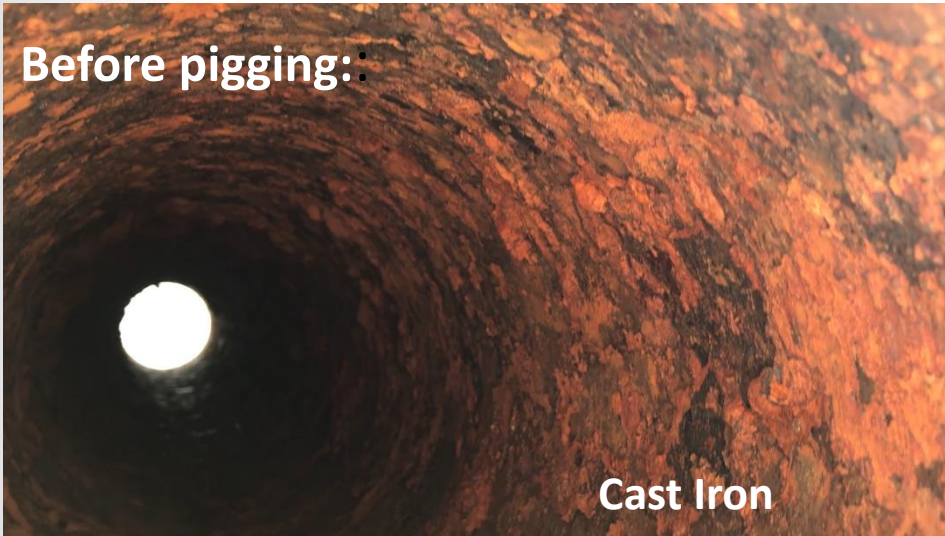
Before pigging:

Cast Iron

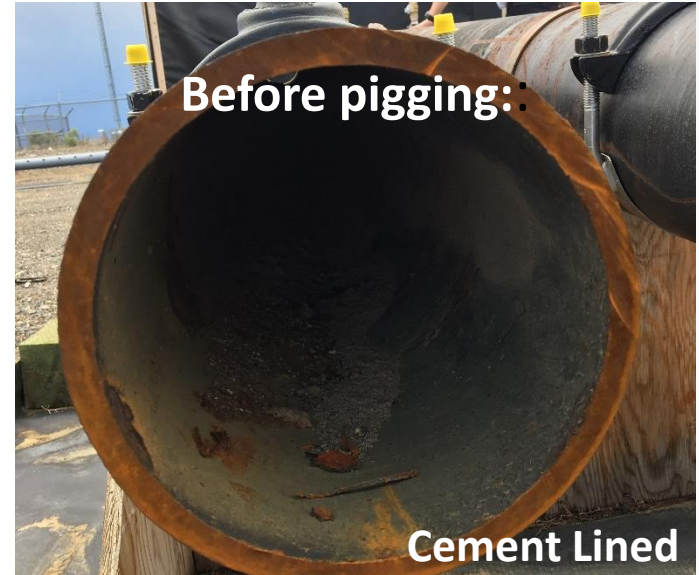
Before pigging:

Cement Lined

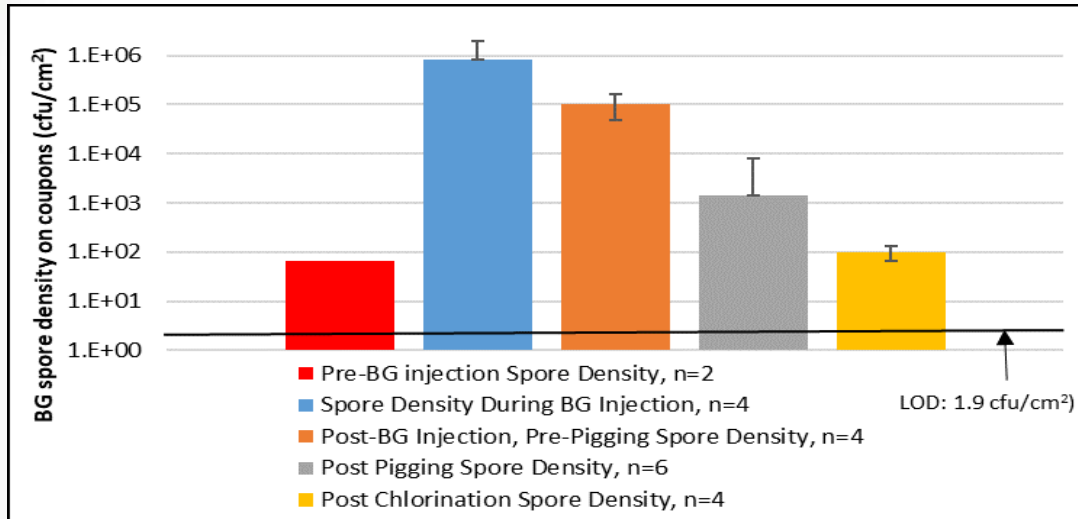
Bg decon from cement mortar-lined pipe section

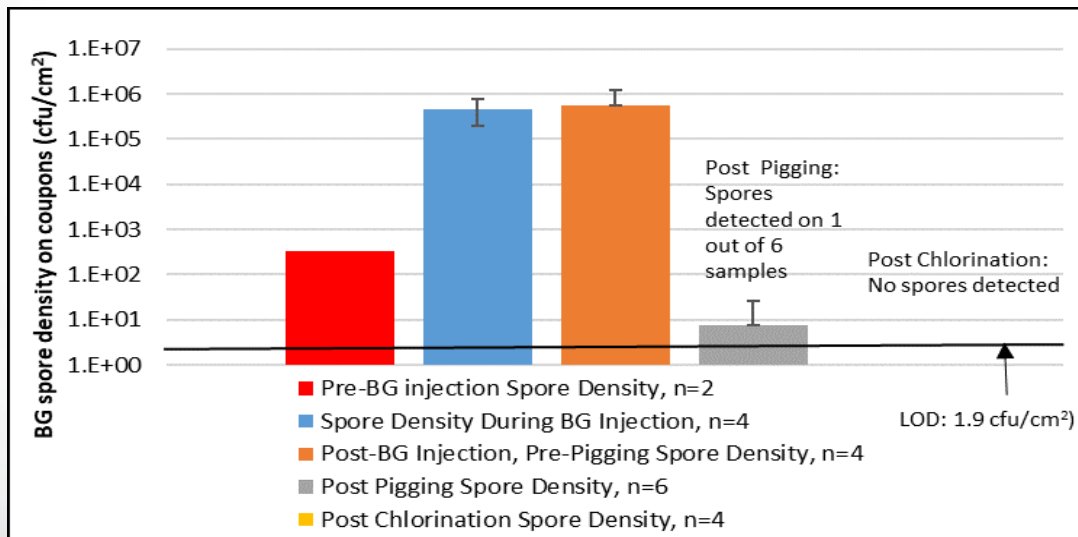
Bg decon from DC Water corroded cast iron pipe

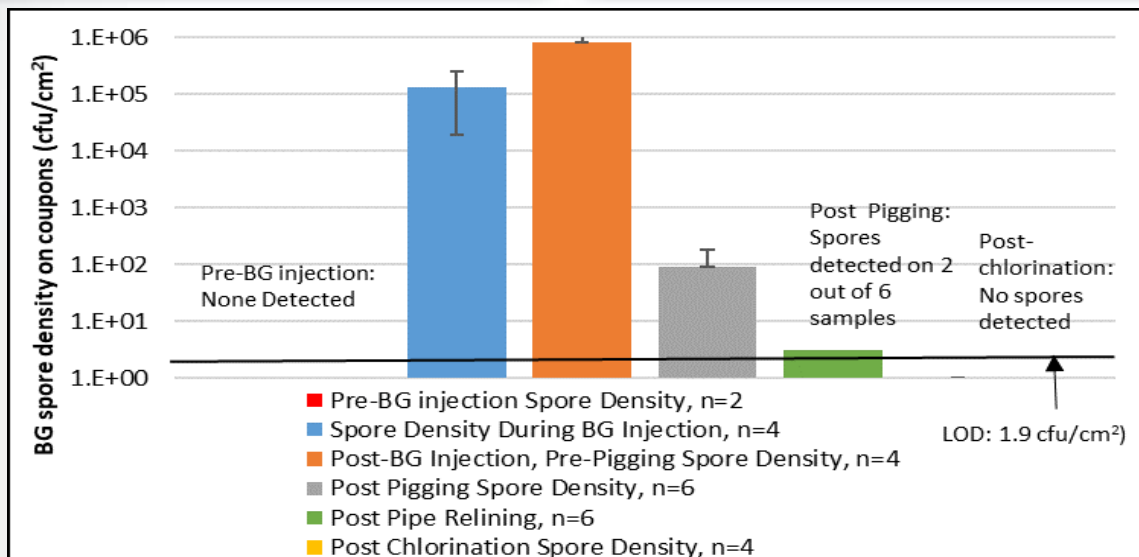
Bg decon from cement mortar-lined pipe section

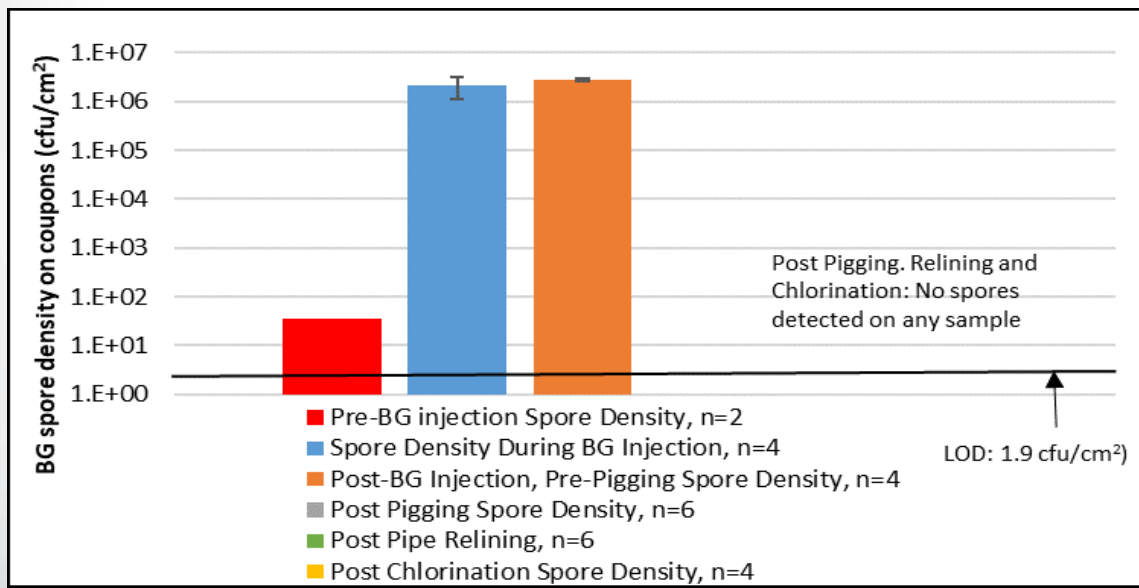
Bg decon from DC Water corroded cast iron pipe

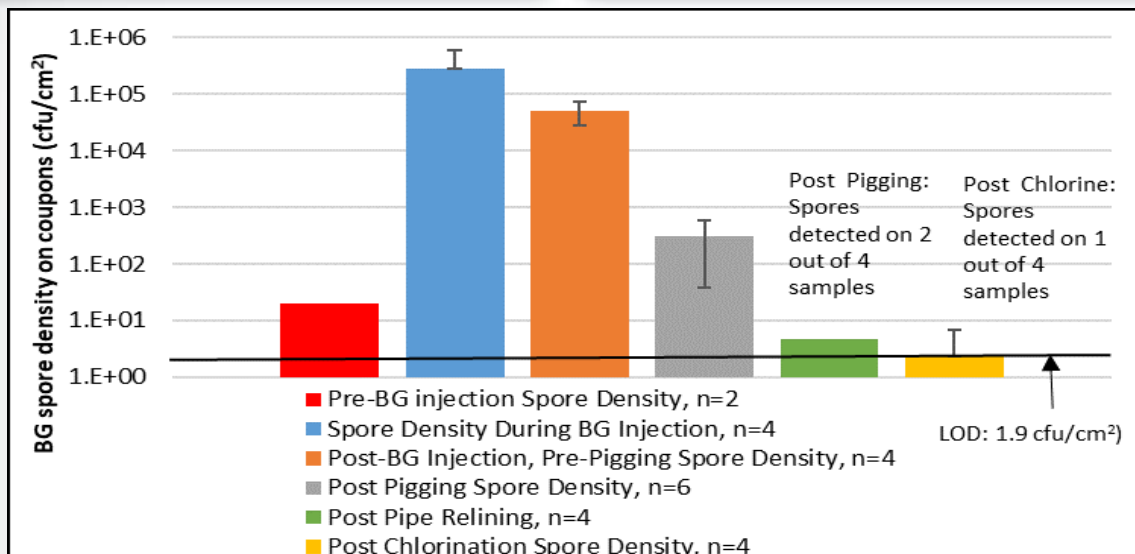
Bg decon from cement mortar-lined pipe section

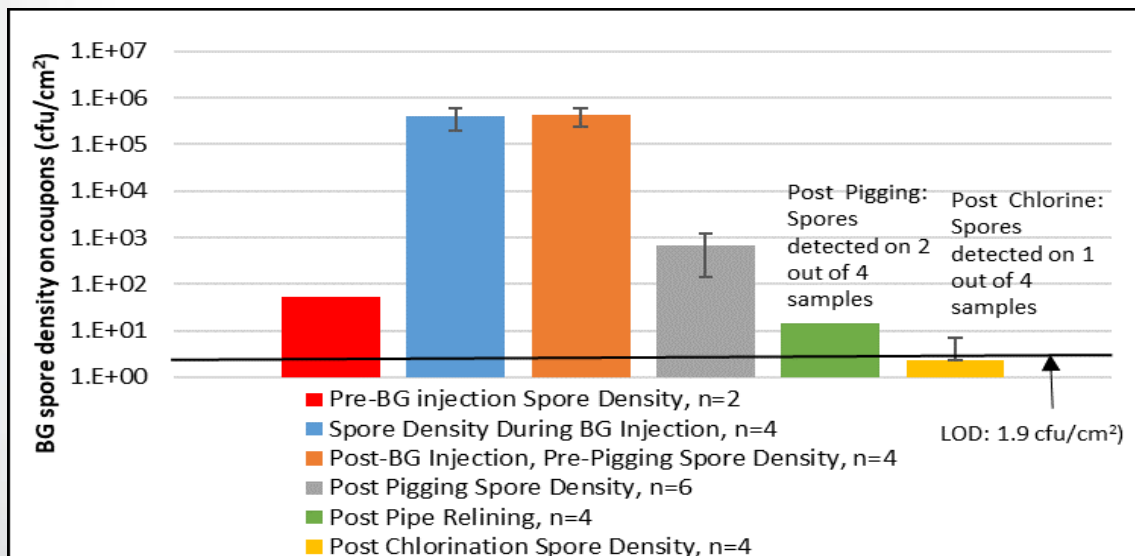
Bg decon from DC Water corroded cast iron pipe

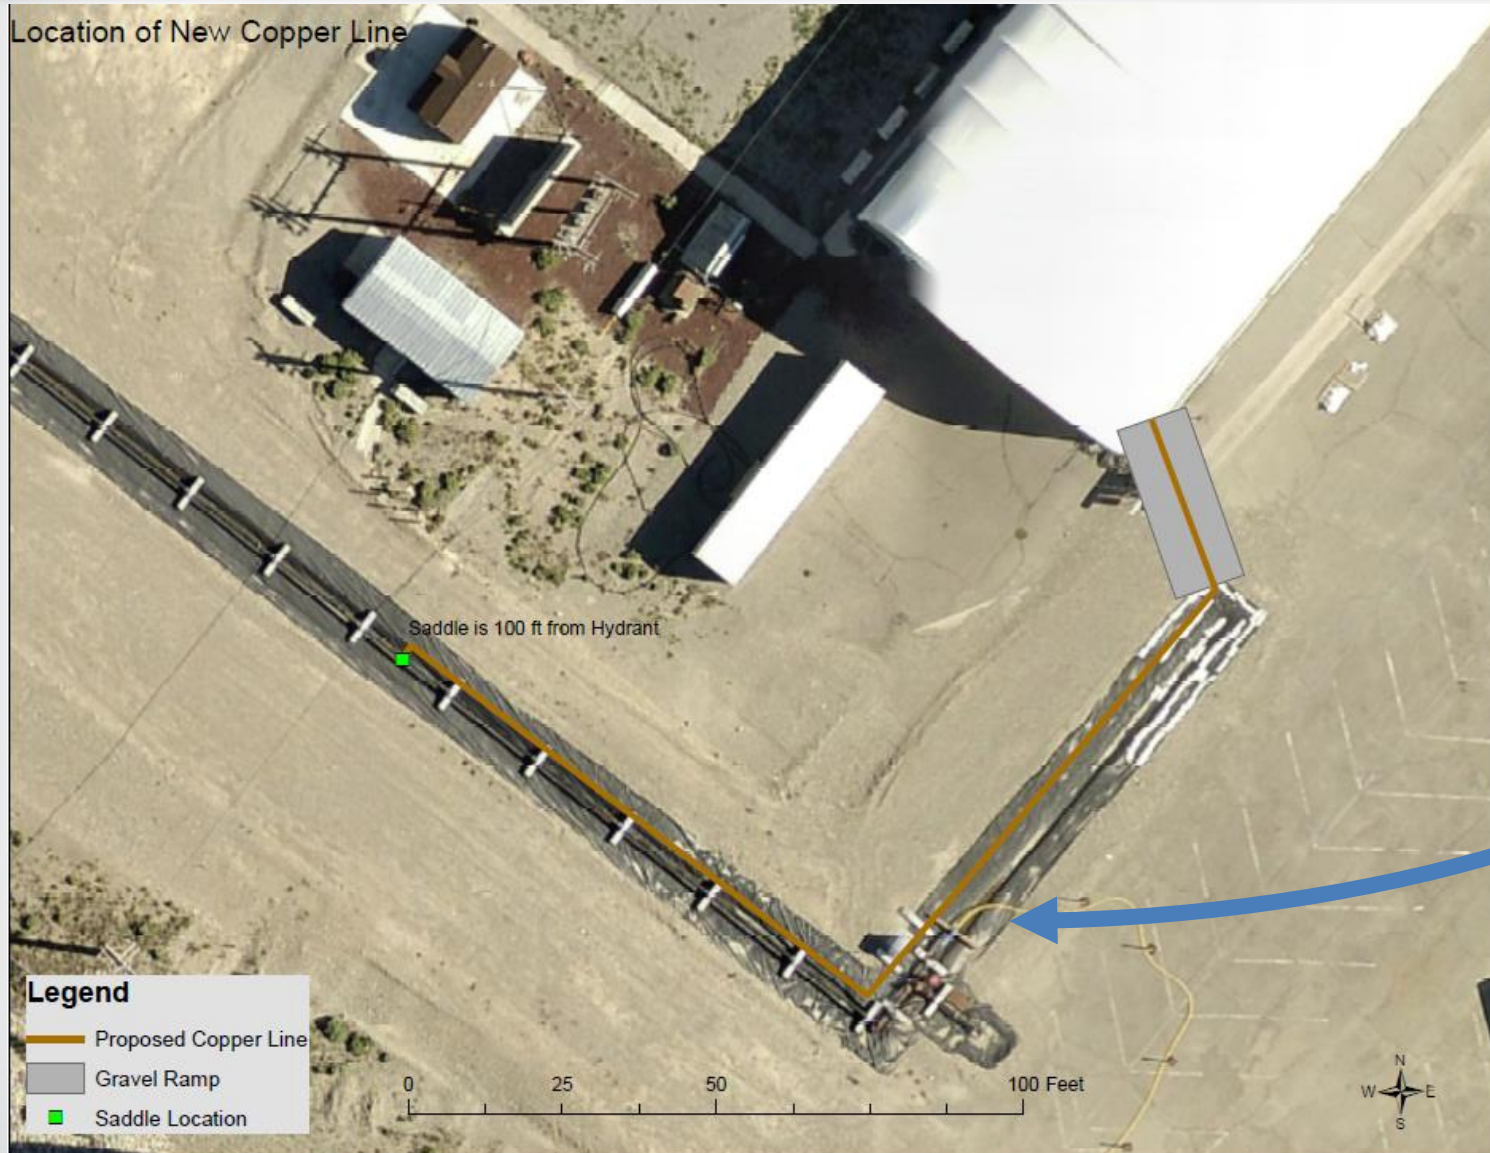
**1" (2.54 cm)
Copper Service
Line to Indoor
Plumbing
(~ 200', 61m)**

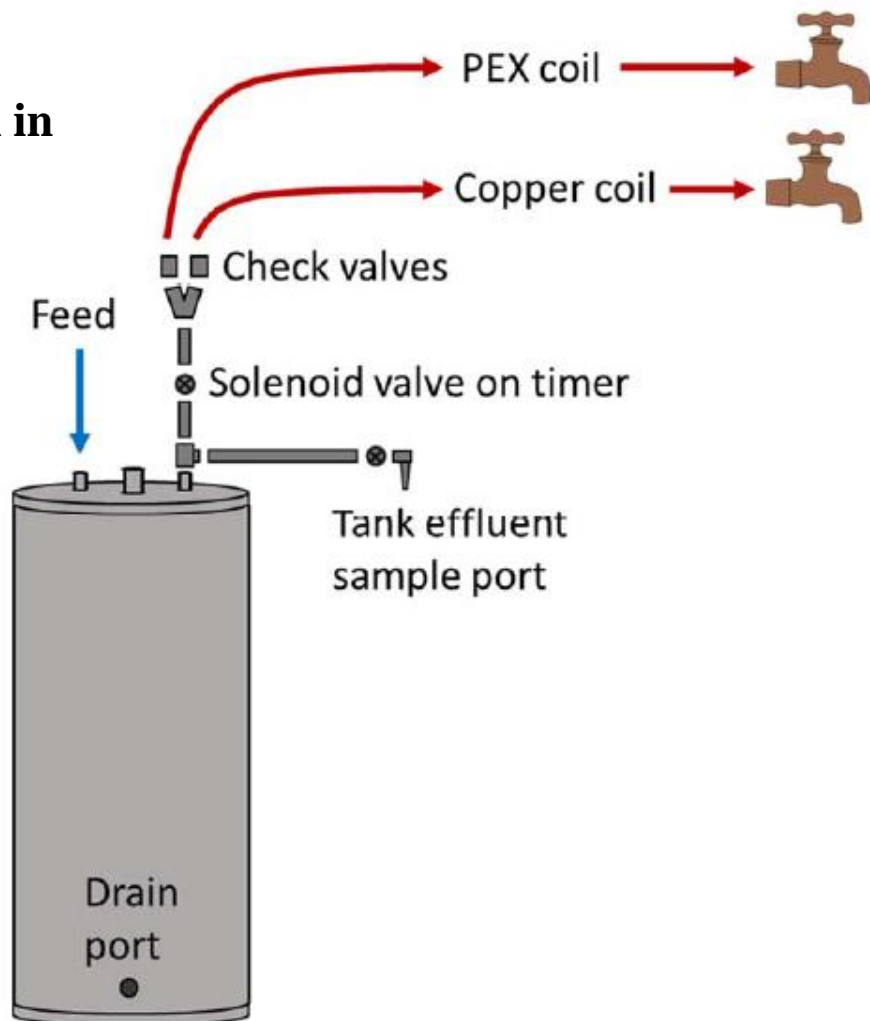
Figure 4. Hot Water Experiment Plumbing

- Conduct longitudinal study on the impacts of flushing and thermal inactivation on *L. pneumophila*, *Pseudomonas aeruginosa*, and NTMs in hot water heaters, plumbing, and fixtures
- Study design: four hot water heaters, two of conventional design and two prototypes with passive control of microbial growth
