Compatibility of Electronic Equipment and Other Materials with Peracetic Acid Fog and Low Concentration Hydrogen Peroxide Vapor

Center for Environmental Solutions and Emergency Response
Office of Research and Development
U.S. Environmental Protection Agency
Research Triangle Park, NC 27711

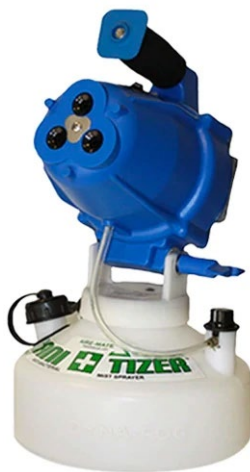
PAA fog was produced using a Sani-Tizer™ ultra-low volume fogger (Curtis Dyna-fog, Ltd., Westfield, IN). The fogger consisted of a motor/blower assembly, nozzle system, nozzle housing, 1-gallon formulation tank, and metering a valve. The PAA solution (MinnCare Cold Sterilant, Mar Cor Purification, Lowell, MA; EPA Registration Number 52252-4) was drawn from the formulation tank through the control valve and into the nozzle system where it was pneumatically sheared into an aerosol or mist with a mean droplet size of 31.0 μm . The droplets were then disseminated throughout the chamber by ambient air passing through the nozzle system. The fogger is shown in Figure 2-1.

Figure 2-1. Fogger used to disperse PAA.

From a previous study (U.S. EPA, 2016), it was determined that fogging 31.25 milliliter (mL) PAA per m^3 of volume to be decontaminated was the minimum amount required for effective decontamination against *B. anthracis* spores. Based on this amount and the volume of COMMANDER, a volume of 750 ml of PAA solution was fogged. The fogger was transferred to COMMANDER and placed on the floor in front of the chamber door, facing the back wall with the nozzle positioned at an angle of approximately 70°. The metering valve knob was positioned on the low flow setting which allows for reduced droplet size. The fogger was plugged into an unenergized power outlet and the fogger's power switch placed in the ON position. A 12-inch (in), 3 speed, oscillating fan (Pelonis Technologies Inc., Exton, PA) was placed in COMMANDER with the speed setting set to the HIGH position in order to promote even fog distribution throughout the chamber. The COMMANDER chamber was sealed and an approximate zero air exchange rate was set by adjusting the chamber's air supply and exhaust valves. The fogger was activated remotely using the SCADA system. Active fogging is defined for this report as the duration of time the unit generated fog output, continued until the volume of solution in the fogger tank was insufficient to support fog production. The fogger was remotely turned off and the chamber allowed to dwell overnight, consistent with a previous study in which PAA was fogged and shown to be effective for *B. anthracis* (U.S. EPA 2016). At the start of the following day, the chamber was aerated. The materials and equipment were collected for photo documentation and evaluation. The remaining solution in each fogger was transferred to a graduated cylinder and measured. The volume of solution dispersed as fog was determined volumetrically.

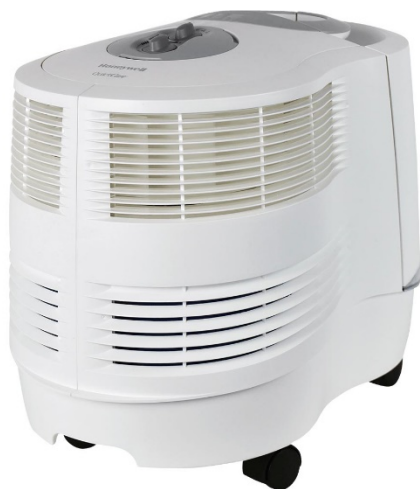
The two LCHPV tests were performed using the Honeywell QuietCare Cool Mist Console Humidifier, HCM-6009 (Honeywell, Morristown, NJ). The humidifier was a cool mist evaporative humidifier that used a small fan to pull air through a wicking filter saturated with aqueous solution from the reservoir to disperse. Each humidifier had two 1 ½ gallon tanks for a total capacity of 3 gallons with 9 possible combinations of output settings. Figure 2-2 shows the Honeywell, HCM-6009 humidifier.

Figure 2-2. Honeywell HCM-6009 humidifier.

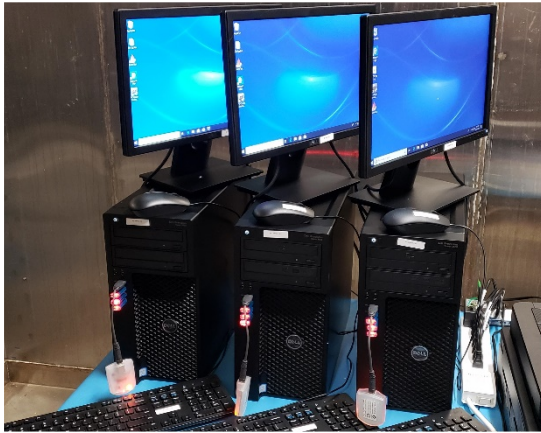
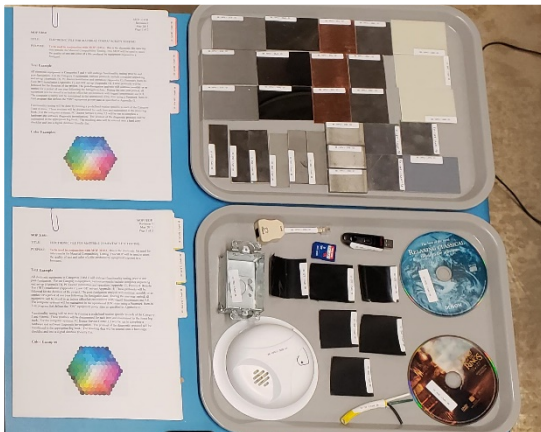
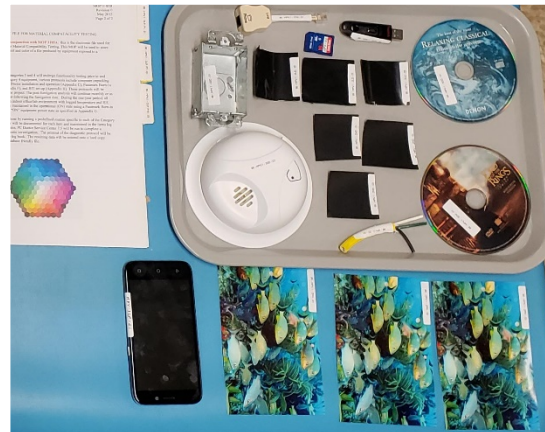
4. Figure 2-4. General setup of Categories 2, 3, and 4 materials and equipment for PAA fog and HPV exposure. Photo a: Category 4 equipment; Photos b, c, and d were Categories 2,3, and 4 materials and personal electronics. Three computers designated as controls for Category 4 remained at the permanent ESD workstation. The control materials and equipment for Categories 2 and 3 remained in the same onsite laboratory as the permanent ESD workstation for long-term storage during the observation period.
5. Five BIs and 1 HOBO logger were placed outside of COMMANDER in the enclosure area for use as controls (unexposed to the treatment conditions).
6. The fogger or humidifier containing prepared aqueous decontaminant solutions were placed inside the COMMANDER. Figure 2-5 shows the humidifier and fan placement during testing.

3. Category 4 computers were assembled, configured, and photographed at the permanent ESD workstation located onsite in Highbay Building Room 106. Baseline functionality testing was completed using PC Doctor Inc.'s PC-Doctor Service Center 11 software. Computers were disassembled, packaged in 4 mil Static Intercept® bags (Xtend Packaging, Inc., Houston, TX), transported on a grounded steel conductive cart (McMaster Carr®, Santa Fe Springs, CA), then reassembled on the temporary ESD workstation located inside of the exposure chamber. Categories 2 and 3 materials underwent baseline testing and photography, were transported to the exposure chamber, then staged as shown in Figure 2-4.

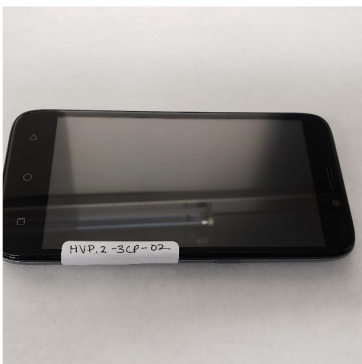
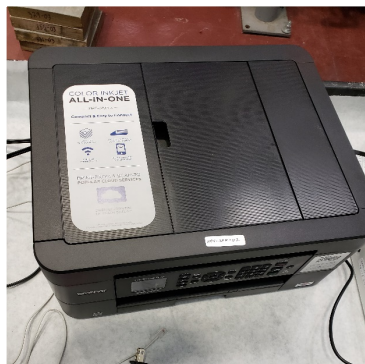
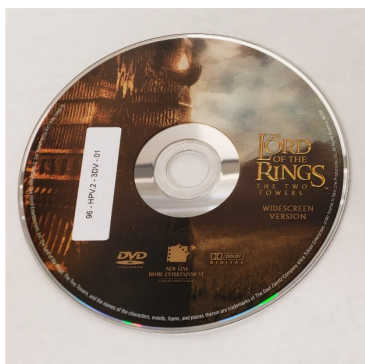
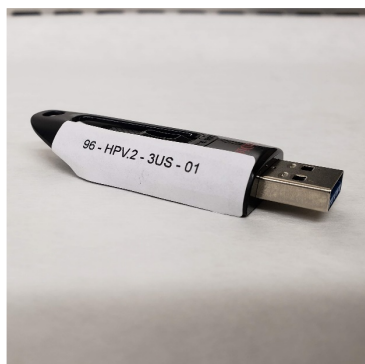
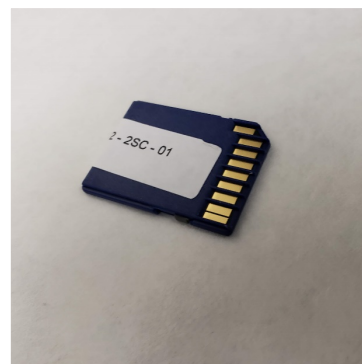
Figure 3-4. Category 3 equipment controls: (a) mobile phone, (b) printer/fax/scanner/copier machine, (c) data CD, (d) data DVD, (e) USB flash drive, and (f) SD memory card.

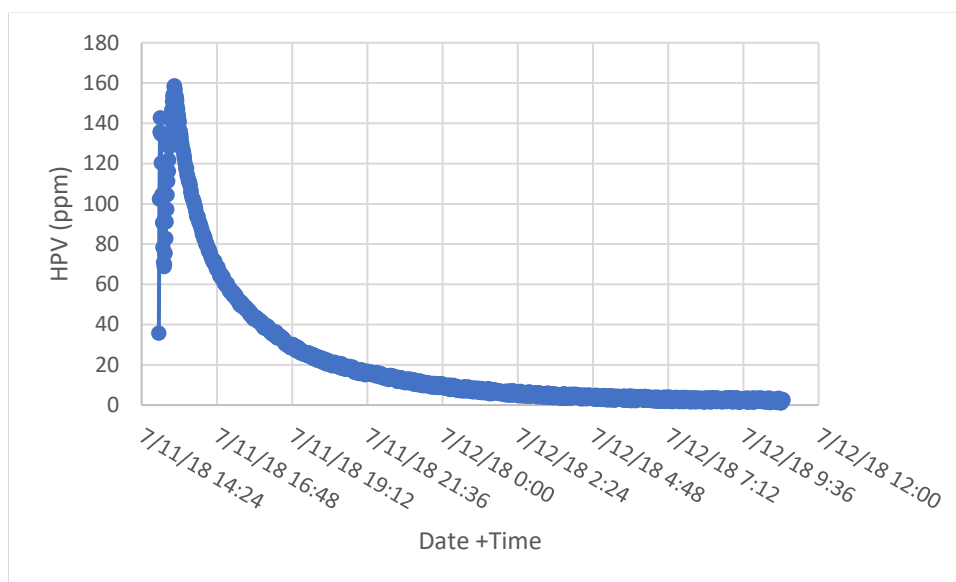
The PAA fog test was performed with the fogger (Section 2.4.1) having the mist setting on LOW. Preliminary flow rate checks with deionized water showed the LOW setting disseminated approximately 59 mL/minute (min). A total of 746 mL of PAA were disseminated during the exposure; 750 mL of PAA were added to the fogger prior to activation and 4 mL of PAA were retrieved upon re-entry the following day. Active PAA fog generation continued for approximately 11 minutes prior to shutting off the fogger, followed by a dwell time of approximately 19 hours prior to starting chamber aeration. Figure 4-1 shows the HPV concentration over the duration of the exposure and during the initial 2 hours of the PAA fog test.

Figure 4-1. HPV concentration during PAA fog test.

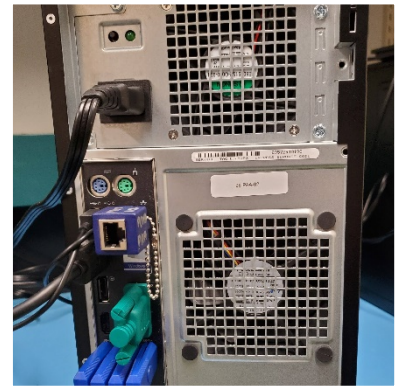
Figure 4-14. Control desktop computer at month 12 of the observation period: (a) monitor, (b) keyboard, (c) computer exterior, and (d) computer interior.

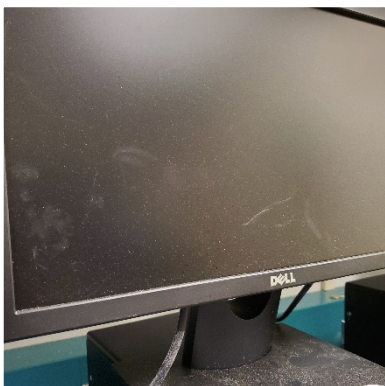
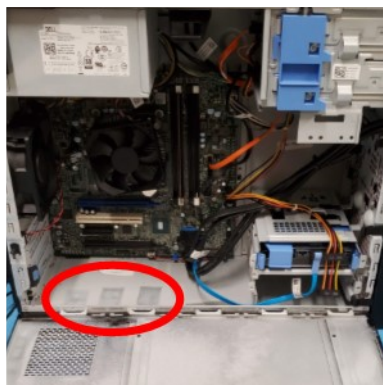
Figure 4-15. T01 desktop computer 12 months after PAA exposure: (a) monitor, (b) keyboard, (c) computer exterior, and (d) computer interior.

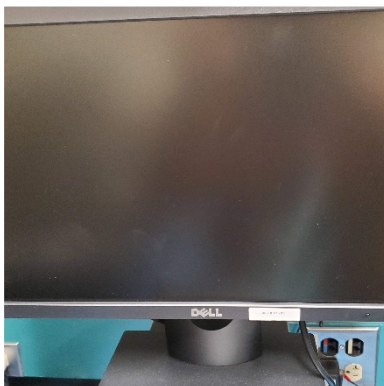
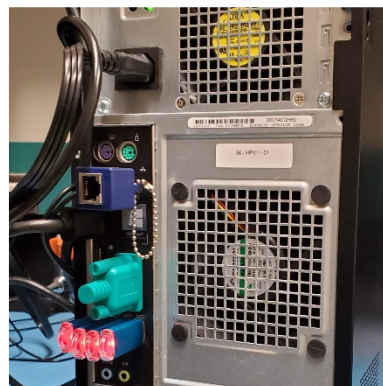
Figure 4-16. T02 desktop computer 12-months after 3% LCHP exposure: (a) monitor, (b) keyboard, (c) computer exterior, and (d) computer interior.

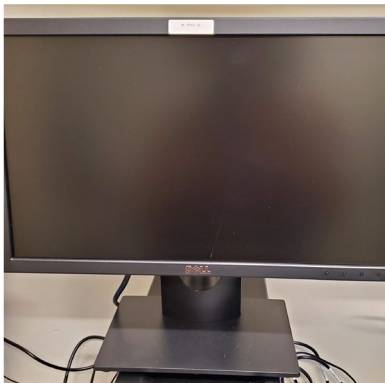
Figure 4-17. T03 desktop computer 12-months after 8% LCHP exposure: (a) monitor, (b) keyboard, (c) computer exterior, and (d) computer interior.
