# Finding Lead Service Lines – Tools and Techniques – What Works?

Simoni Triantafyllidou, US EPA Office Of Research and Development (ORD)

November 14, 2022

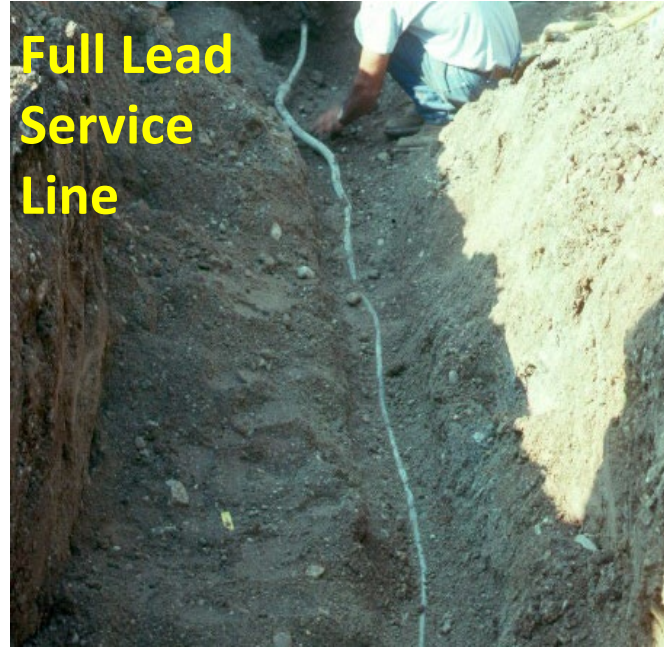
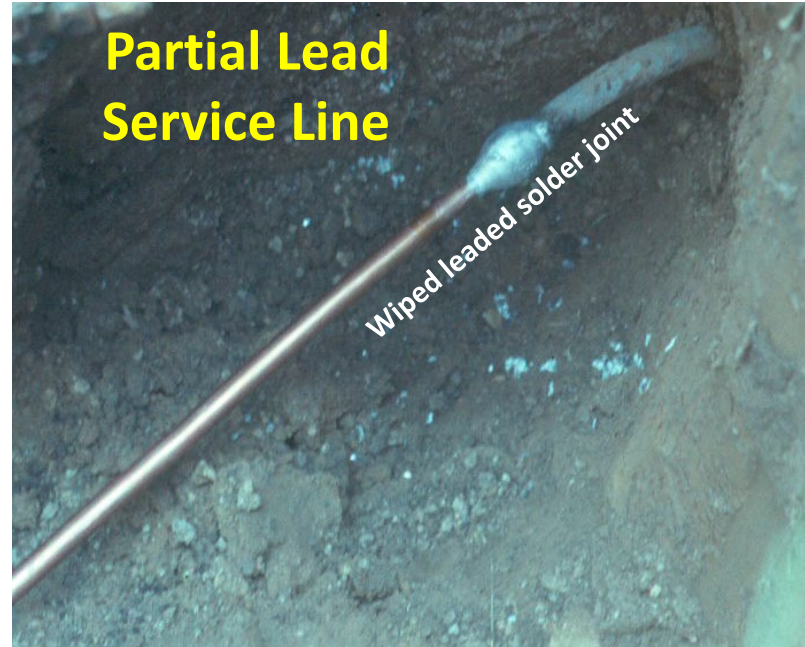
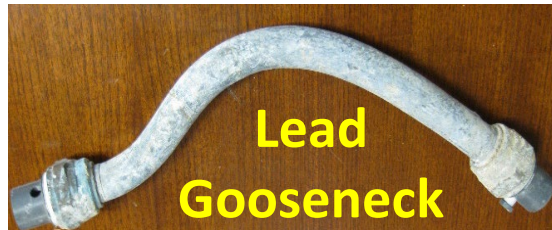
# Legacy lead and lead-lined pipes are primary contributors to water lead contamination

What constitutes a “lead service line”?  
The definition may differ depending on context

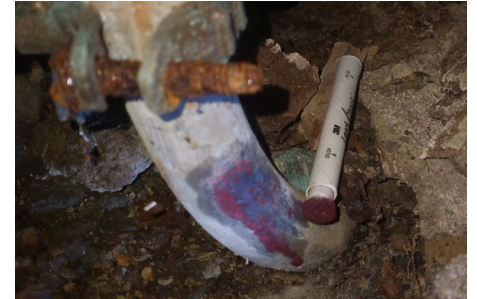
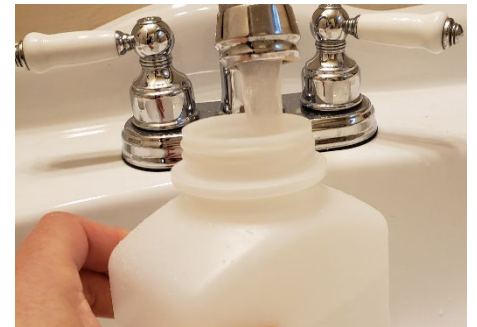
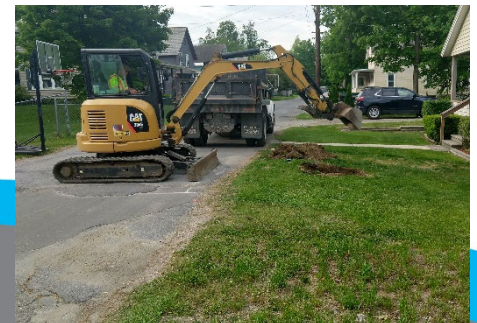
- Basement inspections (paused during COVID):
  - Observe SL material entering foundation
  - Swab test when visual observation was inconclusive
- 700 basement inspections proved records unreliable

- Partial excavation at curb stop
- Observe pipe materials

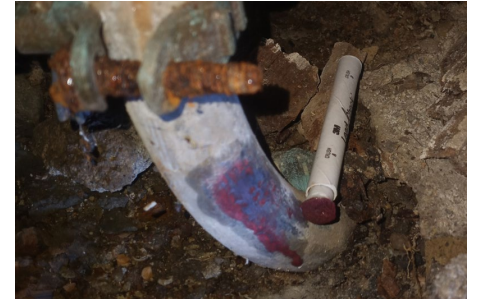
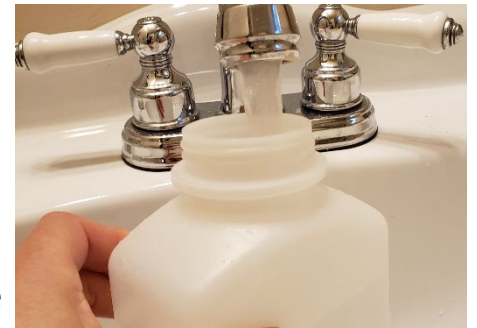
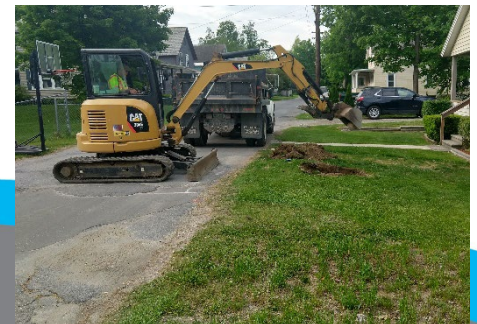
- Basement inspections (paused during COVID):
  - Observe SL material entering foundation
  - Swab test when visual material observation was inconclusive
- 700 basement inspections proved records unreliable:
  - No lead at 71% of homes listed as LSLs
  - Lead at 14 % of homes listed as non-lead

- Excavate at curb stop, >2 linear ft of SL on each side
- Observe pipe materials
- Disturbs pipe (WQ impacts); requires sidewalk/lawn repair; high cost

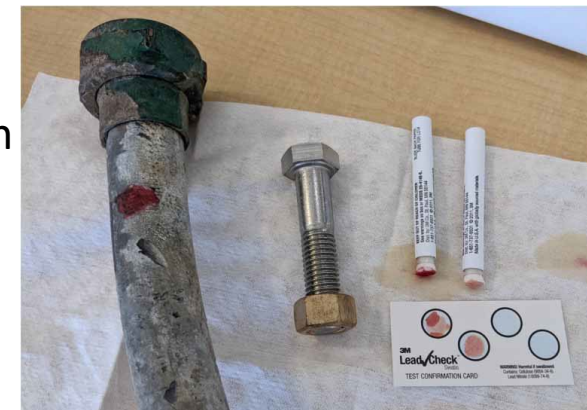
Surface swab kit turns pink for lead gooseneck but not for stainless steel

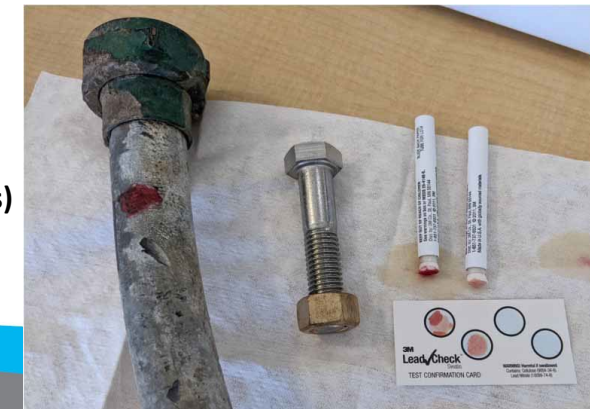
Surface swab kit turns pink for lead gooseneck but not for stainless steel
