# Progression of Clogging in a Permeable Pavement Parking Lot

*Thomas P. O'Connor, P.E., BCEE Environmental Engineer  
Stormwater Management Branch, Water Infrastructure Division*

# Edison Environmental Center Permeable Pavement Research and Demonstration Site

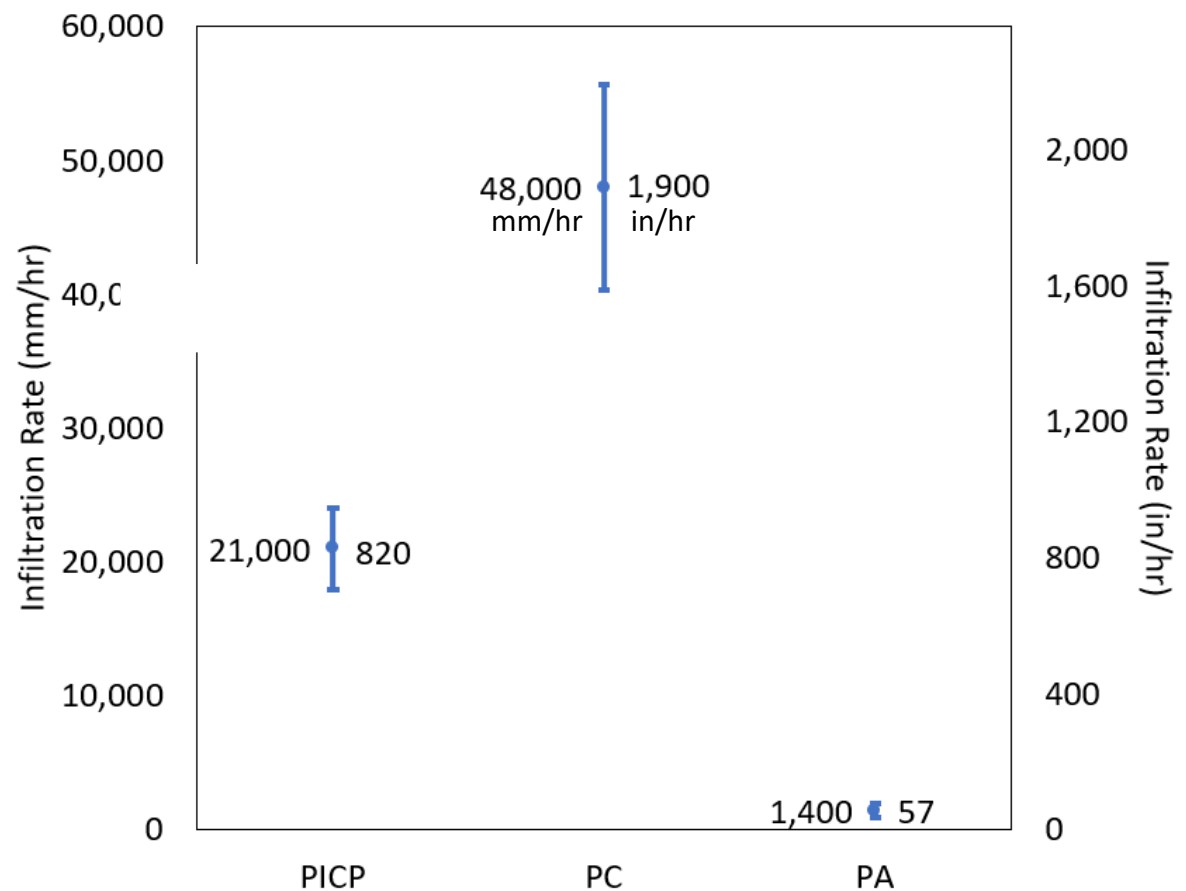
# Mean Surface Infiltration Rates Exceeded Maximum Expected Direct Rainfall Rates.

**100-year, 5-minute  
rainfall intensity  
208 mm/hr (8.2 in/hr)**

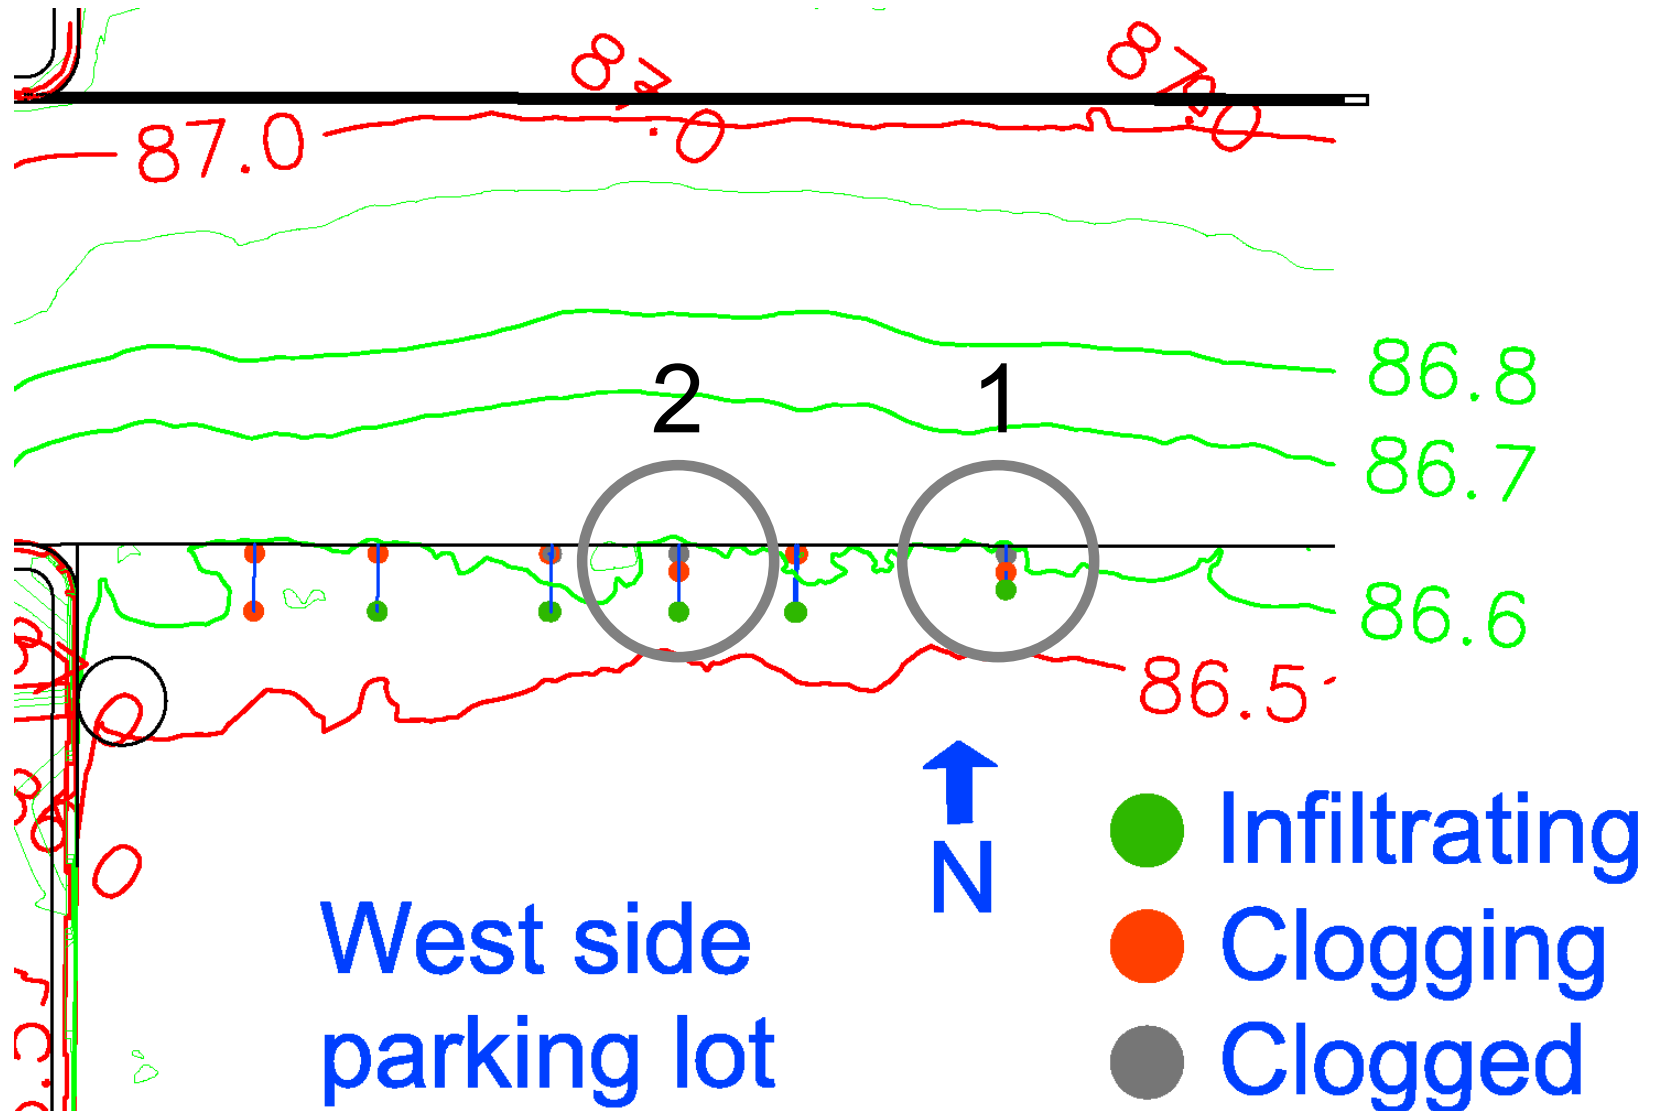
# Zooms of First Two Clogged Locations

Clogged condition occurred  
577 days after installation.

The 86.6 ft contour line  
crosses into driving lane.

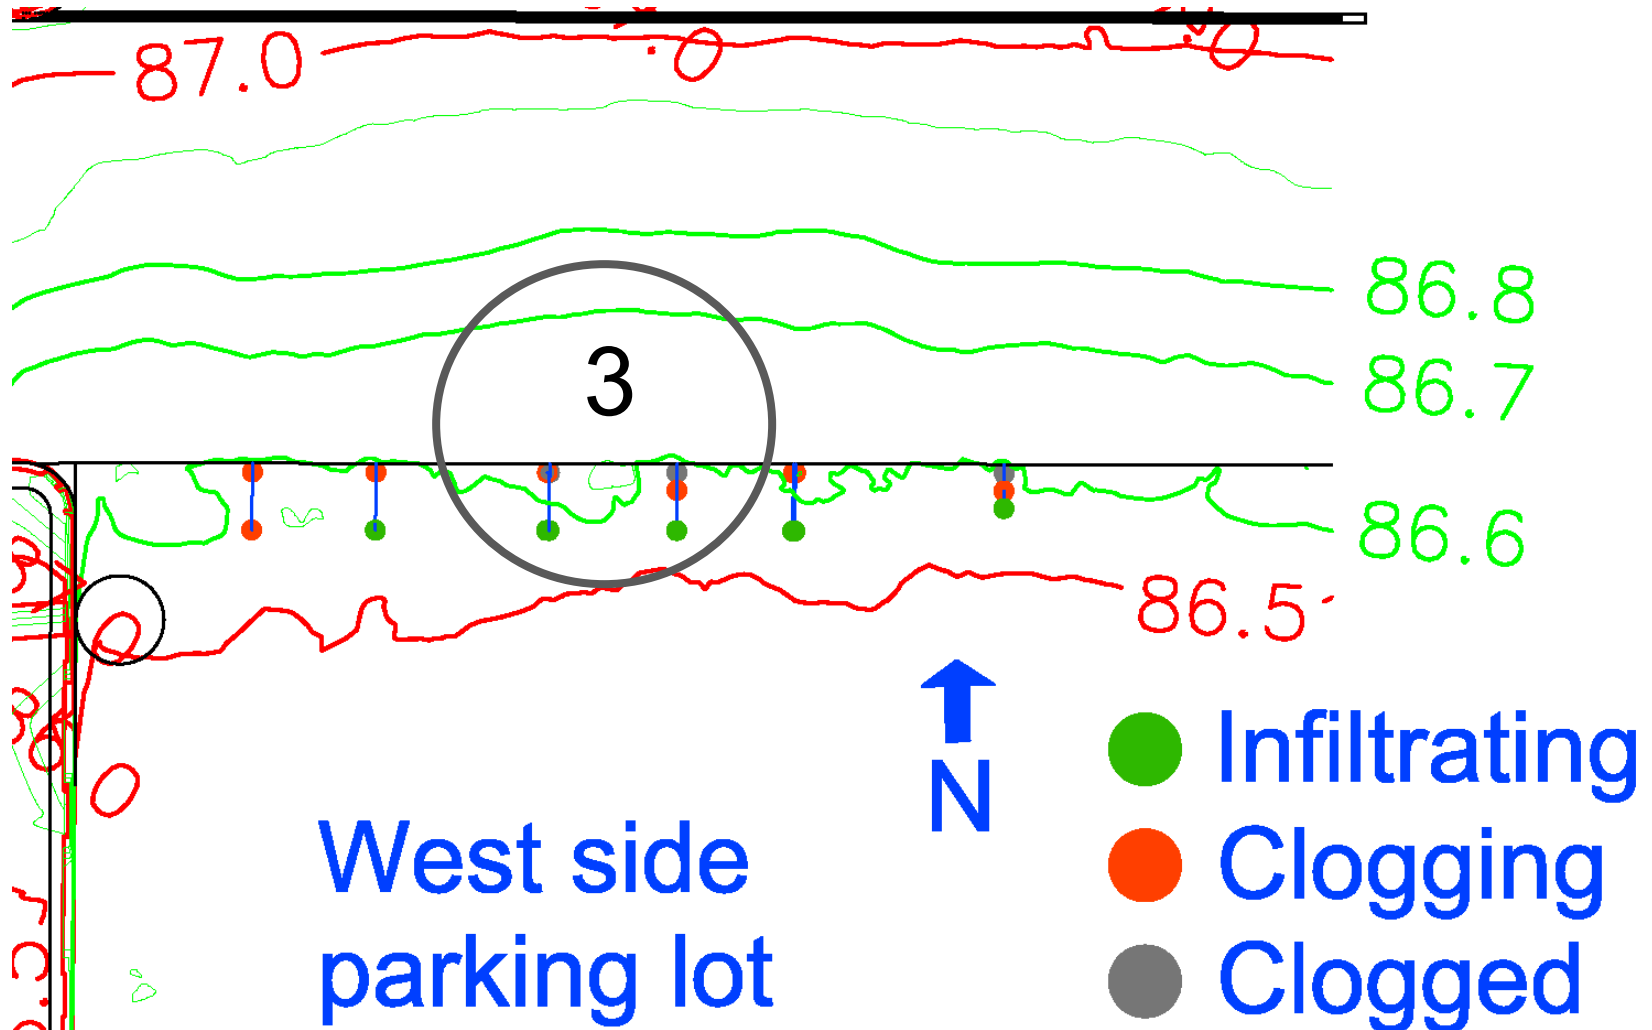
# Zoom of Third Clogged Location and Predictive 86.7 Foot Contour Line

Third location is **Clogged** 728 days after installation.

The 86.6 ft contour line not predictive while 86.7 ft contour line is.
