Compatibility of Material and Electronic Equipment with Chlorine Dioxide Fumigation

ASSESSMENT AND EVALUATION REPORT

U.S. ENVIRONMENTAL PROTECTION AGENCY
OFFICE OF RESEARCH AND DEVELOPMENT
NATIONAL HOMELAND SECURITY RESEARCH
CENTER
RESEARCH TRIANGLE PARK, NC 27711

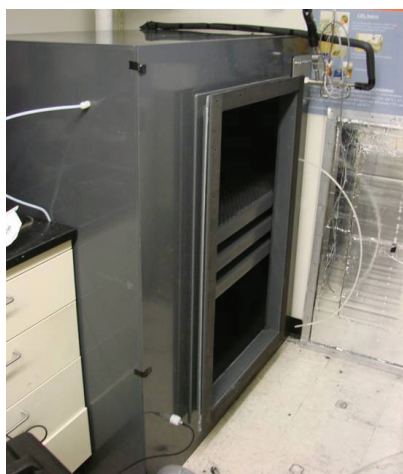
Figure 1-2. Photograph of the MEC Test Chamber.

The chambers are made of opaque PVC with a clear acrylic door, which is fastened with a bolted flange. The door is covered with an opaque material during tests to prevent light-catalyzed reactions from taking place during exposure. The three removable shelves within the chamber are made of perforated PVC. Grounded woven wire mesh (Type 304 Stainless steel, 0.011" gauge wire) was placed on each shelf to dissipate any potential static electricity. The ground wire penetrated the chamber wall and was attached to the electrical service ground. Three fans were placed in each chamber to facilitate mixing.

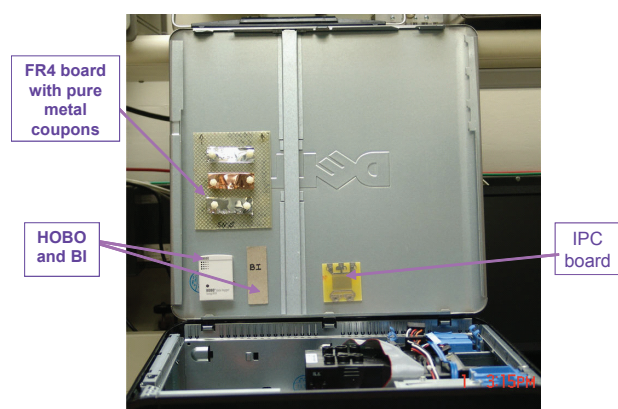
fumigation conditions for BA spores or inactivating BA spores on common building surfaces.¹⁴ While BIs do not necessarily indicate achievement, they will sufficiently indicate a failure to achieve successful conditions. The locations of process measurement monitors, metal coupons, IPC board and BIs within each computer are shown in Figure 1-3. The HOBO® (U12-011, Onset Computer Corporation, Pocasset, MA) is a relative humidity and temperature monitor with a built-in data logger. The placement of these items within the computers was decided based upon the air flow within the chamber and the desire not to affect the operation of the computer. The items were affixed to the inside of the side panel of the computer case using self-adhesive hook-and-loop dots (P/Ns 9736K44 and 9736K45, McMaster-Carr, Atlanta, GA).

Figure 1-3. Location of HOBO®, Metal Coupons, IPC Board, and BI within the Computers (left side panel shown from a top-down view with respect to the computer).

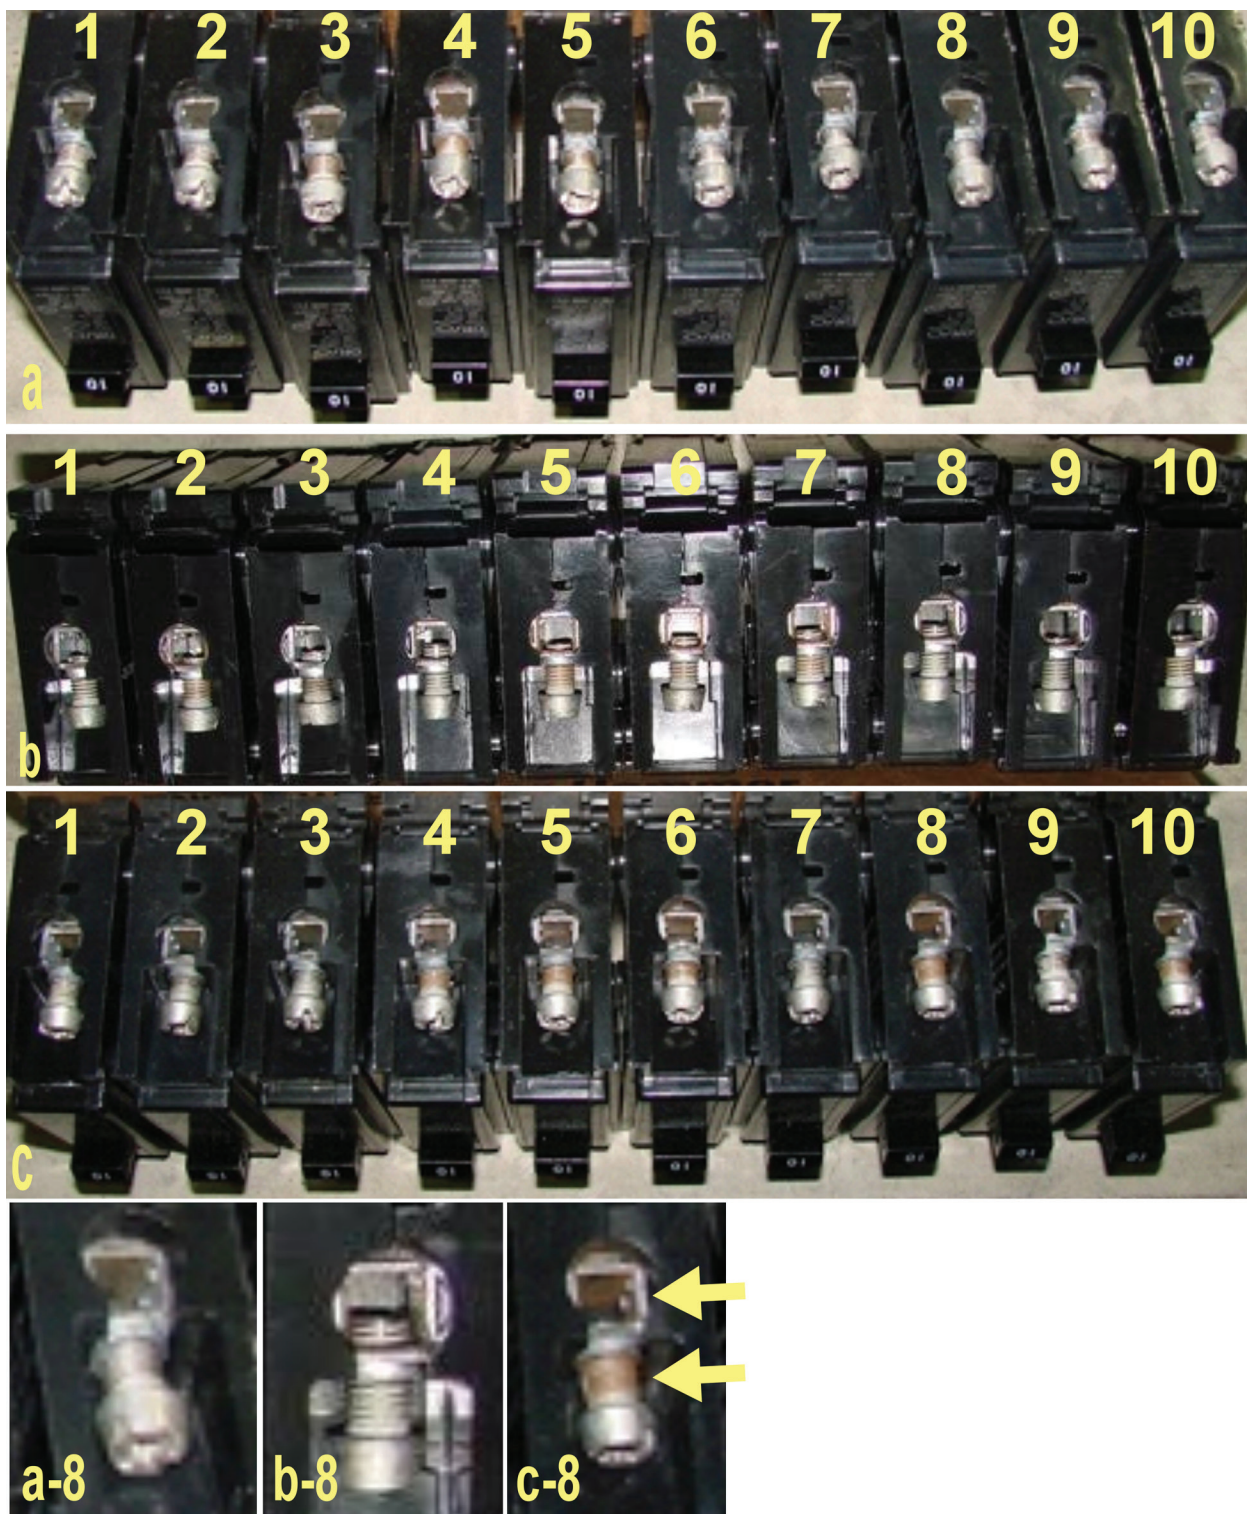
Figure 4-1. Corrosion on breaker screws at 12 months post exposure to (a) ambient conditions only (R05), (b) low RH fumigation (R04), and (c) high RH fumigation (R02); breakers are numbered 1-10 and a close-up of the screws for breaker 8 is shown. The arrows point to areas of corrosion evident on the screw on breaker 8 after exposure to high RH fumigation (labeled c-8 in the figure).

As discussed earlier, the Al and Cu service boxes experienced corrosion on their edges. In addition, both Al services fumigated at the 3,000 ppmv ClO_2 and high RH conditions experienced a green discoloration of one of the wires that had been white insulation. This discoloration can clearly be seen in Figure 4-8. The breakers in both of the high fumigant, high RH runs experienced marked corrosion of the screws. Not unexpectedly, these harshest fumigation conditions caused more corrosion than had been seen under any of the other test scenarios (see Figure 4-1).

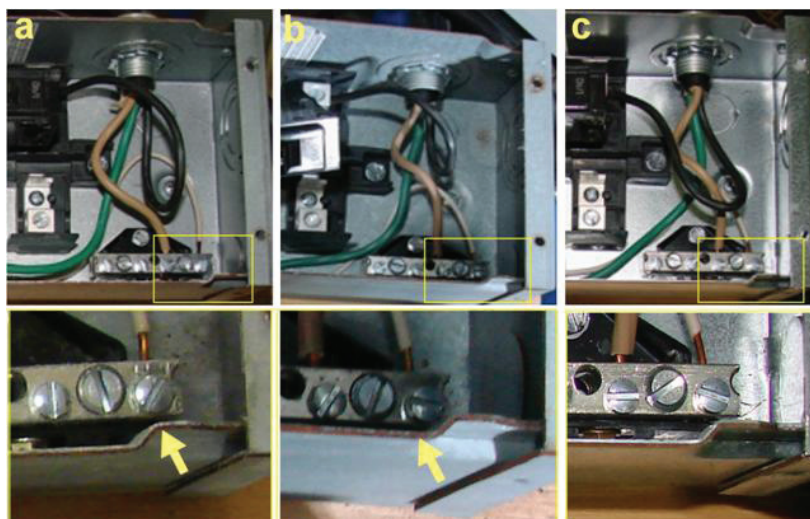
Figure 4-3. Corrosion on Cu service box at 12 months post-exposure to (a) low concentration fumigation (R03), (b) standard fumigation (R01), and (c) low RH fumigation (R04); lower pictures show a zoomed in area designated by the yellow boxes (arrows point out corrosion on edges of services).

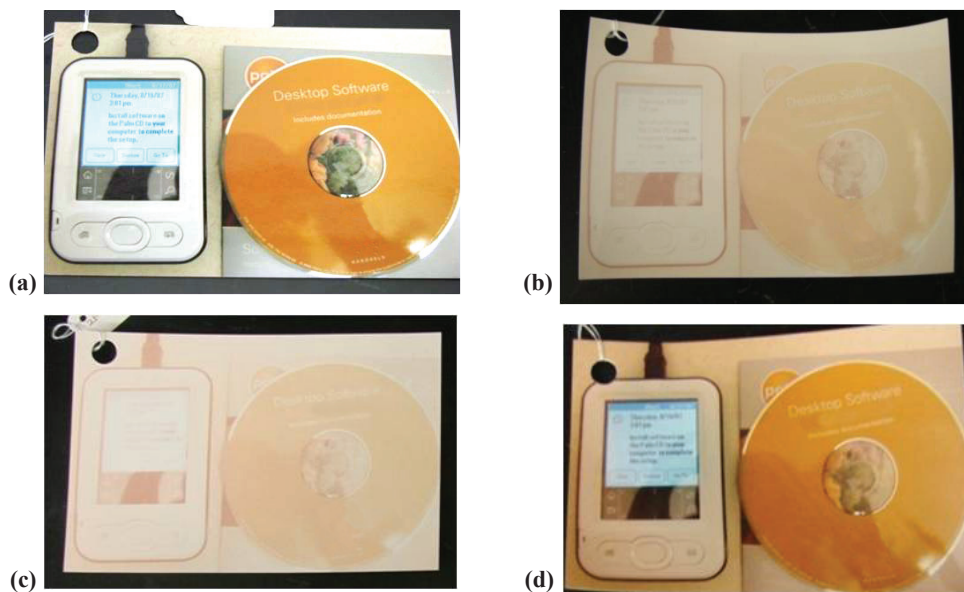
The photographs from the 75 ppmv ClO_2 , 75 percent RH fumigation conditions were not faded, but did appear slightly discolored (yellowed) by year's end (Figure 4-7(d)). However, for the 3,000 ppmv ClO_2 , 75 percent RH conditions, there was severe fading immediately following ClO_2 exposure. Although there was some further lightening by year end, the majority of the damage could be directly attributed to the fumigation process itself.

Figure 4-7. Photograph (a) before, (b) immediately after, and (c) at 12 months post-exposure to standard fumigation (R01), and (d) 12 months post-exposure to low concentration fumigation (R03).

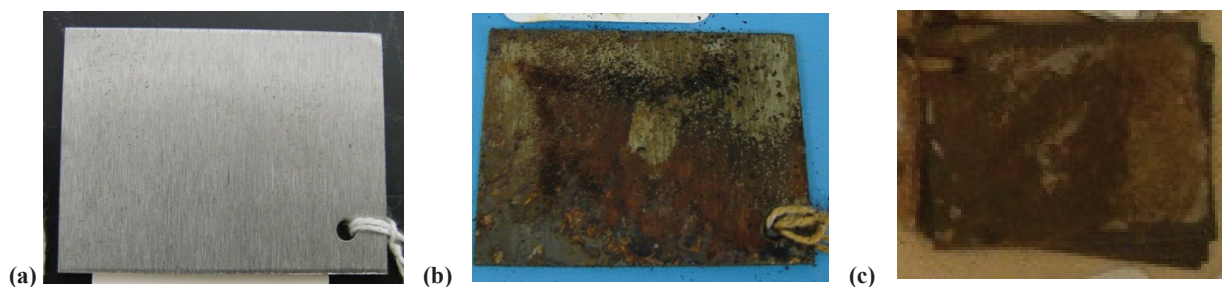
The low carbon steel coupons experienced the same severe corrosion as seen at the 75 percent RH conditions (see Figure 4-5). The 410 stainless steel coupons were also severely corroded as shown in Figure 4-10.

Figure 4-10. 410 Stainless steel coupons (a) before, (b) immediately after, and (c) at 12 months post-exposure to high RH fumigation (R06).

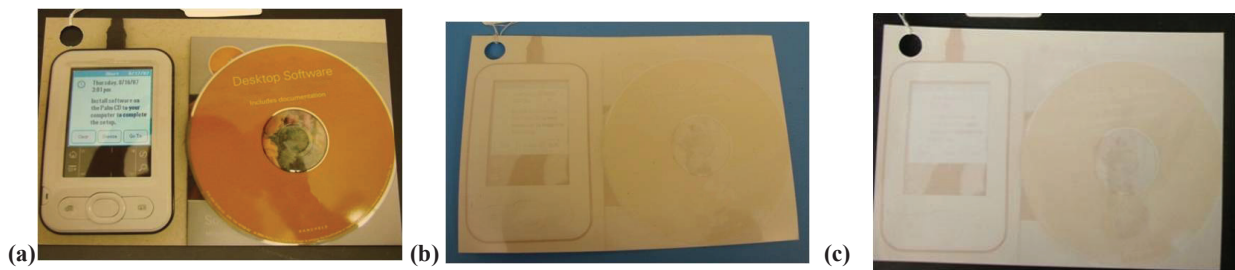
Figure 4-17. Photographs (a) before, (b) immediately after, and (c) 12 months post-exposure to high RH fumigation (R06).

The combination of the 3,000 ppmv ClO_2 fumigation with high RH, both at 24 and 27 °C, led to immediate and severe damage to both inkjet colors and to the photographs. Quality did not appear to be further degraded over the next year, and the last pages of the 15-page stacks looked very similar to the first. The inkjet black printing was still clearly legible, and the laser-printed colors remained quite vibrant throughout. Figures 4-16 and 4-17 show the impacts of high-level, high humidity fumigation on inkjet printed papers and on photographs, respectively.

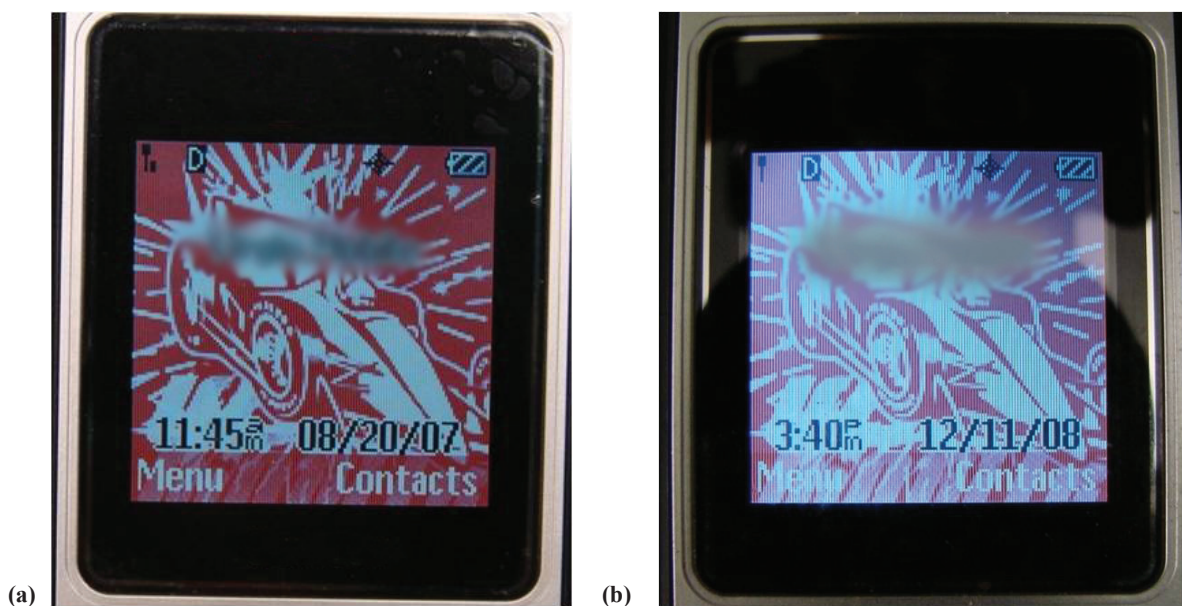
Figure 4-20. Cell phone screen (a) before and (b) at 12 months post-exposure to high RH fumigation (R06).

The only visual change noted for the cell phones was related to screen discoloration seen at the higher level fumigations. The screen legibility did not appear to be compromised. While milder at 75 percent RH, the effect was more marked in the high humidity runs, as can be seen in Figure 4-20.

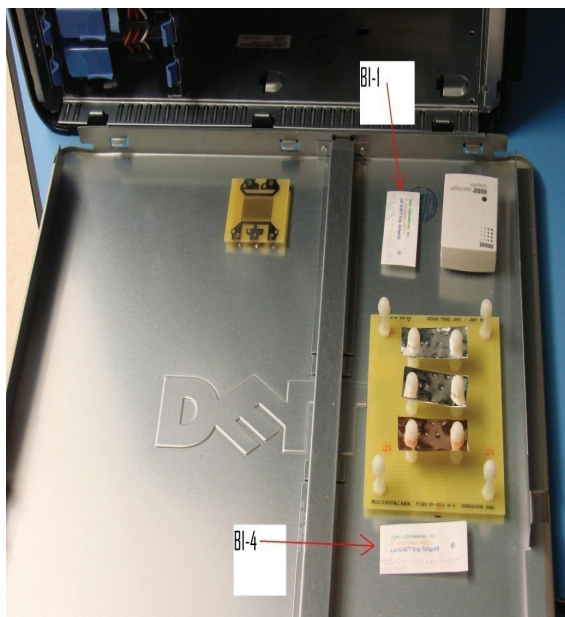
Figure 6-1. Location of two of the five BIs inside the computer side cover.

Figures 6-1 and 6-2 show the locations of the BIs within each computer. These locations were chosen based on the available mounting surfaces that afforded relatively unrestricted air flow. Two BIs were placed on the side cover (Figure 6-1) in areas which would remain open once the side panel was closed. Three more BIs (Figure 6-2) were placed inside the computer to capture both high and low air flow locations. BIs were also present in the MEC
