Tribal Ecosystem Research Program (TERP) Workshop

Proper Functioning Condition (PFC) Assessment for Management and Monitoring

Report to USEPA ORD NERL Environmental Sciences Division (ESD)

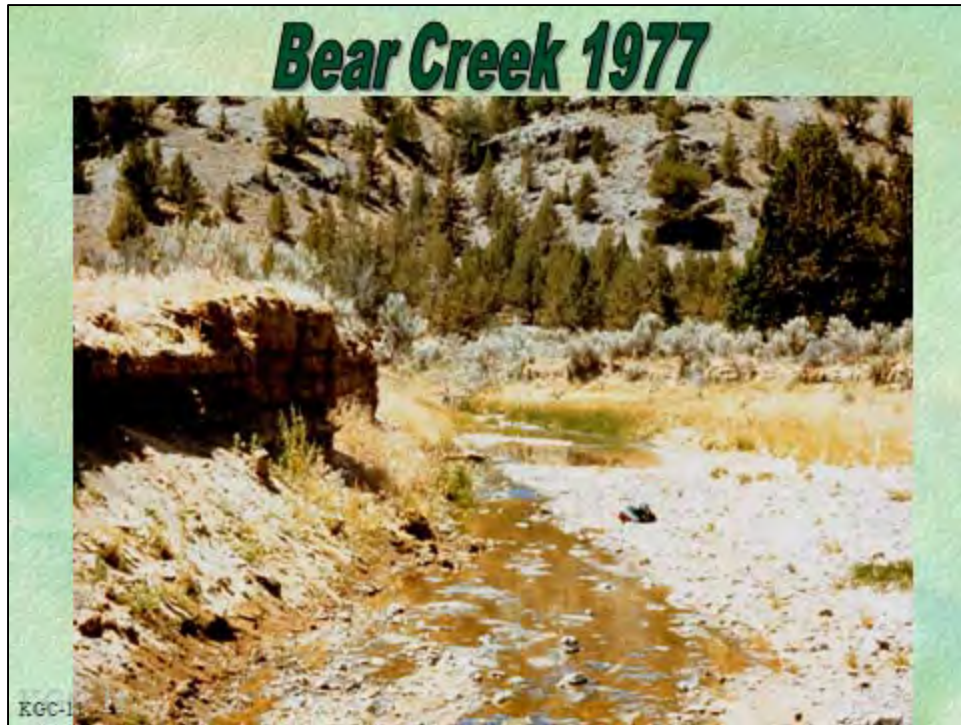
Figure 6. Sample Slide from the Classroom Presentation - Number 3.
Example of PFC at work in Bear Creek. Notice the recovery of the stream channel and flood plain vegetation. Workshop participants learn that with PFC information in hand meaningful land management changes can be made to aid recoveries like this one at Bear Creek. These lecture materials were from the Nevada Creeks and Community Team and can be found at, <http://www.cabnr.unr.edu/swanson/Extension/PFCTeam.aspx>.

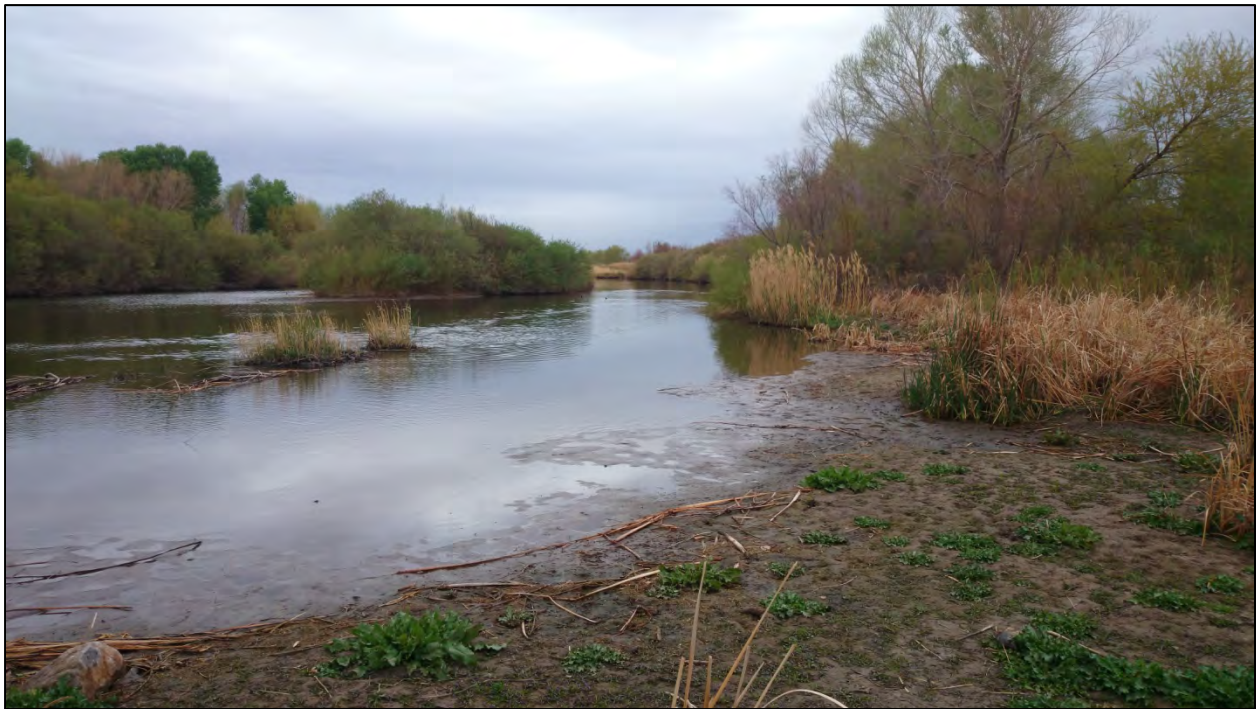
Figure 12. Pabco Section of the Las Vegas Wash Looking Downstream.

Figures 12 through 14 are photographs of the Las Vegas Wash at the Pabco trail head location. Stream access was acceptable and there was much to be learned from the soil and vegetation types located at this site but PFC analyses was not completed by participants.

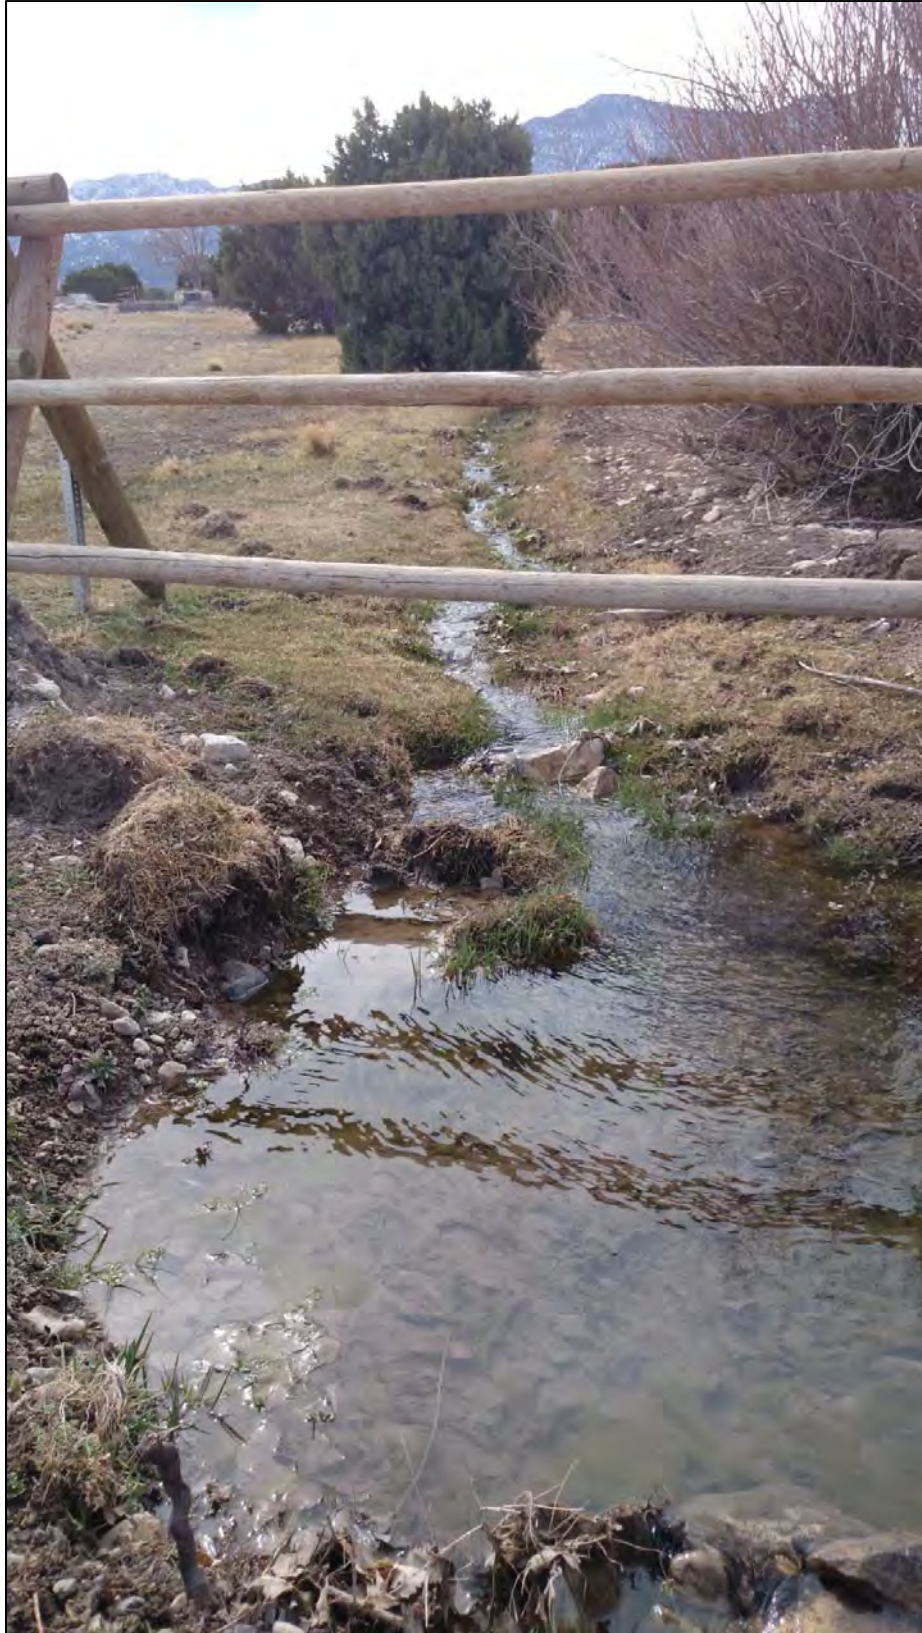
The Deputy Fire Chief told us that the wetland area had been created by diverting the creek in the early 20th century. This area use was by ranchers for cattle, horses and entertaining special guests. The water held in the ponds is currently used for fire fighting purposes and in the winter time, these ponds are stocked with fish for recreational fishing.

Figure 18. Diversion of Water from Cold Creek to the Ponds.

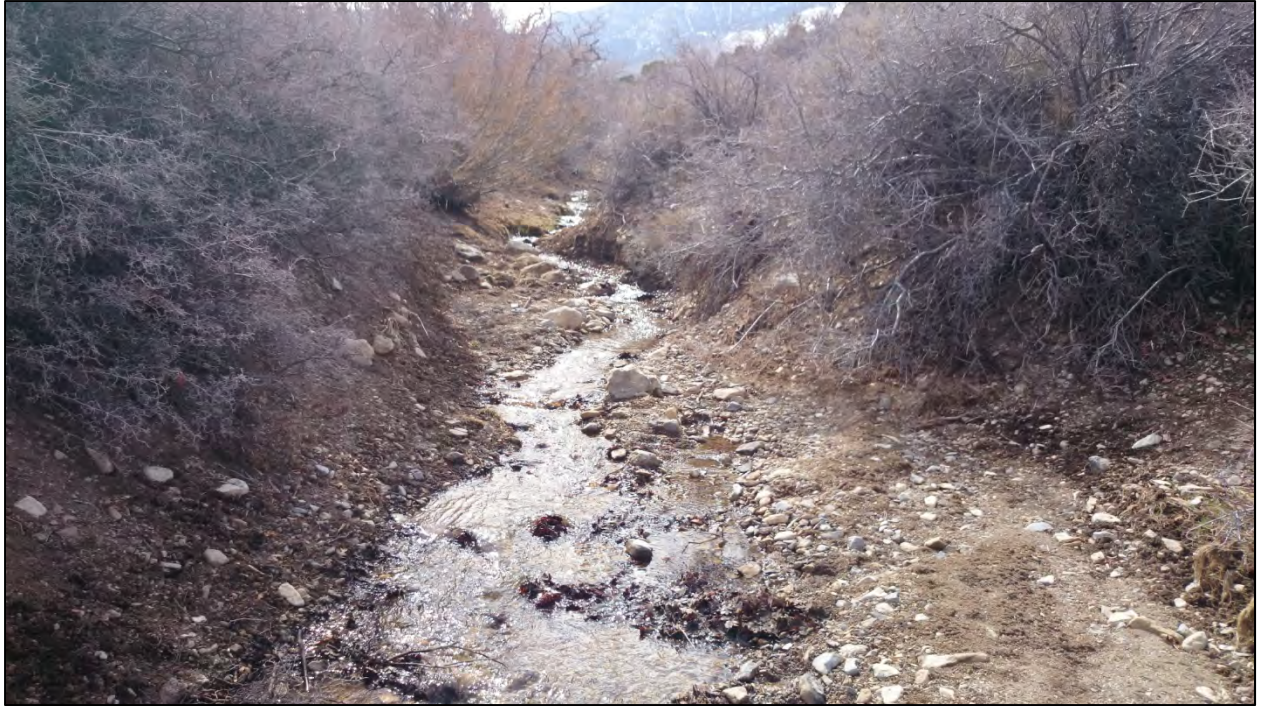
Figure 22. Cold Creek Near Cold Creek Road Pre Visit.

The pre visit photos can be seen in figures 22 and 23. Vegetation was very thick at points along the stream and horse trails (foot paths) lined the sides of the creek and various points. This stream and riparian vegetation is fed and sustained by a spring just upstream from the assessment location. The workshop participants were able to complete a PFC assessment for lotic conditions at this filed site.

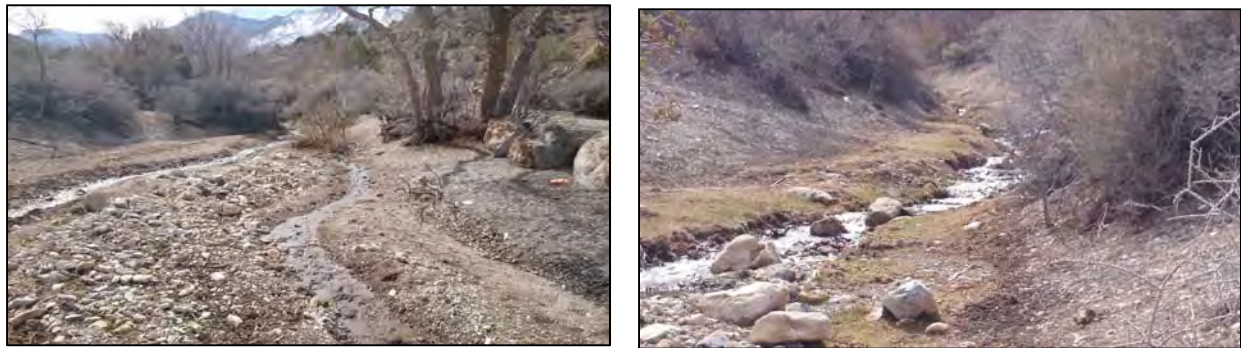
Figure 24. Cold Creek Channel and Riparian. Photographs by John Lin.

For Cold Creek, the width depth ratio and sinuosity are not appropriate for the stream setting. This system is degraded and is not recovering from past channelization, current water diversion and recreational activity. The flood event is too recent to determine the recovery ability.

Horse activity, urbanization in the upstream and upland areas are contributing to stream and riparian degradation.

- (1) Educating the public about waterbody health.
- (2) Implementing creek bank protection.
- (3) Commence riparian vegetation improvement through managing horses and wildlife, and/or through revegetation.
- (4) Maintain and restore the hydrologic connectivity of streams, meadows, wetlands.

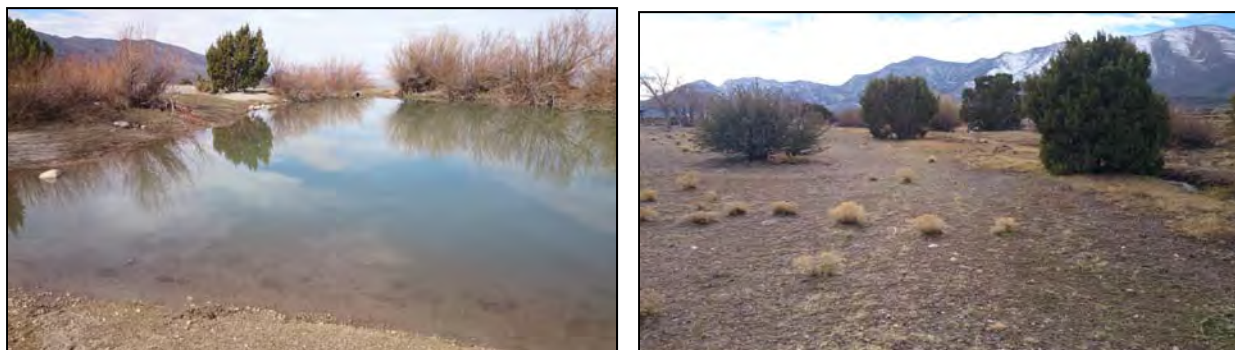
The lentic ponds are artificially maintained as a wild horse stock pond, recreational fishing, and as source water for fire fighting. Water is diverted from Cold Creek just below the spring, via a small channel into the ponds.

Figure 25. Cold Creek Fire Station Maintained Pond and Wetland Area Resulting from the Unlined Channel.

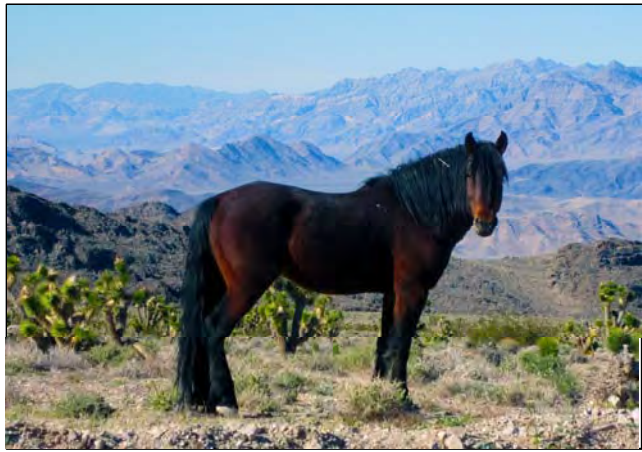
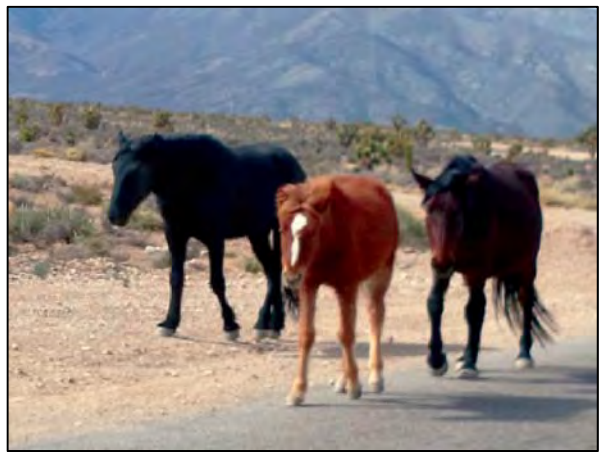
Figure 26. Photographs of Wild Horses in the Cold Creek Watershed. Photographs taken by John Lin & Tad Harris.
