# Empire Abrasive Blast N'Vac for Radiological Decontamination

## TECHNOLOGY EVALUATION REPORT

United States Environmental Protection Agency  
Cincinnati, OH 45268

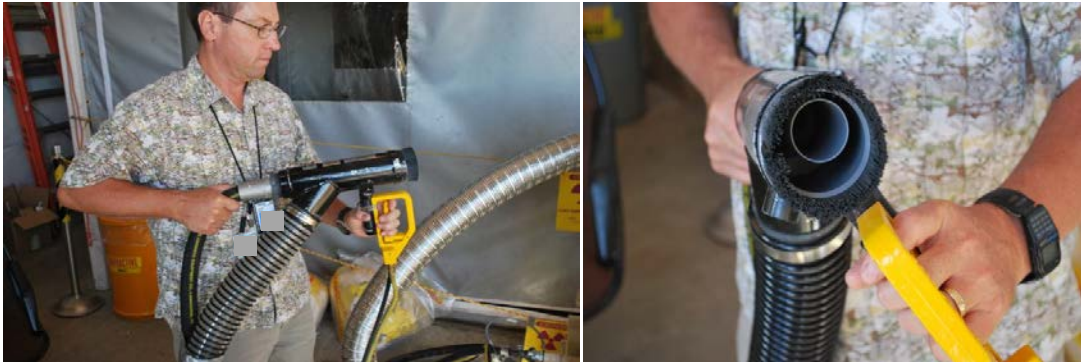
Figure 2-1 shows the Blast N'Vac blasting gun used during this evaluation. The photograph on the right clearly shows the inner blasting head and the vacuum shroud surrounding the blasting head. Figure 2-2 shows (from left to right) the abrasive grit reservoir, the high efficiency particle air (HEPA) filter, and the abrasive grit collection drum situated on a skid. The Blast N'Vac can also be equipped to recycle abrasive grit continuously, but that feature was not used during this evaluation in order to minimize the amount of equipment at risk of becoming contaminated with radiological material. Therefore, the abrasive grit was blasted and collected for disposal in the collection drum. All components in Figure 2-2 were successfully protected from contamination and were returned following the evaluation.

**Figure 2-1. Blast N'Vac as assembled for testing (left). Close-up of Blast N'Vac vacuum head (right).**

Blast N'Vac is a heavy duty abrasive grit blasting technology that also collects the spent abrasive grit by means of a blasting head surrounded with a vacuum collection shroud. During this evaluation, the Blast N'Vac was used with size 24 aluminum oxide abrasive grit. The Blast N'Vac was powered entirely by compressed air. An Ingersoll-Rand 75902 diesel-powered air compressor provided approximately 400 cubic feet per minute (cfm) of compressed air at approximately 120 pounds per square inch (psi). The Blast N'Vac is plumbed to provide not only an adequate amount of compressed air to perform the abrasive grit blasting but also adequate suction to perform the abrasive grit recovery. The air compressor was not provided by Empire Abrasive, but is considered a required utility for operation of the technology. In addition, while not tested as part of this evaluation, the Blast N'Vac came equipped with blasting heads shaped specifically for work in corners.

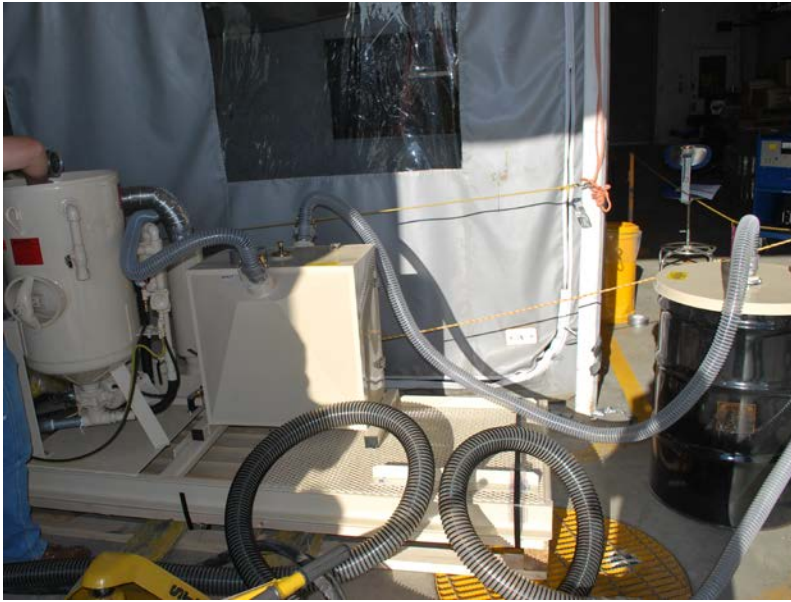
**Figure 2-2. Blast N'Vac abrasive grit reservoir, HEPA filter, and collection drum.**

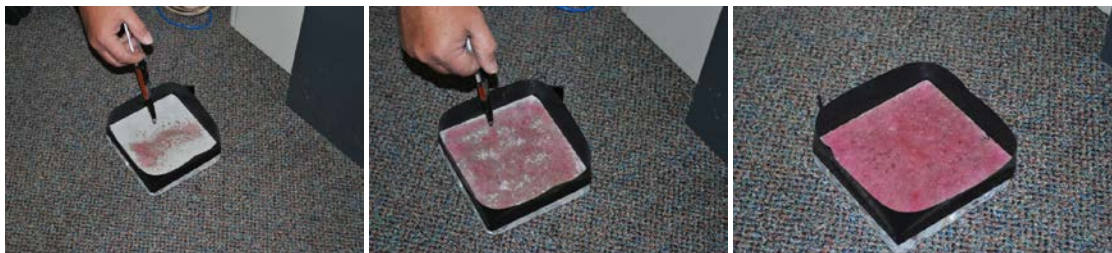
The aerosol delivery device was constructed of two syringes. The plunger and needle were removed from the first syringe and discarded. Then, a compressed air line was attached to the rear of the syringe. The second syringe contained the contaminant solution and was equipped with a 27 gauge needle, which penetrated through the plastic housing near the tip of the first syringe. Compressed air flowing at a rate of approximately 1 - 2 L per minute created a turbulent flow through the first syringe. When the contaminant solution in the second syringe was introduced, the solution became nebulized by the turbulent air flow. A fine aerosol was ejected from the tip of the first syringe, creating a controlled and uniform spray of fine liquid droplets onto the coupon surface. The contaminant spray was applied all the way to the edges of the coupon, which were taped (after having previously been sealed with polyester resin) to ensure that the contaminant was applied only to the surfaces of the coupons. The photographs in Figure 3-1 show this procedure being performed using a nonradioactive, nonhazardous aqueous dye to demonstrate that the 2.5 mL of contaminant solution is effectively distributed across the surface of the coupon.

**Figure 3-1. Demonstration of contaminant application technique.**

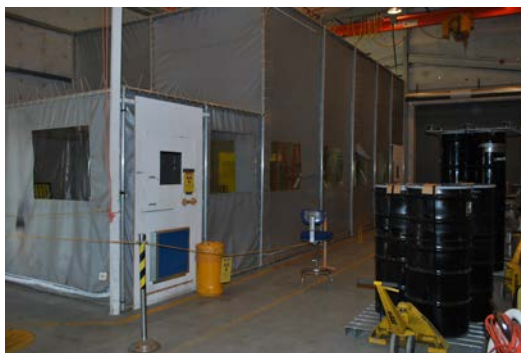
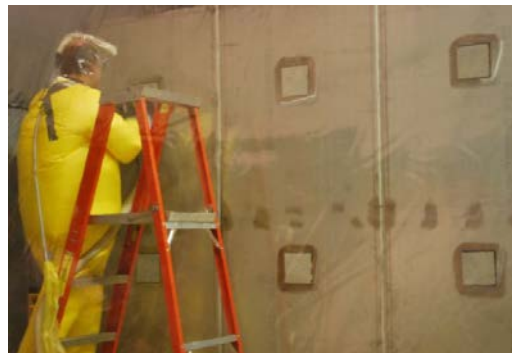
To evaluate the decontamination technologies on vertical surfaces (simulating walls), a stainless steel test stand was fabricated that held three rows of three concrete coupons. A test stand, approximately 9 feet (ft) × 9 ft, was erected within a containment tent. The concrete coupons were placed into holders so their surfaces extended just beyond the surface of the stainless steel face of the test stand. Eight of the nine coupons placed in the test stand were contaminated with Cs-137, which has a half-life of 30 years. One uncontaminated coupon was placed in the bottom row of the test stand and decontaminated using the Blast N'Vac in the same way as the other coupons. This coupon was placed there to observe possible secondary contamination caused by the decontamination higher on the wall. Figure 3-2 shows the containment tent and the test stand loaded with the concrete coupons.

**Figure 3-2. Containment tent: outer view (left) and inner view with test stand containing contaminated coupons (right).**

The containment tent consisted of two rooms. One room contained the test stand to hold the contaminated coupons and the other room (the shorter part of the tent as shown in Figure 3-2) held the collection drum. The abrasive grit hoses (both blasting and vacuum) connected to the blasting head in the room with the test stand through a small opening in the tent wall between the two rooms. The abrasive grit reservoir and air compressor were located outside the containment tent. The positive pressure blasting hose was connected directly to the blasting head through a small opening in the outer tent wall, through the smaller room, and also through a small opening in the tent wall between the two rooms. The vacuum line was connected first to the collection drum and then to the collection shroud surrounding the blasting head, through the same openings in the tent. Each of the tent openings was taped closed around the hoses. Figure 3-3 shows the smaller diameter blasting hose and the larger diameter vacuum hose connecting to the blasting head as the operator applies the Blast N'Vac to a concrete coupon.

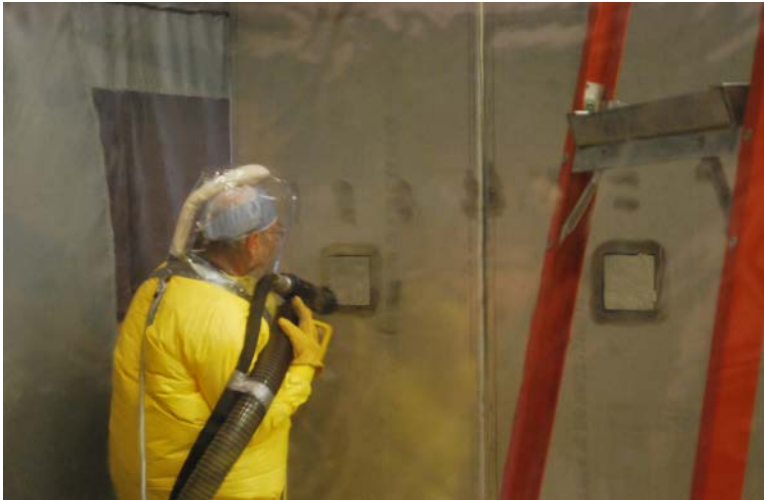
**Figure 3-3. Operator applying Blast N'Vac to concrete coupon.**

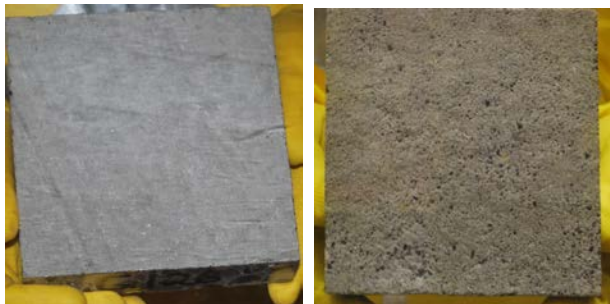
A number of operational factors were documented by the Blast N'Vac operator. One of the factors was damage to the surface of the concrete coupons. Figure 5-1 shows photographs of a coupon before and after blasting with the Blast N'Vac. The surface of the coupon

at the right has been removed by the Blast N'Vac and the aggregate layer of concrete has been exposed. This is evidenced by the large pieces of gravel and sand that are visible. Because of the extensive surface removal, the effectiveness of the Blast N'Vac will have to be weighed against the amount of surface damage caused by the decontamination technology.

**Figure 5-1. Test coupon surfaces before (left) and after (right) treatment with the Blast N'Vac.**

<b>Surface damage</b>	<p>Surface removed and aggregate exposed. See description and photograph in text.</p>
<b>Cost</b>	<p>As evaluated, the price of the Blast N'Vac would be \$11,840. This price includes the blasting equipment only and not the compressed air required for operation or the blasting grit.</p>
